Jerry Hofer

February 6, 2023

Tree Consultation Proposal For: McIntosh Property

Site Information: TaxParcel 127449000 3210 NW McIntosh Rd. Camas, WA 98607

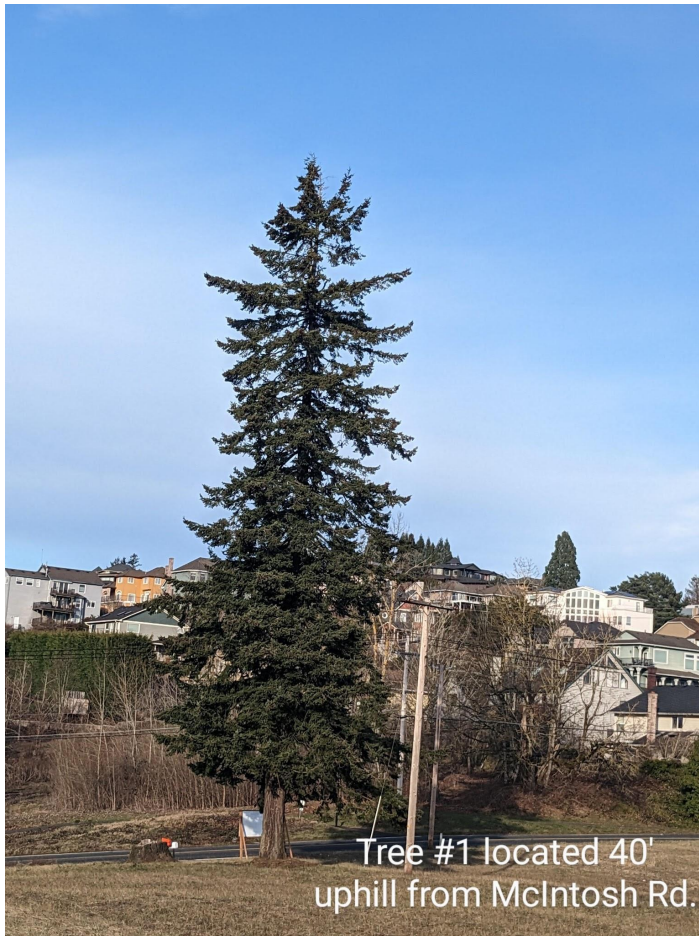
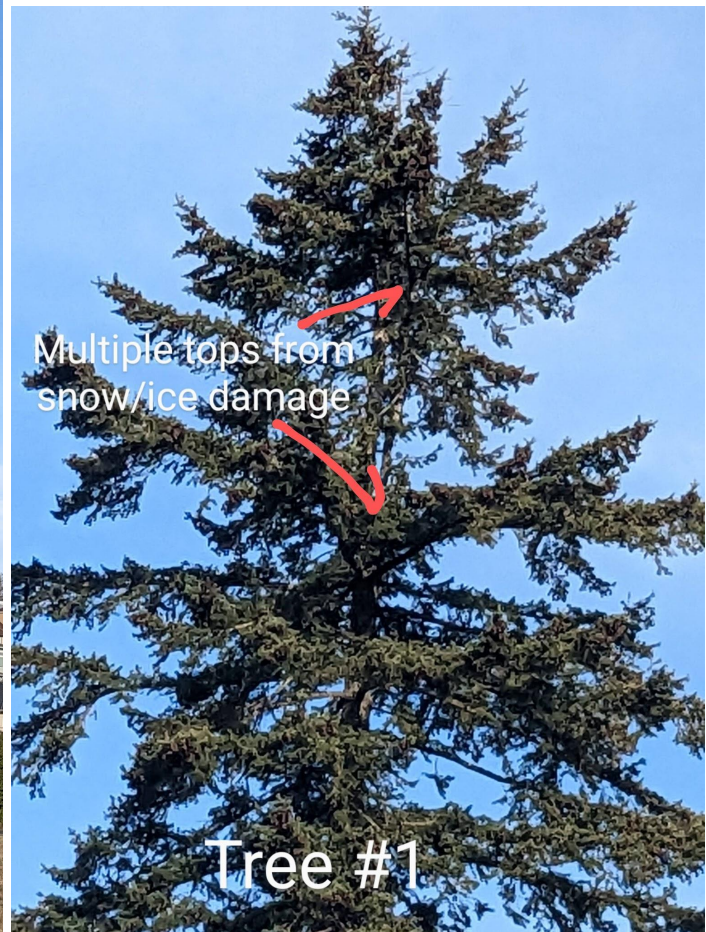
Tree #1 is a 37" Douglas fir, 90' tall and located about 40' south of McIntosh Road where the entrance for this subdivision will be built. While the tree looks in good condition, it exhibits some past breakage about 15' from the top. This breakage resulted in several branches growing upward to become new tops. This creates a weak area subject to future breakage, especially from a freezing rain, ice/snow event.

Where the multiple stems start in near the top of tree #1, is a weak area that often times results in breakage occurring with strong winds, and heavy freezing rain or ice/snow events. Because this tree

would be hanging over the subdivision access road, it would be a potential hazardous situation for cars or pedestrians. Given both factors listed above, I recommend that tree #1 be removed. Additional trees will be planted along both sides of the access roads.

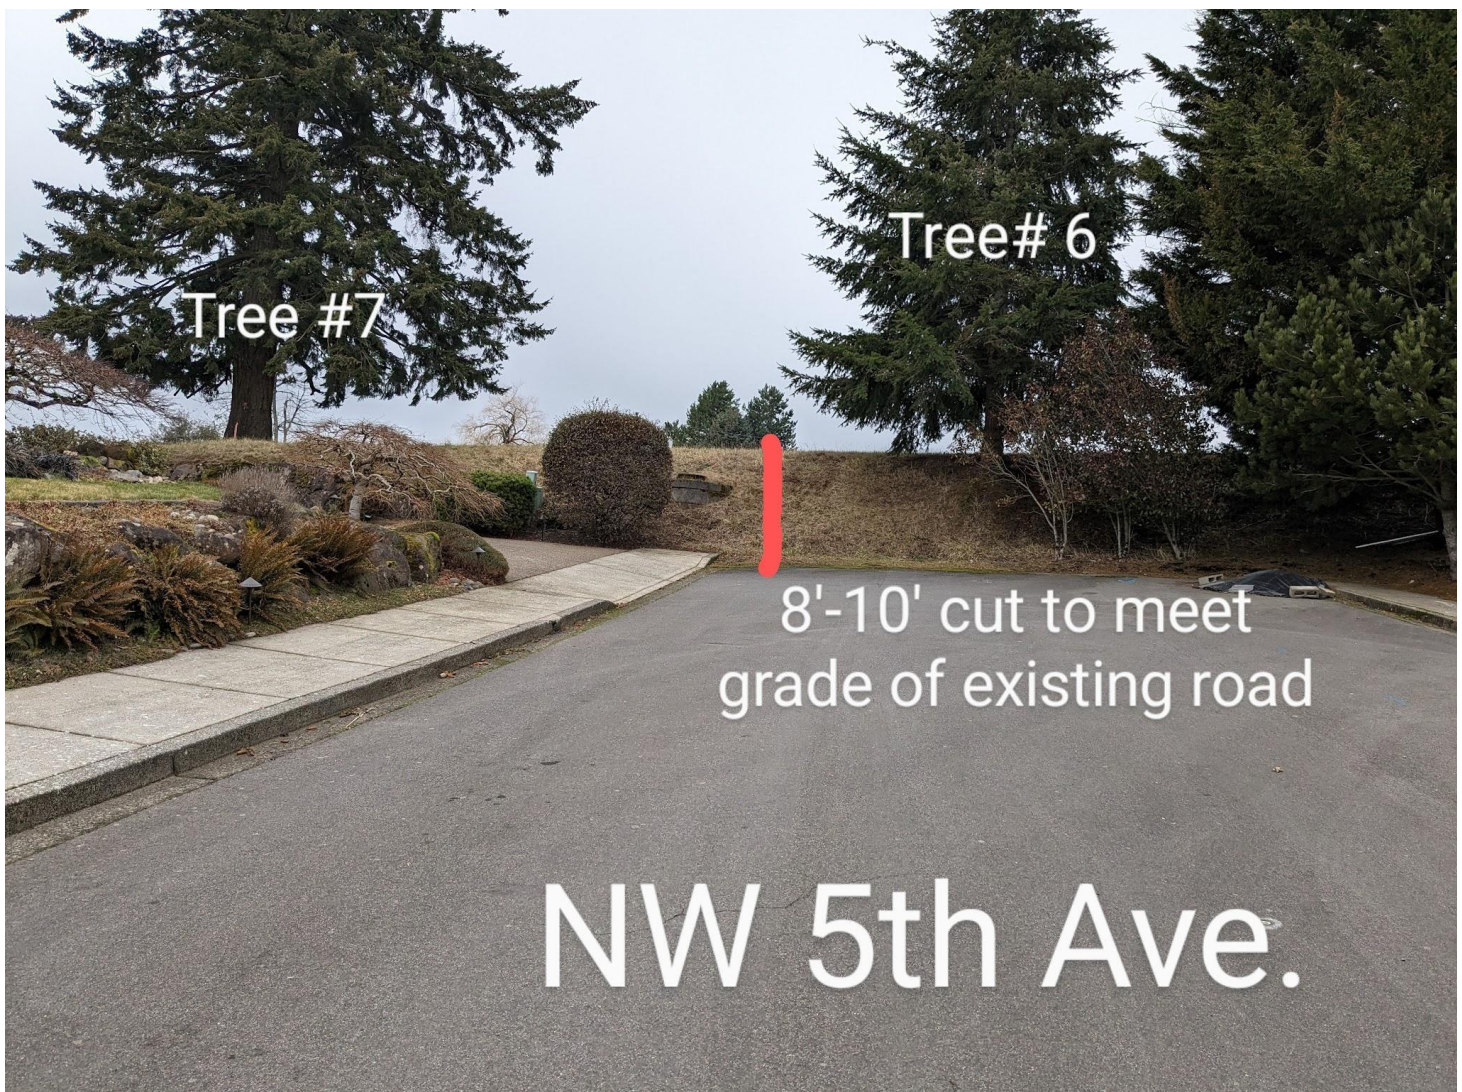
Trees #3, #4, #5, #6 and #7 are located where the new access road will join NW 5th Ave. Trees #6 and #7 are shown in the photo below. Trees #3, #4, and #5 are 14"-17" alder located behind tree #6. Because of the cut, 8' - 10' deep, that will be needed to match the elevation of NW 5th Avenue roadway and sidewalks, these trees will need to be removed. The existing sewer line will be removed and reconstructed to make it deeper next to tree #7. This will likely kill the tree making it a hazardous situation for existing houses on adjacent property as well as new houses. Trees #3, #4, & #5 located immediately behind tree #6 will also be removed for this work. There will be new trees planted in the street strip along NW 5th Ave.

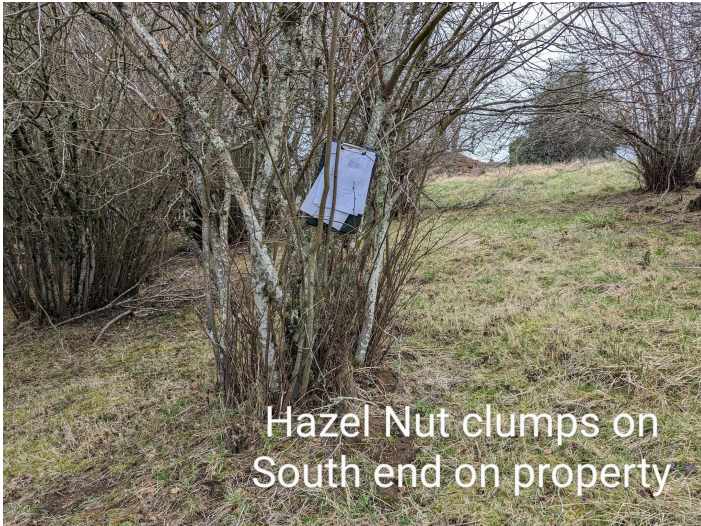
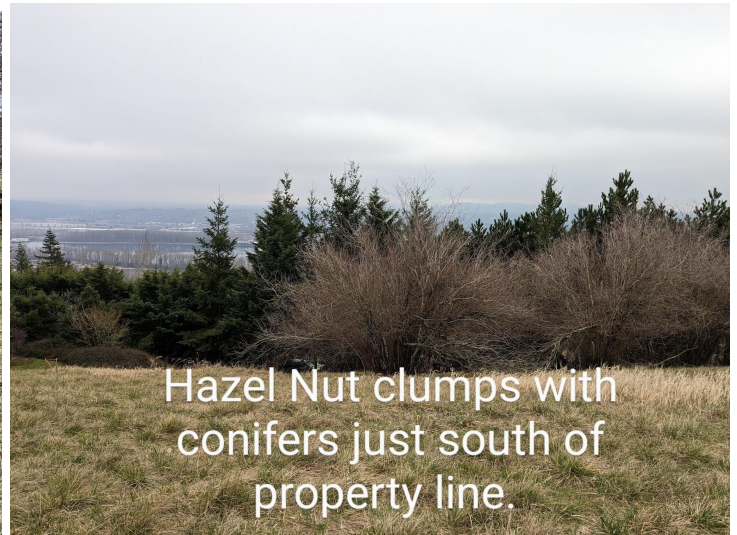
There are 10 clumps of hazelnut trees/shrubs on the south side of the property, just north of the property boundary. The clumps range in size from 2' - 8' with 5-40 stems per clump. The height ranges from 8' - 10'. They provide some vegetative and visual diversity, and are planned to be left. See photo below:
