## Downtown Camas Infrastructure Analysis

May 2020

Prepared for:  
**City of Camas Public Works Department**

Prepared by:  
**MacKay Sposito**

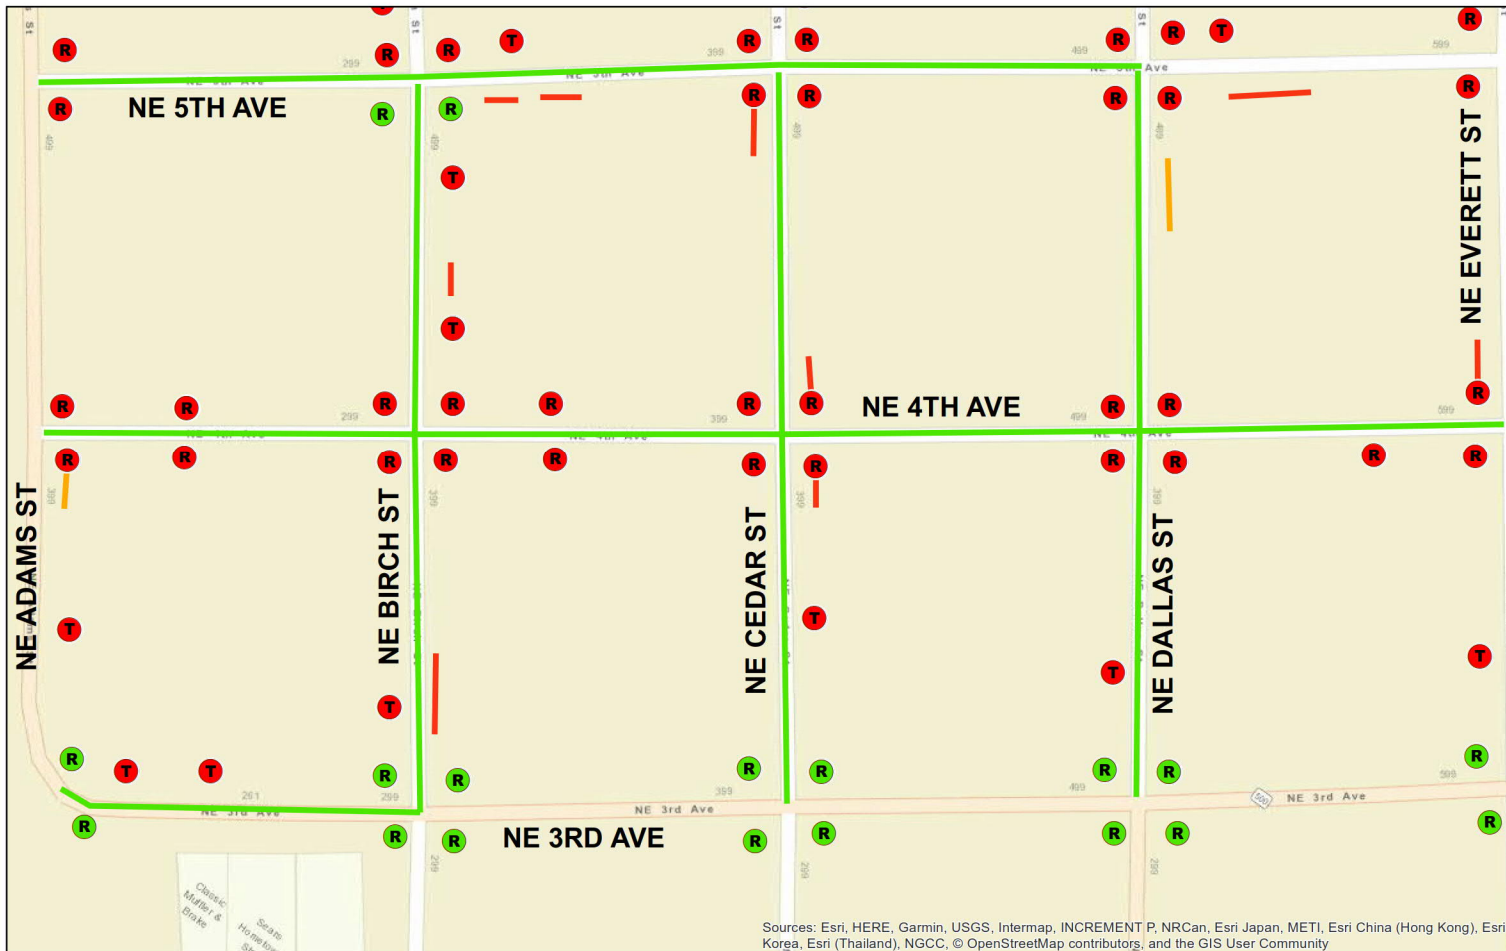
P-1 Isolated Sidewalk, ADA Ramp, and Tripping Hazards Replacement - Downtown Core

The project includes removing and replacing isolated sections of sidewalk to replace existing exposed aggregate sidewalks and address severe cracking and tripping hazards. The project also includes constructing new ADA compliant curb ramps to address safety concerns and accessibility deficiencies within the Downtown Core. The limits of this work are from the right-of-way or building face to back of existing curb. The project includes addressing all areas in the Downtown Core that do not meet the >25% criteria and assumes the work will be completed in a single project. See project P-2 for similar improvements outside of the Downtown Core. The project assumes that design and construction will meet the City's Downtown Design Manual guidelines. Examples of removal/replacement include:

- Exposed aggregate sidewalks
- Severely cracked or lifted sidewalks, including panels around existing tree wells
- Installing ADA compliant curb ramps where none currently exist
- Replacing existing curb ramps that are out of compliance

Because this project focuses on isolated locations it does not include installation of new electrical. Tree removal and replacement will be required in some locations. Please see below for an estimated quantity and refer to P-9 for tree removal and replacement project.

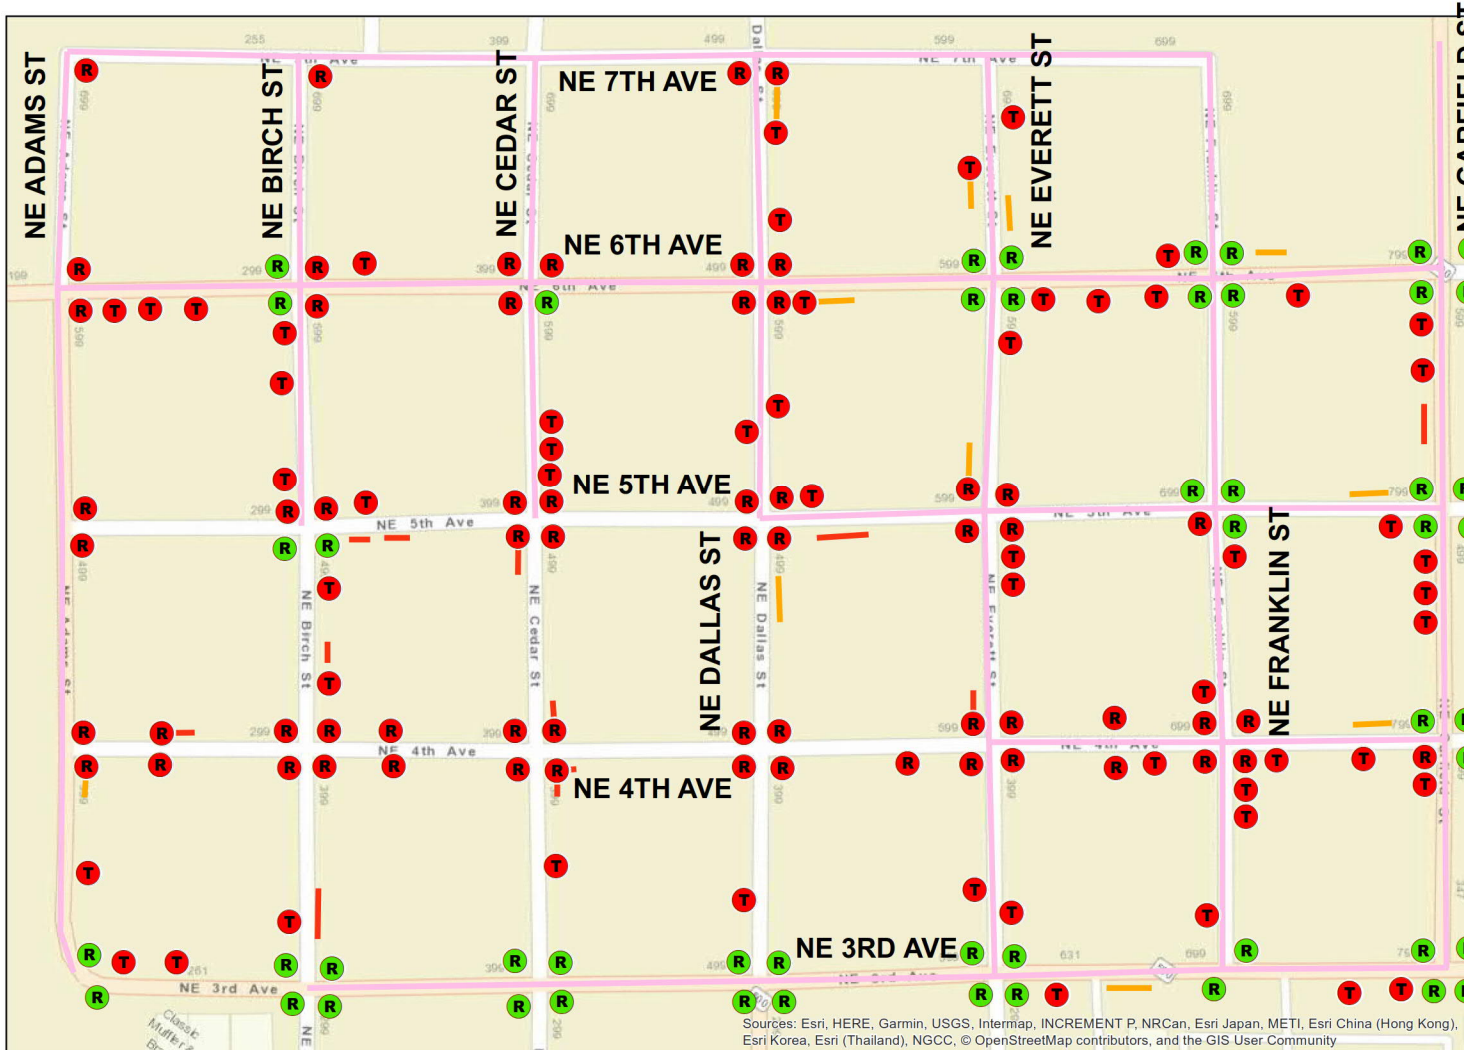
P-2 Isolated Sidewalk, ADA Ramp, and Tripping Hazards Replacement – Outside Core

The project includes removing and replacing isolated sections of sidewalk to replace existing exposed aggregate sidewalks and address severe cracking and tripping hazards. The project also includes constructing new ADA compliant curb ramps to address safety concerns and accessibility deficiencies outside the Downtown Core area. The limits of this work are from the right-of-way or building face to back of existing curb. The project includes addressing all areas outside the Downtown Core that do not meet the >25% criteria and assumes the work will be completed in a single project. Examples include:

- Exposed aggregate sidewalks
- Severely cracked or lifted sidewalks, including areas around existing tree wells
- Installing ADA compliant curb ramps where none currently exist
- Replacing existing curb ramps that are out of compliance

Because this project focuses on isolated locations it does not include installation of new electrical. Tree removal and replacement will be required in some locations. Please see below for an estimated quantity and refer to P-9 for tree removal and replacement project.

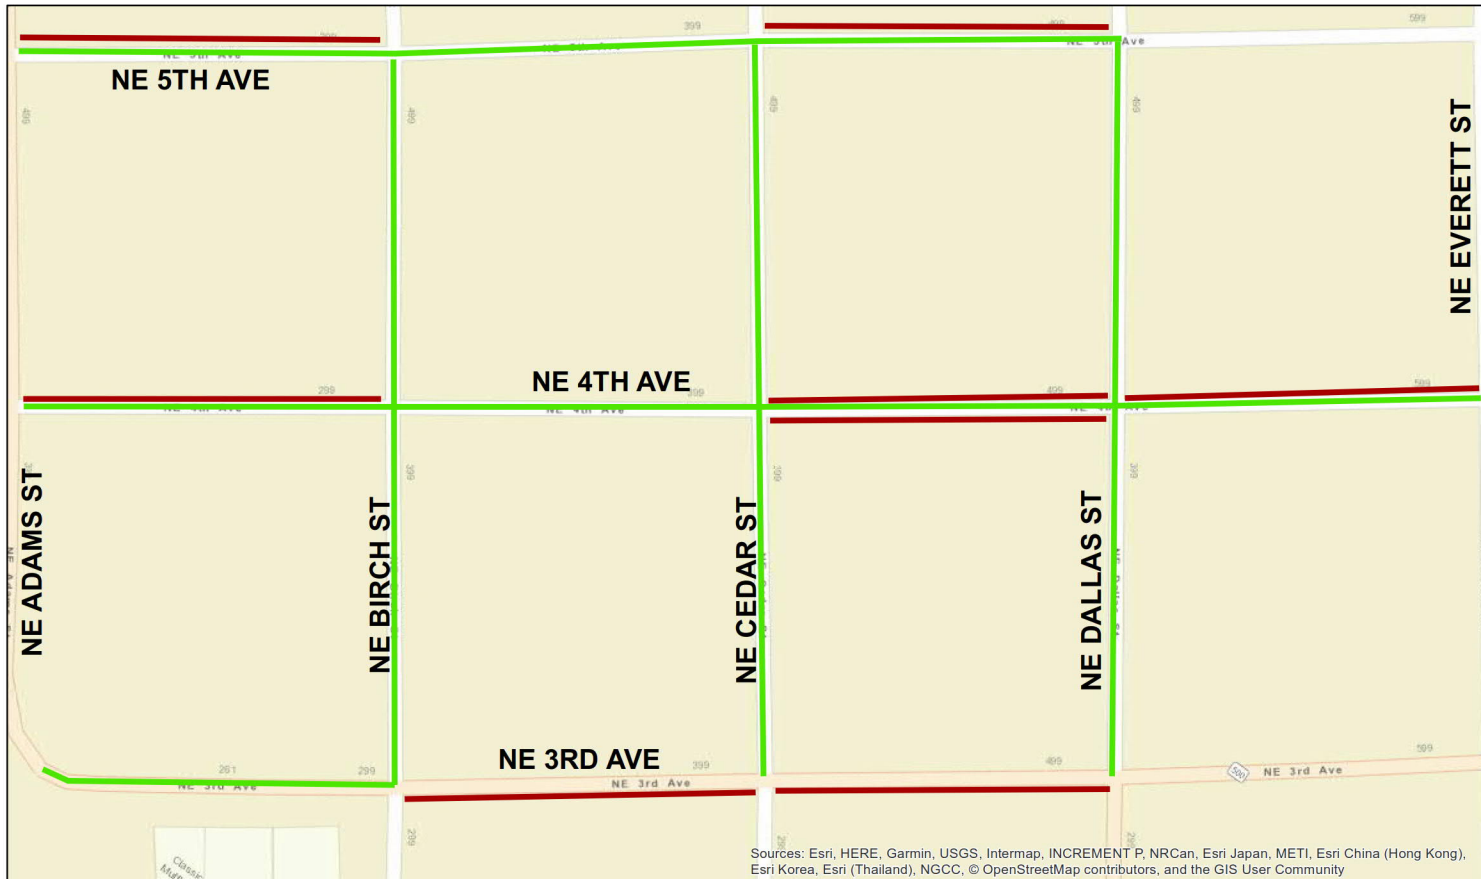
### P-3 Full Block Sidewalk and ADA Ramp Replacement – Downtown Core

**Project Description:**  
 This sample project includes removing and replacing a single side of one full block of sidewalk, and replacing or installing new ADA compliant curb ramps to address safety concerns and accessibility deficiencies within the block. The limits of this work are from the right-of-way or building face to back of existing curb between the block. The project includes areas that meet the >25% sidewalk replacement criteria. The project assumes that design and construction will meet the City's Downtown Design Manual guidelines. The existing furnishings will be preserved and protected during construction of this project including:

The project includes removing and replacing existing trees when adjacent to severely cracked or lifted sidewalk panels. Refer to P-9 for tree removal and replacement project and P-8 for new electrical project.

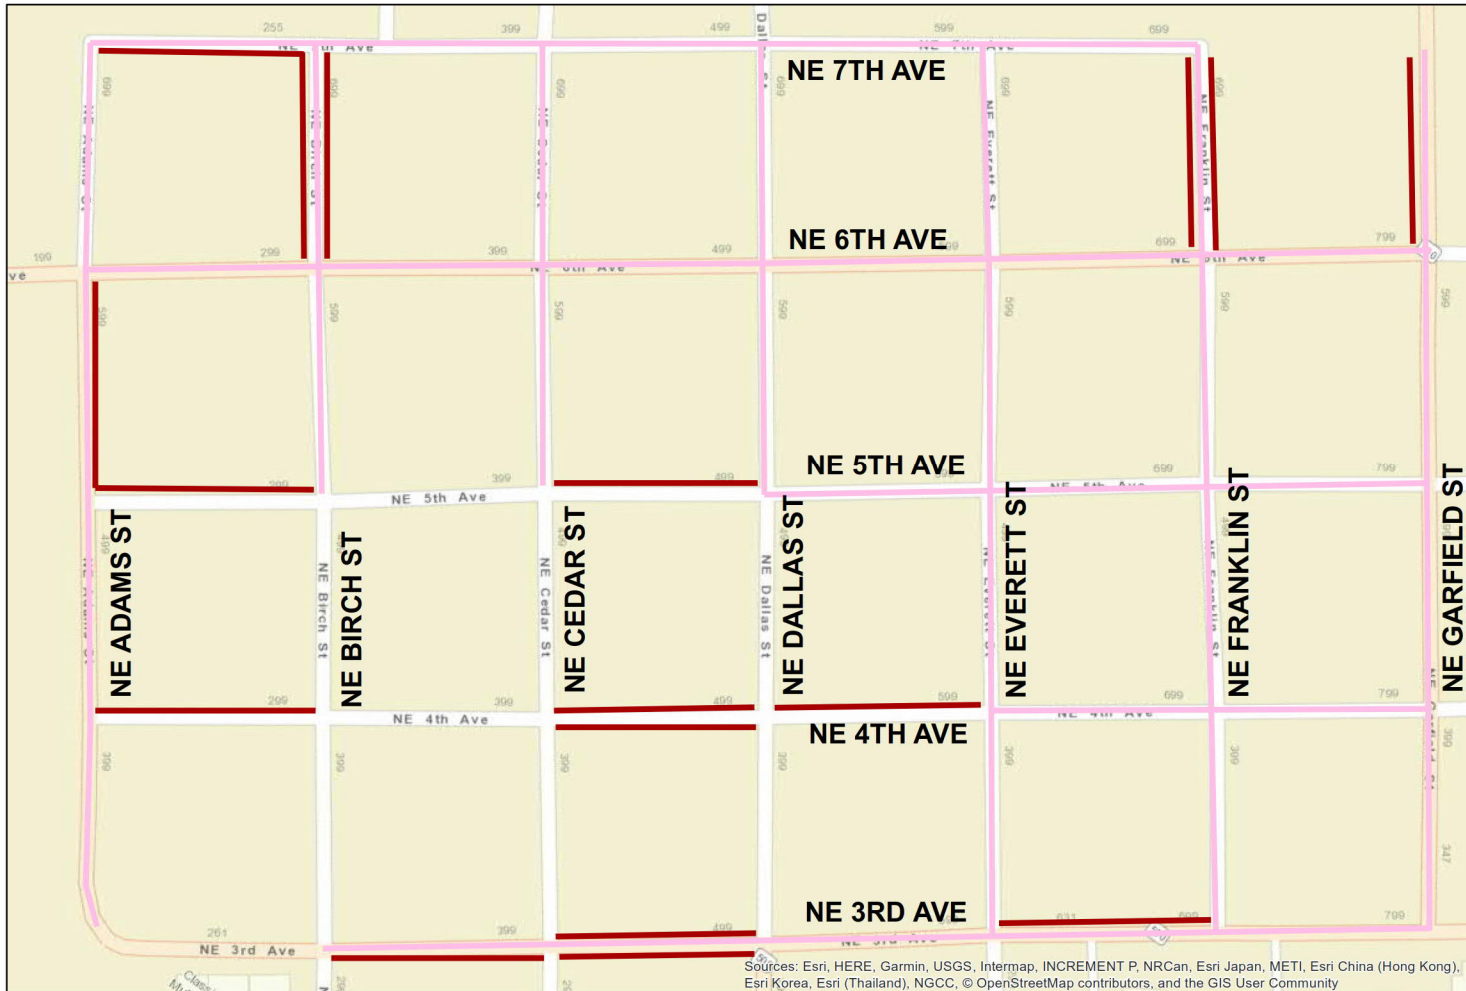
P-4 Full Block Sidewalk and ADA Replacement – Outside Core

The project includes removing and replacing a single side of the street for full block sections of sidewalk, and replacing or installing new ADA compliant curb ramps to address safety concerns and accessibility deficiencies within the block. The project also includes constructing sidewalks where none currently existing to improve connectivity. The limits of this work are from the right-of-way or building face to back of existing curb. The project meets the >25% sidewalk replacement criteria. The project includes removing and replacing existing trees when adjacent to severely cracked or lifted sidewalk panels. Refer to P-9 for tree removal and replacement project and P-8 for new electrical project.
