## MEMORANDUM

**DATE:** December 7, 2015

**RE:** Initial Site-Specific Evaluation of Geohazard Areas A and C  
Camas Subdivision – Leadbetter Road  
Camas, Washington  
15948-02

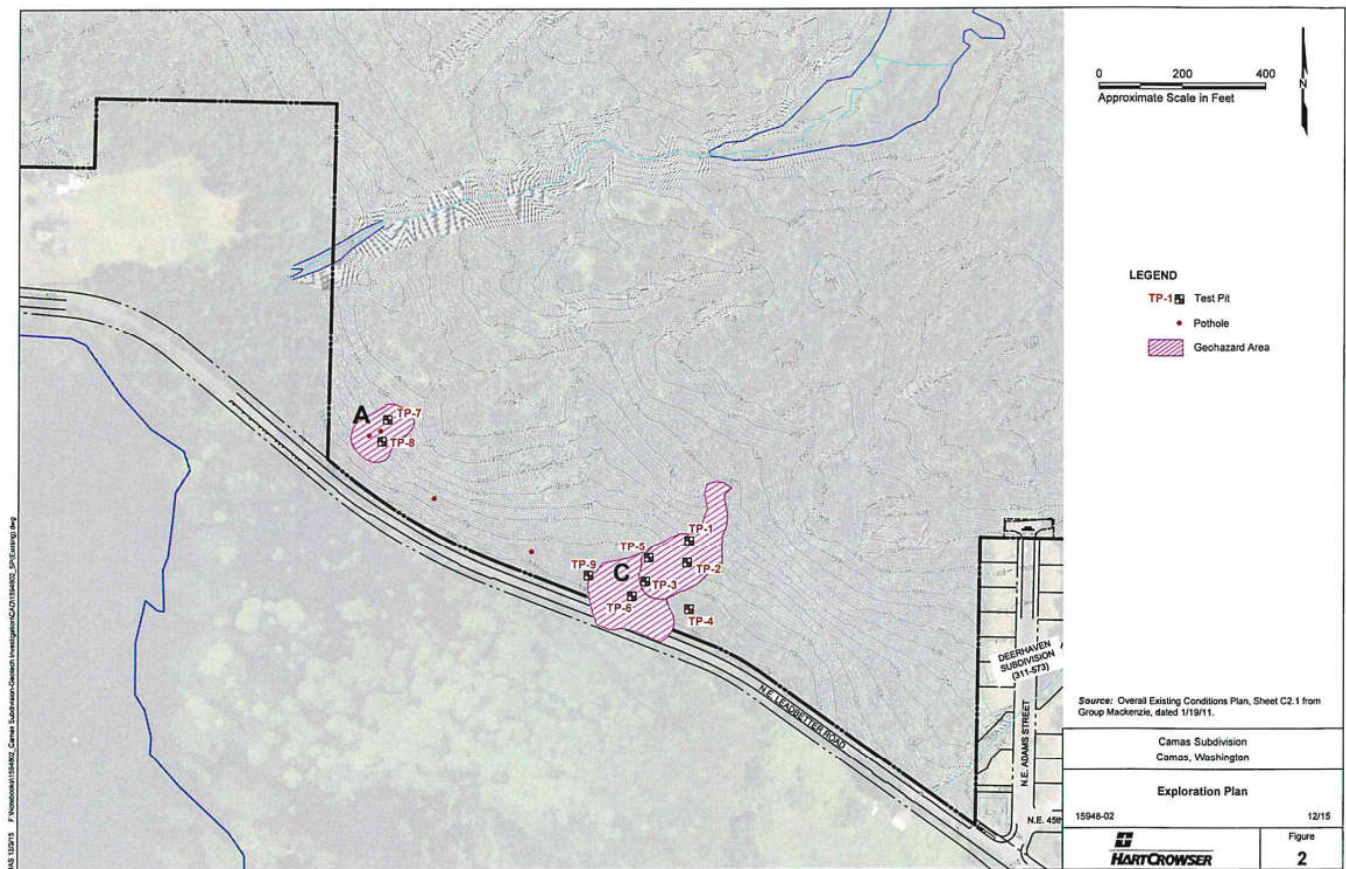
The location of the site is shown on Figure 1. The locations of Geohazard Areas A and C and our recent test pit explorations are shown on Figure 2.
