## MEMORANDUM

DATE: Thursday, February 22, 2024  
 TO: Eric Papenfuse | Eric's Custom Design  
 FROM: Peter van Oss, ASCA RCA #826 | ISA Certified Arborist, PN-8145A  
 RE: Tree Survey at 748 SW Valley Street, Camas, WA

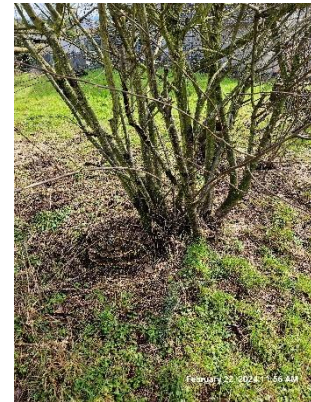
Peter van Oss performed a site inspection on February 22, 2024, to evaluate the existing conditions of the site and the foreseeable impacts related to the planned development of the site. There are five trees shown on the site plans toward the center of the property which are sucker growth from a previously removed tree. Photo 1 shows the old stump with numerous fruiting bodies that indicate that the tree was removed some time ago. The new growth stems from the roots of the removed tree which is referred to as sucker growth. The tree that is located along the east side of the property is a young pine tree that is located at the bottom of the slope of the backyard.

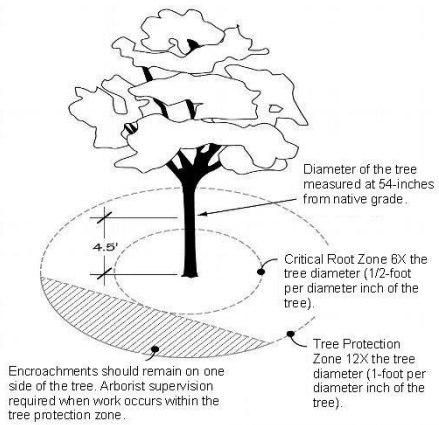
## EXISTING TREE PLAN

Trees #1 through #5 are suckers from a removed cherry plum (*Prunus cerasifera*) and they are all less than 12-inches in diameter meaning that they are not considered "significant" trees per City of Camas code 18.3.50 – Definitions. The volunteer trees are in the footprint of the new structure and retention of the trees is not viable.

Tree #6 is a 9-inch DBH shore pine (*Pinus contorta*) located near the property line on the bottom of the slope and it is anticipated that the fill soils from grading will impact the tree significantly. All six trees on the property are recommended for removal.

Based on the observations and information provided, the professional opinion is that the trees should be allowed for removal since the impacts from construction will not allow for the retention of the trees. If further questions or additional information is needed, please feel free to reach out.

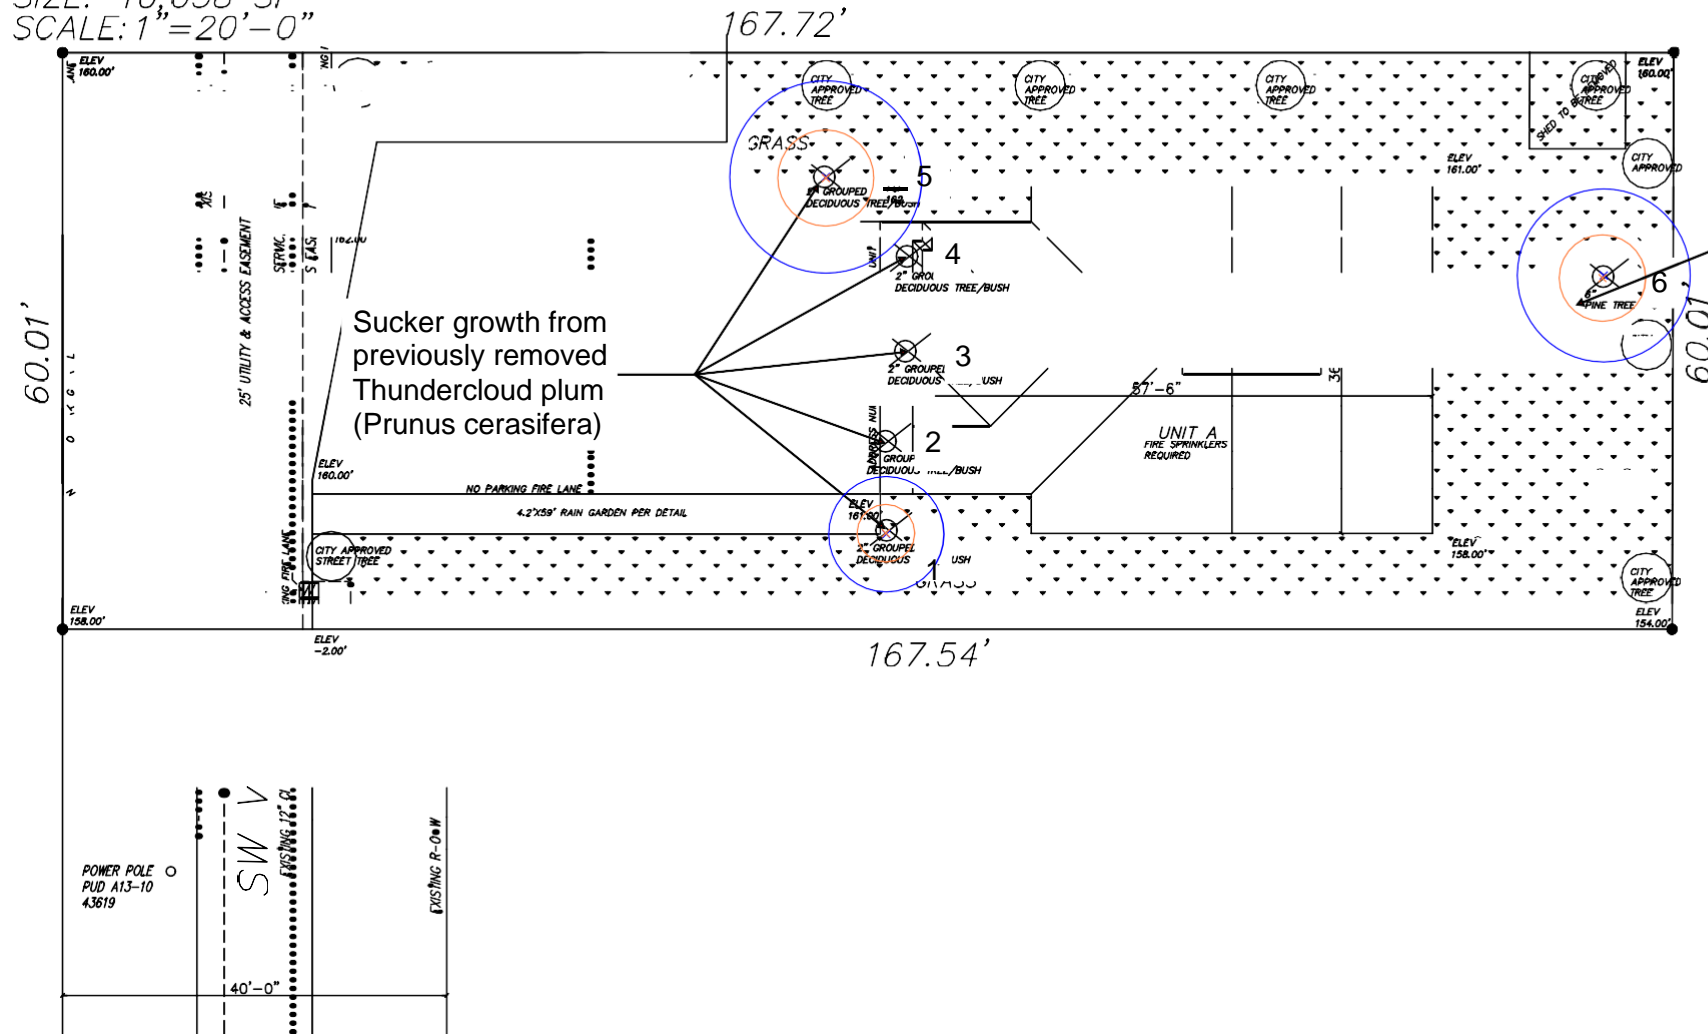
Significant fill anticipated which will likely kill the tree in the near future.
