1811 NW Hood Street Tree Survey Camas, Washington

June 15, 2021

TREE SURVEY

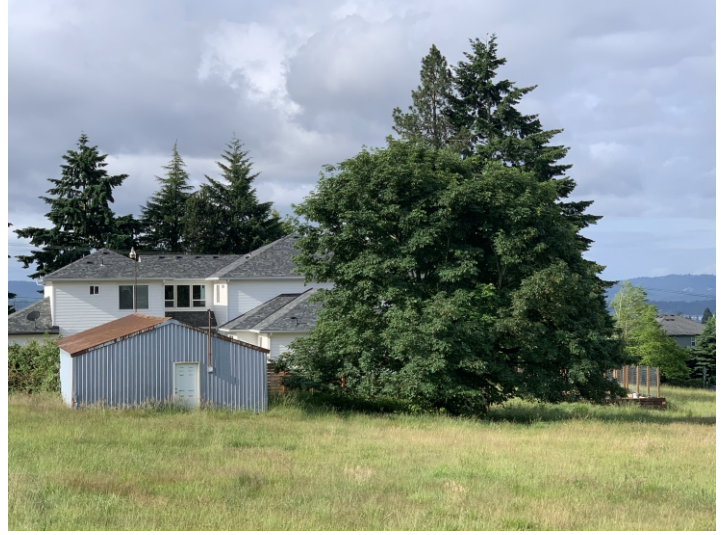
- One large over-mature bigleaf maple (Tree#5) is located within the southwest corner of the northern parcel just north of the property line for 1611 Hood Street (Fig. 2). Tree#5 has many structural issues (Photo Sheet 1) including a large crack bifurcating the bole along the south side, a 6' crack along the west side as well as signs of previous branch failure and moderate to severe rotting at the base. This tree currently poses a high risk to the fence and yard belonging to the property to the south. Additionally, these trees fall within the footprint of a proposed residential lot, unavoidable rootzone impacts are likely to occur during construction. This tree is recommended for removal.

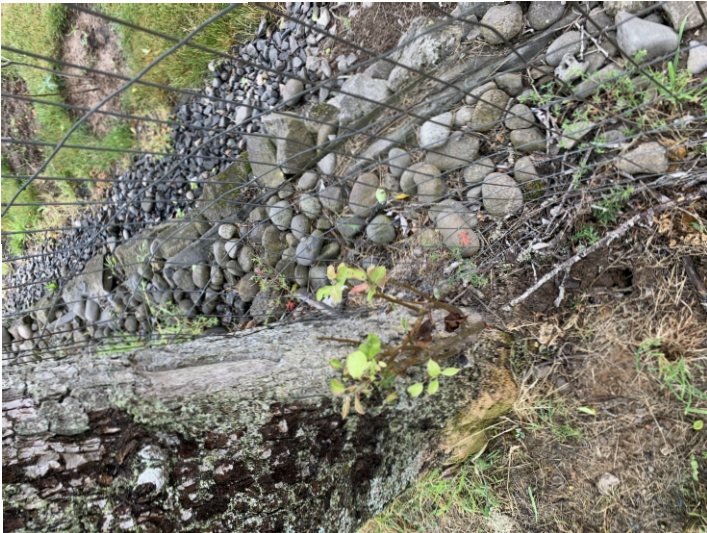
- One ornamental apple tree (*Malus sp.*) (Tree#1) is located within the northwest corner of the parcel (Fig. 2) Tree#1 is healthy, but a French drain is located directly below it in the adjacent parcel (Photo Sheets 1 and 2). No uprooting is occurring at the present time but there is a high likelihood of this occurring in the future. Additionally, this tree falls within the footprint of a proposed residential lot, unavoidable rootzone impacts are likely to occur during construction. This tree is recommended for removal.

Tree#1 French Drain

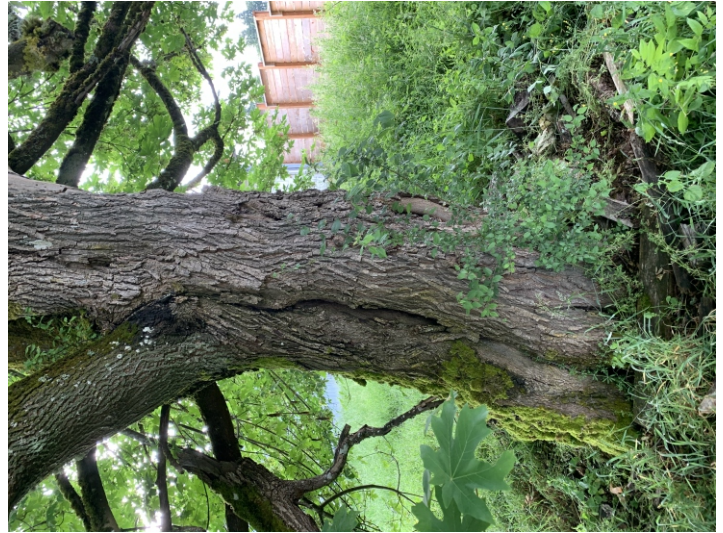
Tree#5 West crack

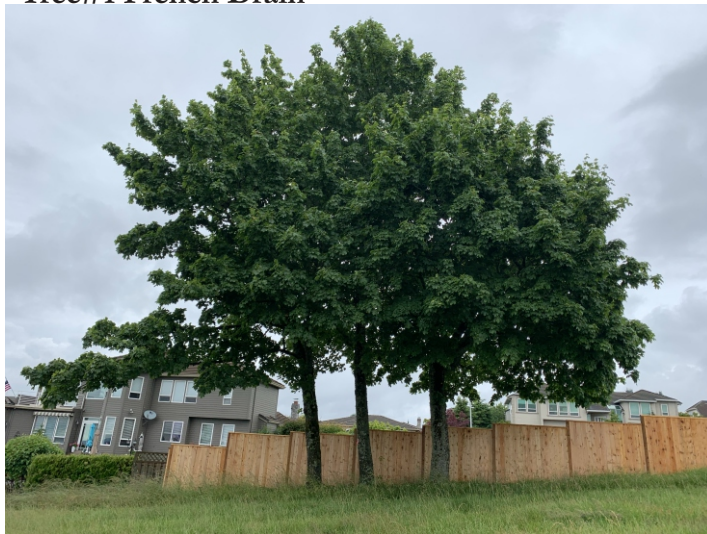
Tree#2-4

- Three mature big-leaf maples (*Acer macrophyllum*) (Tree#2-4) are located approximately in the center of the northern property line (Fig. 2). The central maple (Tree#3) has a small cavity at the base and minor exposed roots, the health of this tree is fair. The other two bigleaf maples in this location (Tree#2, 4) are healthy. These trees fall within the footprint of a proposed residential lot, unavoidable rootzone impacts are likely to occur during construction. These trees are recommended for removal.

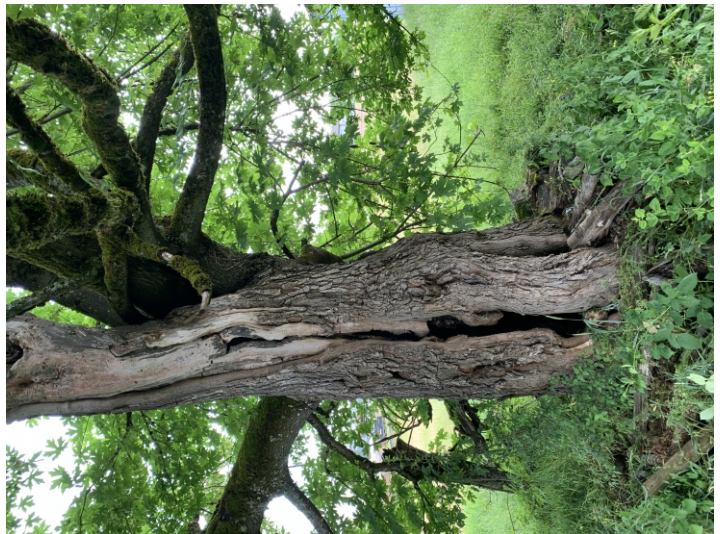
Tree#5 South crack/bole splitting

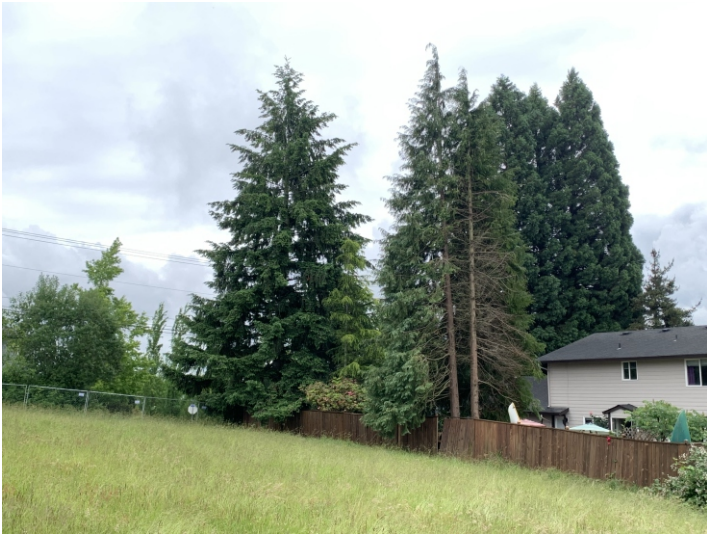
Off-site Tree#1-3

An additional 9 (nine) trees were identified on adjacent parcels to the west and southeast of the study area (Fig. 2). Most of these trees were just on the other side of the western fence-line of the southern parcel and could not be fully assessed. The DBH for these trees was estimated from the east side of the fence and general health was noted (Appendix 1 and Photo Sheet 1). Proper investigation of the roots and stem below eye-level over the fence could not be completed from this vantage. An additional two trees are located within the yard of the adjacent parcel to the southeast. Retention versus removal of all off-site trees is not addressed here due to both the inaccessibility for full assessment and the ownership status of these trees relative to the proposed development. Please also note that the root protection zone for all off-site trees is based on estimated DBH.

- Erect and maintain readily visible Root Protection Zone (RPZ) fencing approximately 30' from the outer dripline of the trees to be preserved. The fence shall be 4' orange construction/snow fencing and at least four feet high
- Maintain the protective barriers in place until the final construction acceptance is issued
- If excavation is required at the edge of the RPZ, cleanly sever the roots of trees to be retained
- Install Arborist chips on the outer edge of the dripline as a buffer between the construction zone and the outer edge of the dripline. This material is considered an excellent product to prevent stress from the construction activities.
