# Stockton Avenue Bridge Structural Evaluation Findings

# Stockton Avenue Bridge at Soquel Creek

(Br. No. 36C0110)

## Structural Condition Evaluation

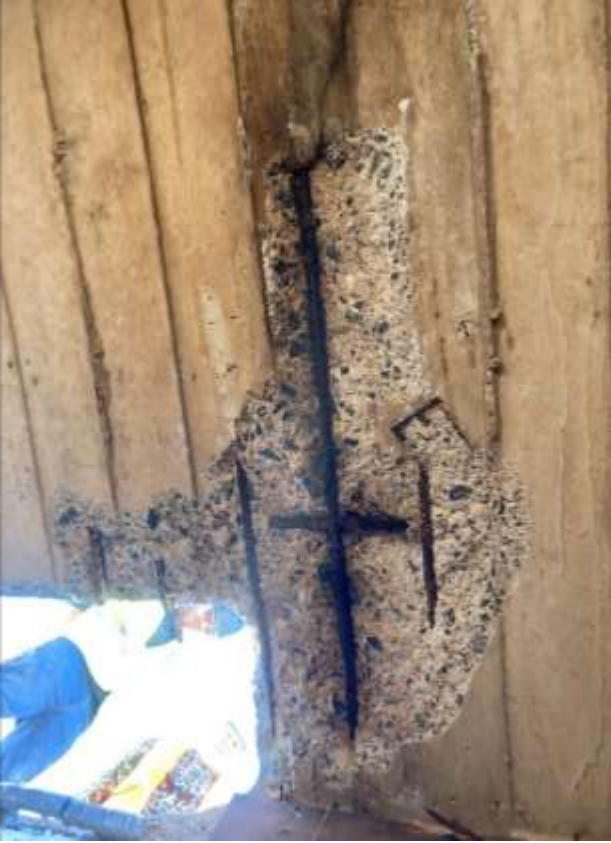
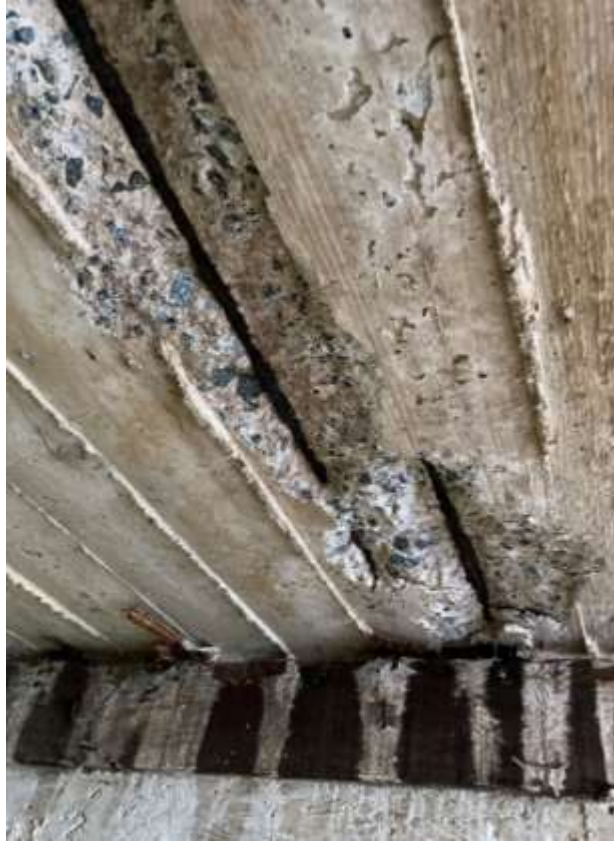
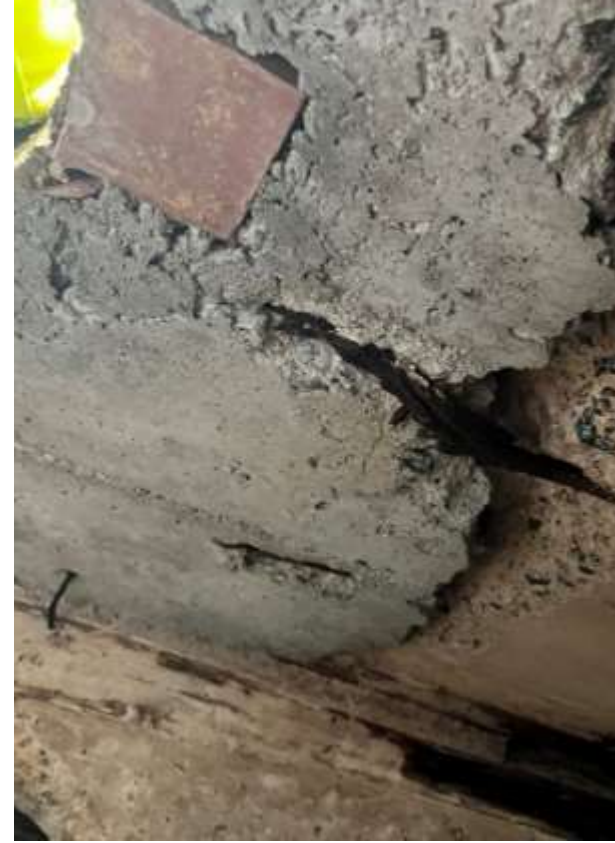
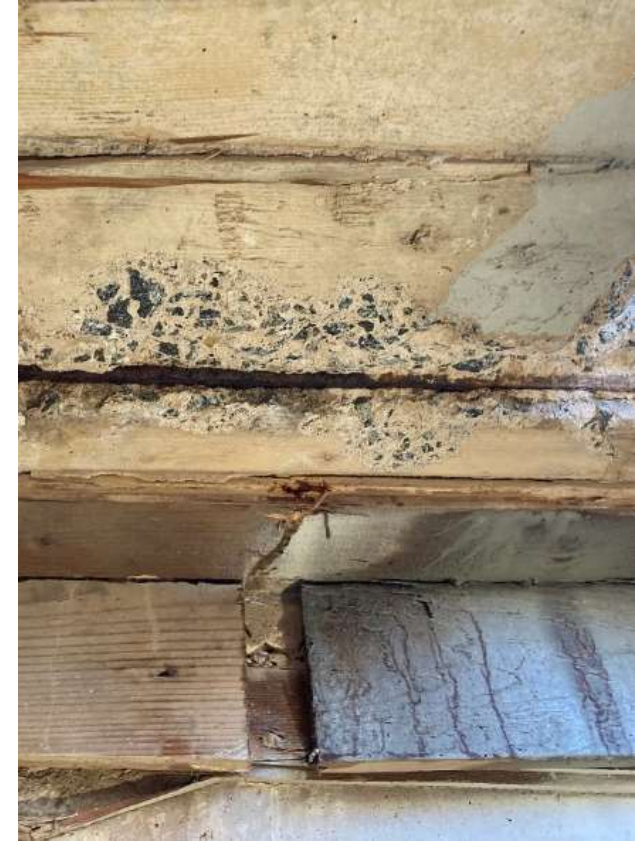
## EXISTING SIDEWALK CONDITIONS

July 2025 Site visit  
(manhole access only)

- Corroding reinforcement and spalling was observed in beneath the sidewalk. Underside of the bridge deck at roadway manholes not visible due to formwork.
- Chain-drag evaluation of the deck located several areas that indicated delaminations of the concrete
- Additional deck openings were recommended

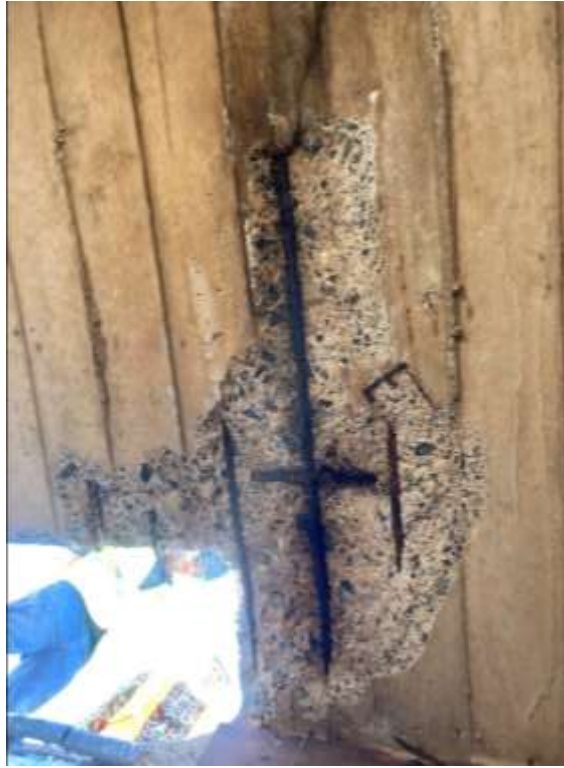
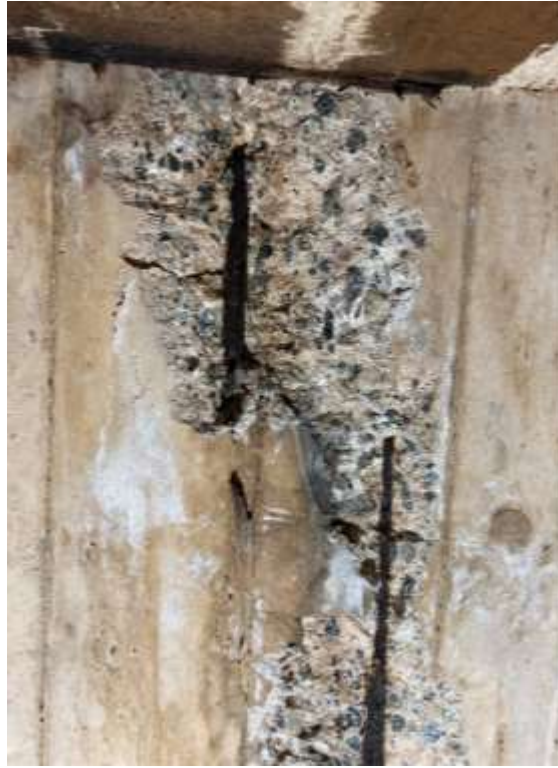
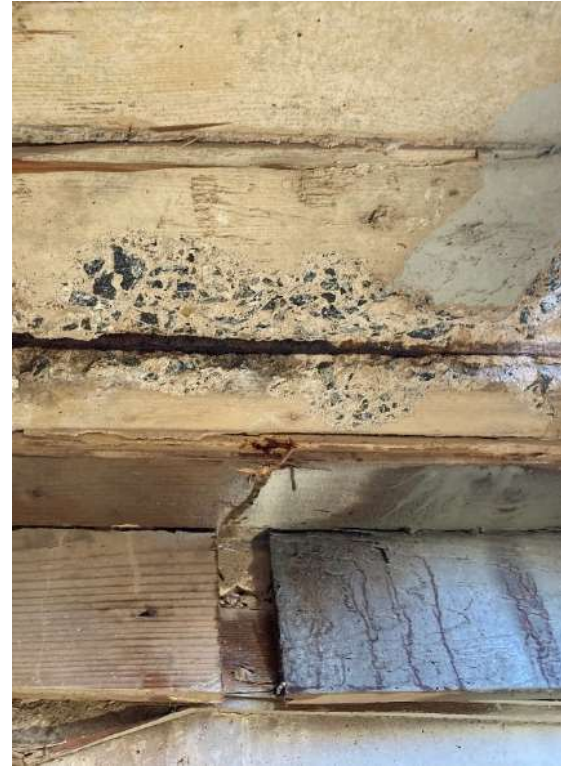
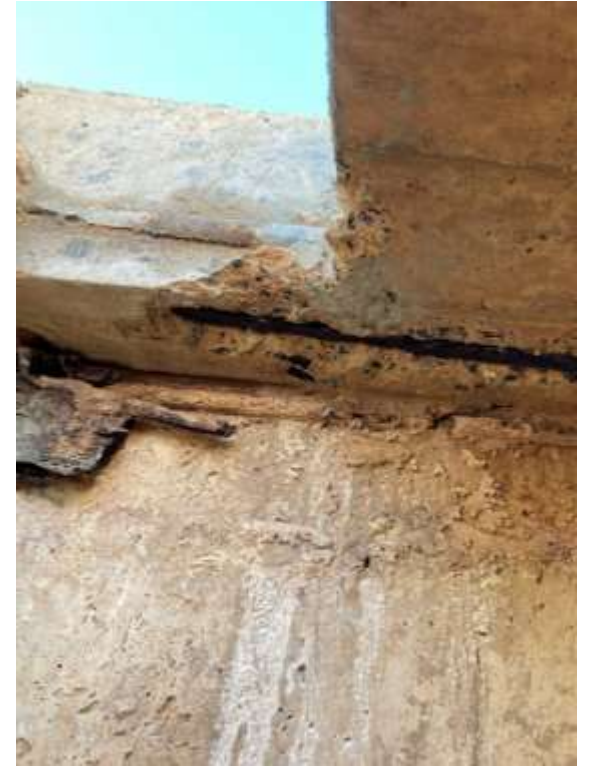
## EXISTING ROADWAY DECK CONDITIONS

March 2026 Site Visit

- Openings for bridge cell access provided for viewing of almost 20% deck slab formwork removal
- Significant spalling and corrosion consistent with existing roadway surface cracking. The type and frequency of this corrosion damage was not isolated.

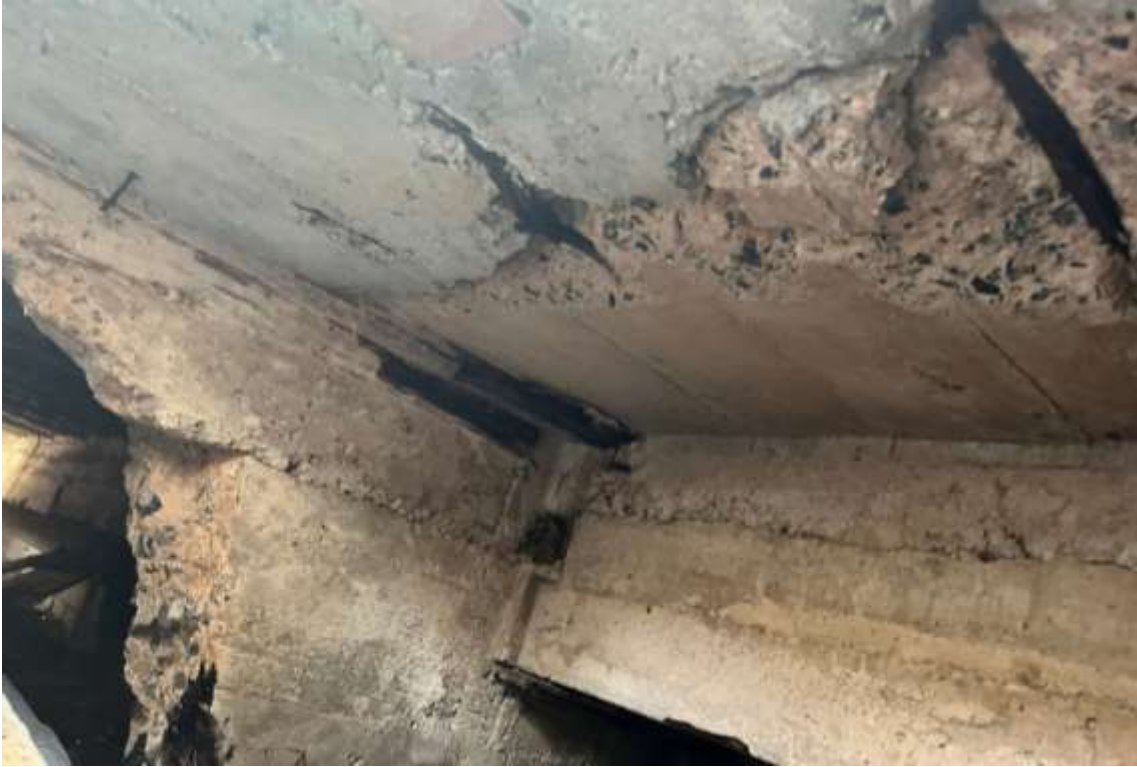
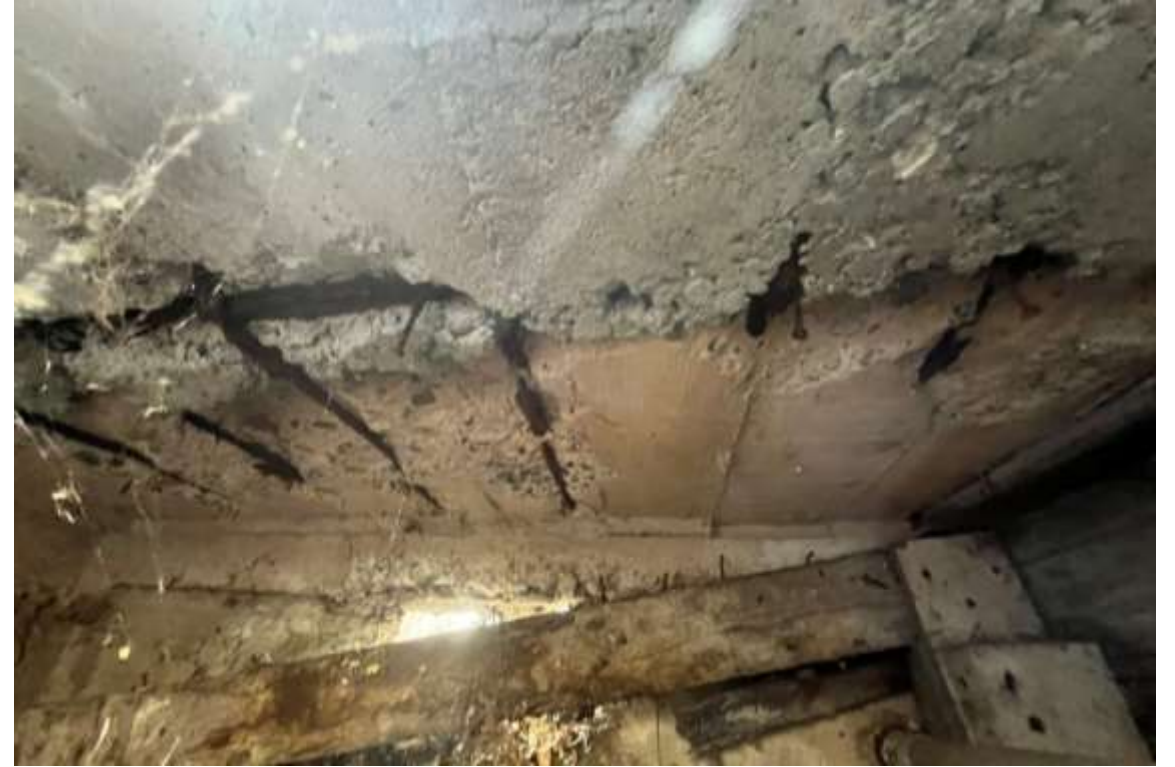
## EXISTING ROADWAY DECK CONDITION

Additional Photos of Roadway Deck Soffit Spalls and Corrosion
