P A S T
CONSULTANTS LLC

February 21, 2024

Re: 417 Riverview Avenue, Capitola, CA – SOI Standards Design Review Letter
APN. 035-132-06

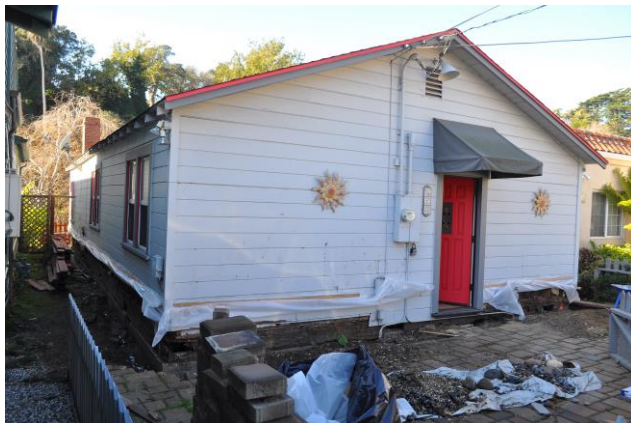
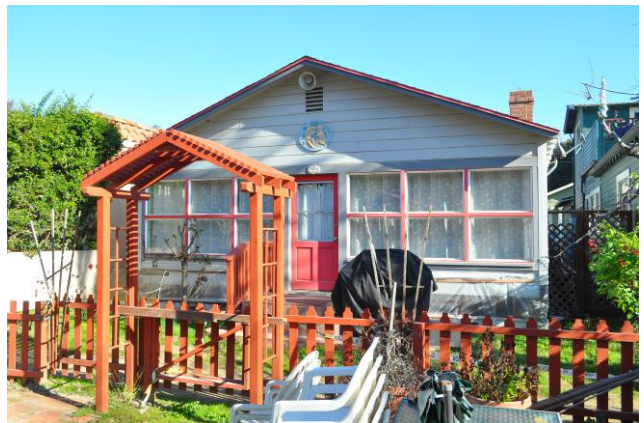
Figures 1 and 2. Left image shows the east elevation. Right image shows the west (Soquel Creek) elevation.

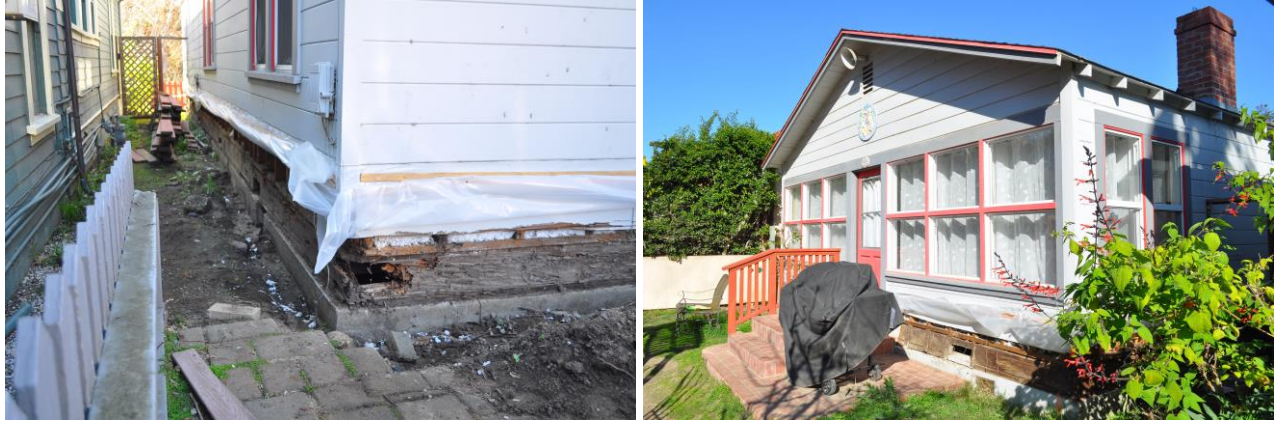
The site visit revealed extensive deterioration in the foundation, the wood sill plate and the bottoms of the wall studs where they meet the sill plate (**Figure 3**). The rear (Soquel Creek) elevation contains a bank of wood windows, with a replaced door and a new entry porch (**Figure 4**).

Figures 3 and 4. Left image details the south elevation, showing extensive rot to the sill plate. Right image details the west elevation, showing the deteriorated chimney and rear deck, which was replaced previously.

The proposed project will lift the building onto a new foundation and replace the deteriorated wood structural elements, including the sill plate, and will repair or replace the wall studs. All wood siding will be removed to repair the structure. Since the building needs to be lifted from the top plate, the existing fireplace and chimney will need to be removed. Presently, the exterior chimney is in poor condition.

1. Prior to removal, photograph the chimney from at least two sides to match color, bond pattern and dimensions of the existing brick.
2. Measure brick dimensions for accurate replication. Measure raised "corbel" detail at upper part of chimney, so this detail can be replicated.
3. Choose replacement panels for appropriate color match, bond pattern match, corbel detail and brick connections at the corners.

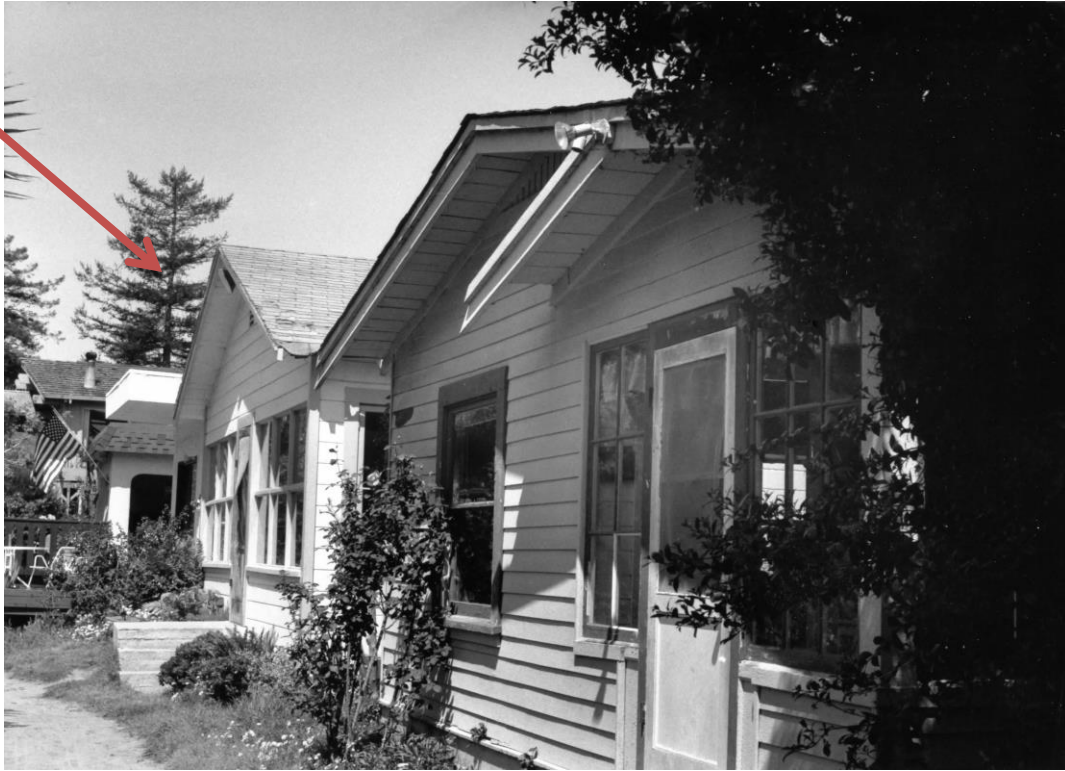
Figure 5. View looking north along the residences' west-facing elevations. An arrow indicates the subject property. Note that the rear entrance utilized a series of concrete stairs and no porch rail (*Courtesy: Charles Rowe, Old Riverview Historic District, National Register of Historic Places Registration Form* (listed, 1988)).
