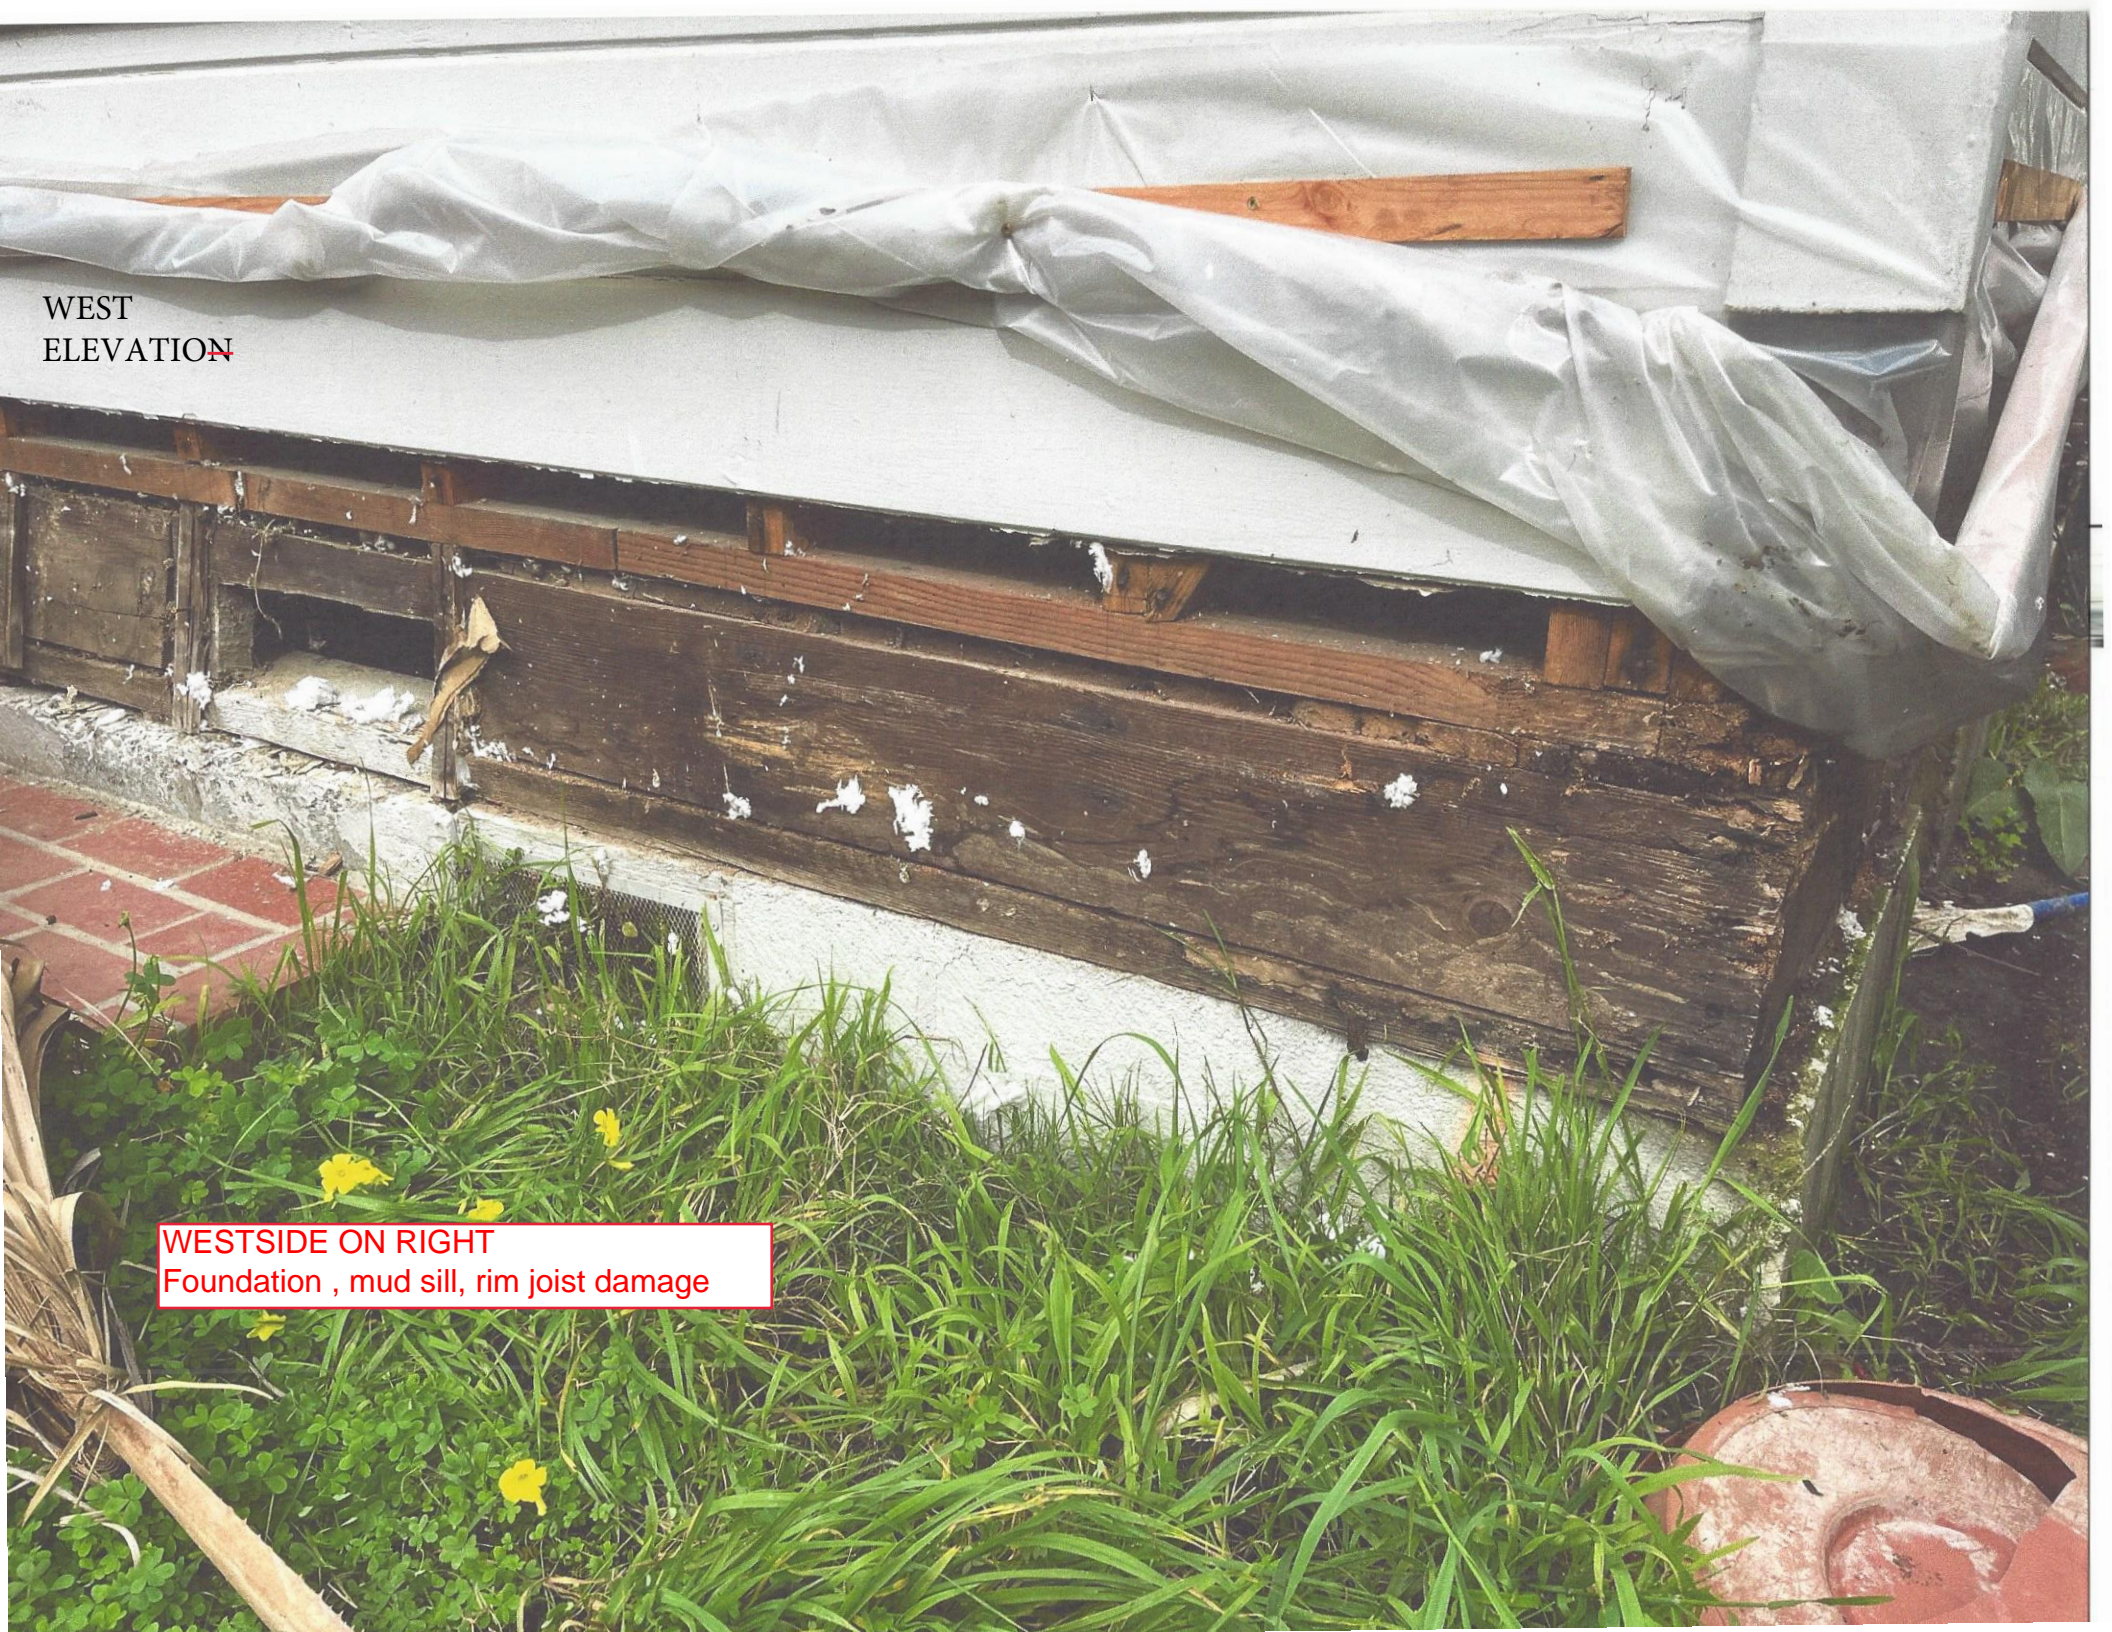
WESTSIDE ON RIGHT  
Foundation , mud sill, rim joist damage

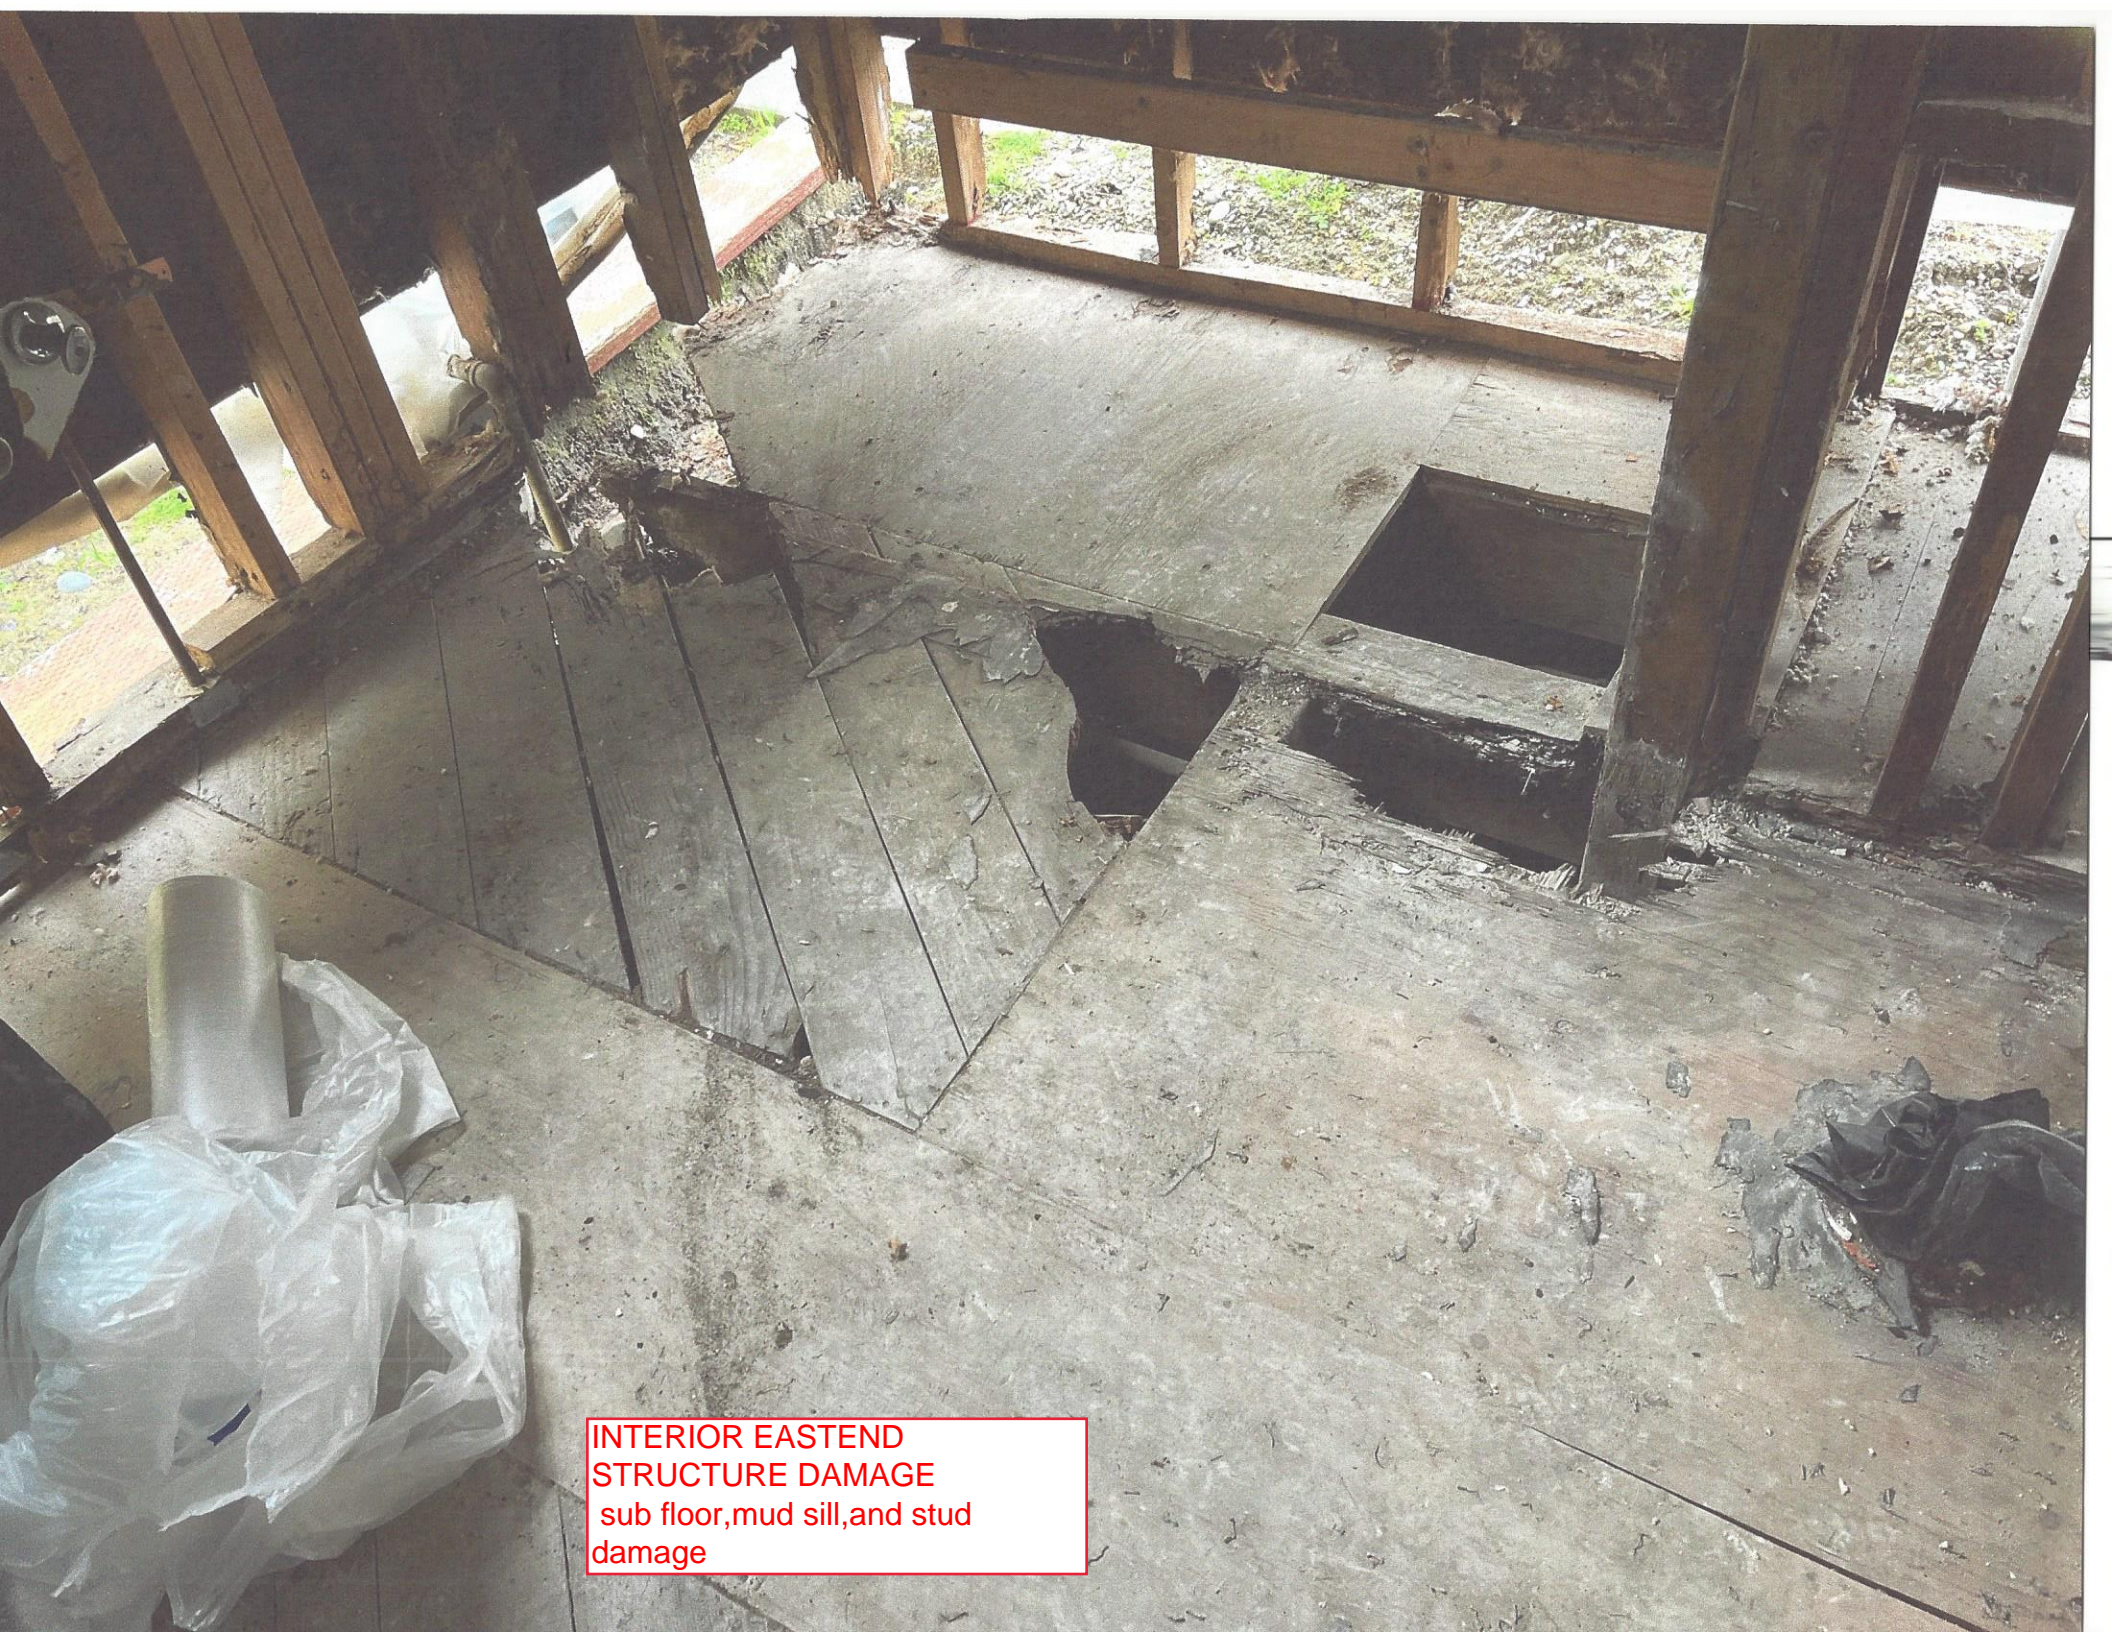
**INTERIOR EASTEND  
STRUCTURE DAMAGE**  
sub floor, mud sill, and stud  
damage

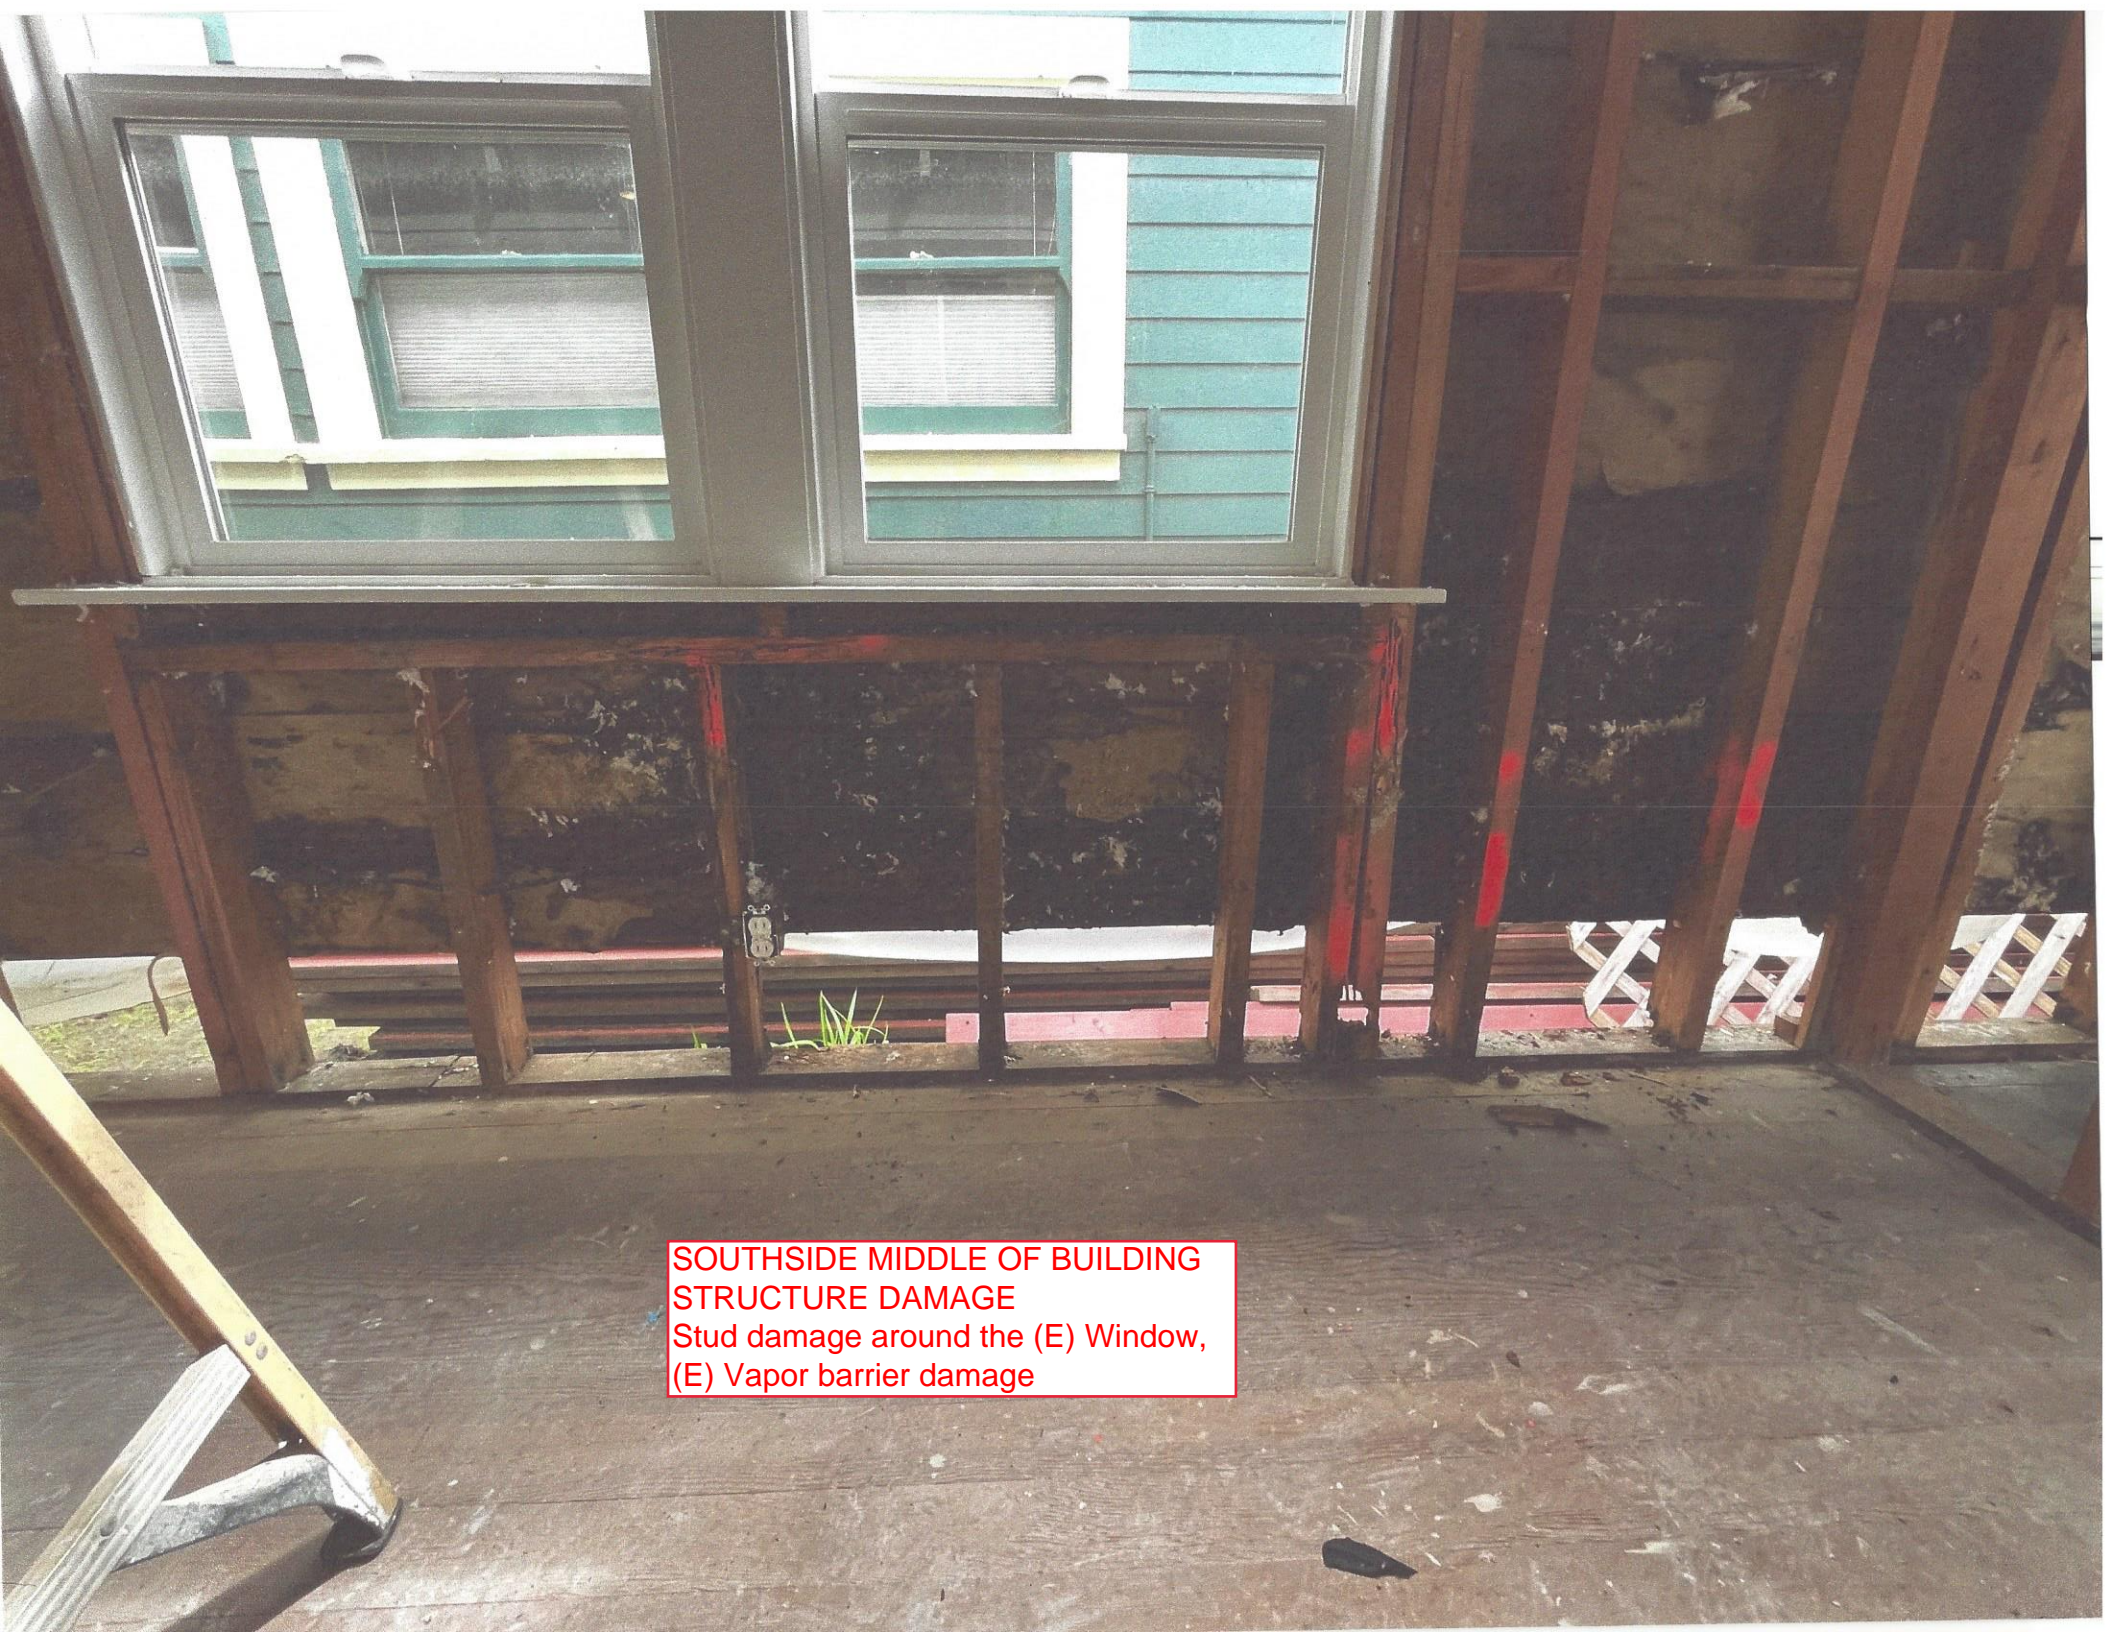
**SOUTHSIDE MIDDLE OF BUILDING  
STRUCTURE DAMAGE**  
Stud damage around the (E) Window,  
(E) Vapor barrier damage

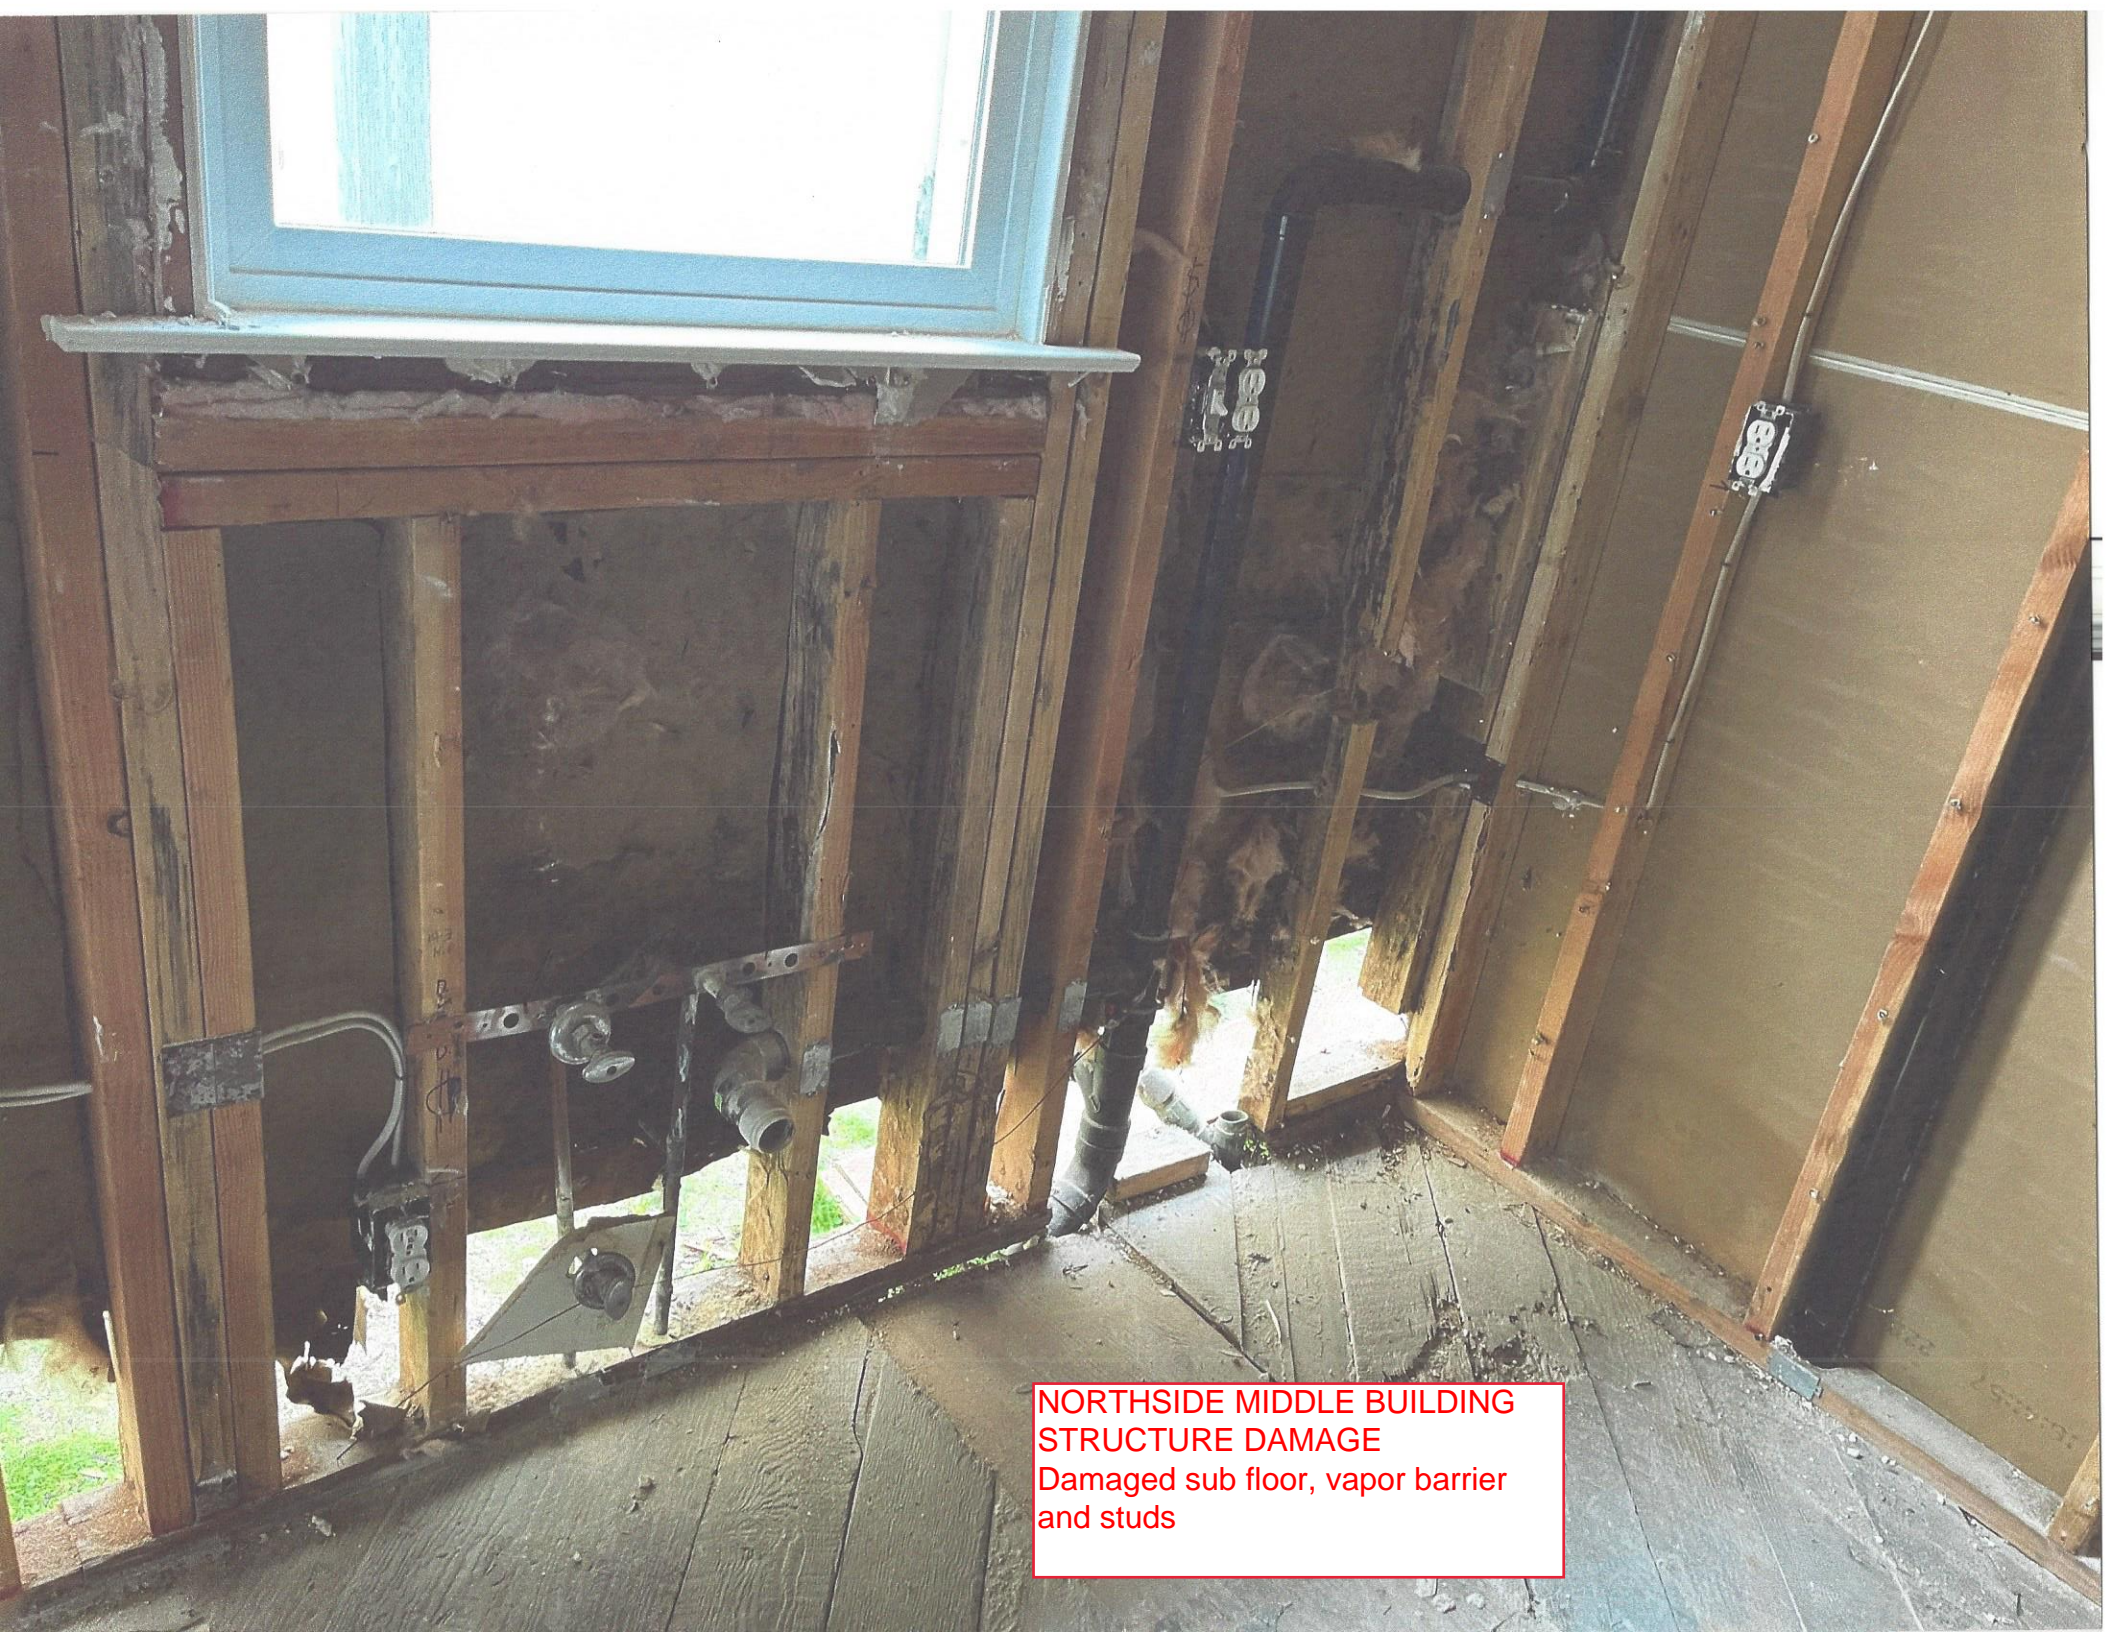
**NORTHSIDE MIDDLE BUILDING  
STRUCTURE DAMAGE**  
Damaged sub floor, vapor barrier  
and studs

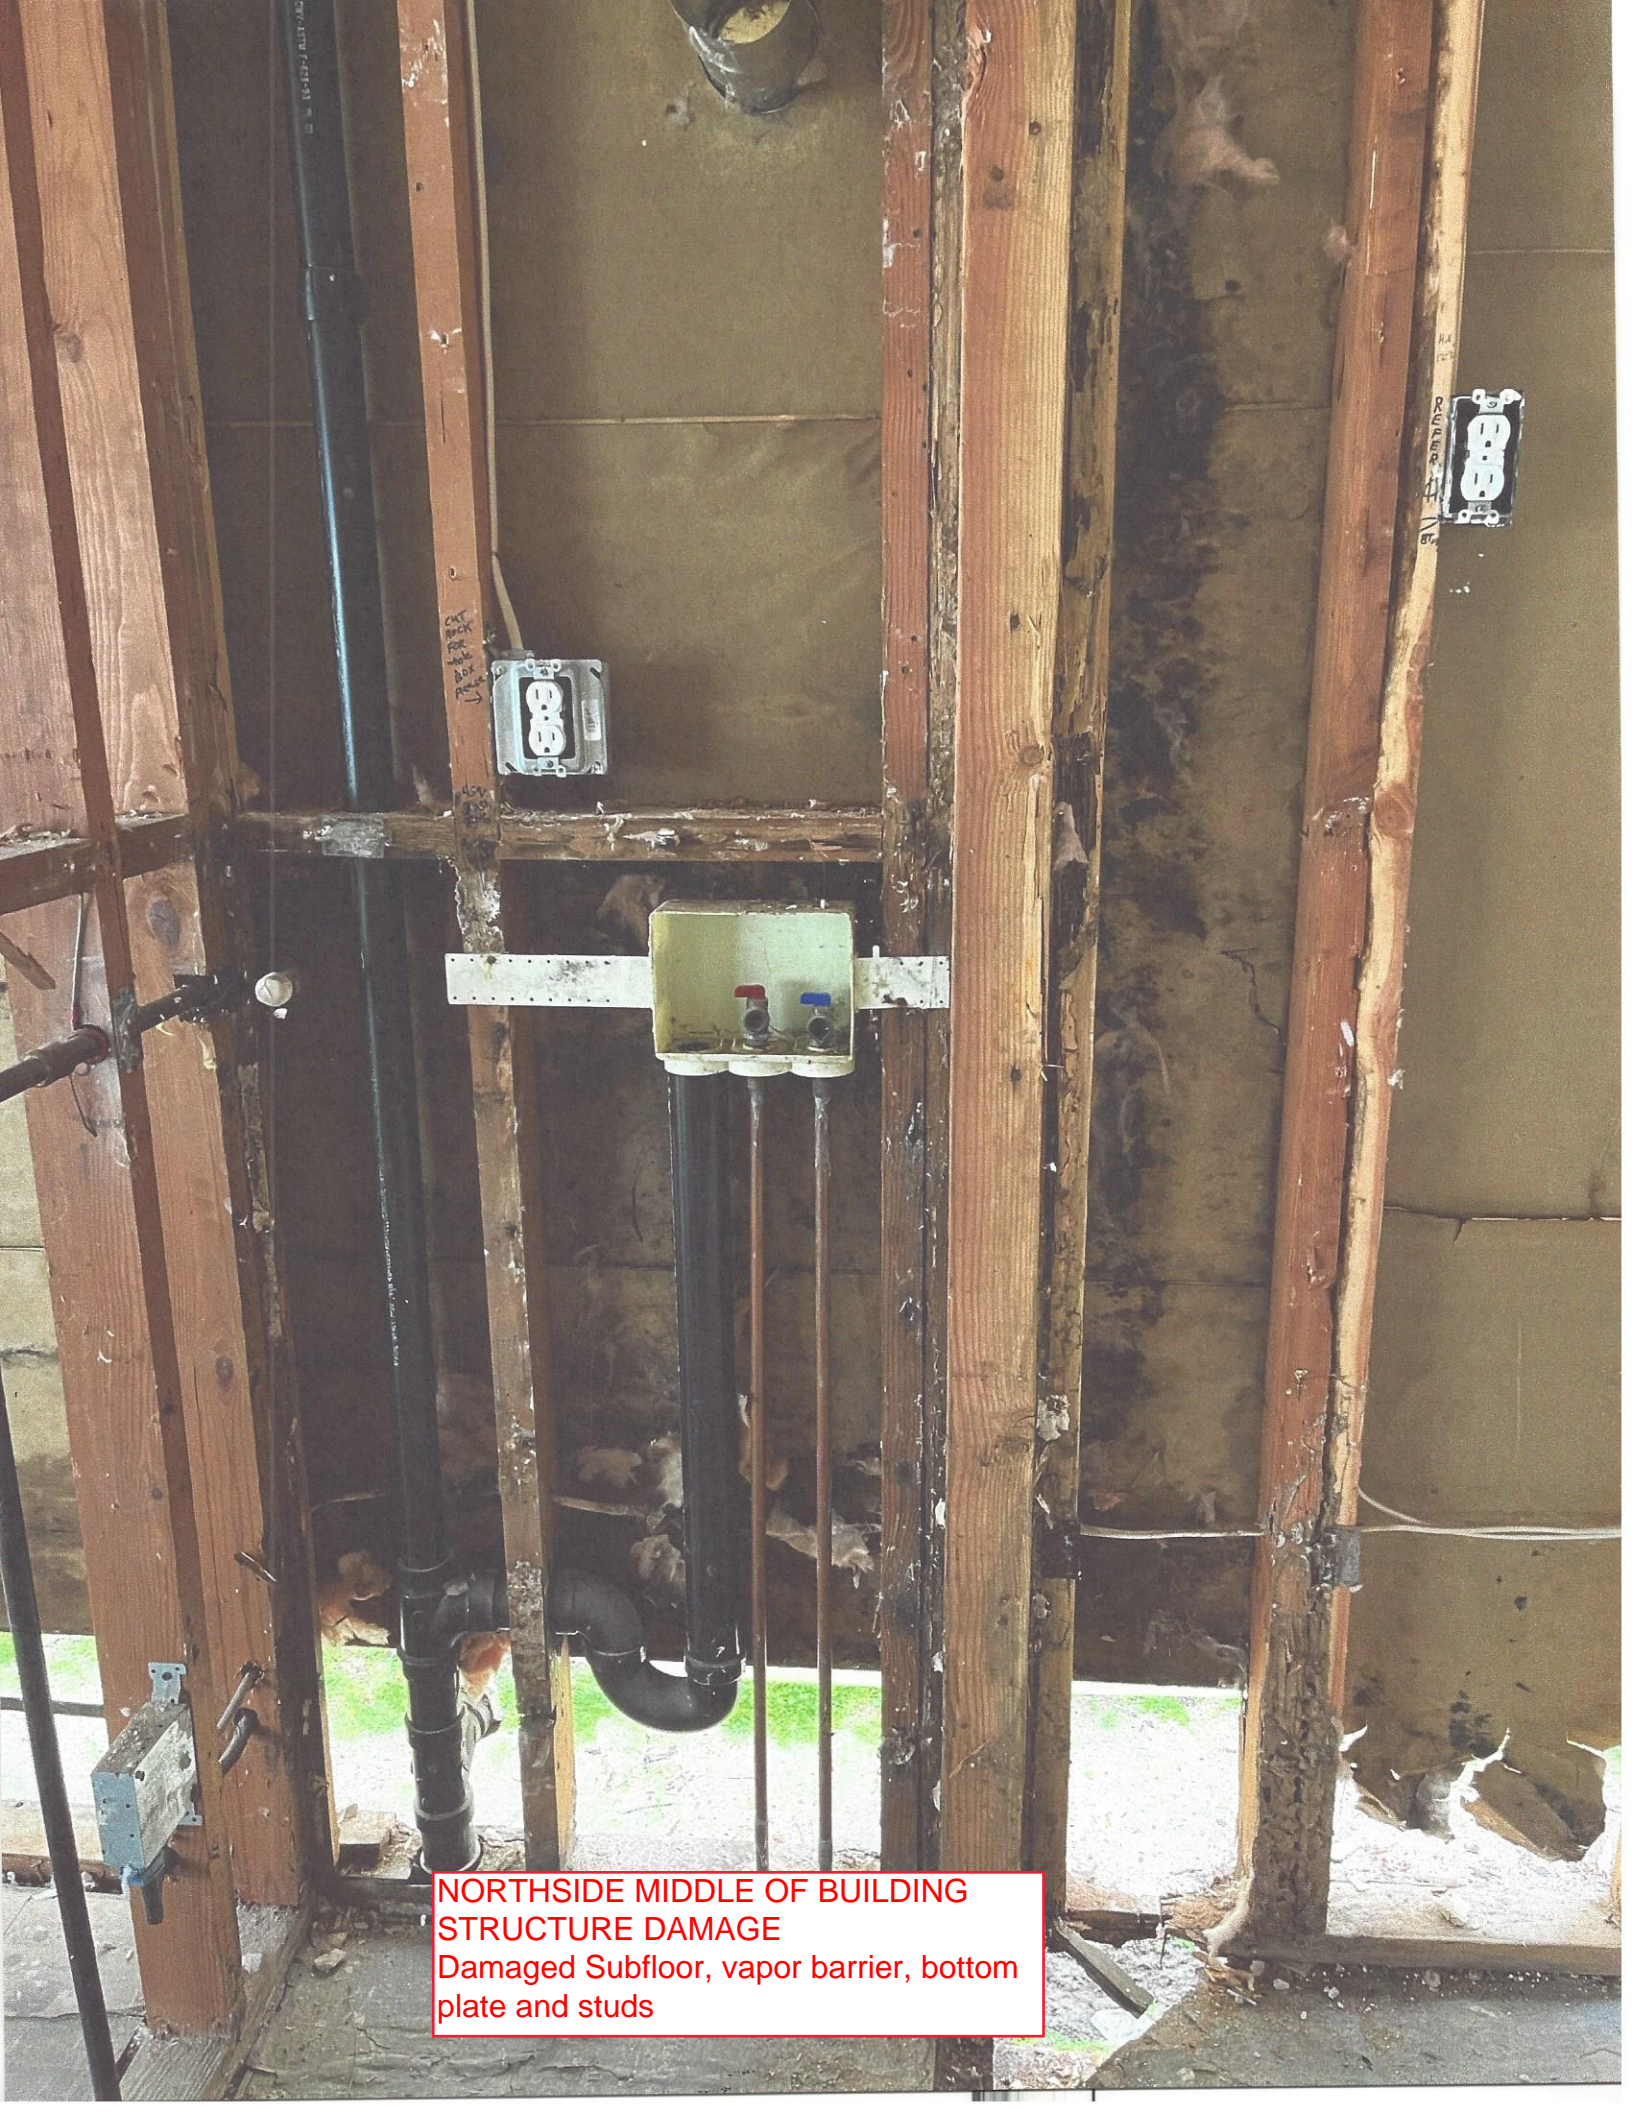
**NORTHSIDE MIDDLE OF BUILDING  
STRUCTURE DAMAGE**  
Damaged Subfloor, vapor barrier, bottom  
plate and studs

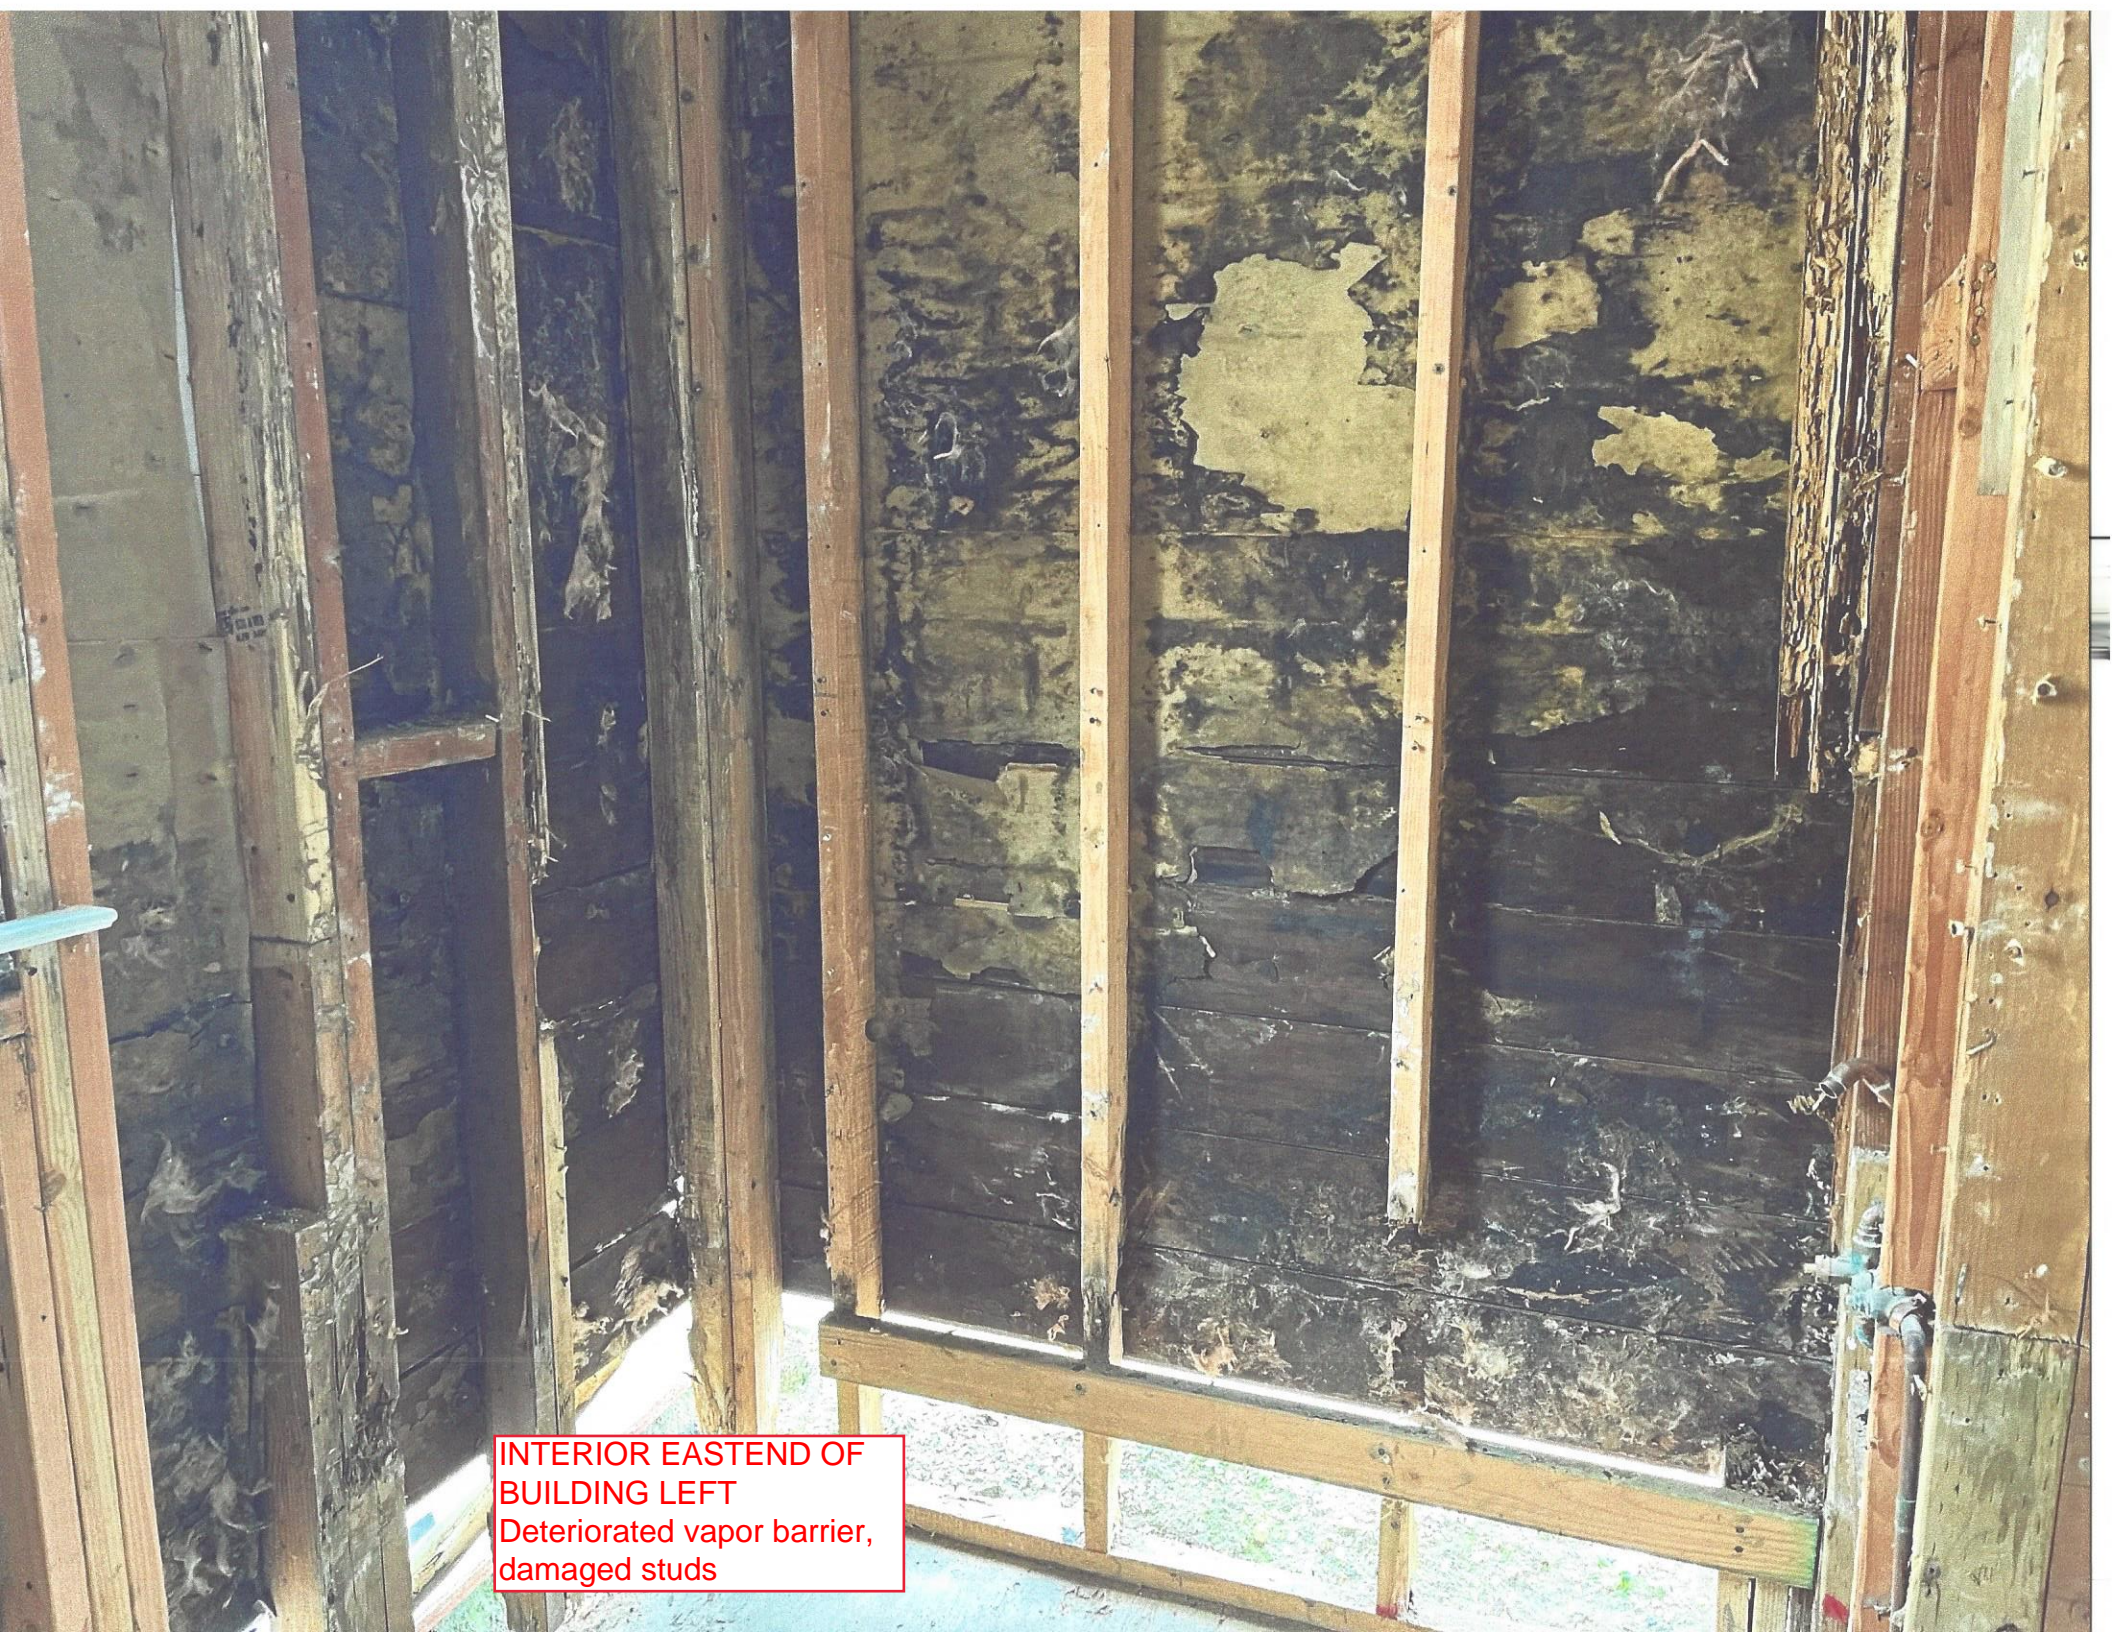
INTERIOR EASTEND OF  
BUILDING LEFT  
Deteriorated vapor barrier,  
damaged studs
