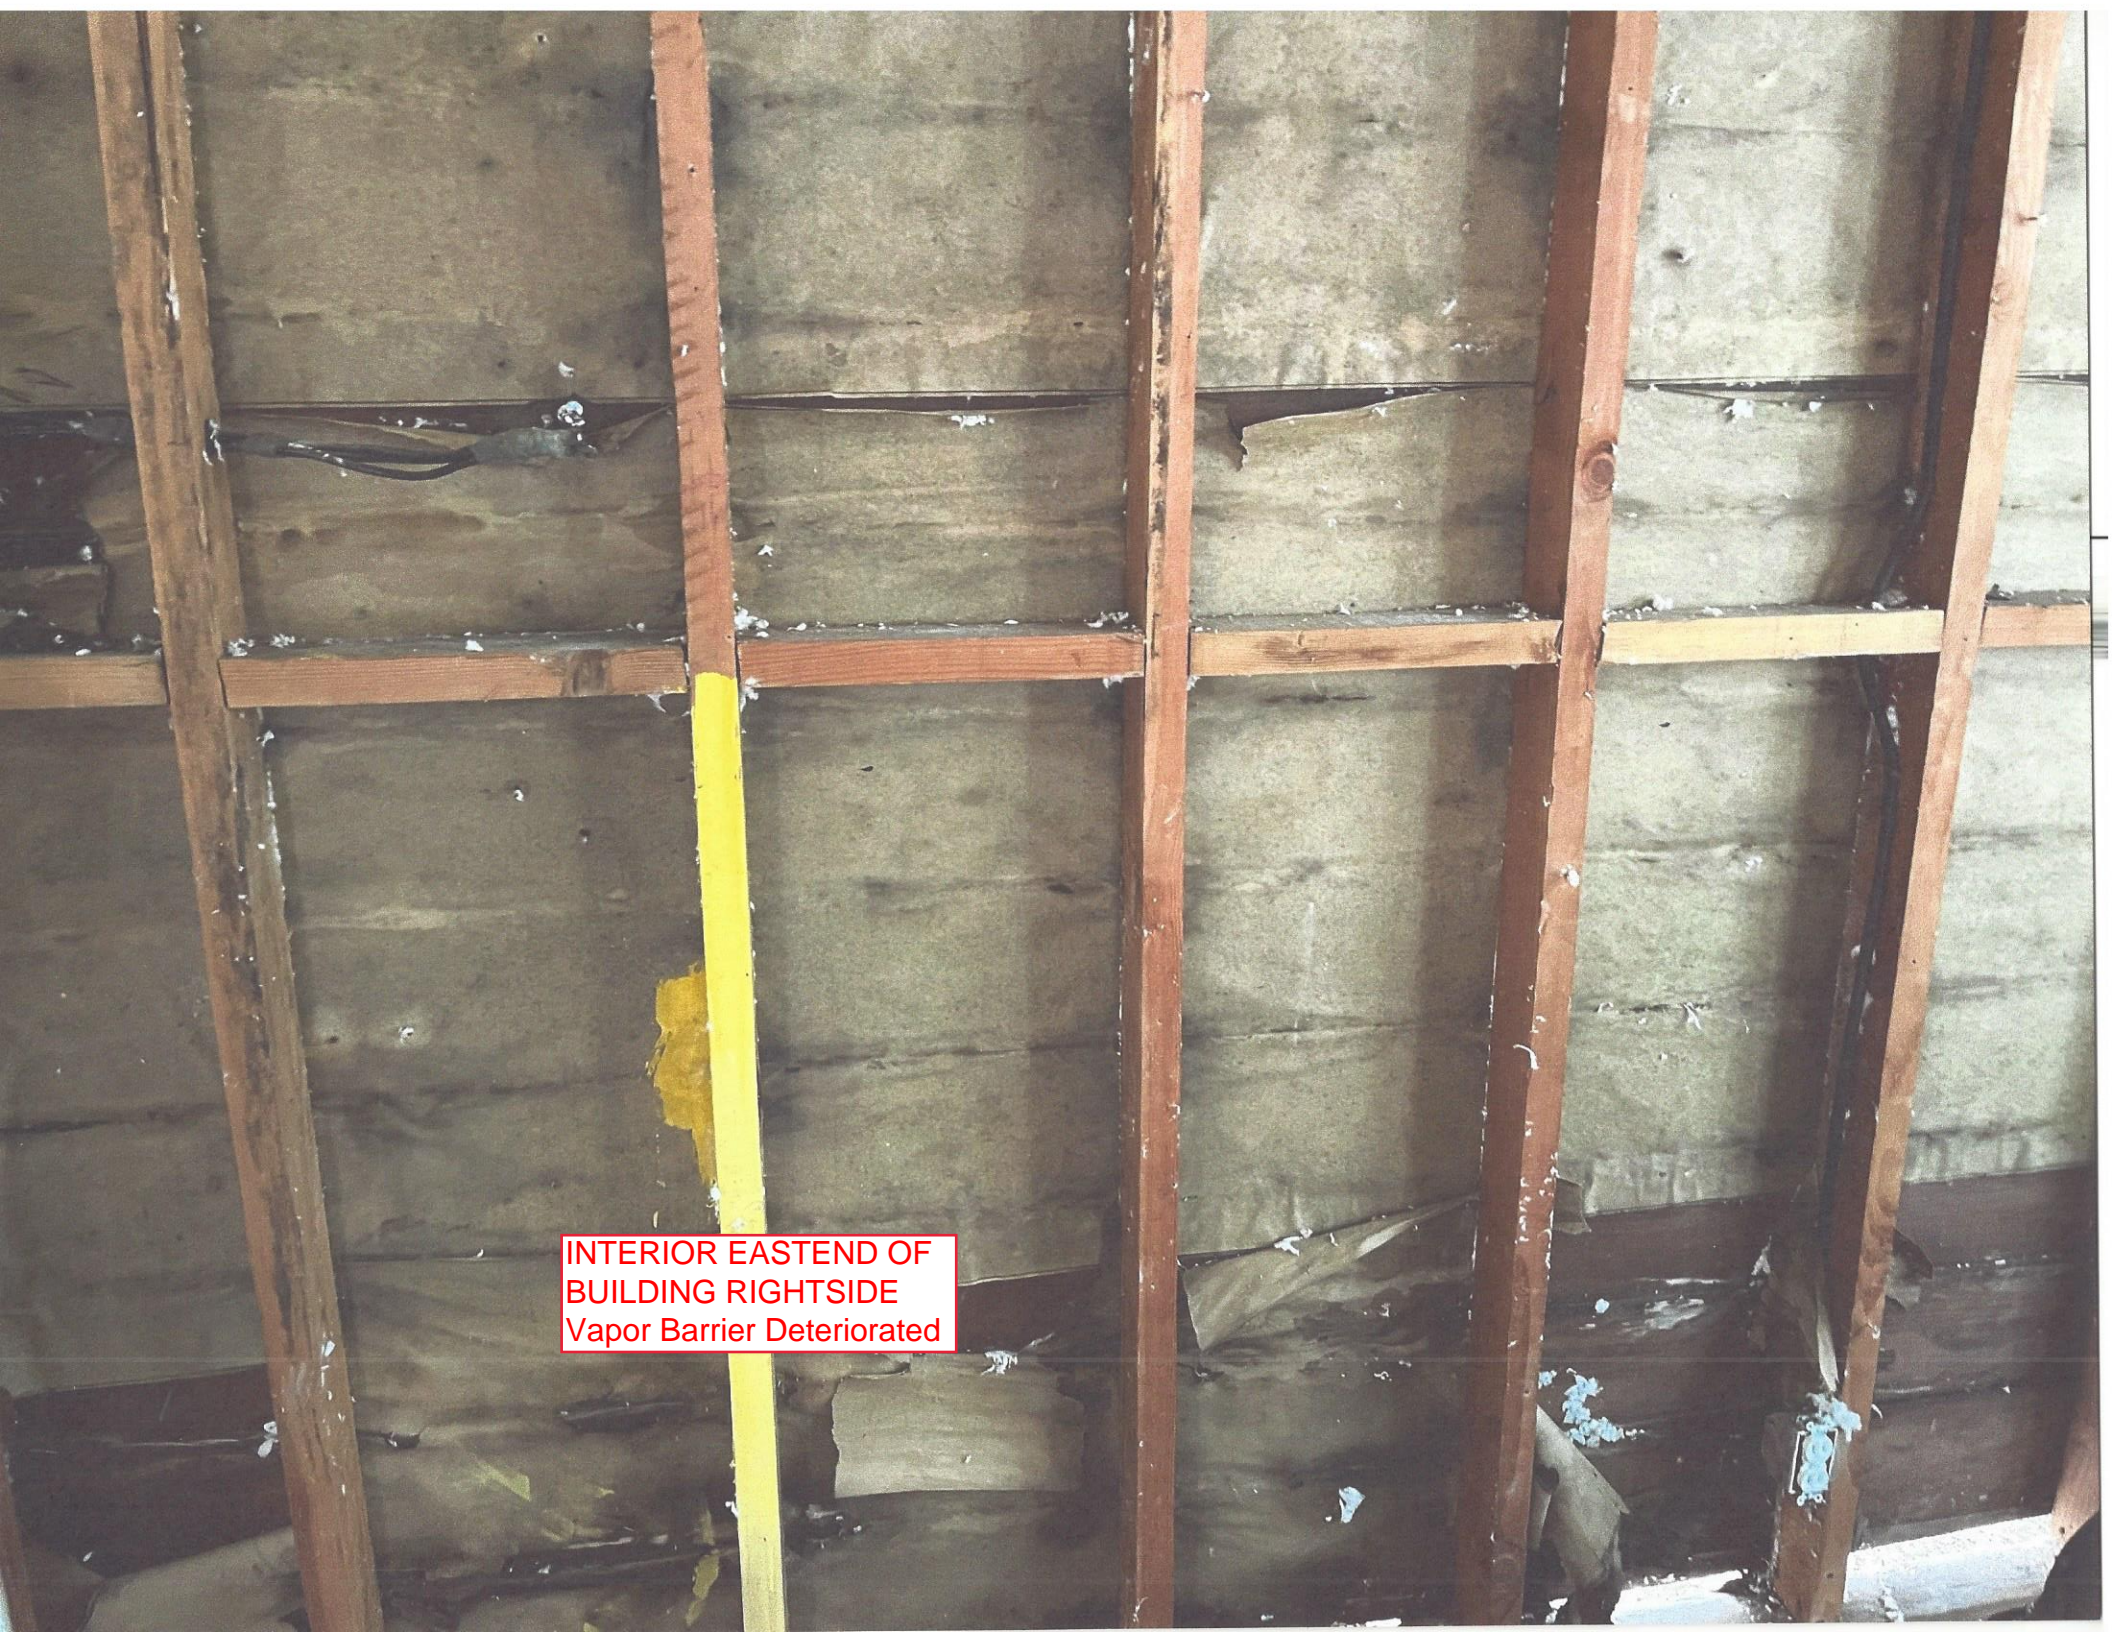
INTERIOR EASTEND OF  
BUILDING RIGHTSIDE  
Vapor Barrier Deteriorated

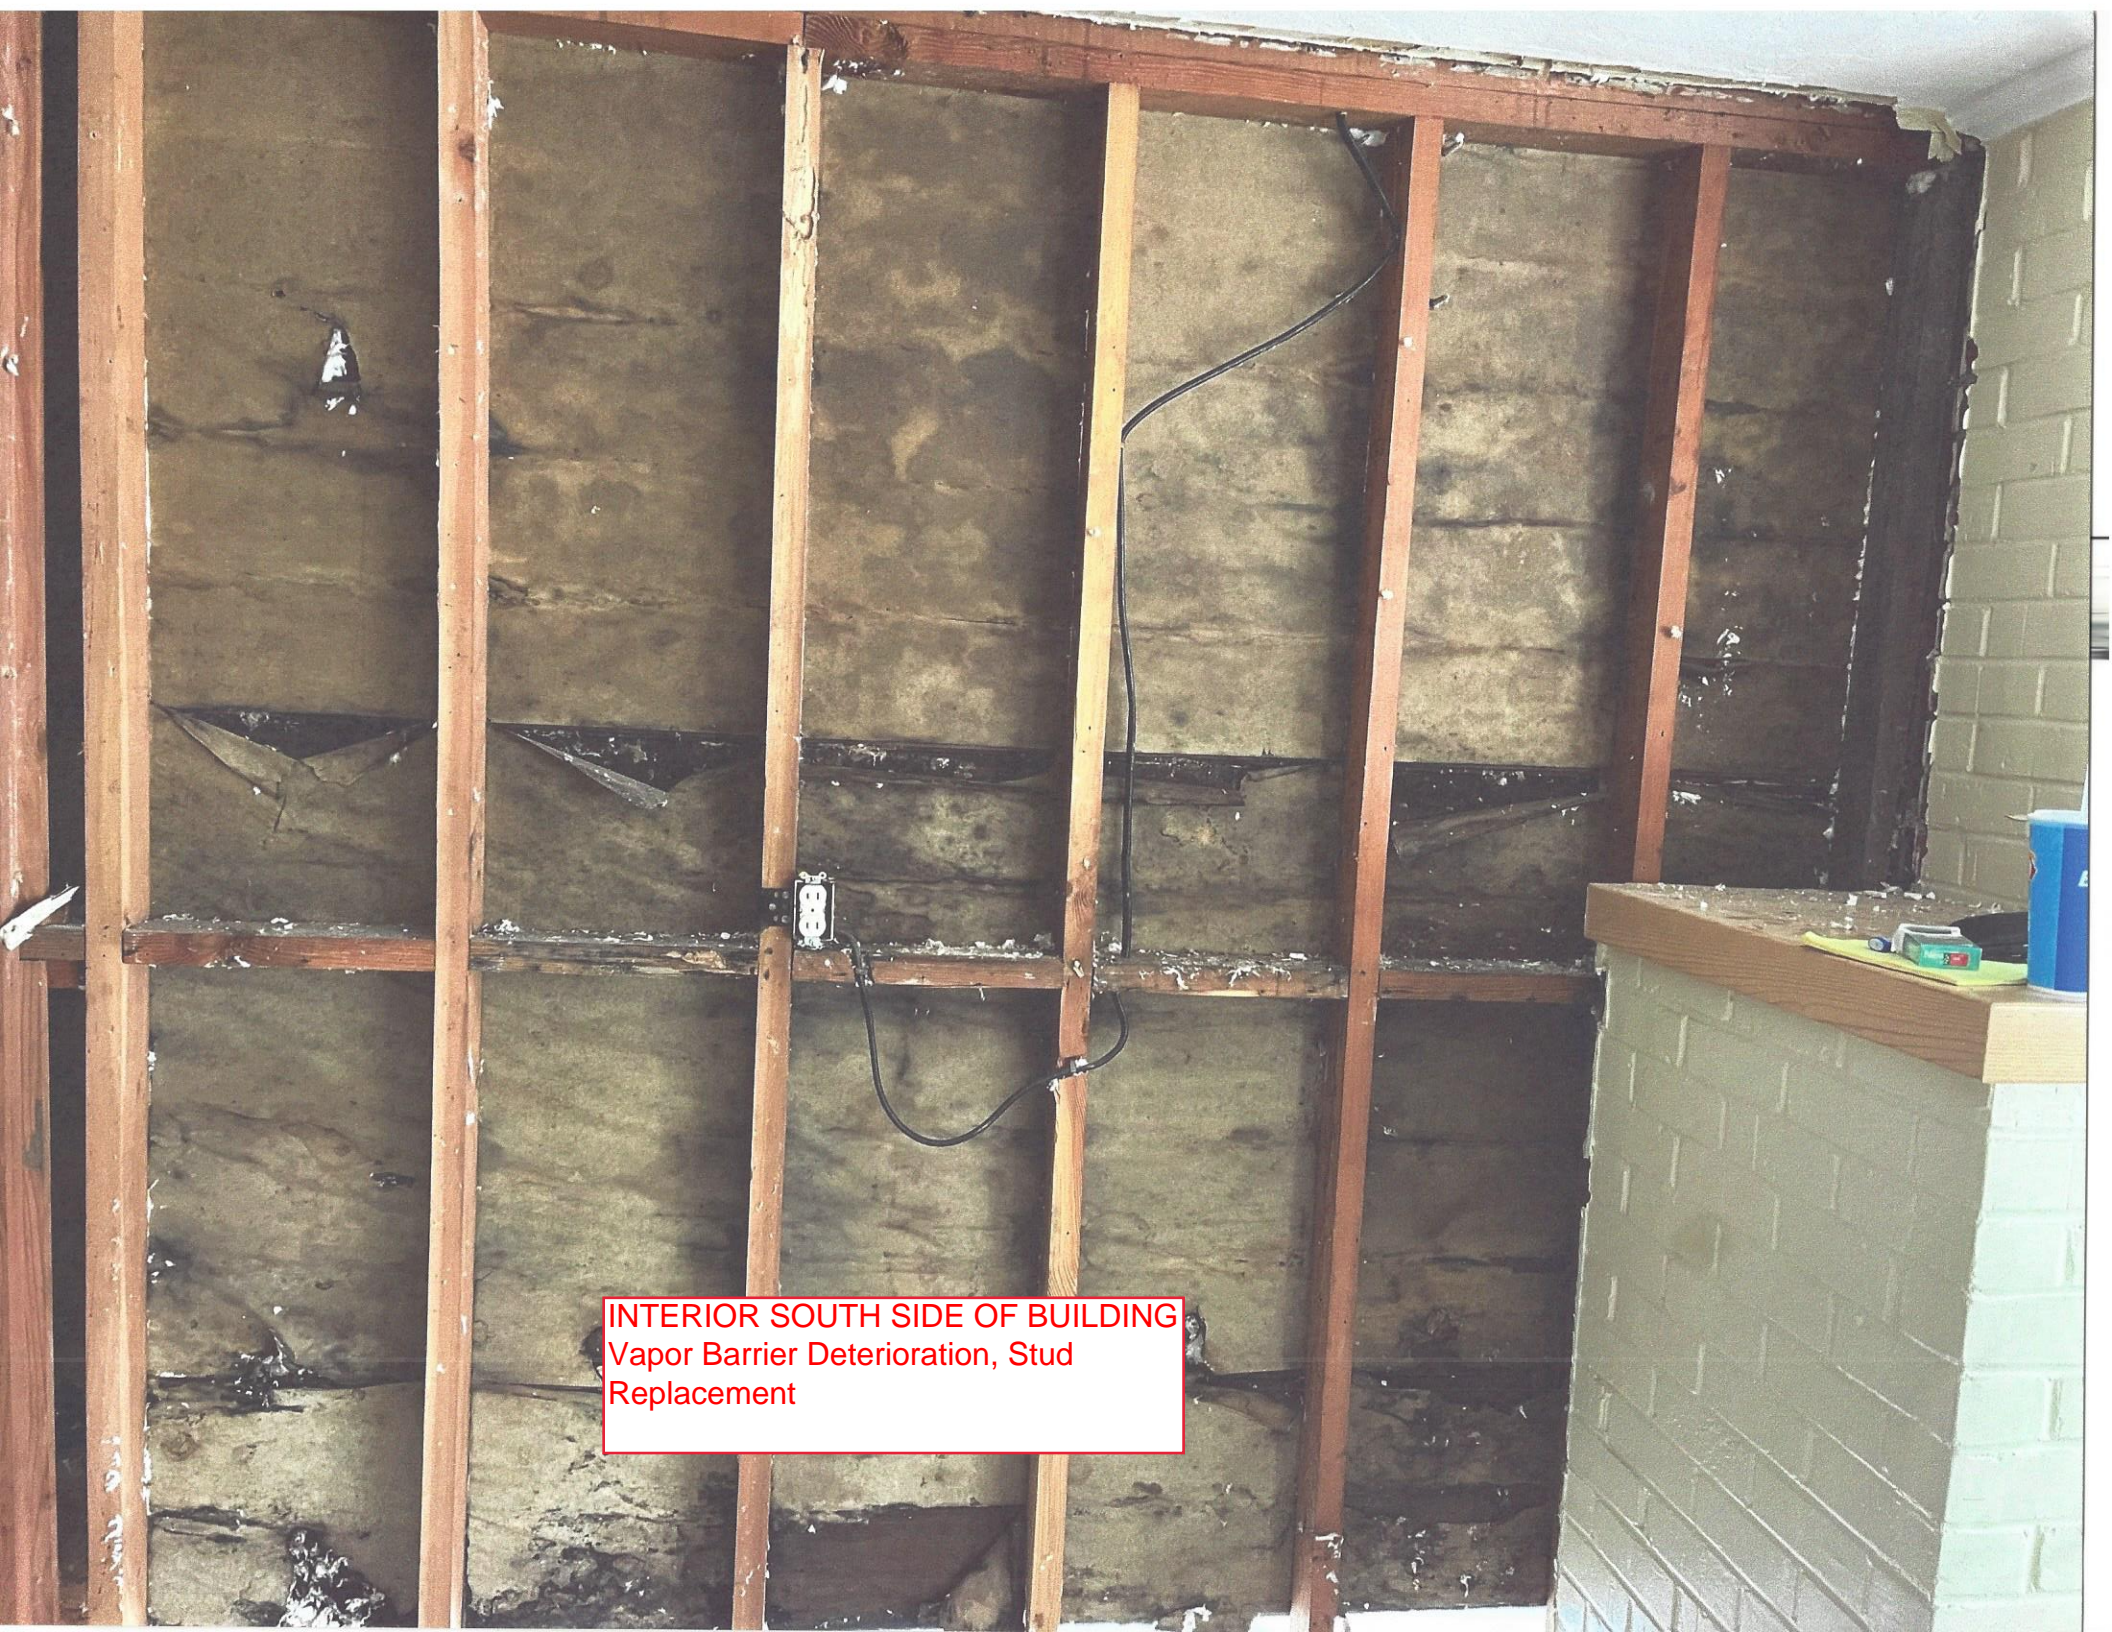
INTERIOR SOUTH SIDE OF BUILDING  
Vapor Barrier Deterioration, Stud  
Replacement

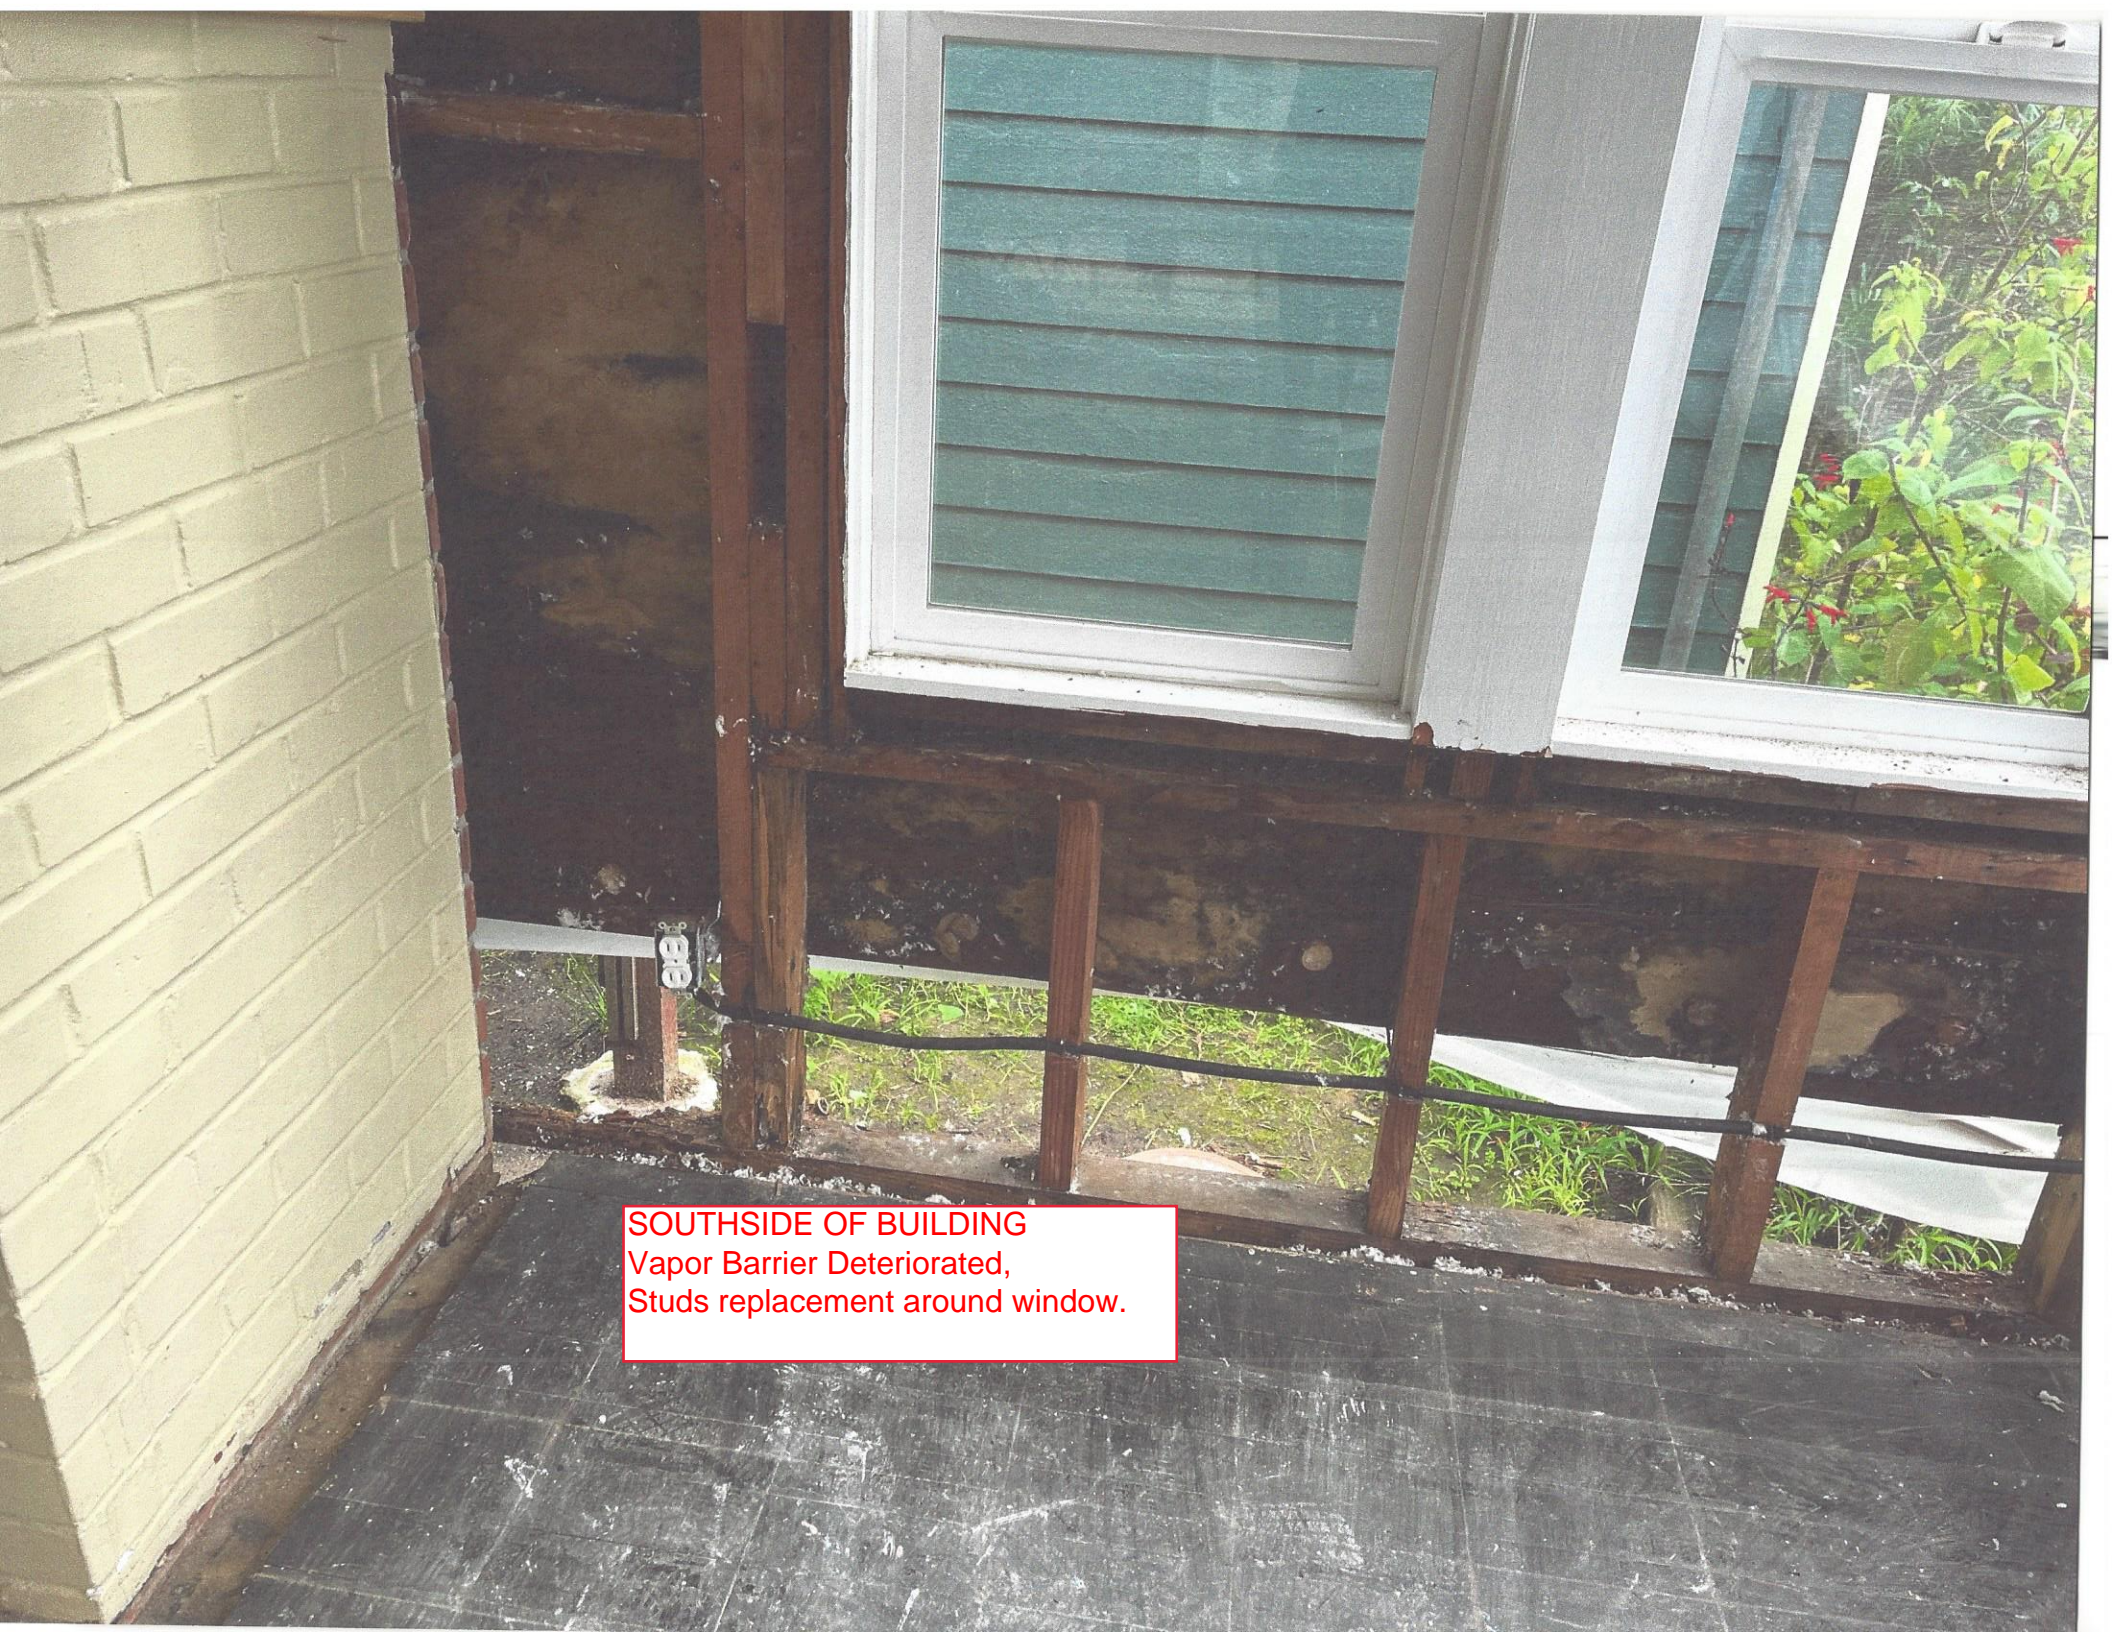
**SOUTHSIDE OF BUILDING**  
Vapor Barrier Deteriorated,  
Studs replacement around window.

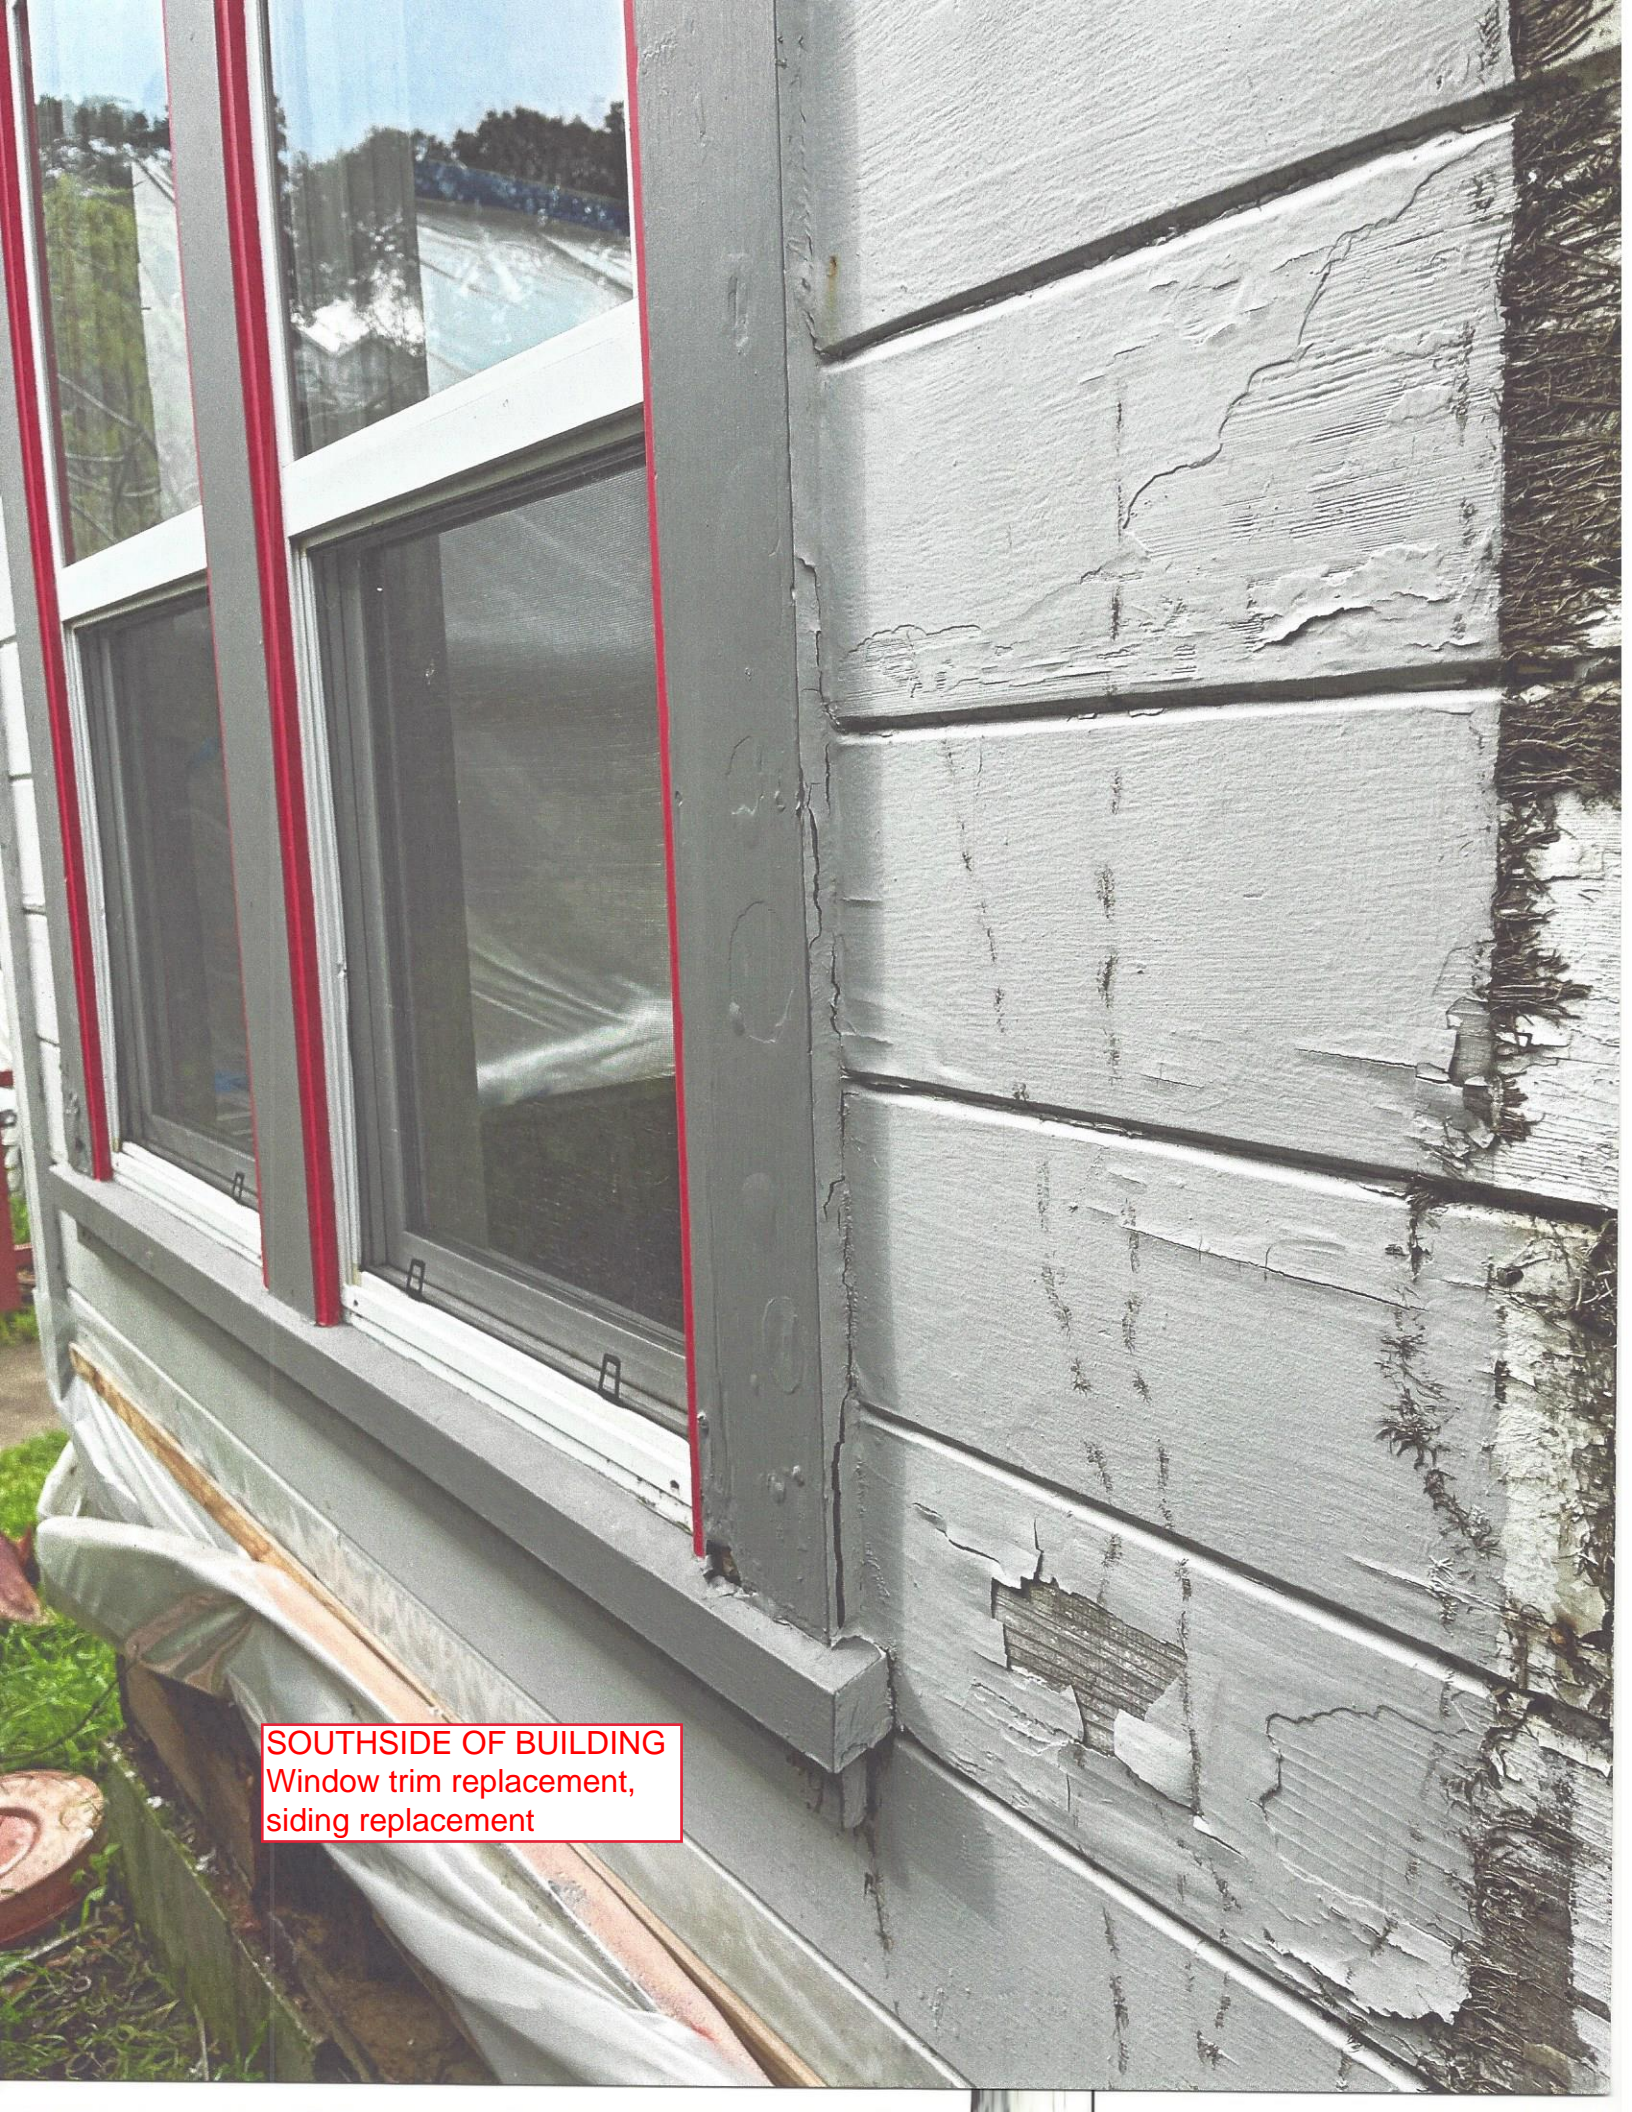
**SOUTHSIDE OF BUILDING**  
Window trim replacement,  
siding replacement

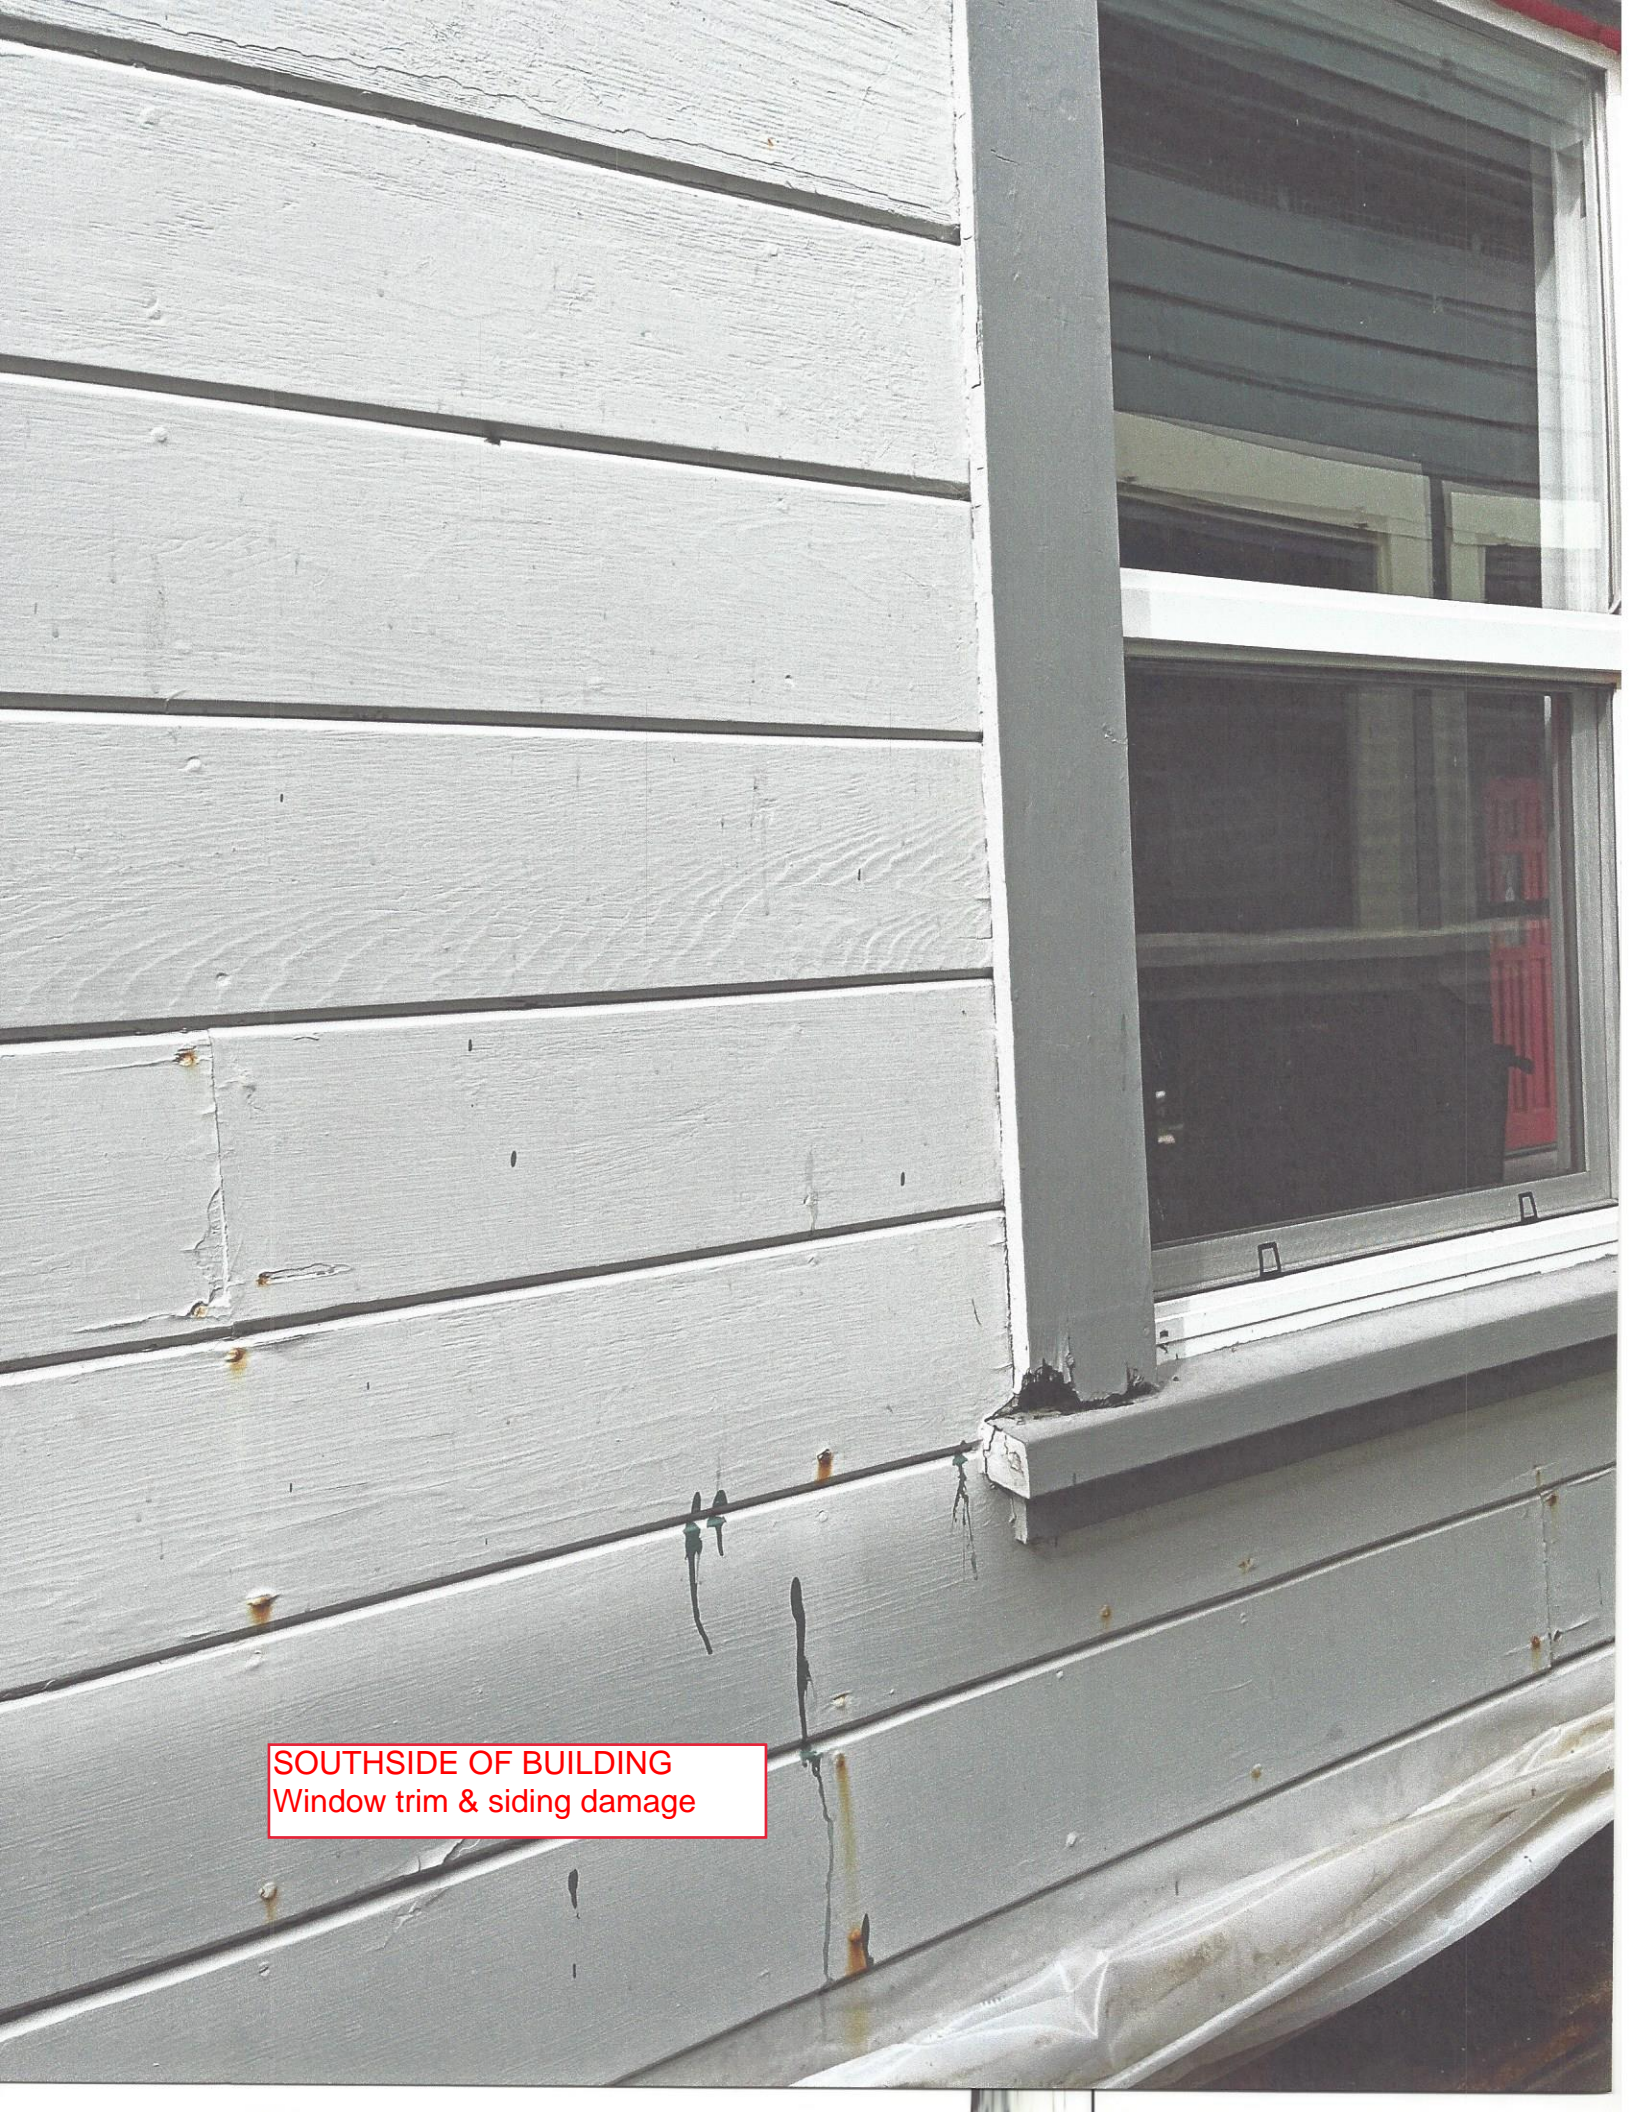
**SOUTHSIDE OF BUILDING**  
Window trim & siding damage

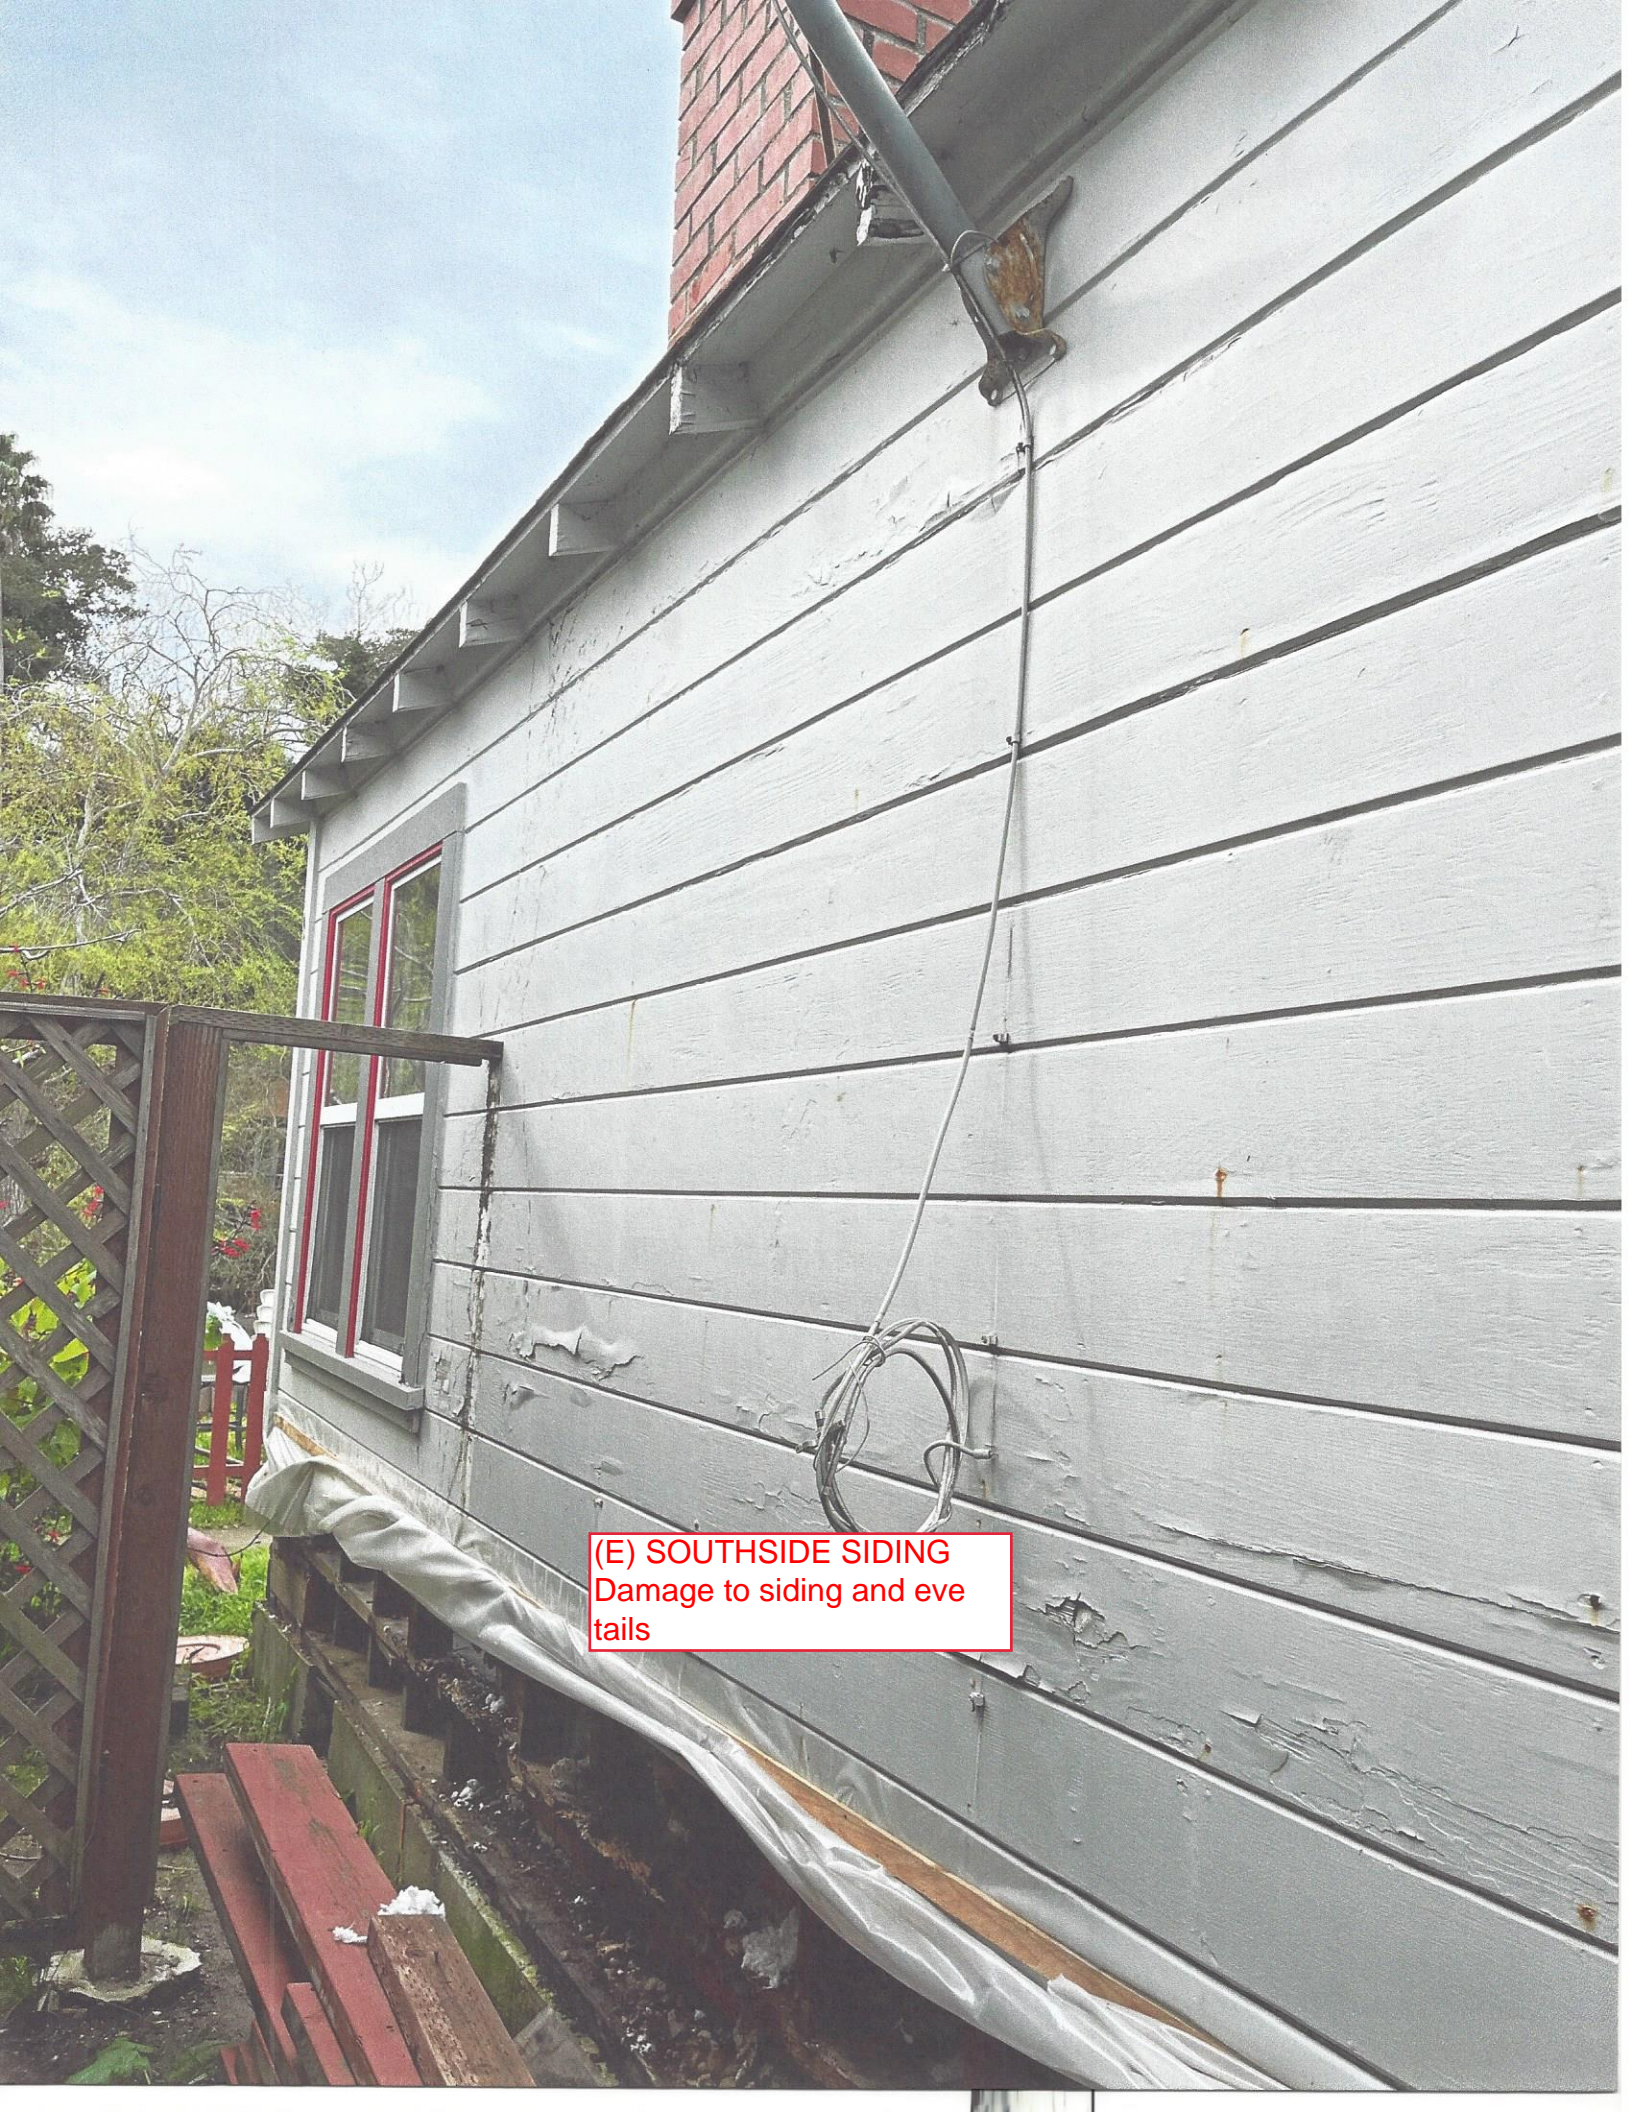
**(E) SOUTHSIDE SIDING**  
Damage to siding and eve tails
