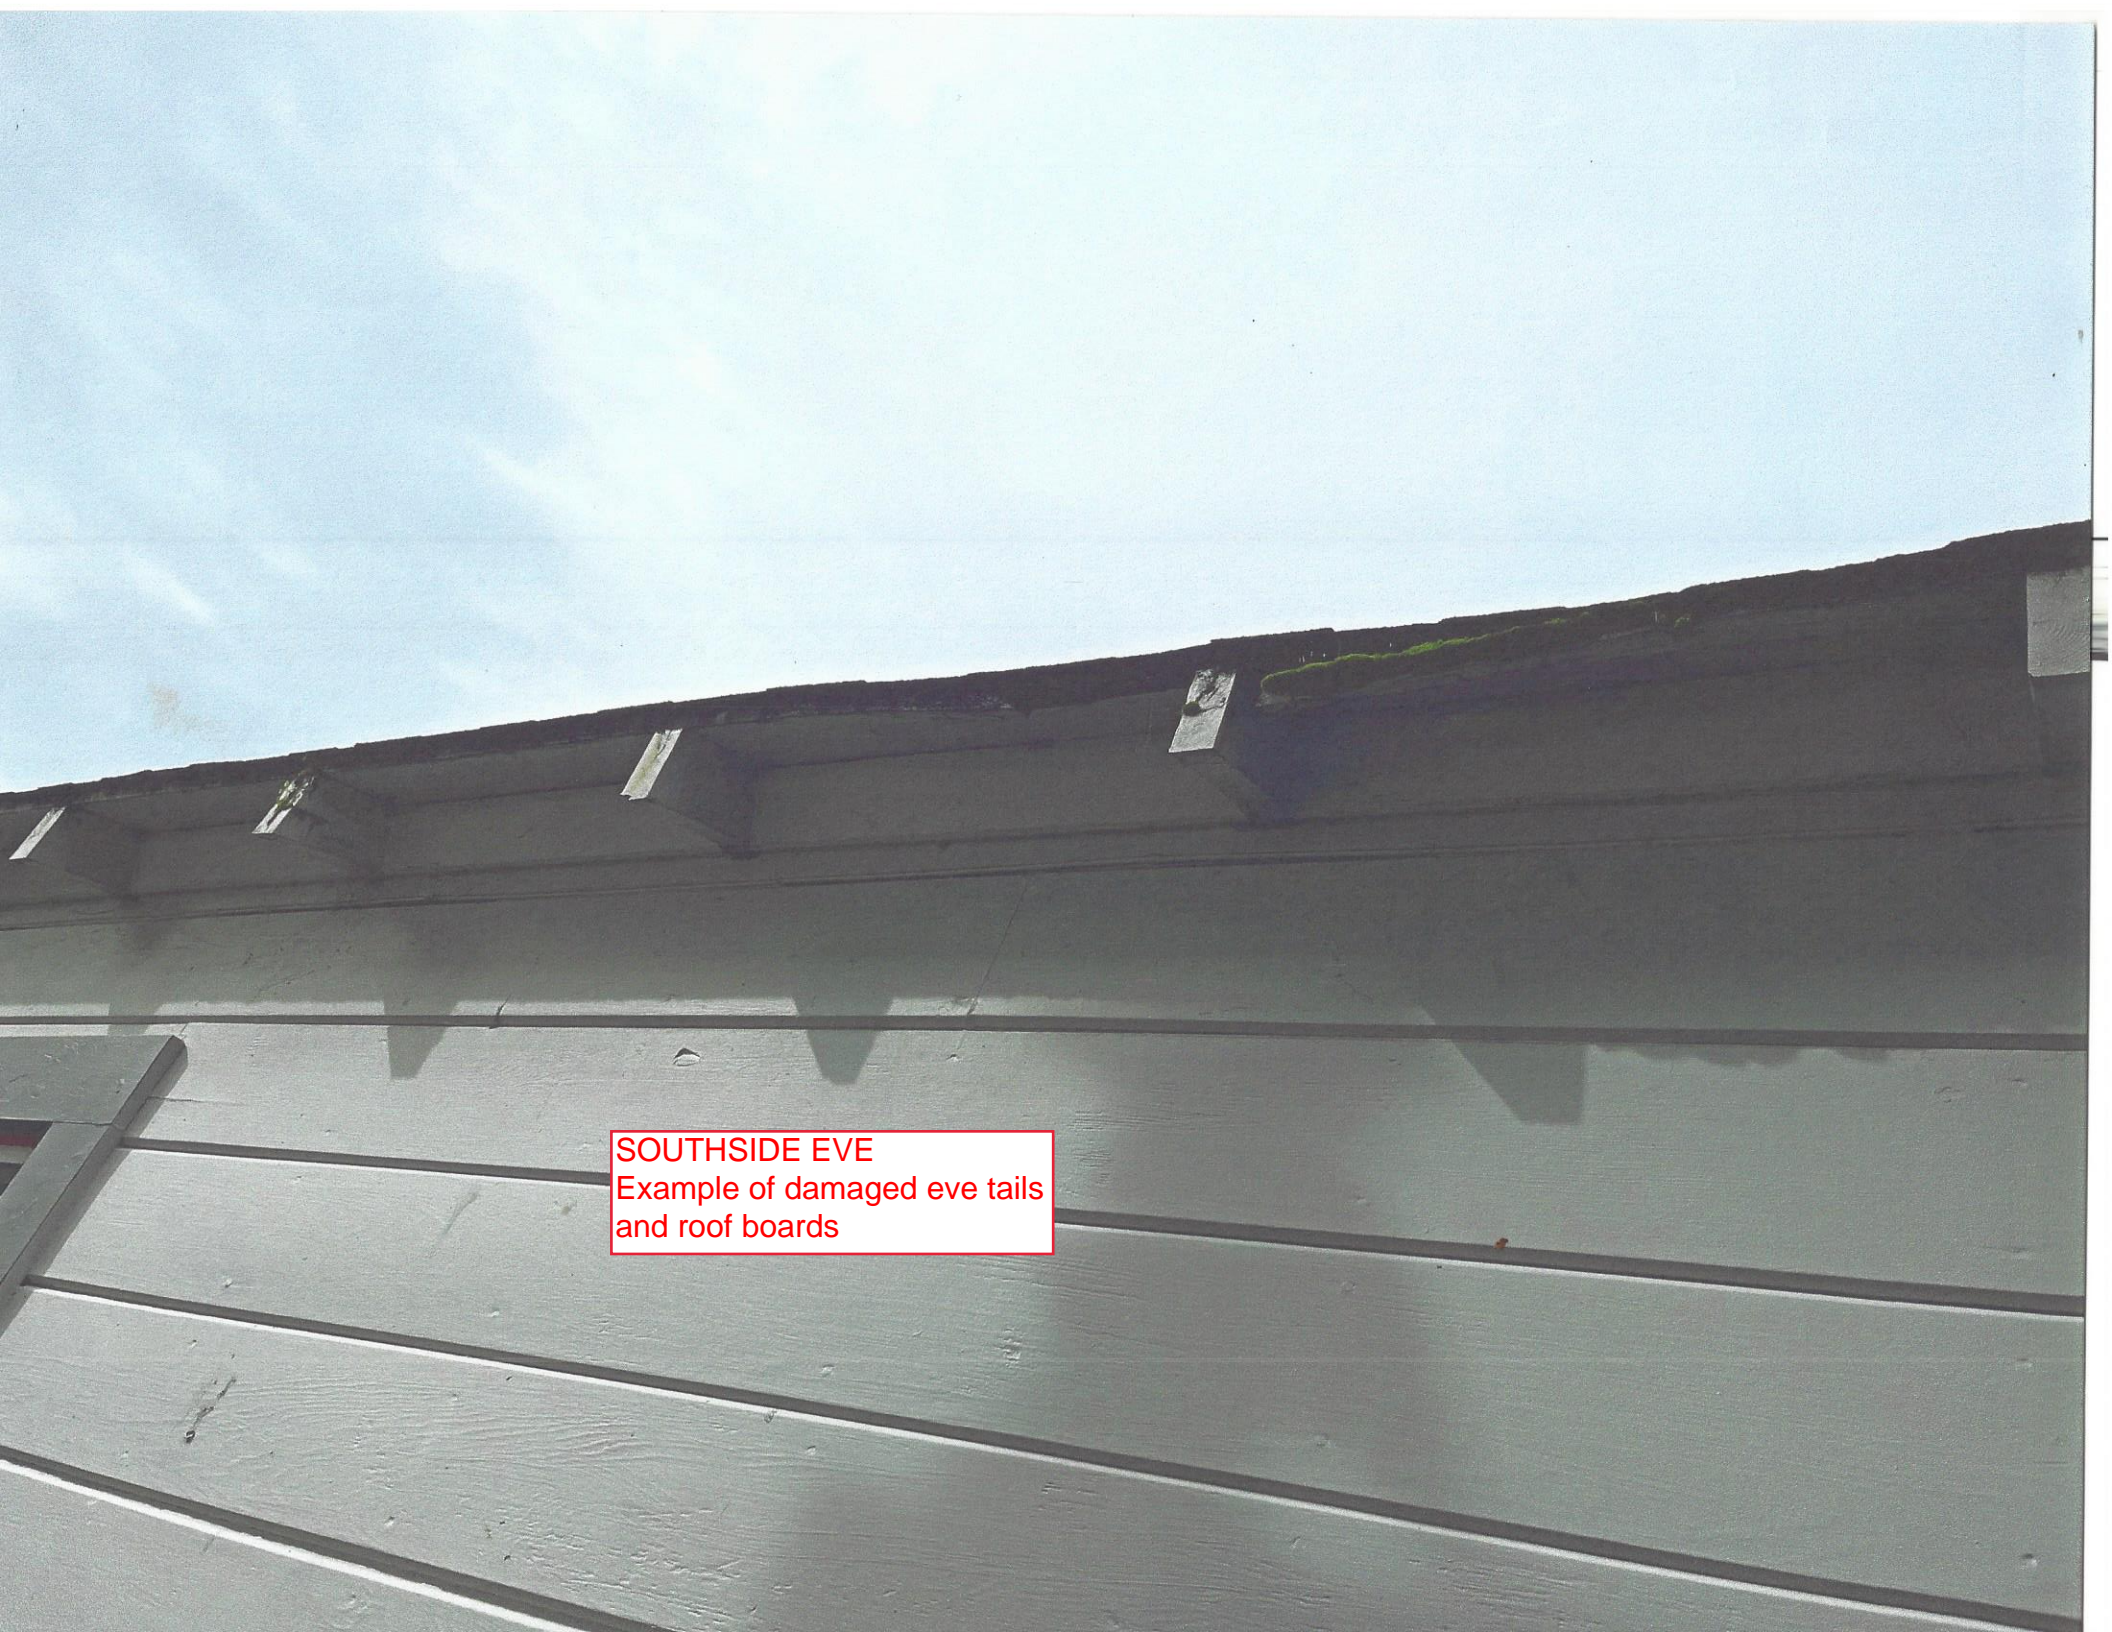
SOUTHSIDE EVE  
Example of damaged eave tails  
and roof boards

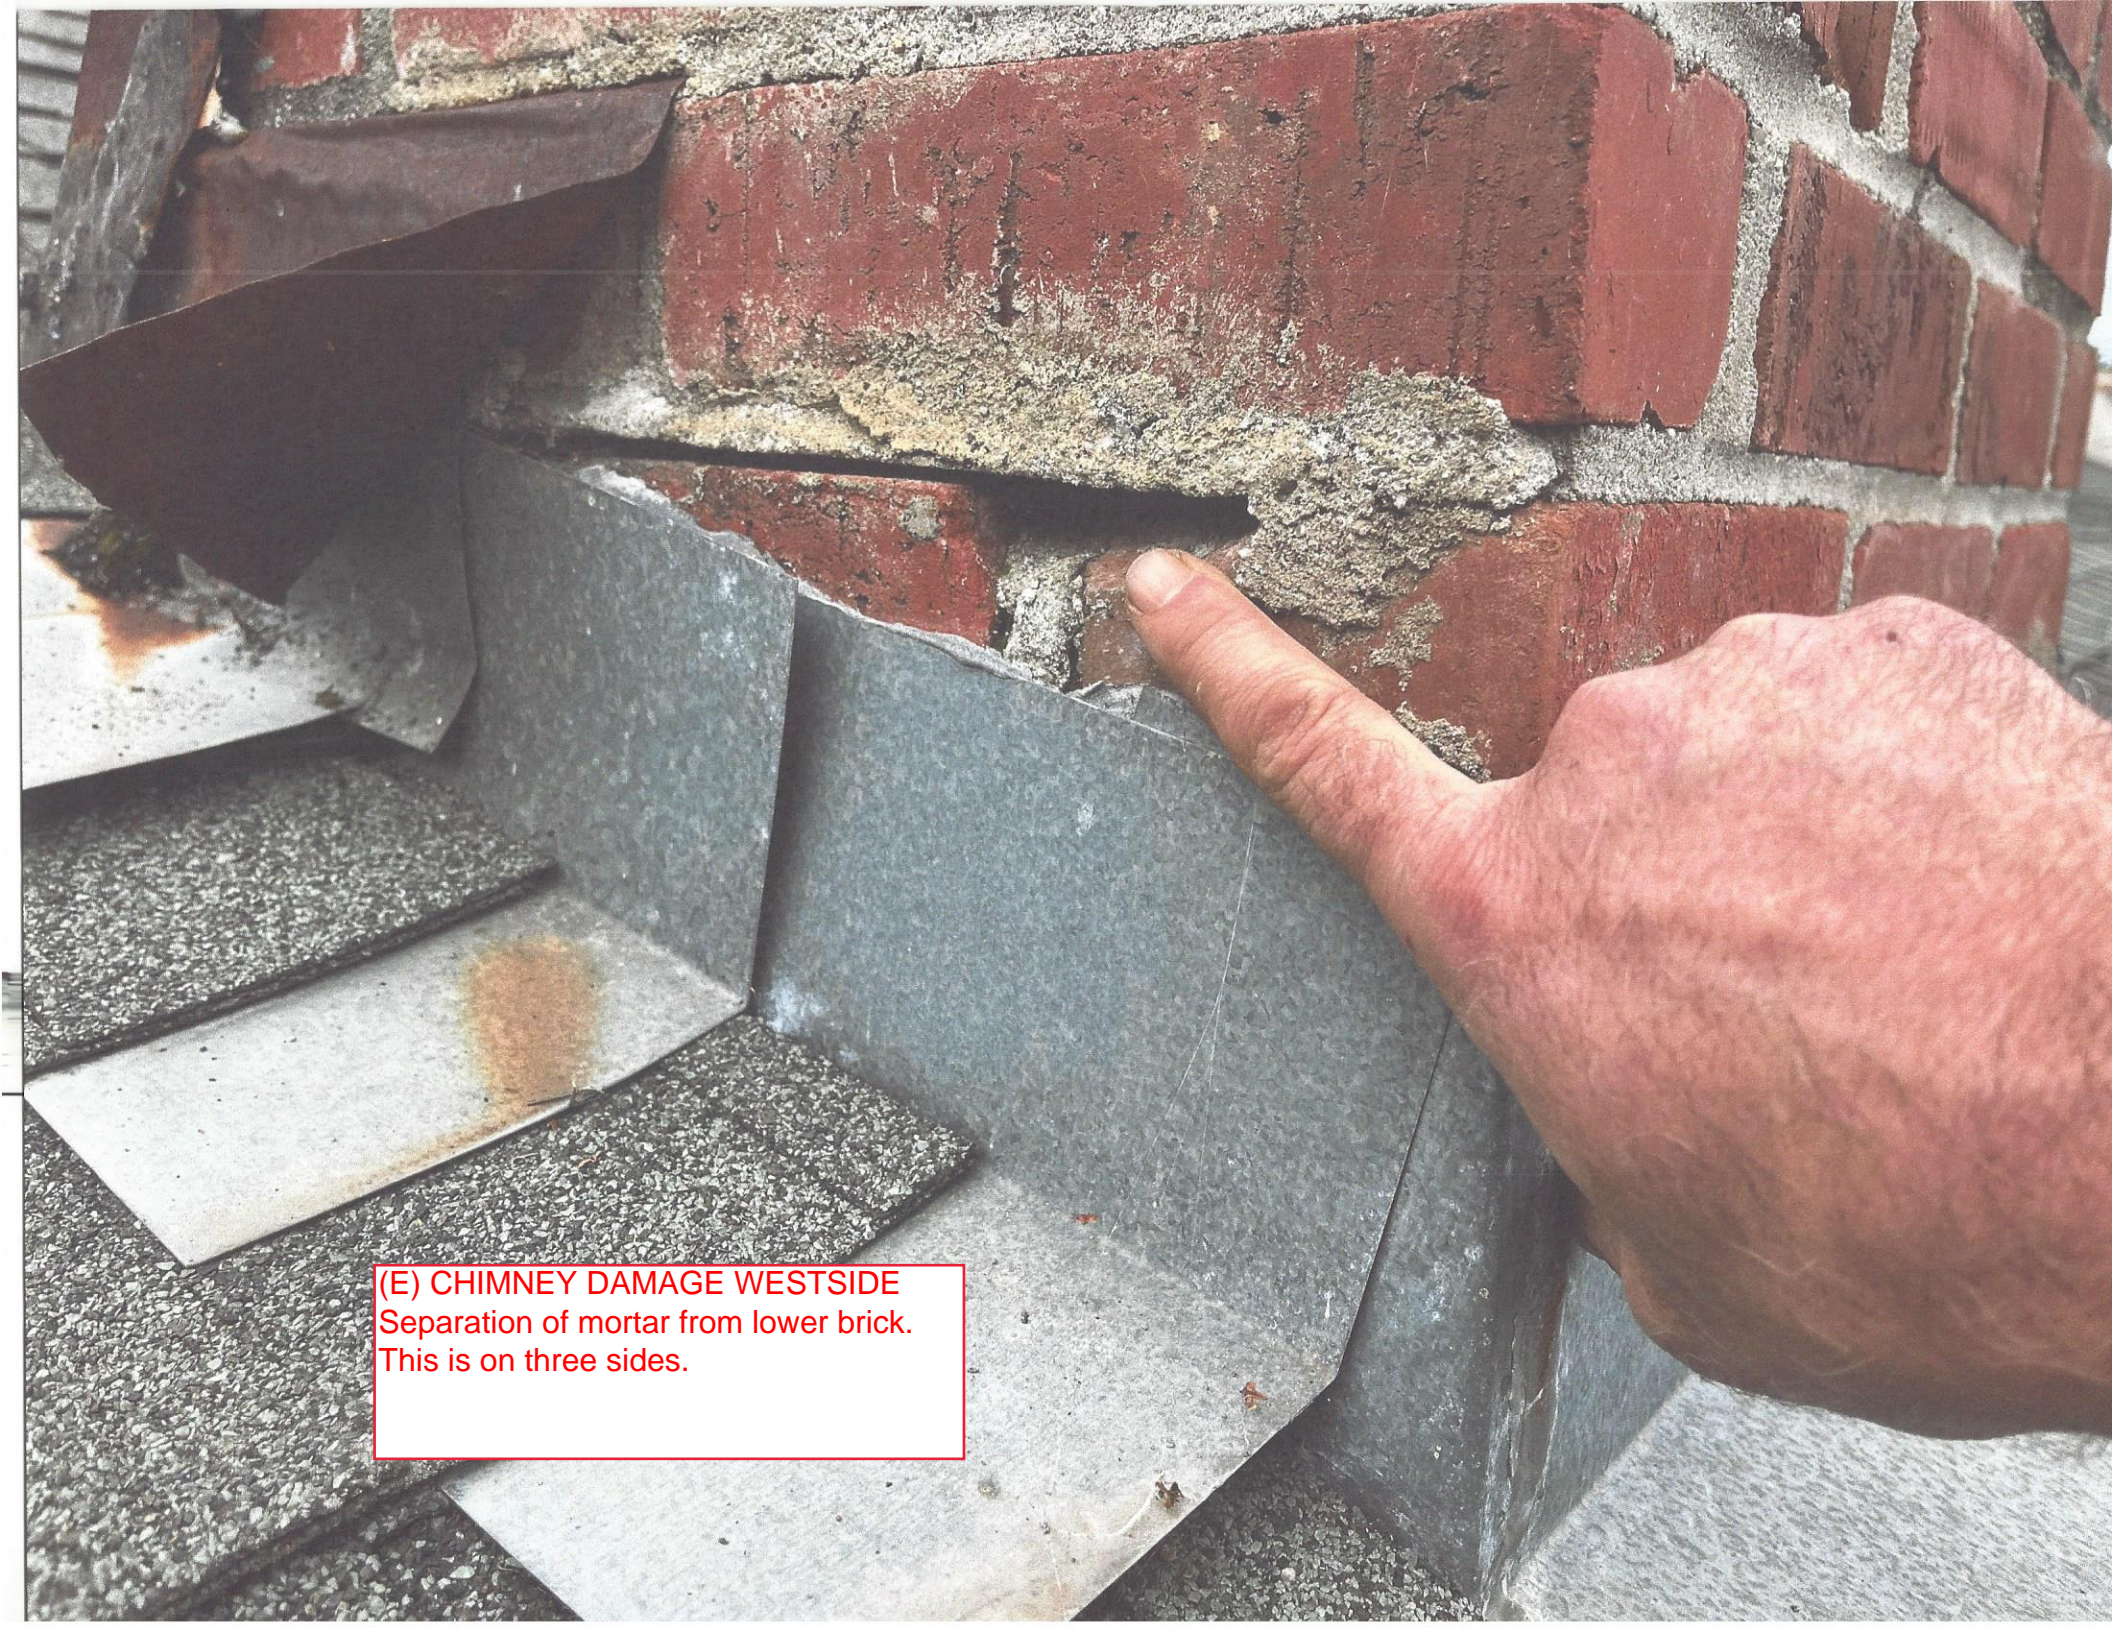
(E) CHIMNEY DAMAGE WESTSIDE  
Separation of mortar from lower brick.  
This is on three sides.

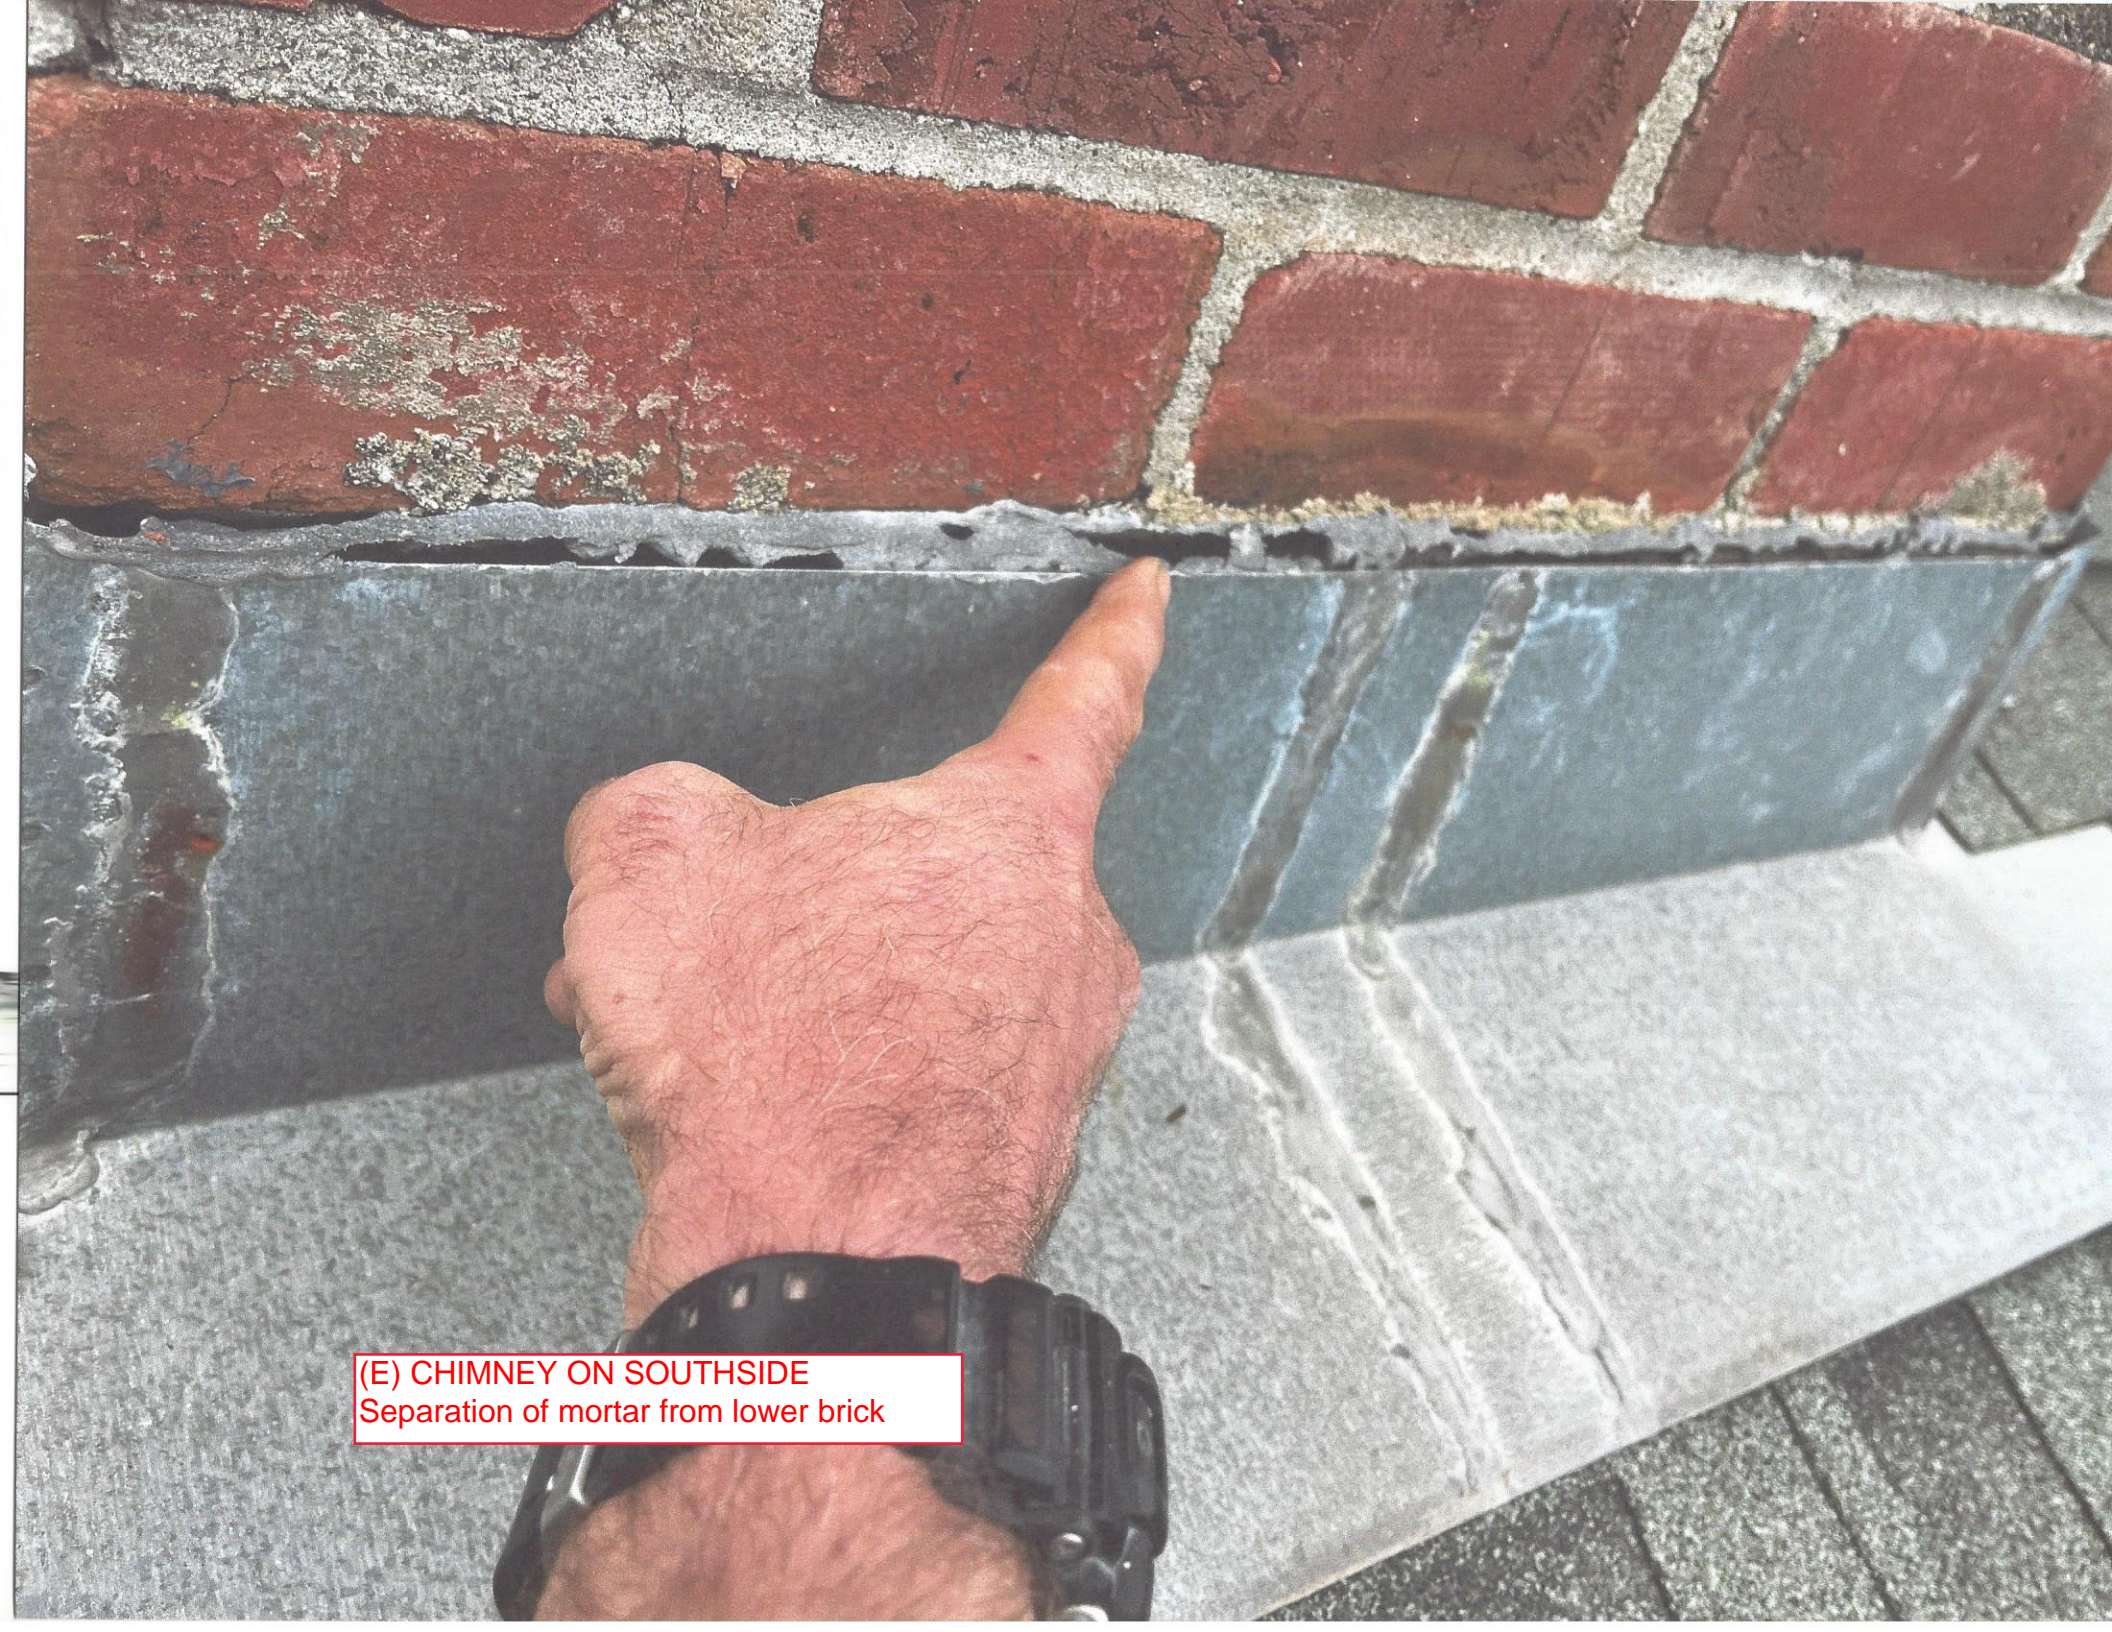
(E) CHIMNEY ON SOUTHSIDE  
Separation of mortar from lower brick

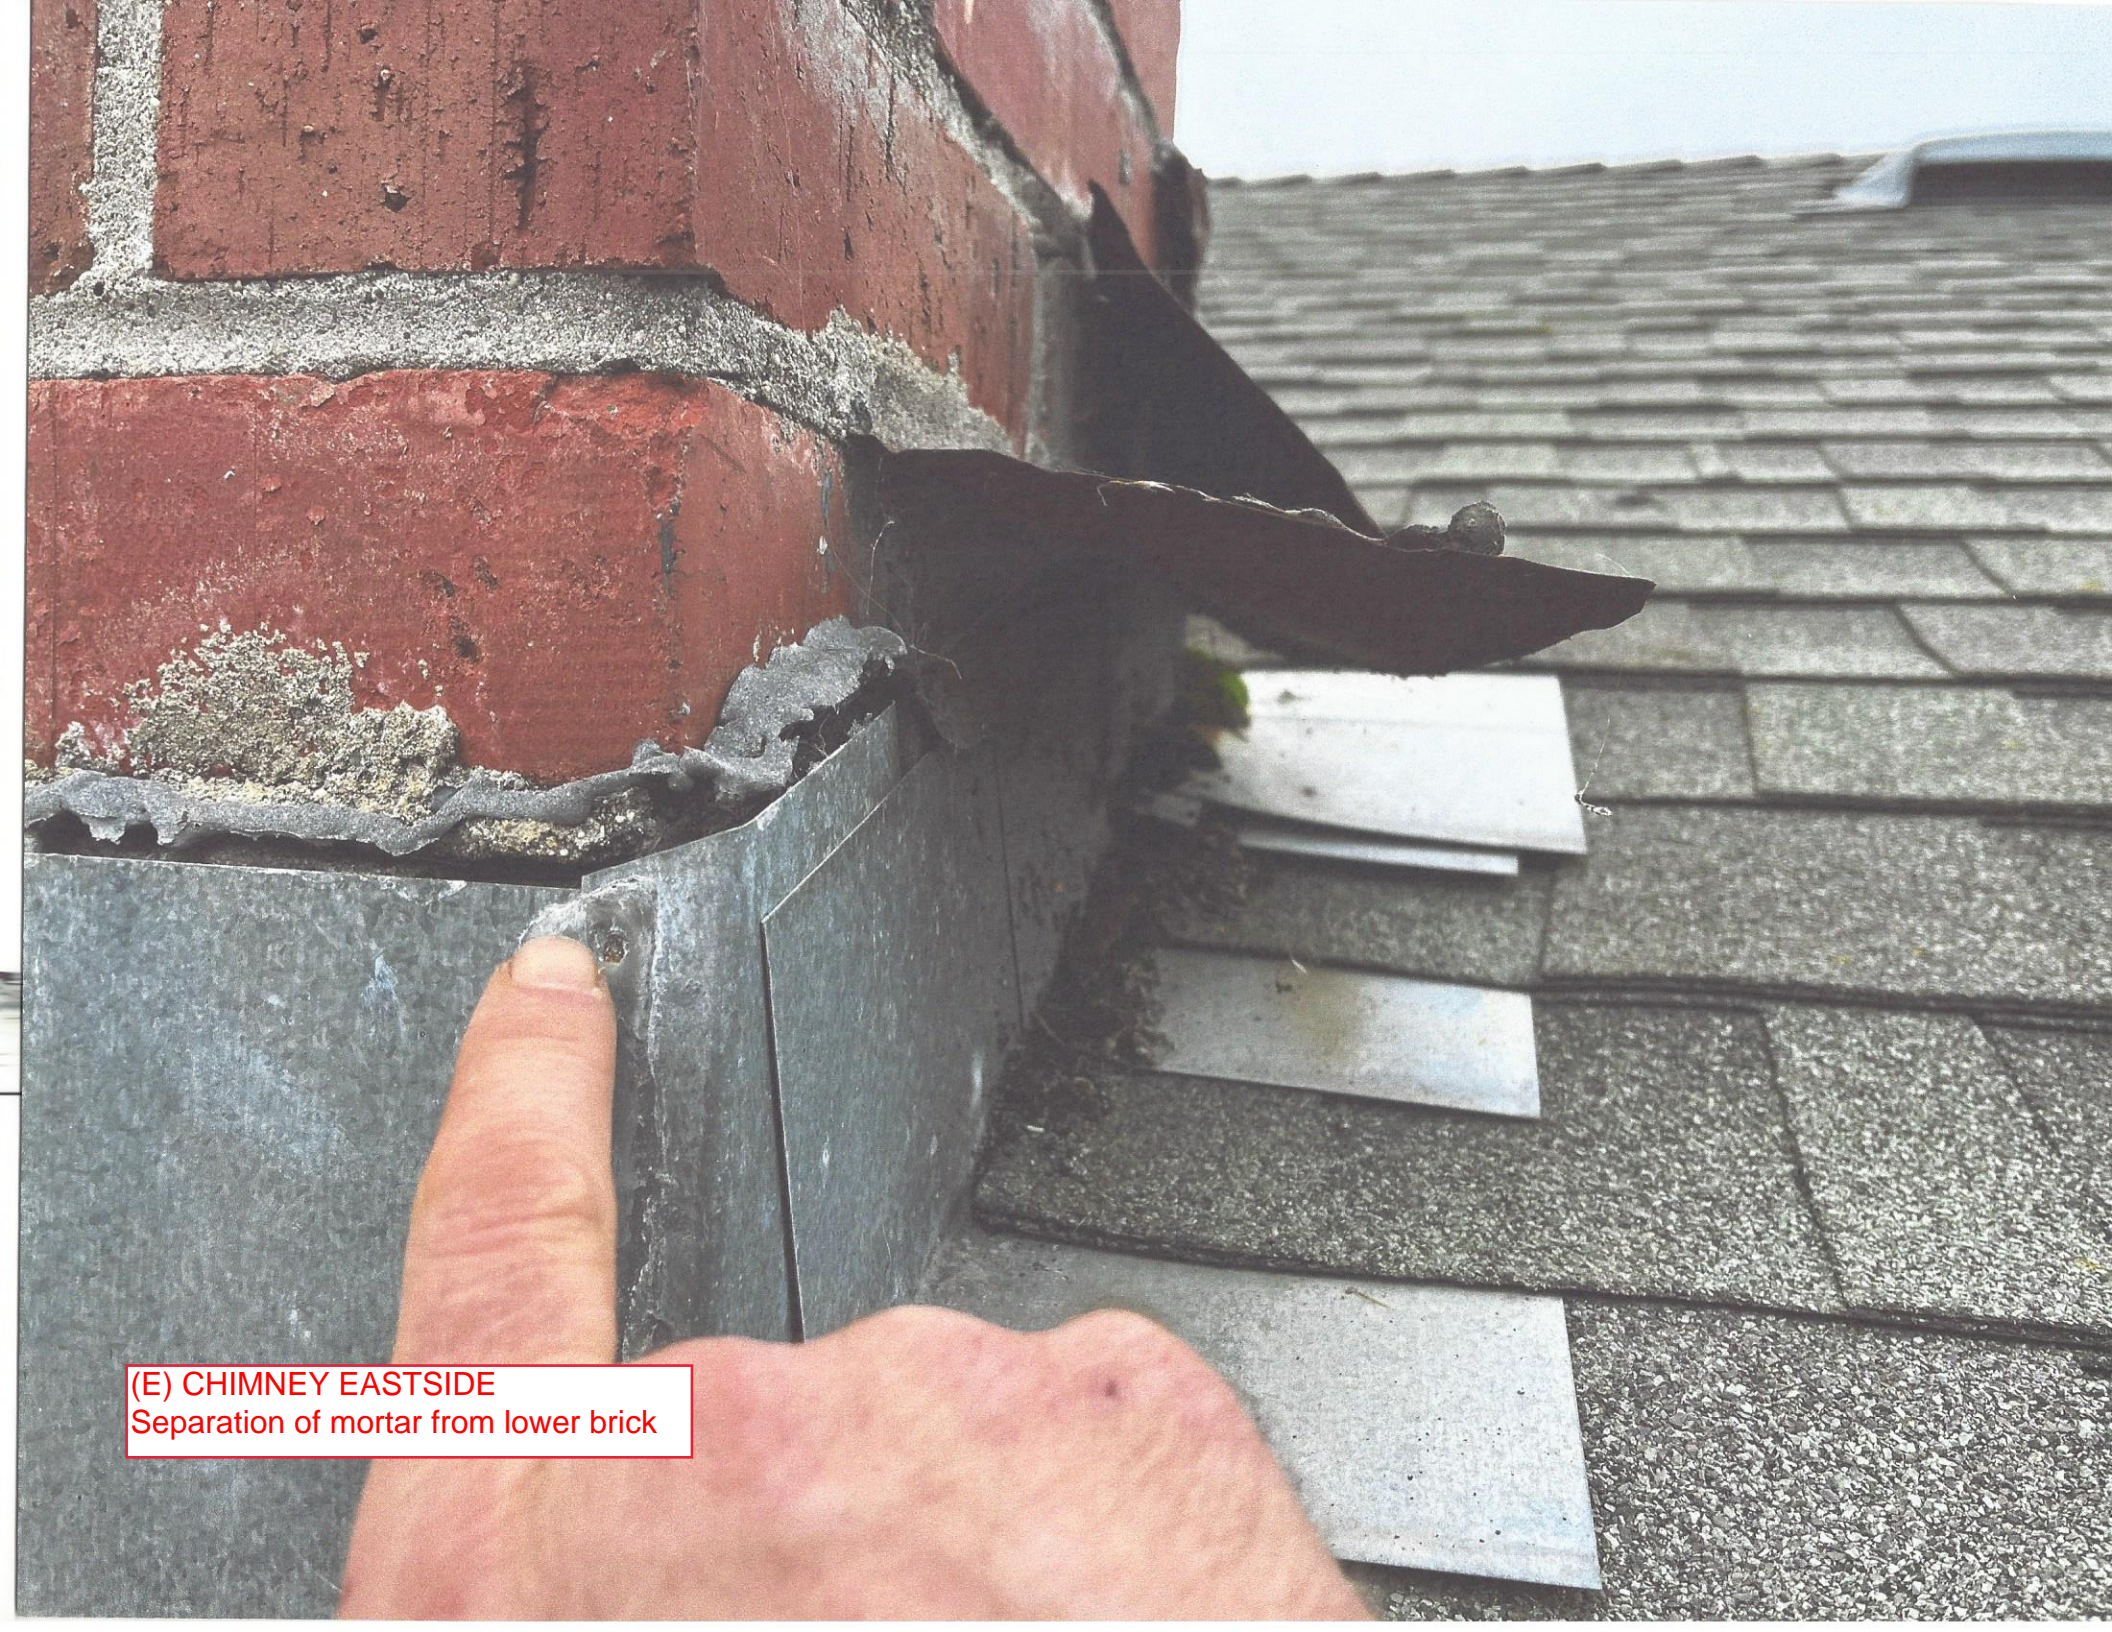
(E) CHIMNEY EASTSIDE  
Separation of mortar from lower brick

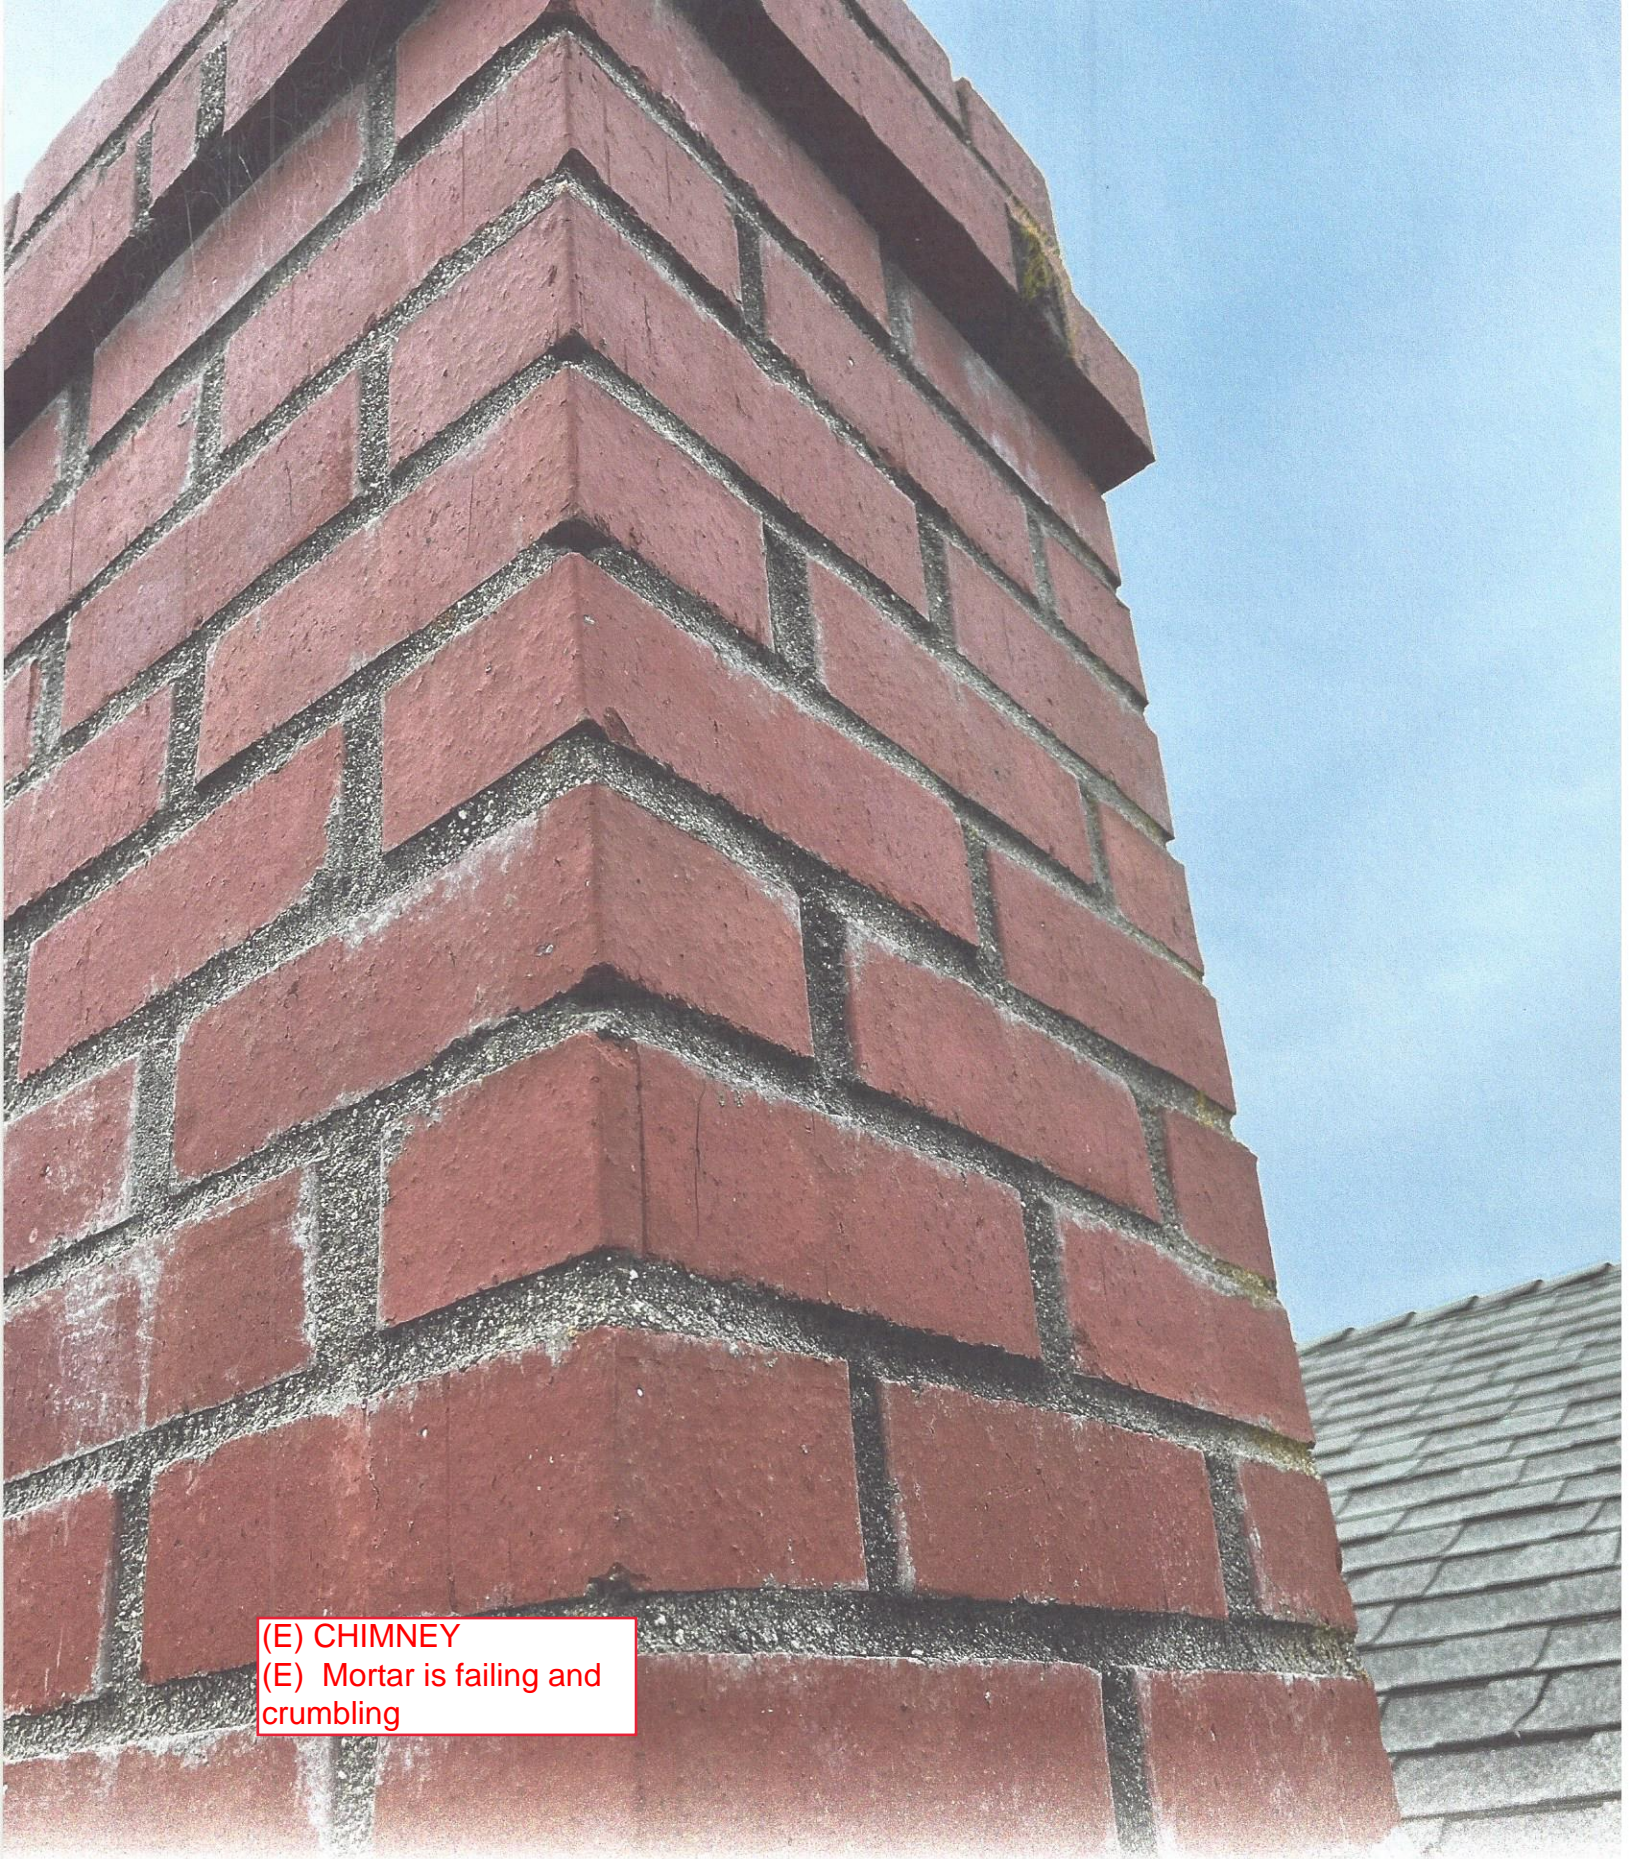
(E) CHIMNEY  
(E) Mortar is failing and  
crumbling
