ARBORIST REPORT-
Evaluation of a Monterey Cypress

709 Riverview Drive
Capitola, CA 95010

9/9/2024

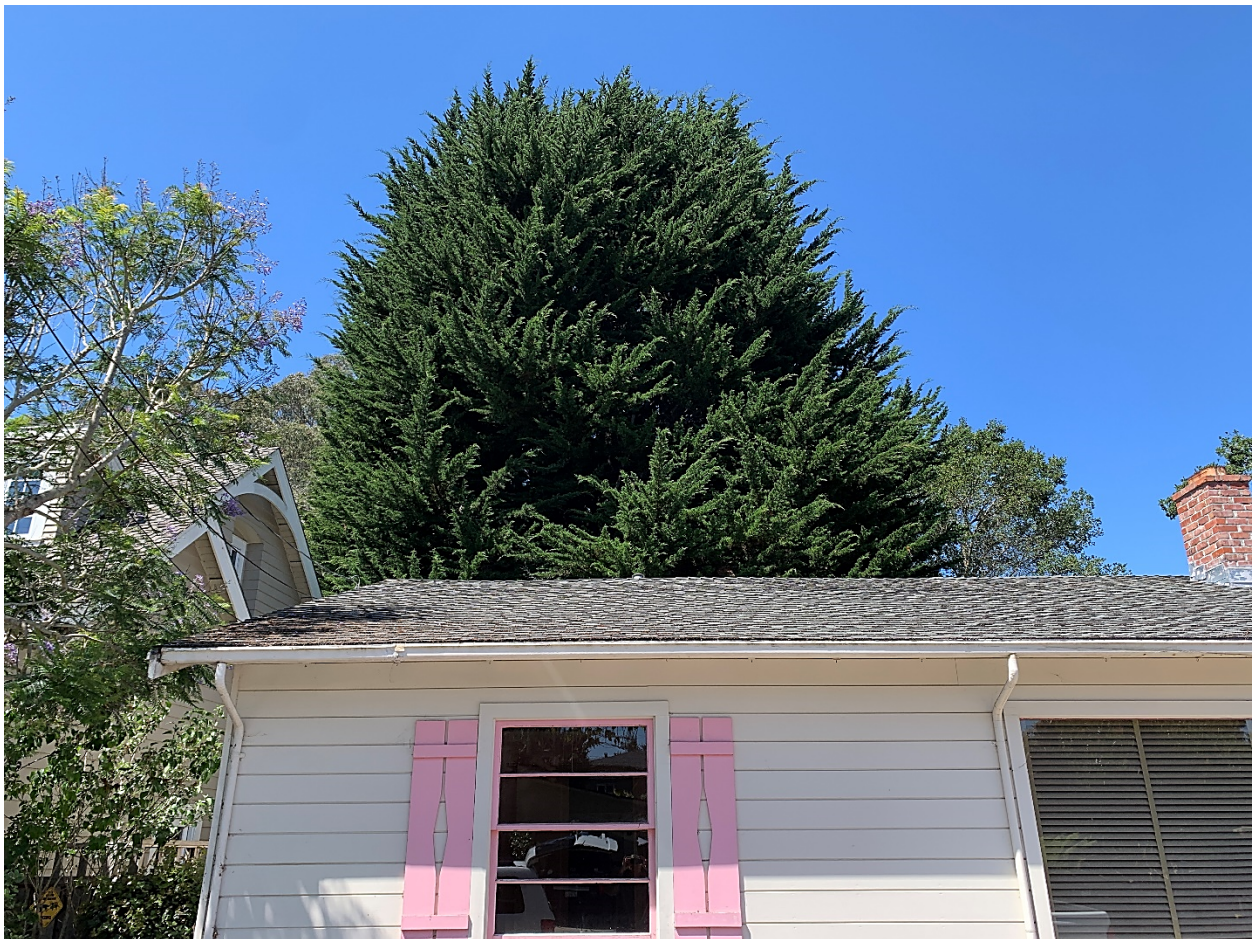
The tree grows in the back yard of the home, (Image #1).

Image #1 – Cypress tree canopy growing above home. View from the front yard.

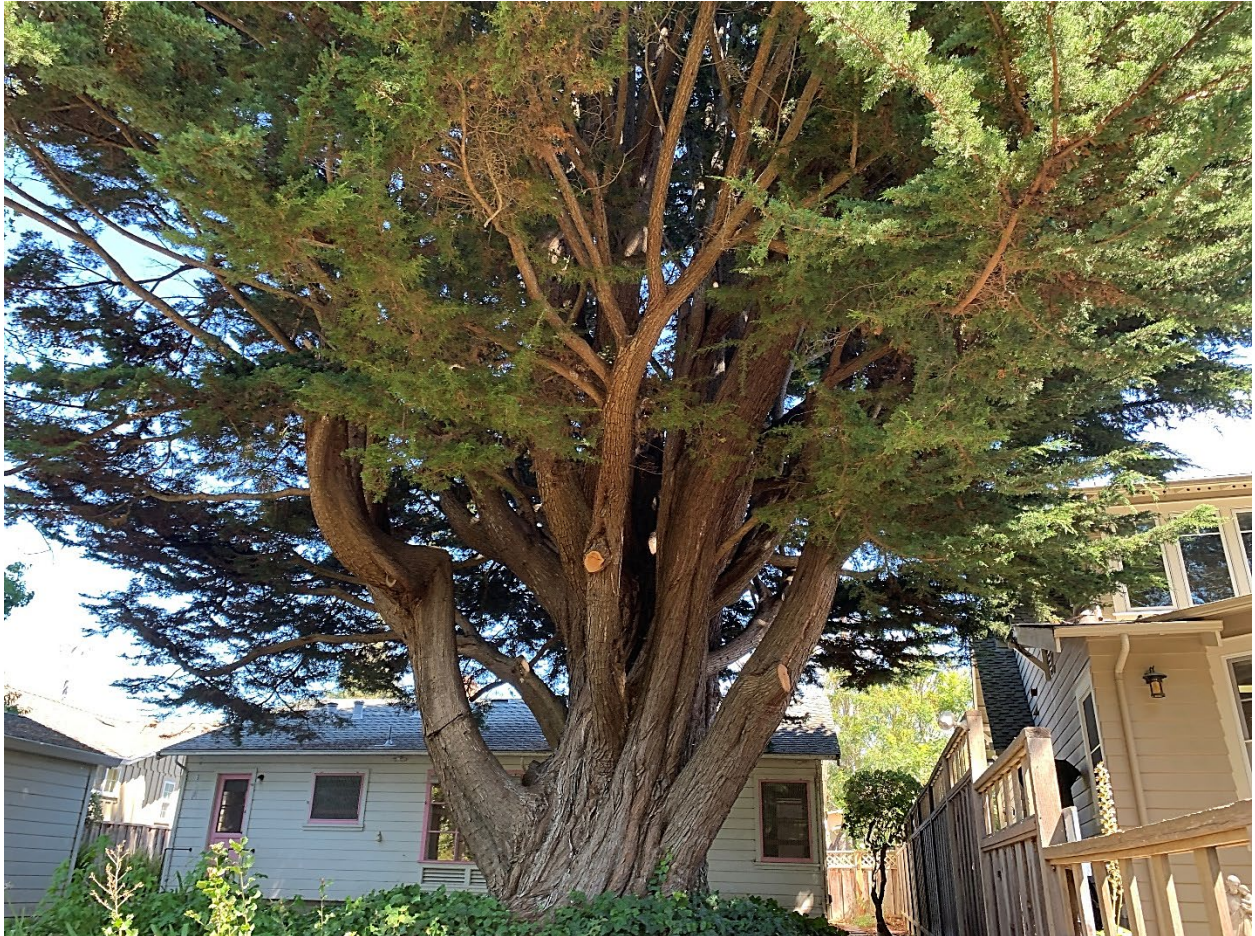
The tree grows on level ground. West of the tree, the property slopes down to the rear fence line. The cypress grows about 8-feet from the southern property line and is the same distance from the existing home. The canopy overhangs the adjacent property by about 15-feet, (Image #2).

Image #2 – Cypress tree, looking east, with existing home in background. Note canopy overhangs adjacent home. West of the tree, the property slopes down.

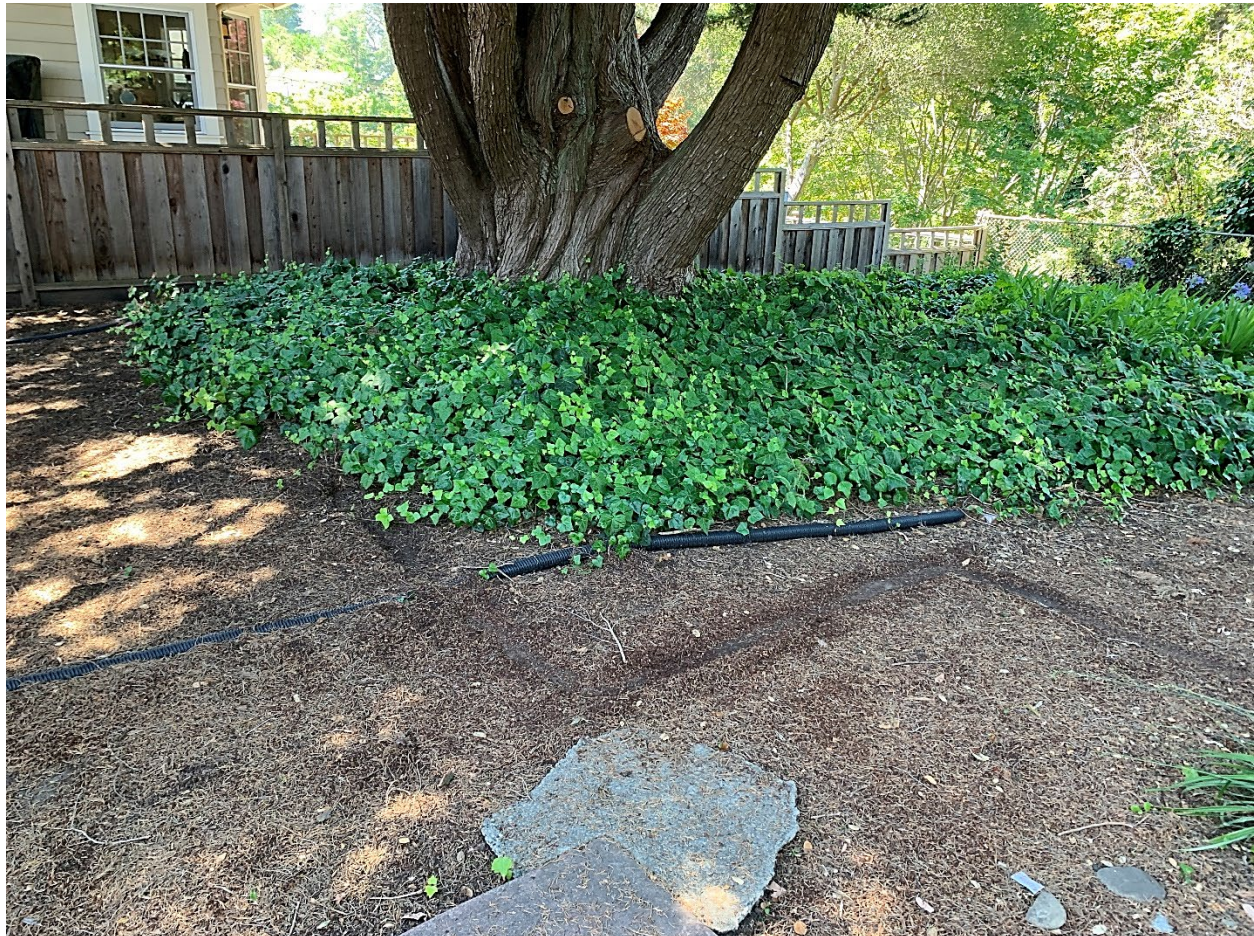
A dense groundcover of English ivy grows under the tree's canopy, (Image #3). The tree has a large rooting area of undisturbed soil to collect water and sustain its growth.

Image #3 – Cypress with English ivy ground cover growing beneath the canopy area.

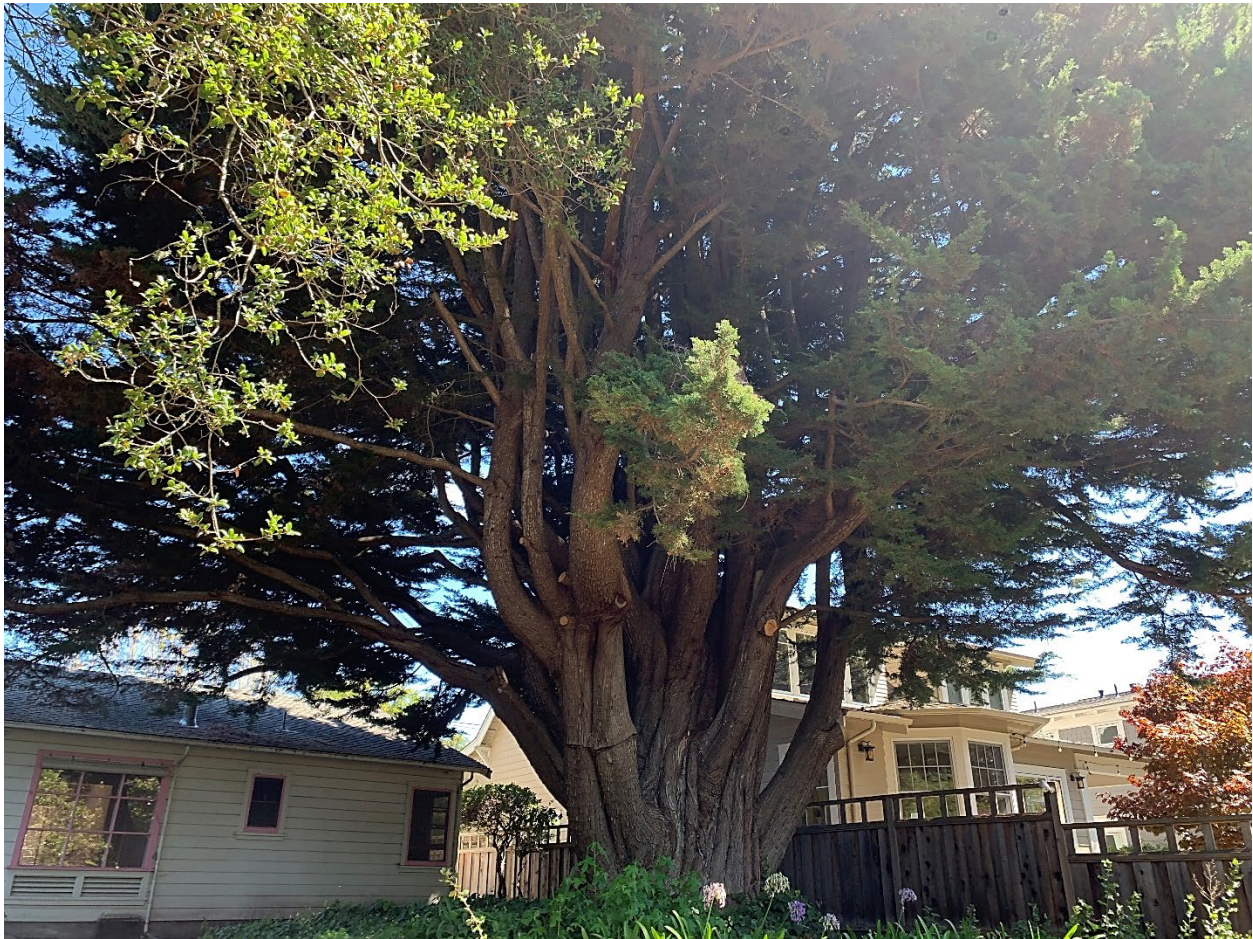
Structure - The cypress has multiple trunks. The trunks are layered against each other, with one set of trunks originating near the base of the tree, and a second set beginning at about 5 – 6-feet above grade. Multiple trunks are considered a structural defect; however this growth habit is typical of the species, and I did not note other defects that when combined with multiple trunks would create a cause for concern, (Image #4).

Image #4 – Note multiple trunks growing near the base of the tree and a second set higher up.

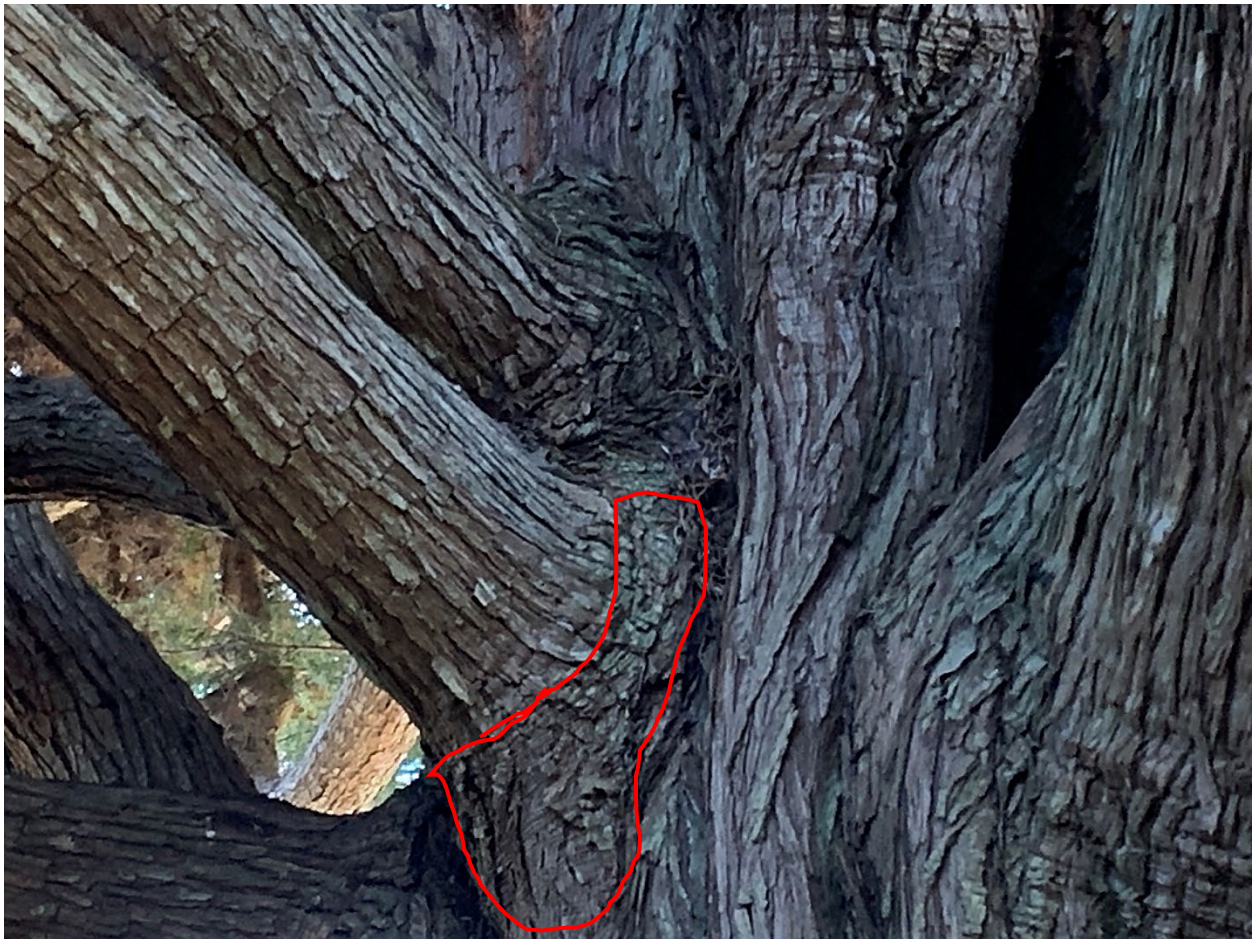
I inspected the limb to trunk attachments on the larger scaffolds and they appeared sound. The limbs had ample amounts of attachment wood, and the angles of attachment were proper for good stability, (Image #5).

Image #5 – Note the extra attachment wood around the limb, (circled).

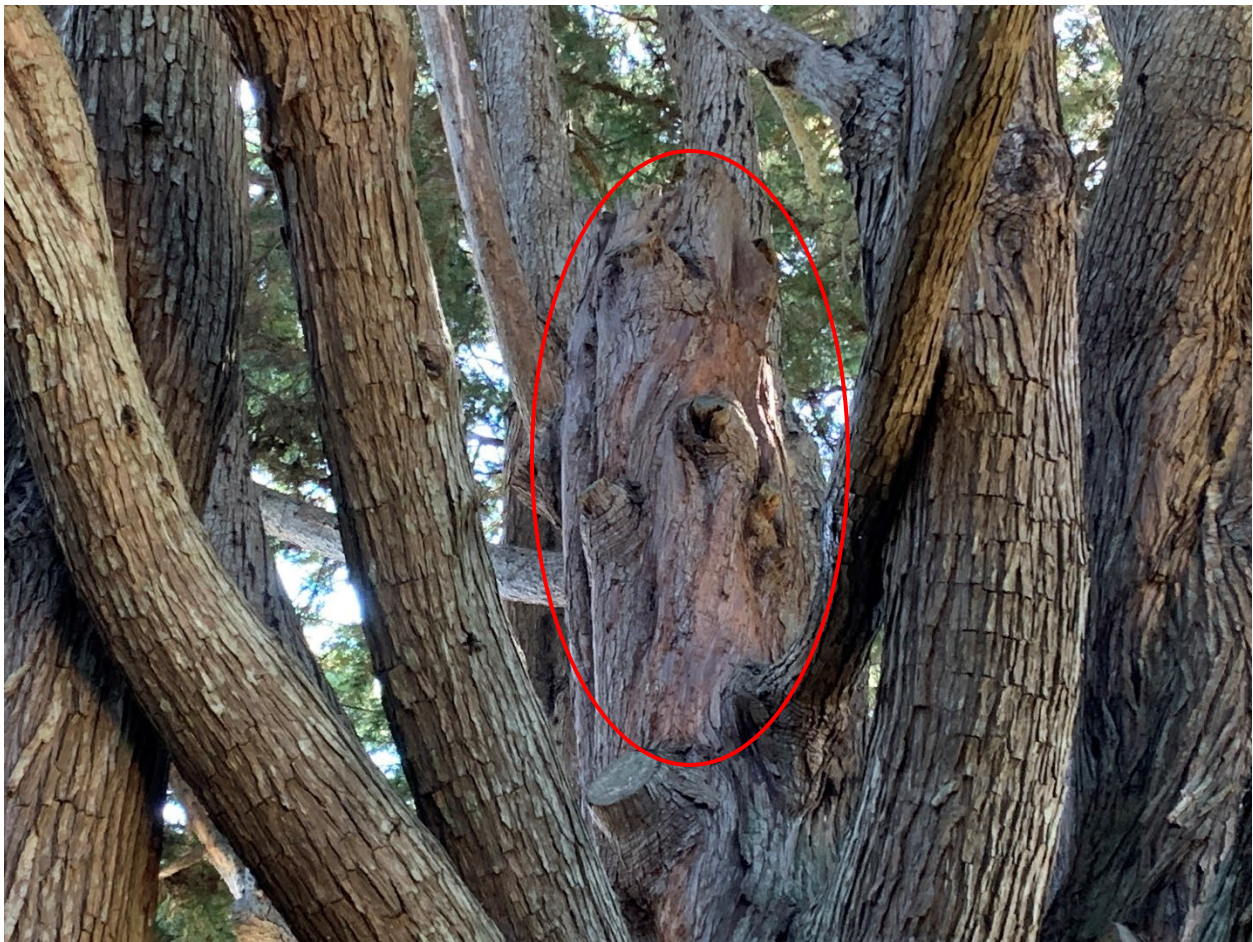
I noted a large, (14" diameter X 5-feet), deadwood stub in the center of the tree, (Image #6).

Image #6 – Note deadwood stub, (circled).

This stub was pruned many years ago and any live growth that remained on its lower limbs has since died back, or been removed.

The large stub shown in image #5 should be inspected for signs of decay. If none are found it can be retained, or if pruned, a cut should be made above the live branch growing to the north. The other deadwood stubs I noted, should be pruned back to a live side branch.

1. Have the large deadwood stub in the center of the tree inspected for decay.
2. Perform minor tree pruning. Remove deadwood stubs, and clearance prune tree a minimum of 5-feet from neighboring home.
3. If any of the new development encroaches closer to the tree than the existing home, mitigation to offset the loss of roots should entail hand digging and root pruning.

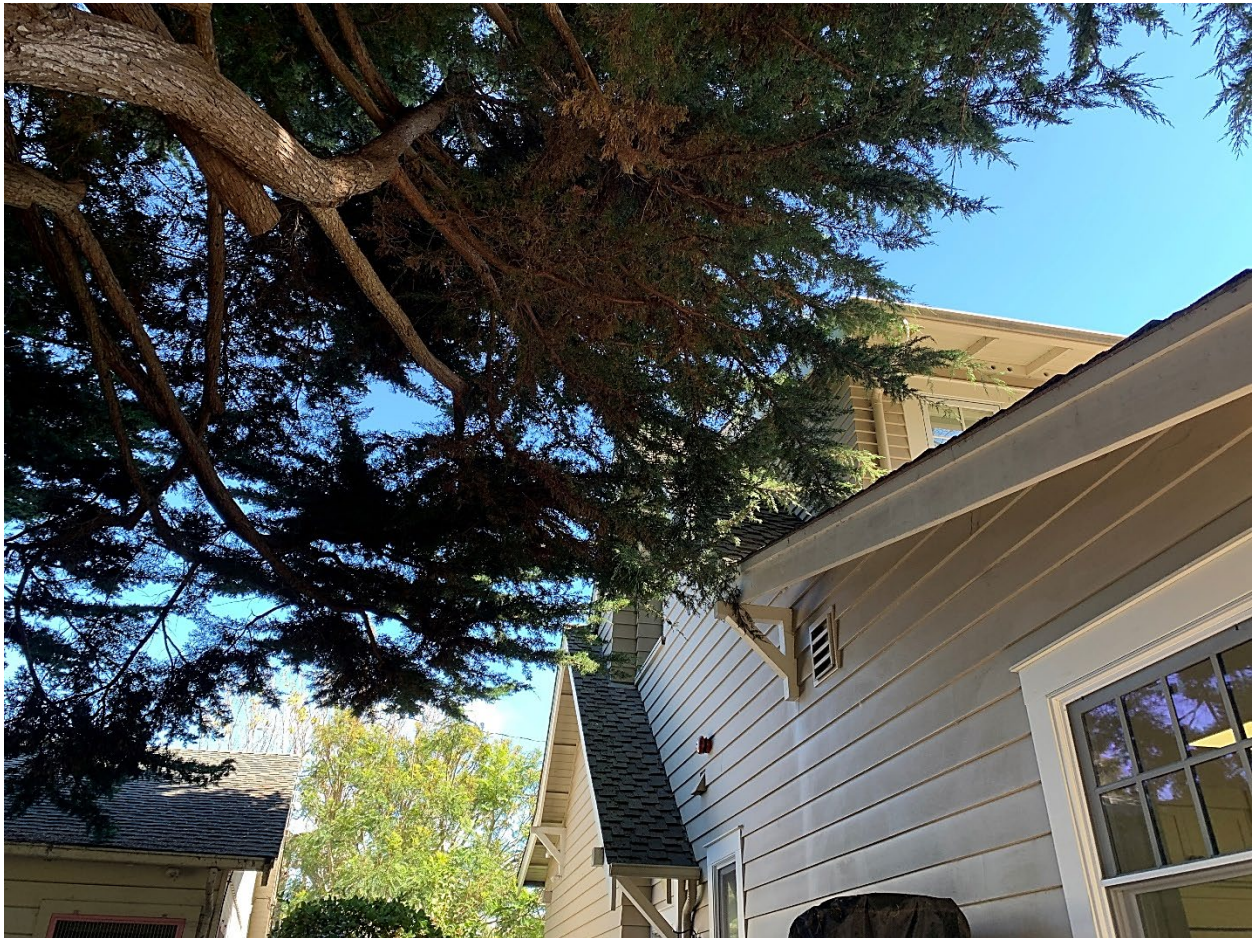
Some pruning work should be done to improve the trees long term health, to provide clearance from the neighboring home, (Image #7), and may be necessary to create clearance for the proposed development.

Image #7 – Note limb growth on or near neighbors roof. The limbs growing close to the home should be shortened.
