Project No. SC11778
23 June 2020

Subject: Inspection Monitoring & Maintenance Report

Reference: Blufftop Retaining Wall and Seawall
4800 Opal Cliff Drive
APN 34-251-05
Capitola, California

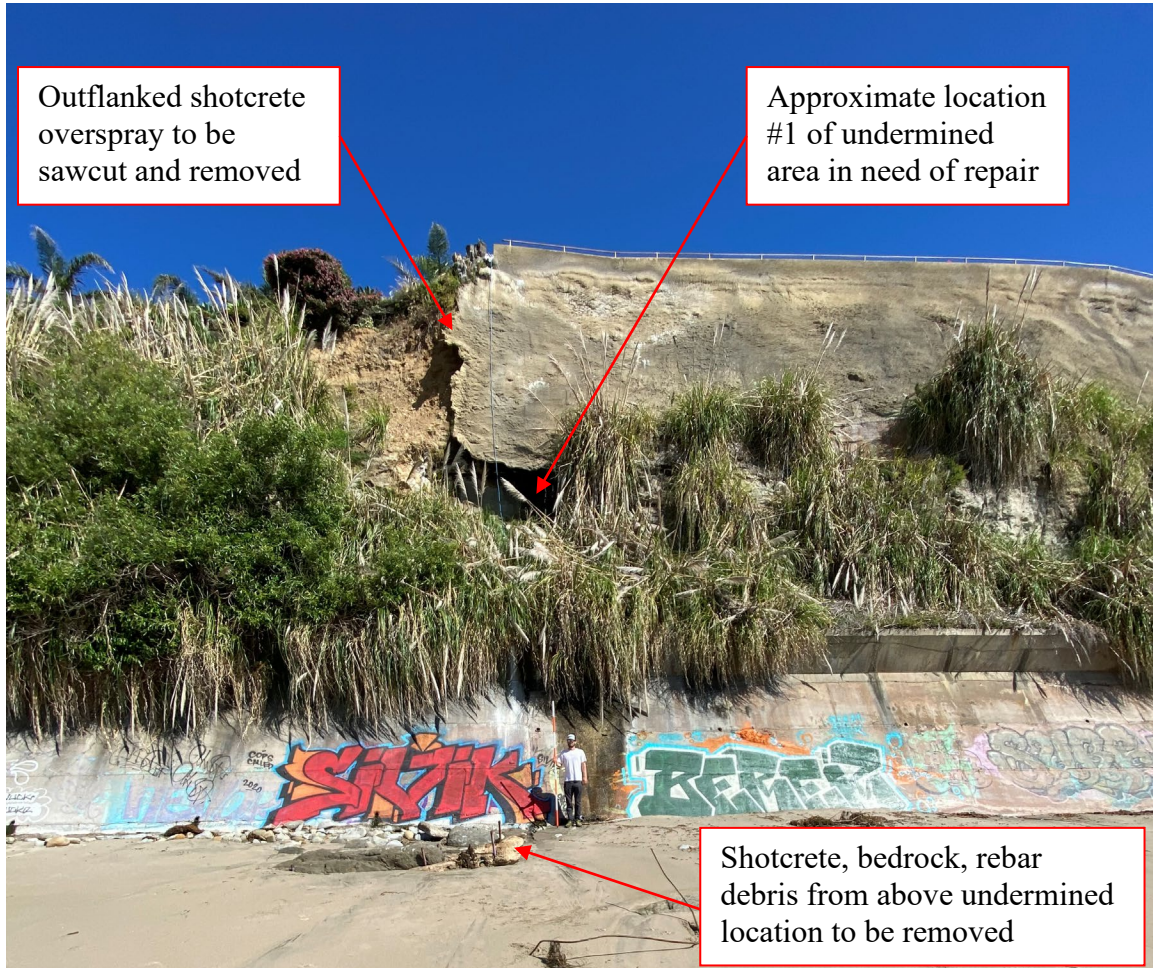
connected to the blufftop wall at 4820 Opal Cliff Drive; see Photo 4 attached to this letter. At the upcoast end of the blufftop wall, the bluff face at 4790 Opal Cliff Drive is not protected by a retaining wall system and is subject to ongoing blufftop recession; see Photo 1 attached to this letter.

We identified two areas along the base of the blufftop retaining wall that are undermined and in need of immediate maintenance and repair. The two areas are located at the (1) upcoast end of the wall and (2) approximately 15 feet from the downcoast property line between 4800 and 4820 Opal Cliff Drive. See Photos 1 and 4 attached to this letter for the locations. The undermined areas consist of a shotcrete shell covering unsupported, bedrock blocks ranging in size from less than an inch to approximately 1.5 feet thick.

Photo 1: 4800/4790 Opal Cliff Drive Property Line View - 26 May 2020

To facilitate the repair in these two locations, the overhanging shotcrete shell should be trimmed and vegetation cleared. Shallow rock dowels (1 inch diameter min.) should be installed at least 8 feet into the bedrock bluff face below the base

of the wall. The repair shotcrete should incorporate steel reinforcement tied to the steel rock dowels to minimize shrinkage crack widths. The repair shotcrete should match the existing shotcrete texture and color. Miradrain panels connected to the existing drainage system and weep holes should be installed prior to shotcrete. All work should be done to conform with HKA's recommendations for this project site and confirmed by HKA in the field. The specific extent of the repair should be confirmed by HKA in the field during construction. For cost estimate purposes the contractor should assume a repair area for location 1 of 13' wide x 6' tall x 1.5' deep and a repair area for location 2 of 6' wide x 5' tall x 1' deep.

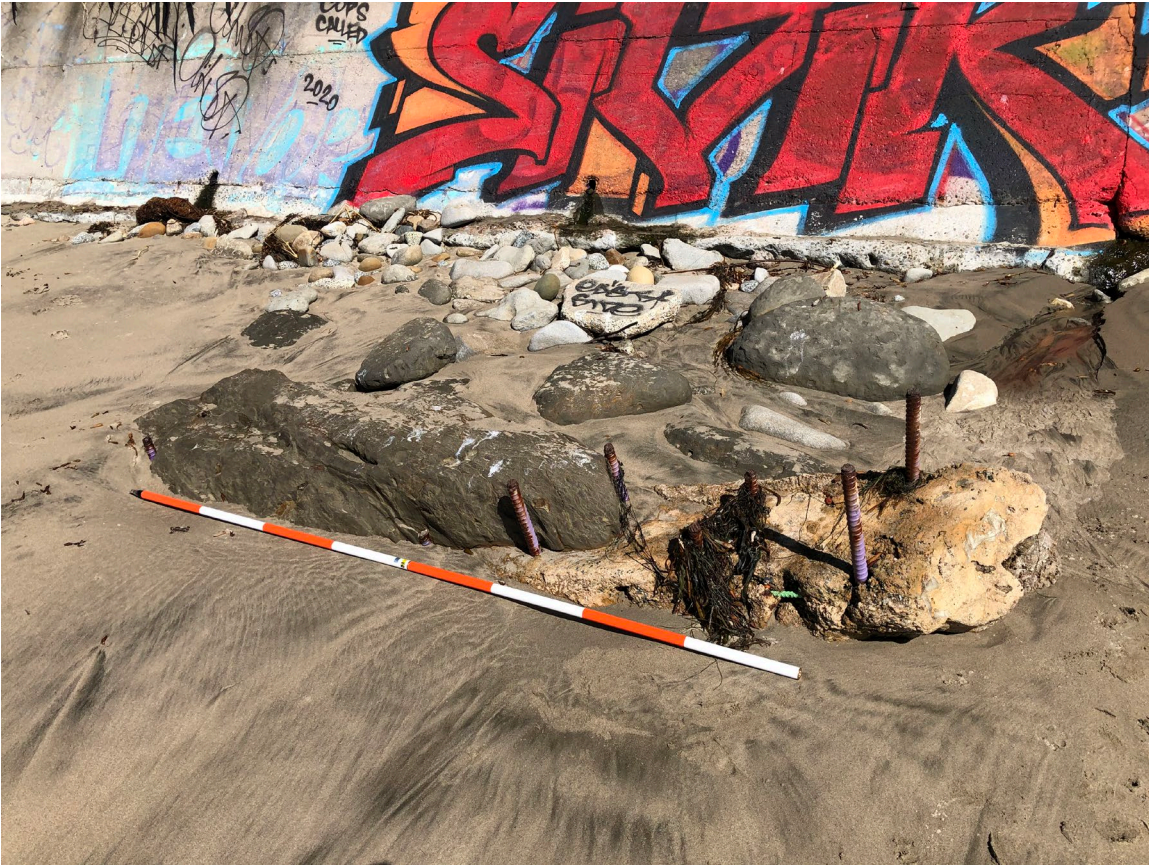
At location 1, a large mass of shotcrete, bedrock, and rebar dislodged and fell to the beach as shown in Photos 2 and 3. The void left by the mass measures approximately 11' wide x 2' tall x 1.5' deep, which matches the debris mass on the beach. The exposed bedrock/terrace contact is visible along with the existing Miradrain panels and pvc pipes. Active seepage was observed at the bedrock/terrace contact.

Photo 2: Close up of shotcrete, bedrock, rebar debris to be removed - 26 May 2020

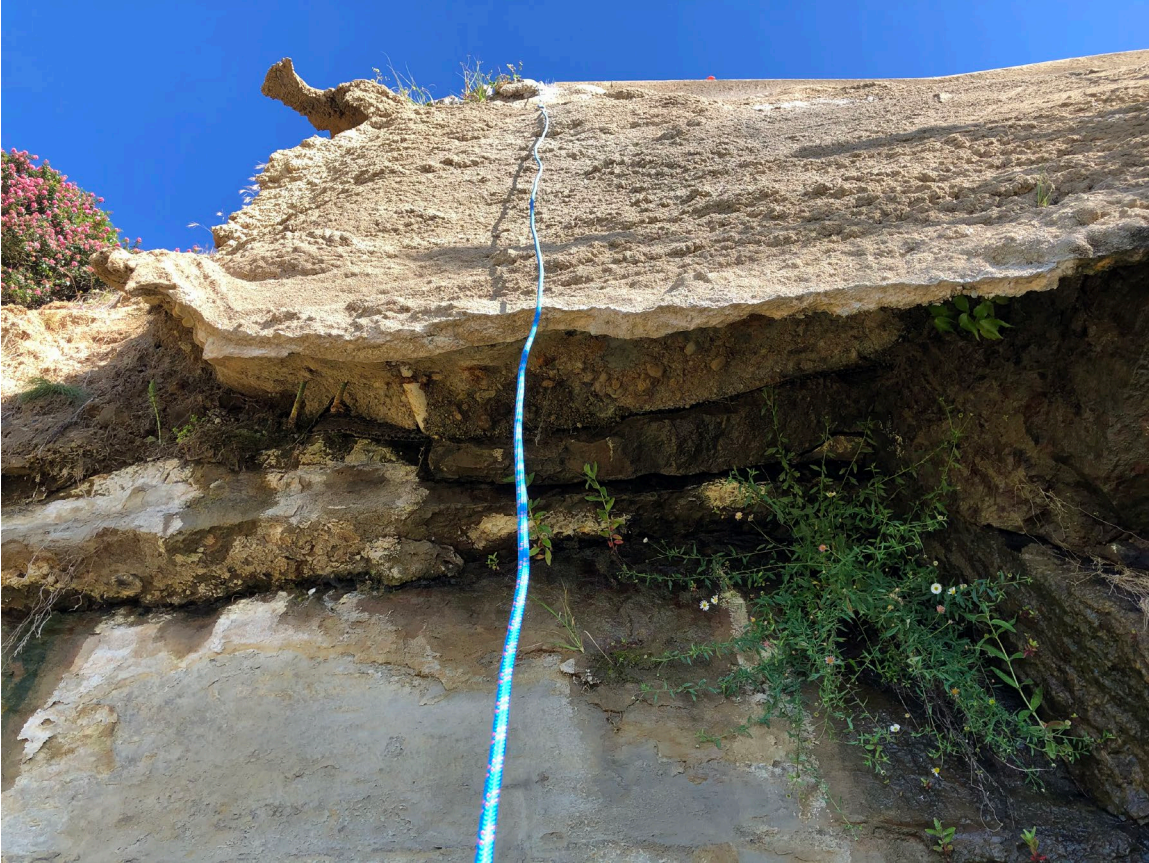
Photo 3: Close up of undermined area in need of repair - 26 May 2020

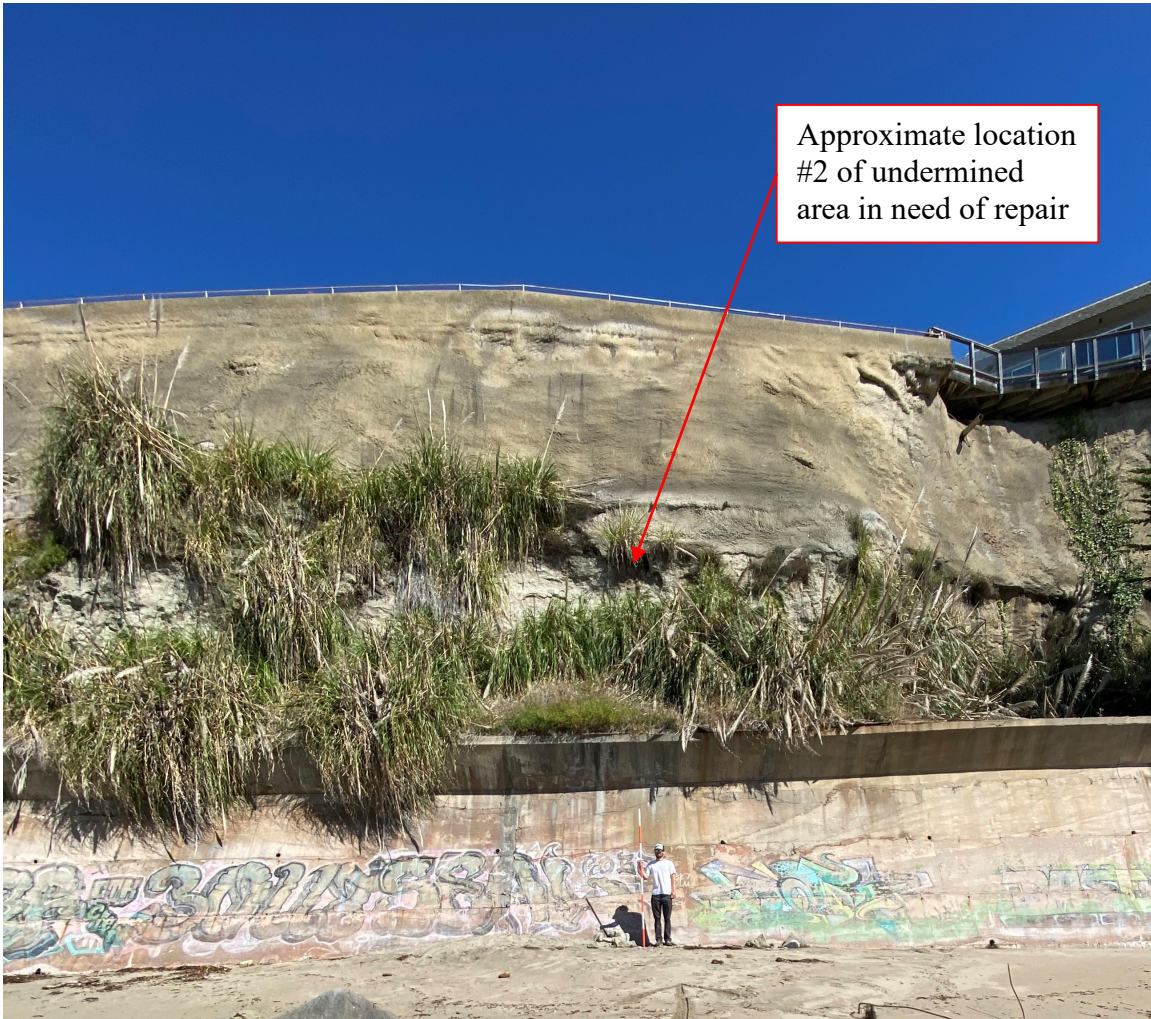
Photo 4: 4800/4820 Opal Cliff Drive Property Line View - 26 May 2020

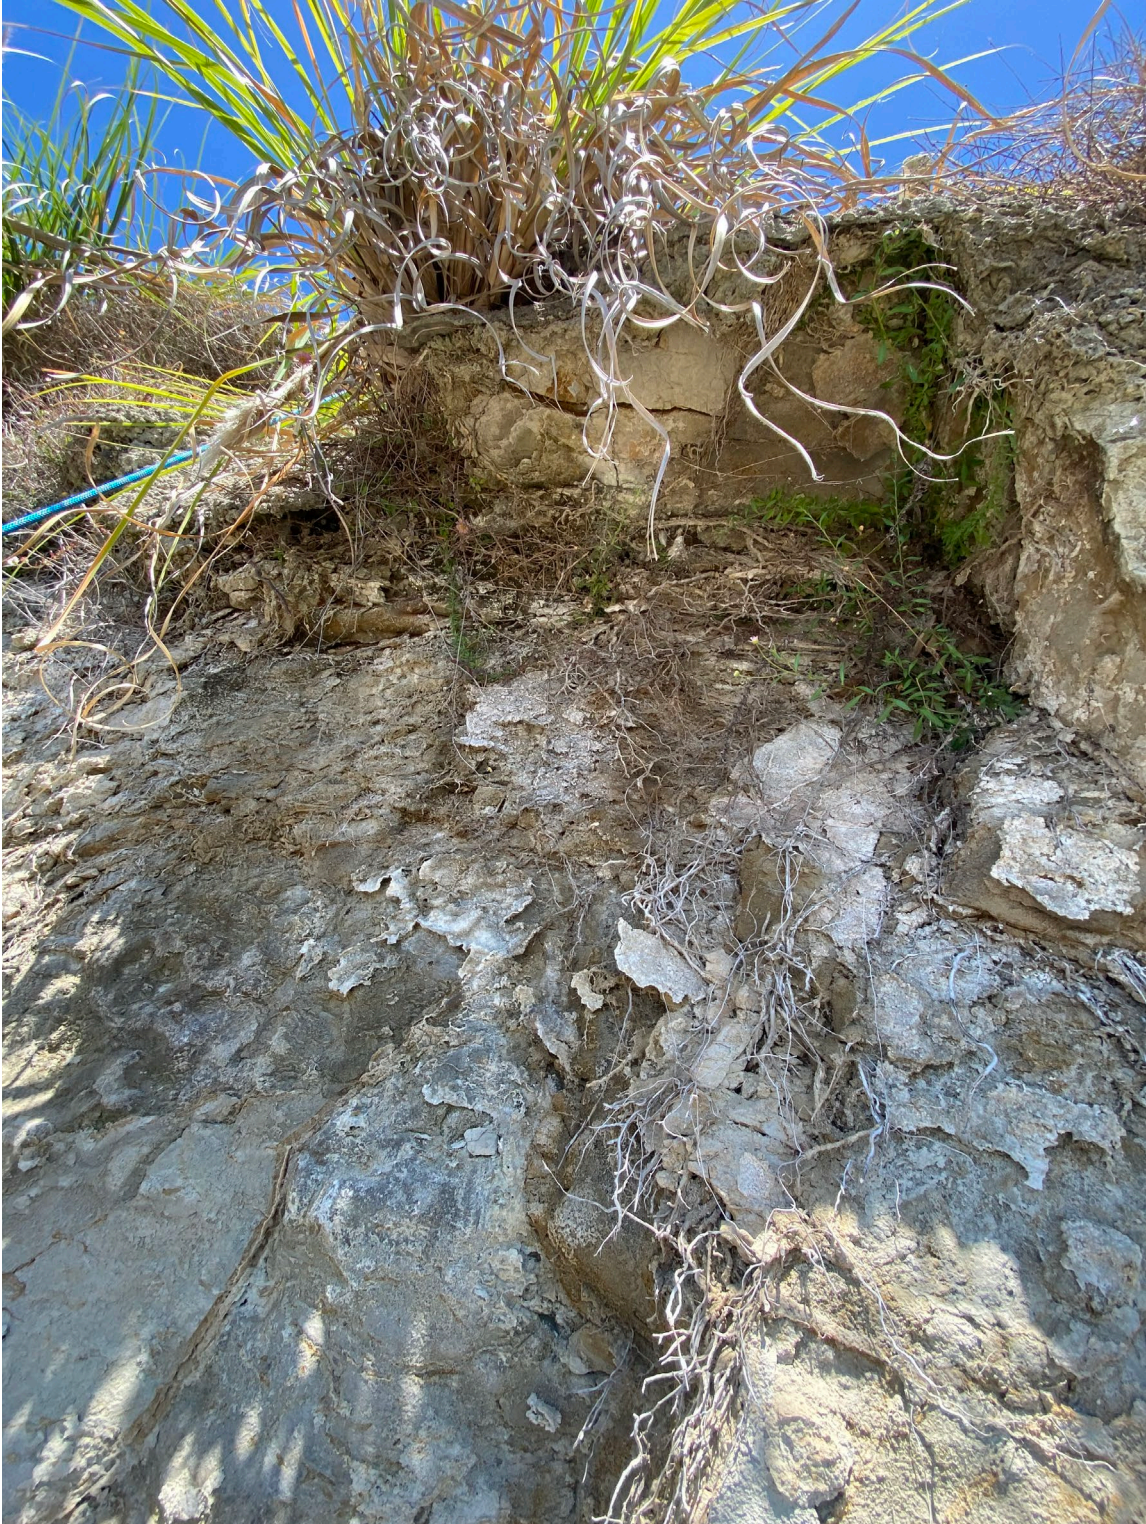
At location 2, blocks of bedrock have been broken off leaving a void measuring approximately 6' wide x 5' tall x 1' deep. Loss of these unsupported, bedrock blocks will expose the base of wall drainage system and the easily eroded terrace deposits, exacerbating the scope of the repair.

Photo 5: Close up of undermined area in need of repair - 26 May 2020

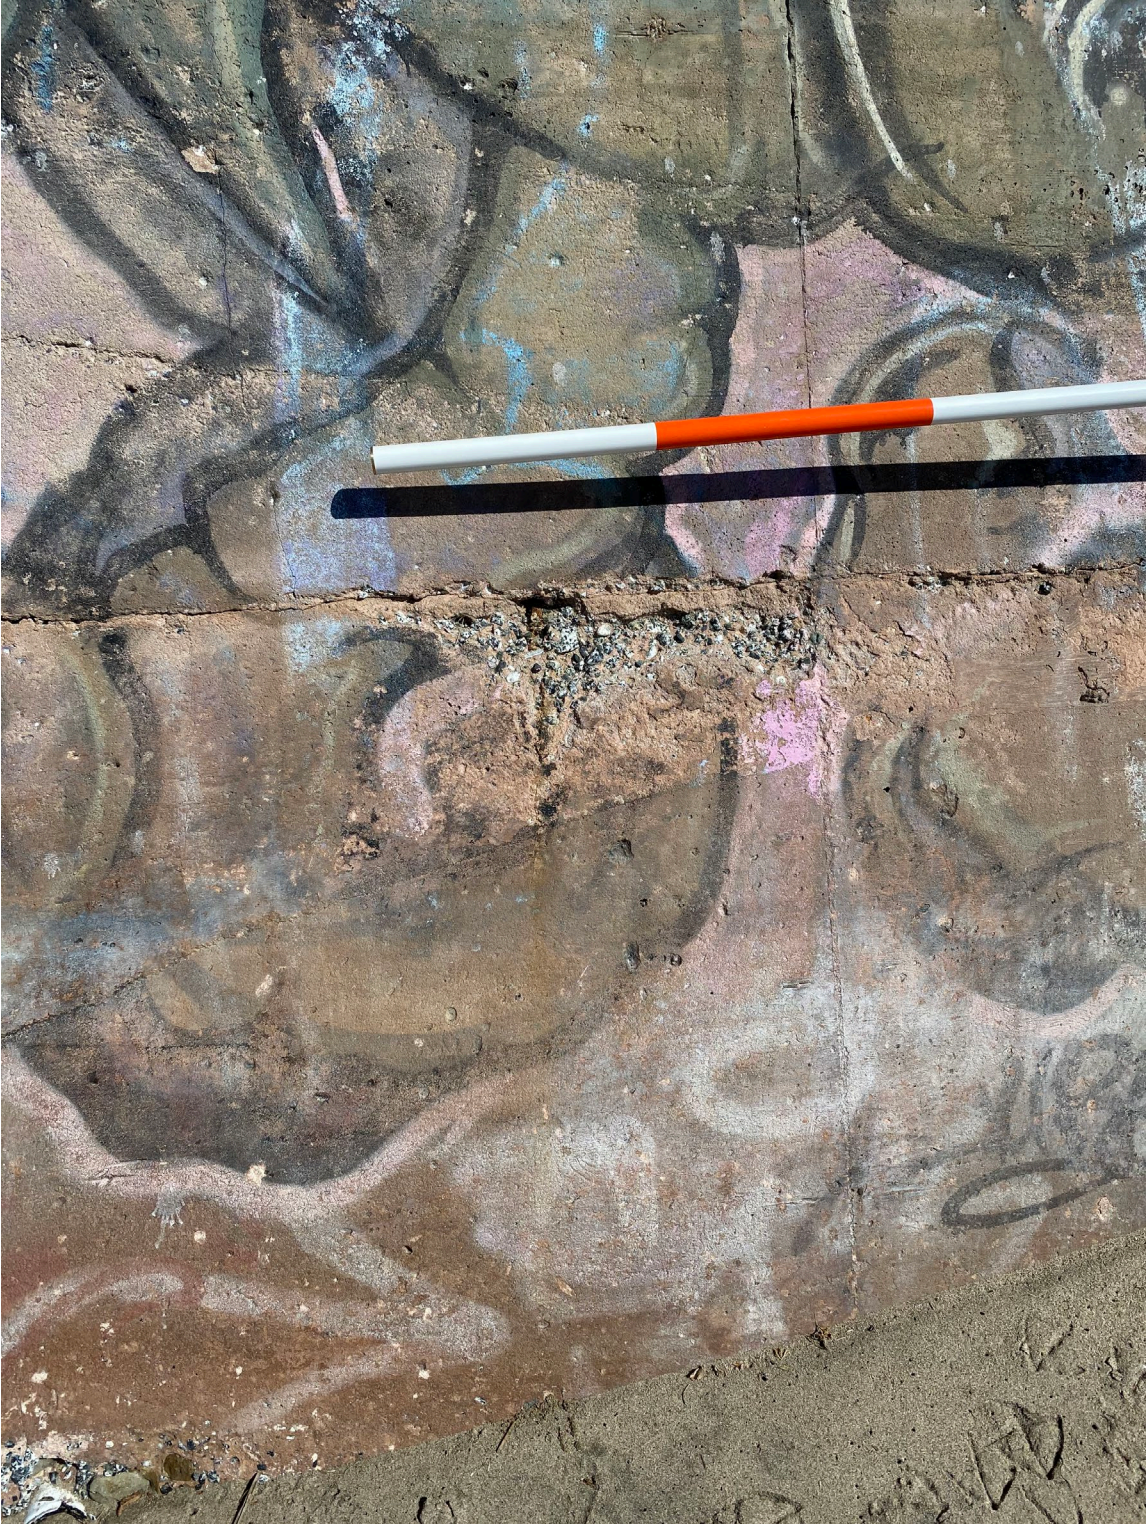
There are multiple instances of concrete spalling along the blufftoe gravity seawall, as shown in Photo 6. The spalled concrete should be patched with similar colored and textured concrete as the existing blufftoe seawall. The materials used to patch the spalled section of the seawall should be of marine environment quality. If a concrete mixture is used it should have a maximum water to cement ratio of 0.40. The spalled area should be properly prepared by cleaning and roughing surface prior to placement of concrete patch.

Photo 6: Close up of concrete spalling on bluff toe concrete gravity seawall - 26 May 2020
