P A S T
CONSULTANTS LLC

Re: 106 Cliff Ave., Capitola, CA – Preliminary Design Review Letter
APN. 036-112-17

This letter summarizes the findings of our site visit and provides preliminary recommendations to the subject project's design drawings for conformance with the Secretary of the Interior's Standards for Rehabilitation.

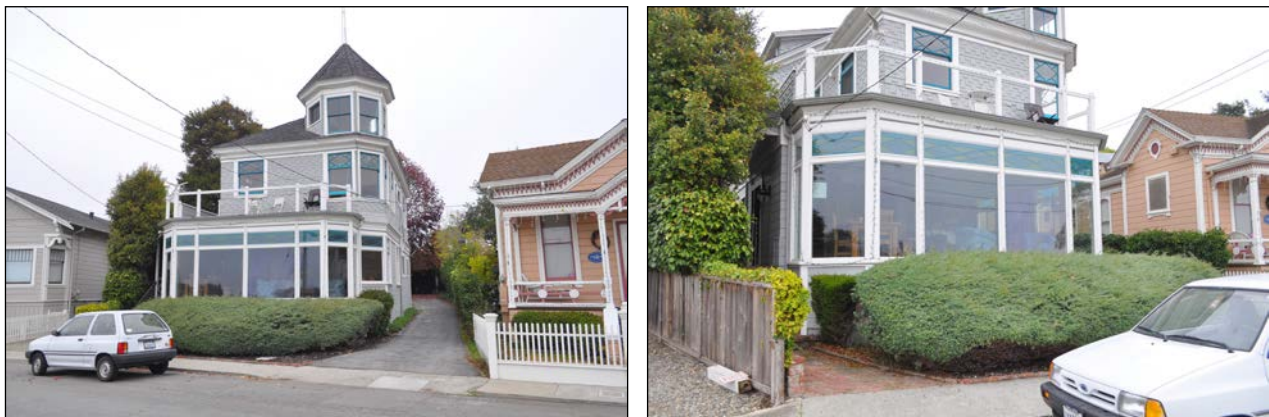
Figures 1 and 2. Left image shows the front (west) elevation, as viewed from the street. Right image details the front porch enclosure on the west elevation.

While no permit exists that dates the modifications that enclosed the front porch and relocated the original entrance to the house's north elevation, inspection of the materials indicate the porch alterations to be of recent construction, possibly in the 1990s. The porch enclosure clearly is a recent alteration to the subject house and is not character defining.

Since the porch enclosure is a recent addition and is not character-defining, returning the front porch to an open configuration is appropriate, but should be based on any existing photographs of the front elevation that show the porch's original configuration, such as shown on **Figure 9**.

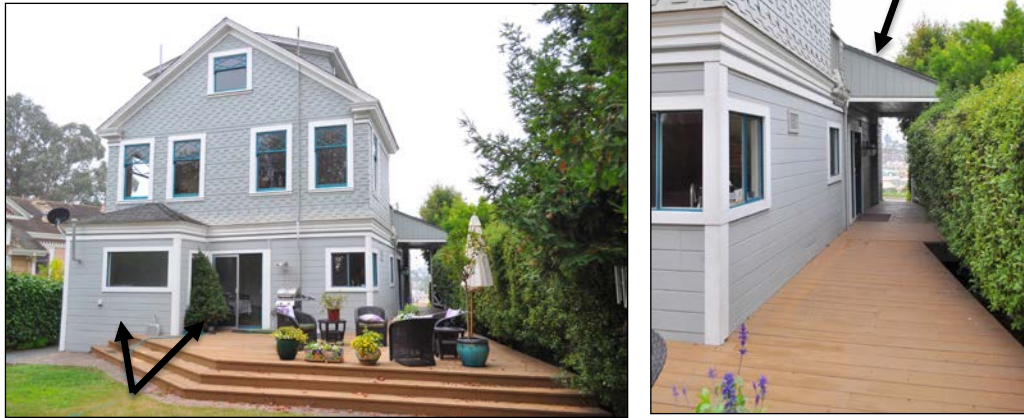
Figures 3 and 4. Left image shows the rear (east) elevation, with arrows indicating a rear addition and circa-1960s aluminum sliding glass doors. The upper-story wood sash windows are original. Right image details the north elevation, with modified entrance beneath the shed roof (arrow).

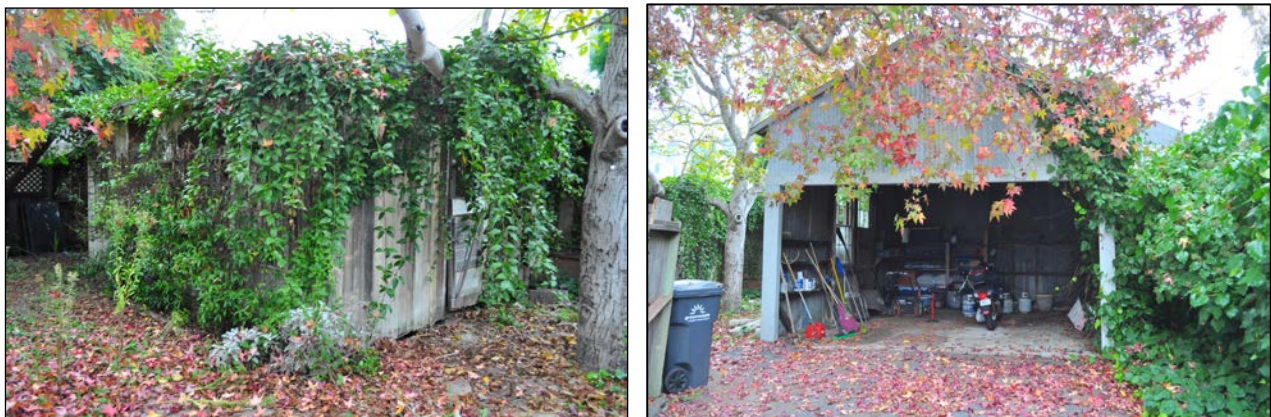
Figures 5 and 6. Left image shows the circa-1949 wood-clad shed outbuilding at the northwest property corner. Right image details the circa-1933 corrugated metal vehicle shed.

The above list indicates the remaining character defining features that are original to the subject house and that communicate the Queen Anne Victorian style. While the two outbuildings appear to be over 50 years old, both outbuildings were constructed out of the period of significance (circa-1904) of the subject house and in styles and materials that are not in keeping with the Queen Anne-style house. For these reasons, the two outbuildings are not considered to be character-defining features of the site.

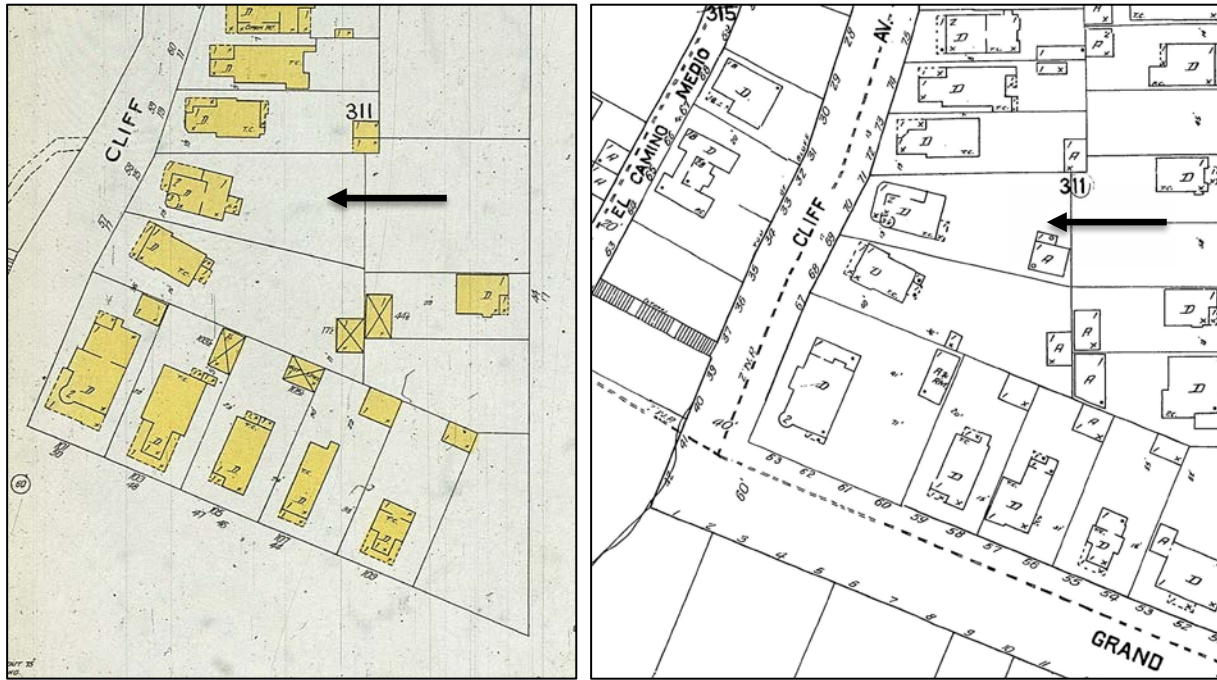
Comparison of the subject property's appearance on the 1905 and 1933 Sanborn maps show changes made to the site (**Figures 7 and 8**). The 1905 map indicates a rear service porch that was removed and replaced by the present rear addition by 1933. The 1933 map shows that the corrugated-metal garage appears on the site by 1933.

Figures 7 and 8. Images of the 1905 (left) and 1933 (right) Sanborn maps, showing the subject property.

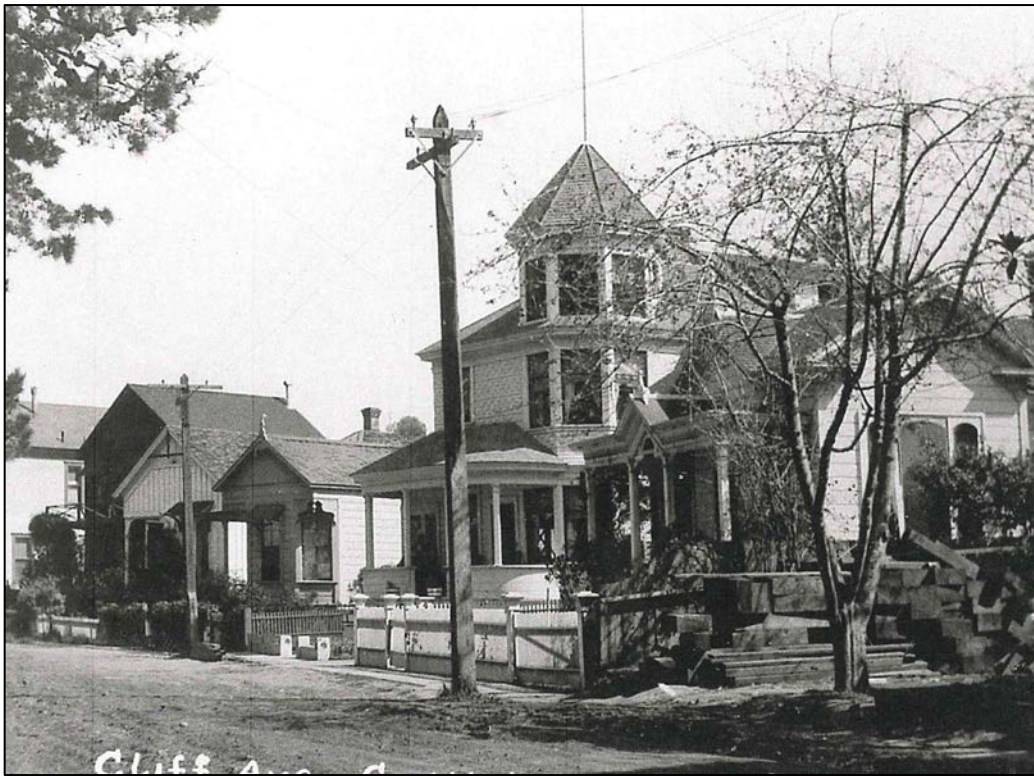
Figure 9. Undated image of the subject property, showing the open porch and entrance on the west elevation.

The undated photograph indicates an open front porch and west-elevation entrance, the patterned upper-story wood shingles and second-floor decorative wood sash windows. The remaining character-defining features are:
