AN ASSESSMENT OF THE TREES WITHIN THE PROXIMITY OF PROPOSED IMPROVEMENTS ON THE LANDS  
OF SAMUEL ABBEY – 106 CLIFF AVENUE – CAPITOLA, CA - (APN 045-123-25)

Site visit by:  
Nigel Belton – ISA Certified Arborist WE-0410A  
July 17, 2021

Job – Sam Abbey – 8.10.20

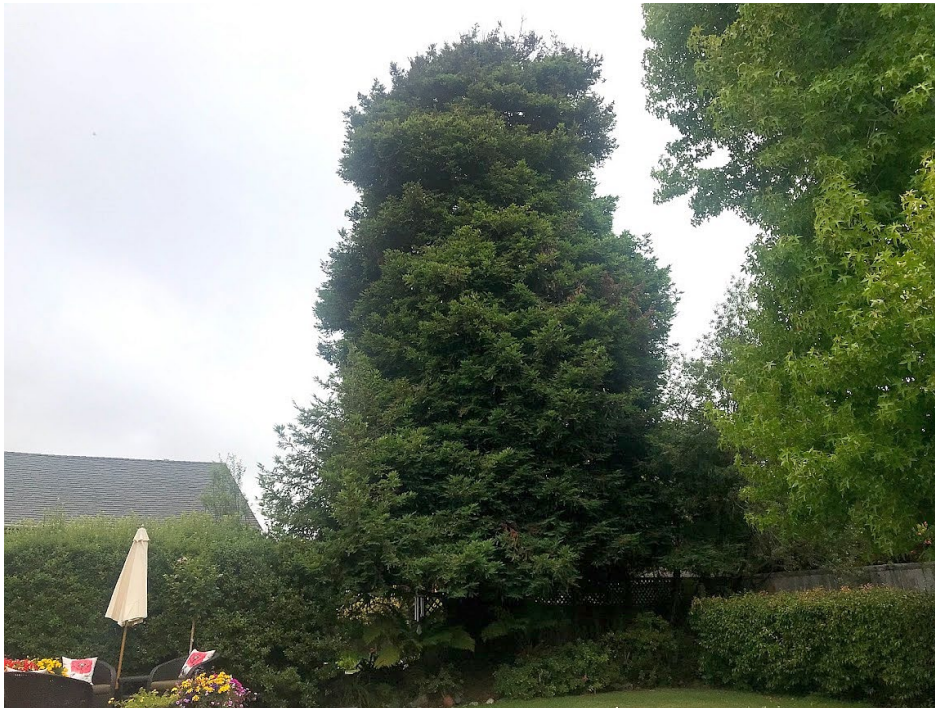
**Tree #1 – 80-inch DBH Coast Redwood (*Sequoia sempervirens*):**

This tree is suitable for preservation, based upon its good condition ratings and because of its location at the edge of the construction footprints. The trunk transects the north property boundary.

The large Coast Redwood located on the north property boundary must be preserved and protected during the construction period. The project arborist must provide oversight during the construction period.

The Tree Protection Zone around the Coast Redwood must be delineated with a Tree Protection Zone Fence. This fence must consist of steel chain-link construction and be securely attached to steel posts that are driven into the ground (see the attached Tree Protection Plan).

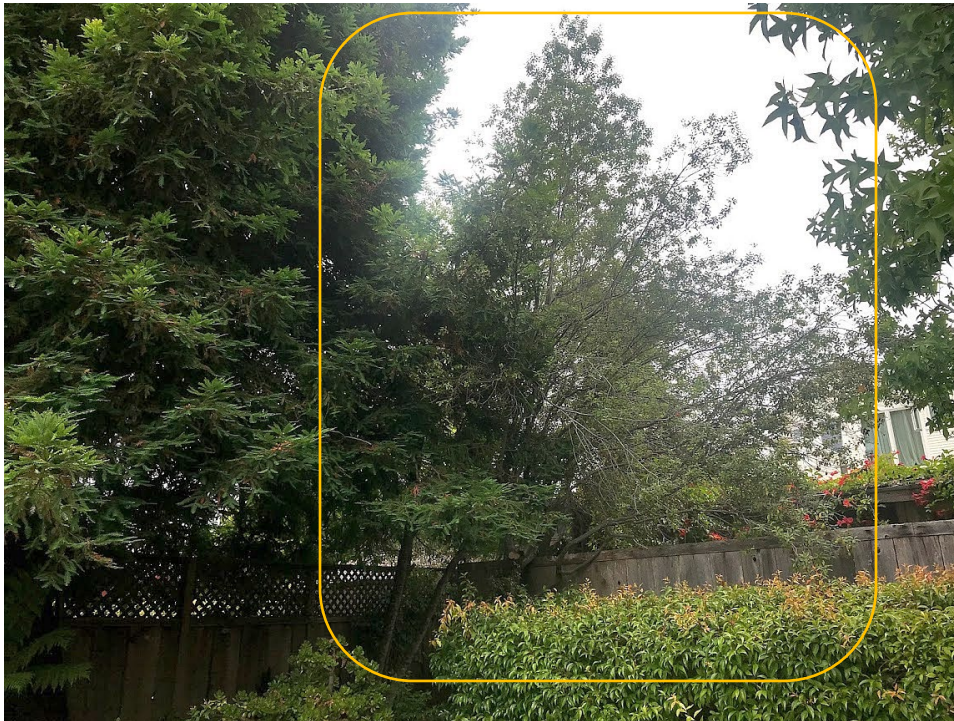
Tree #2 – 5.5, 4 & 4-inch DBH Kohuhu Pittosporum (*Pittosporum tenuifolium*):

Tree #3 – 6.5, 3 & 4-inch DBH Kohuhu Pittosporum:

I determined that both of these trees are unsuitable for preservation because of their poor condition ratings. Both trees are located within the proximity of the construction footprint.

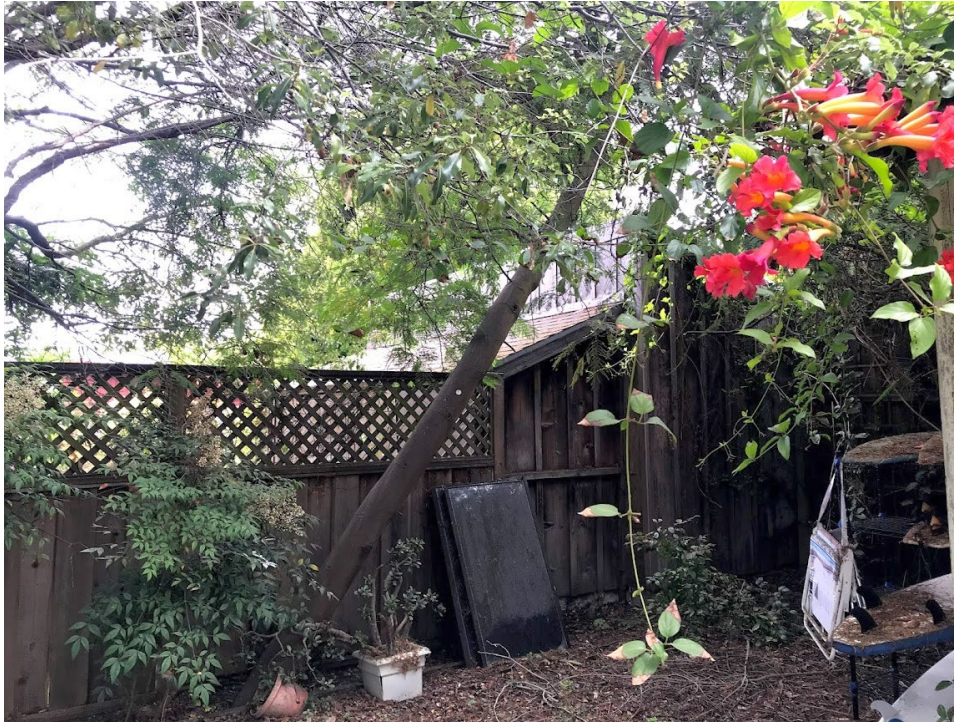
Tree #4 – 8-inch DBH Bailey Acacia (*Acacia baileyana*):

I determined that this tree is unsuitable for preservation because of its strong lean to the east. This tree is located within close proximity to the construction footprint which also precludes its preservation.

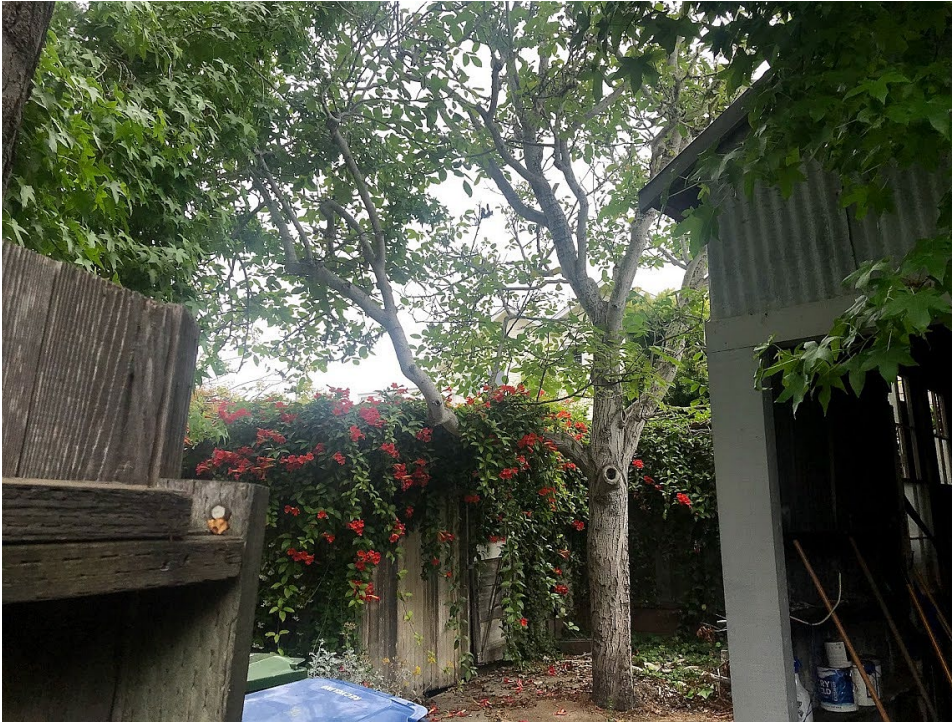
Tree #5 – 14.5-inch DBH English Walnut (*Juglans regia*):

The walnut is suitable for preservation based upon its condition ratings but its location within the construction footprint requires that it be removed.

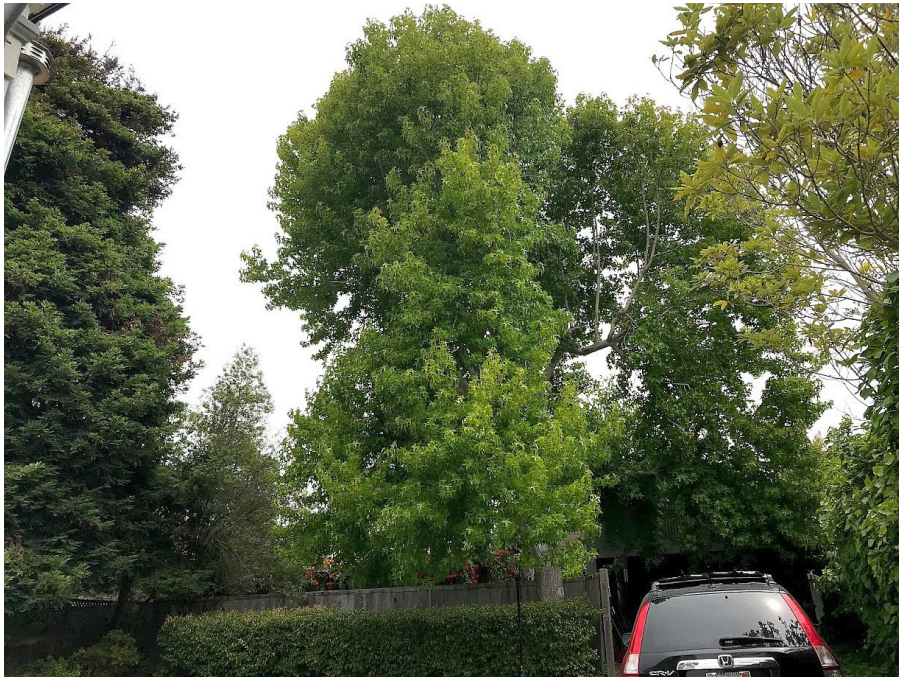
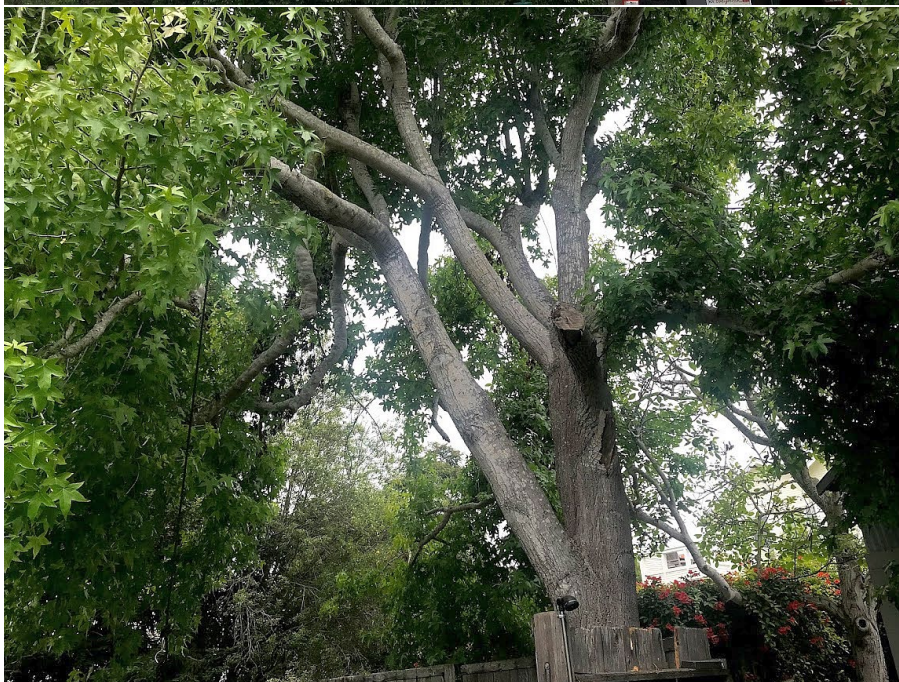
Tree #6 – 21-inch DBH Liquidambar (*Liquidambar styraciflua*):

This tree is not suitable for preservation due to its poor structural condition, resulting from the development of a heavy limb structure which is predisposed to failure and the presence of internal decay in the trunk. This tree must also be removed because of its location within the new construction footprint.

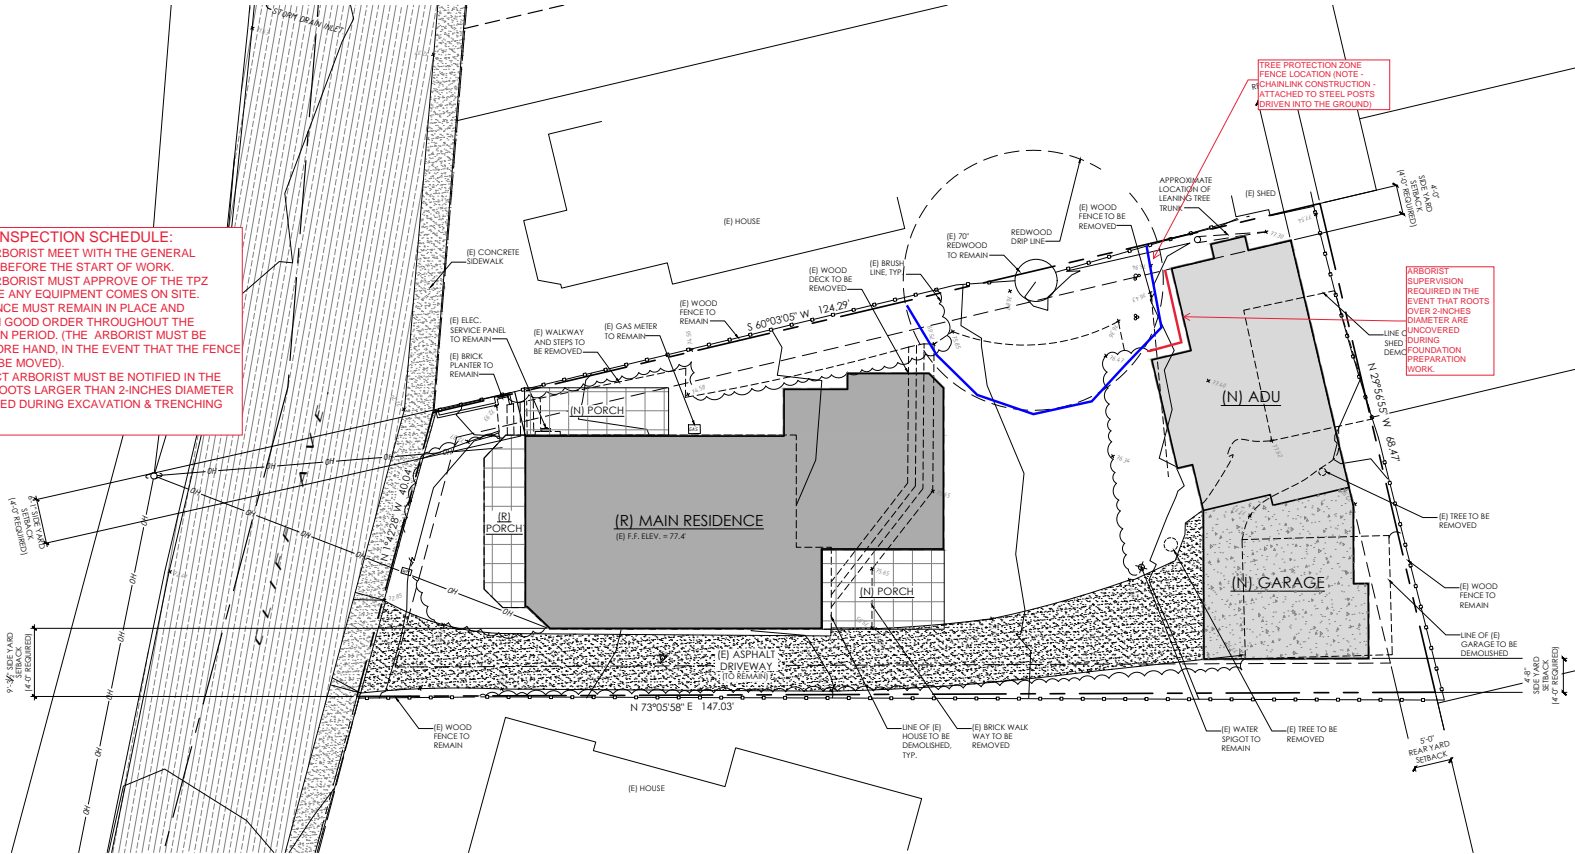
**TREE PROTECTION PLAN:**

**TREE #1 - THE 80-INCH DBH COAST REDWOOD ON THE NORTH BOUNDARY LINE.**

**ARBORIST INSPECTION SCHEDULE:**  
 1- PROJECT ARBORIST MEET WITH THE GENERAL CONTRACTOR BEFORE THE START OF WORK  
 2- PROJECT ARBORIST MUST APPROVE OF THE TPZ FENCE BEFORE ANY EQUIPMENT COMES ON SITE.  
 3- THE TPZ FENCE MUST REMAIN IN PLACE AND MAINTAINED IN GOOD ORDER THROUGHOUT THE CONSTRUCTION PERIOD. (THE ARBORIST MUST BE NOTIFIED BEFORE HAND, IN THE EVENT THAT THE FENCE MAY HAVE TO BE MOVED).  
 4- THE PROJECT ARBORIST MUST BE NOTIFIED IN THE EVENT THAT ROOTS LARGER THAN 2-INCHES DIAMETER ARE UNCOVERED DURING EXCAVATION & TRENCHING WORK.
