Arborist Report
Evaluation of a Blue Gum Eucalyptus at:
935-B Balboa Avenue, Capitola, CA

12/17/2019

Prepared for:
Strock Real Estate
245 Center Avenue,
Aptos, CA. 95003

Prepared by:
Kurt Fouts

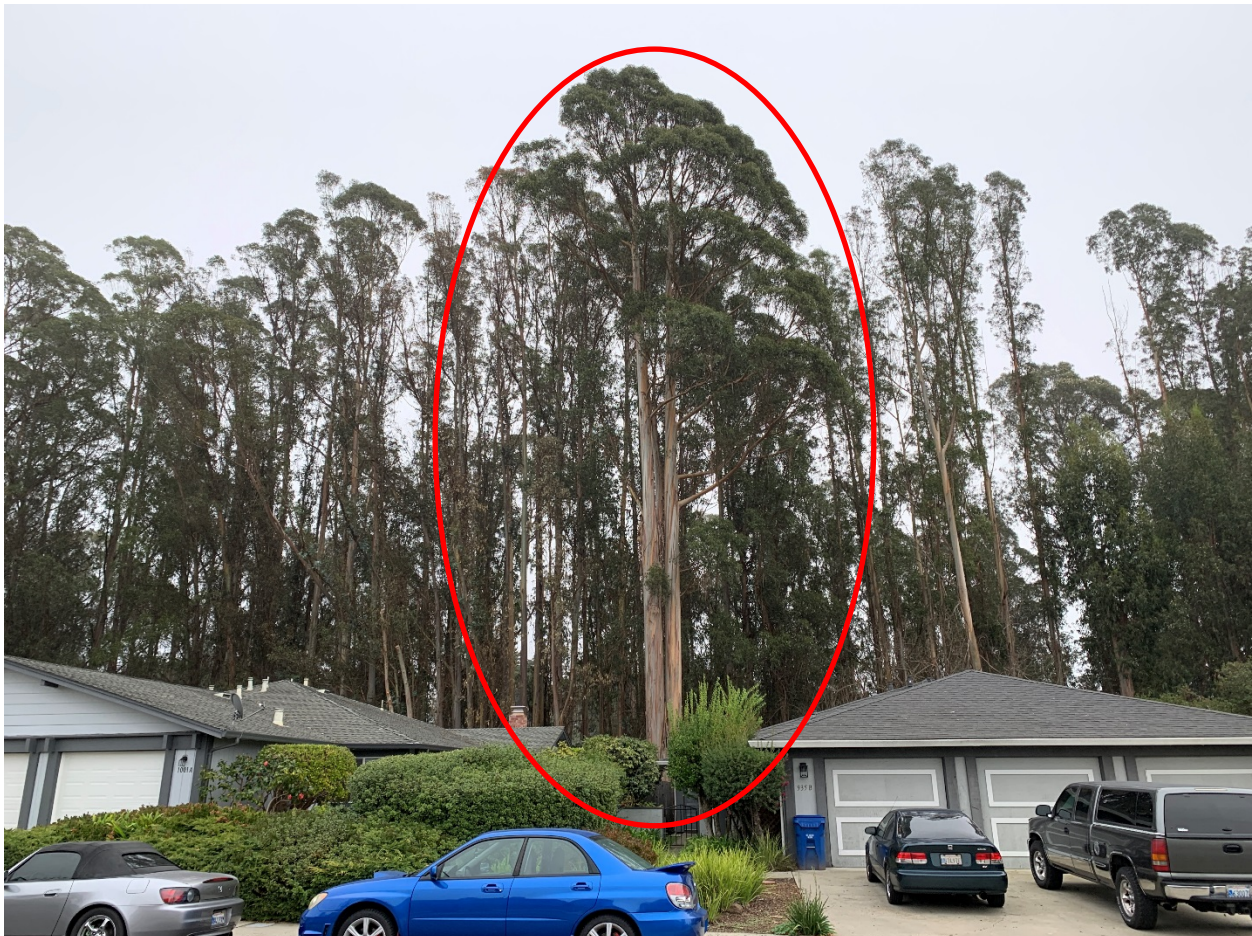
The blue gum eucalyptus (*Eucalyptus globulus*) tree is in a rear yard of 935-B Balboa. The tree trunk is sited on the fence line about 12 feet from the home. The tree has a 60-inch diameter trunk at 4 feet above grade and is 110 feet tall with a 35-foot diameter spread (Image #1)

Image #1 – blue gum eucalyptus (circled), in back yard of 935-B, as viewed from Balboa Avenue.

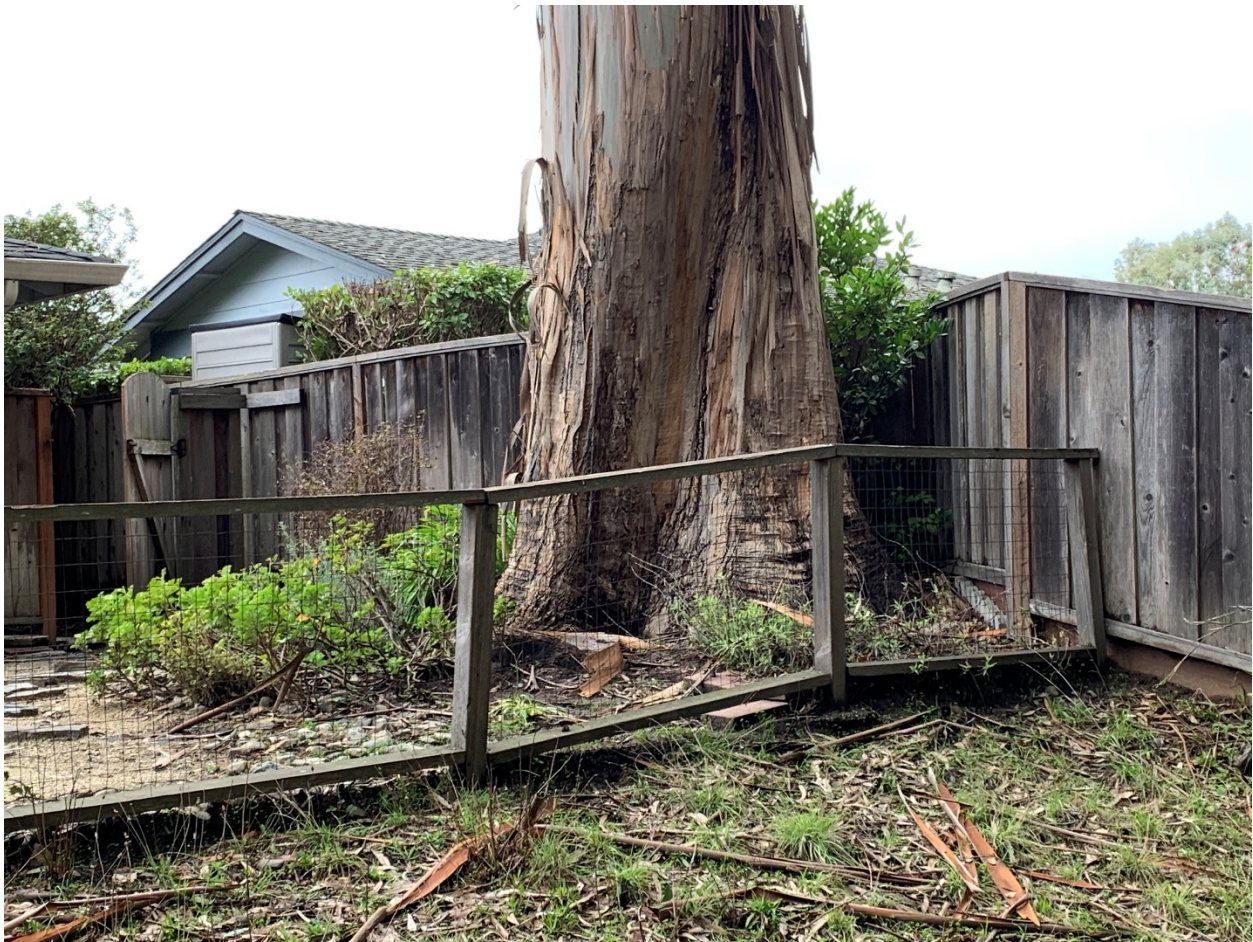
The mature blue gum has good trunk taper, appears well rooted and has large rooting areas to the north, east and southeast (Image #2).

Image #2 – Well tapered trunk. Location is on fence line at top of slope with good rooting area below.

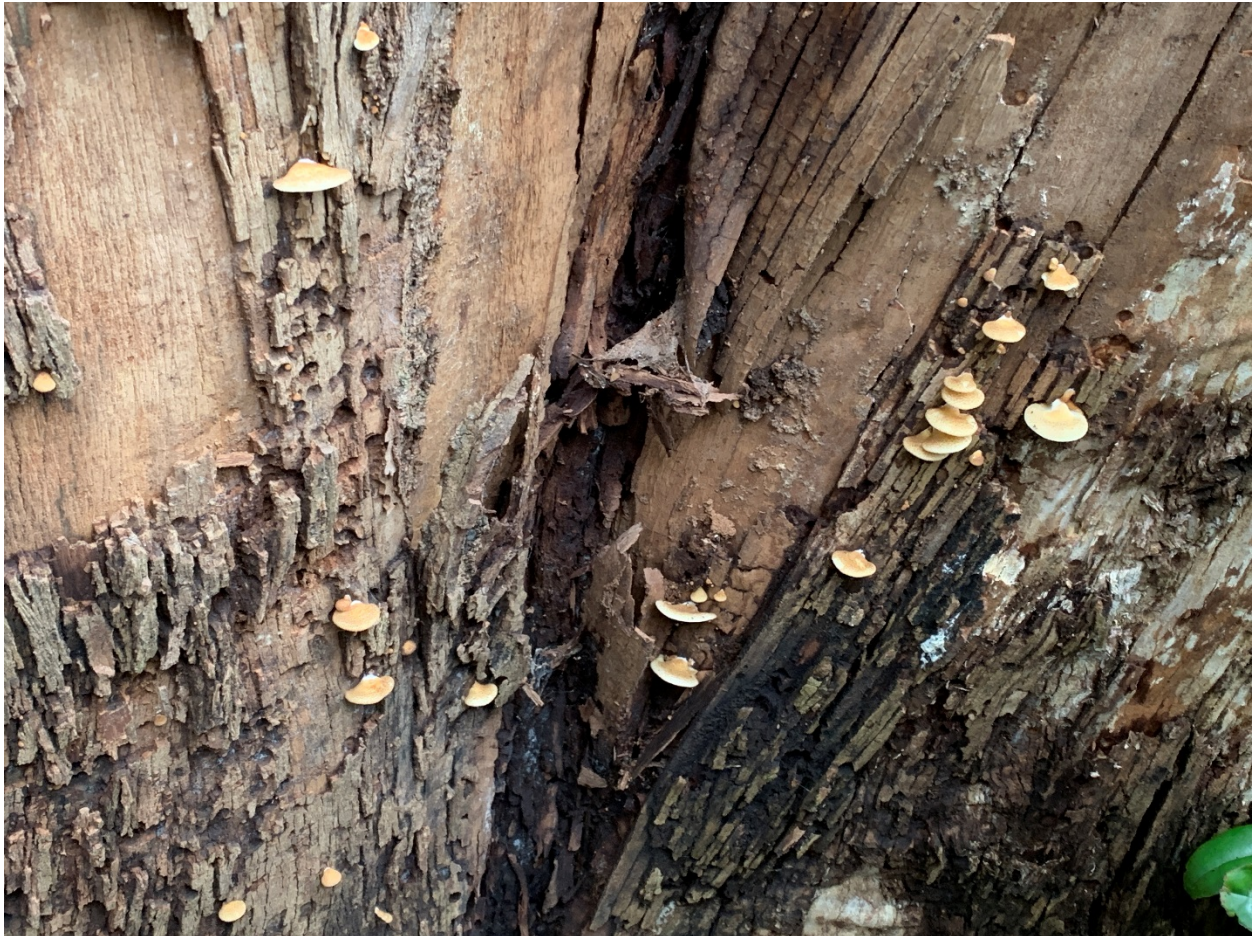
Wood decay fungi were found growing on the north side of the lower trunk (Image #3)

Image #3 – Wood decay fungi,

The fungus species was not identified. A sounding taken with a rubber mallet around the circumference of the tree did not produce any hollow resonance that would indicate decay.

The fungi found in the lower trunk area are not causing any significant wood decay, as indicated by a mallet sounding, but should be monitored periodically, to determine if decay develops.

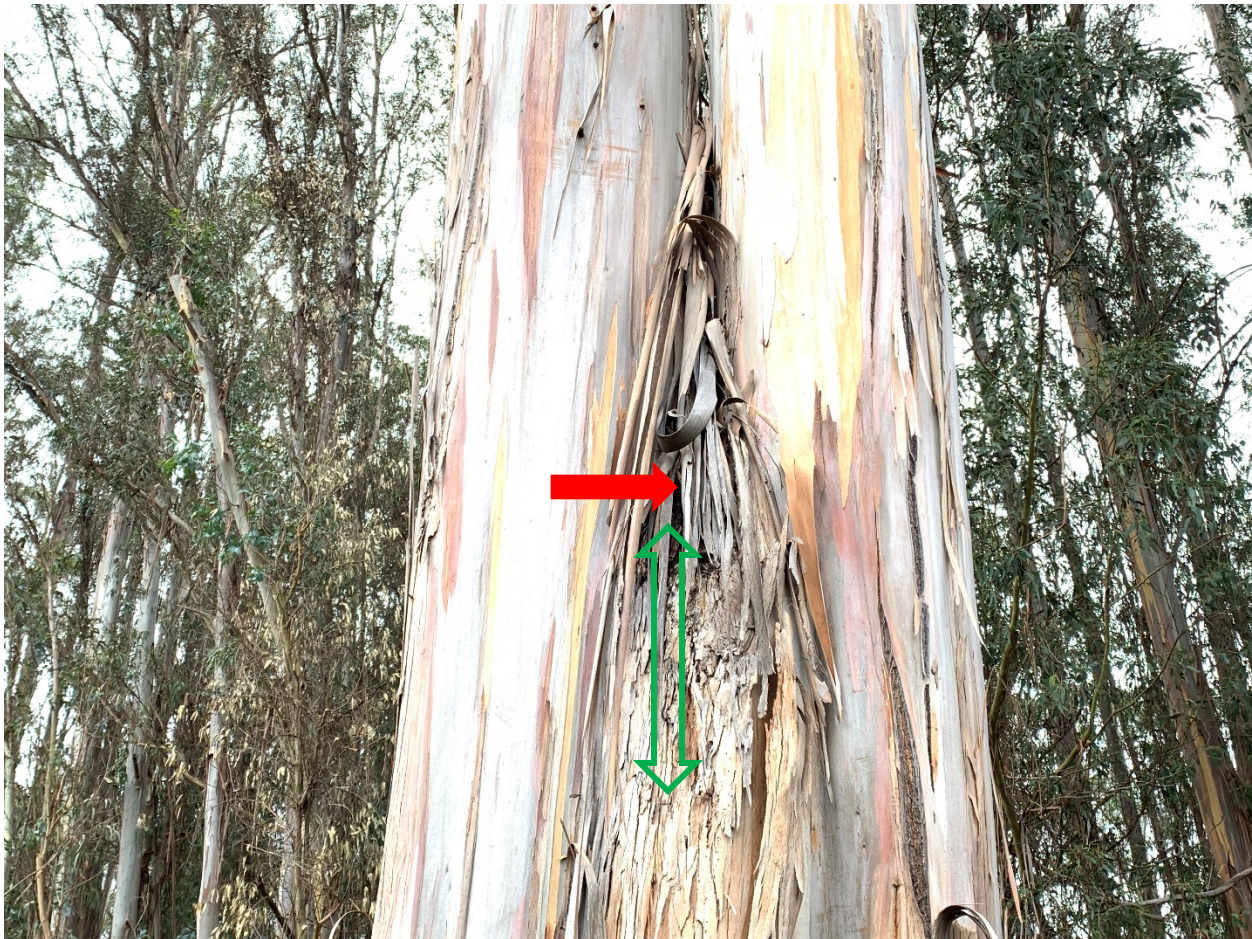
At eleven feet above grade, the trunk separates into two co-dominant trunks. (Image #4). Included bark* can be seen between the two trunks.

Image #4 – Trunk union and separation into two trunks (red arrow), with included bark (green arrow).

The angle of attachment is steep (narrow). The union area was partially obscured with bark debris and the quality of the attachment point could not be fully assessed.

The most notable structural characteristic of this blue gum are the two sets of co-dominant trunks. The steep angle of attachment of the two trunks with included bark, contribute to a poor structural connection.

This defect is common in blue gum and does not by itself, indicate the tree is likely to fail. However, co-dominant trunks are a failure point on trees and the blue gum species show a pattern of failure at this point.

A cable installed two thirds of the distance up from the base of the tree, between the two co-dominant trunks would reduce movement of the trunks during wind events. If installed, cable systems must be maintained with the tension periodically adjusted. No pruning is recommended for this tree.

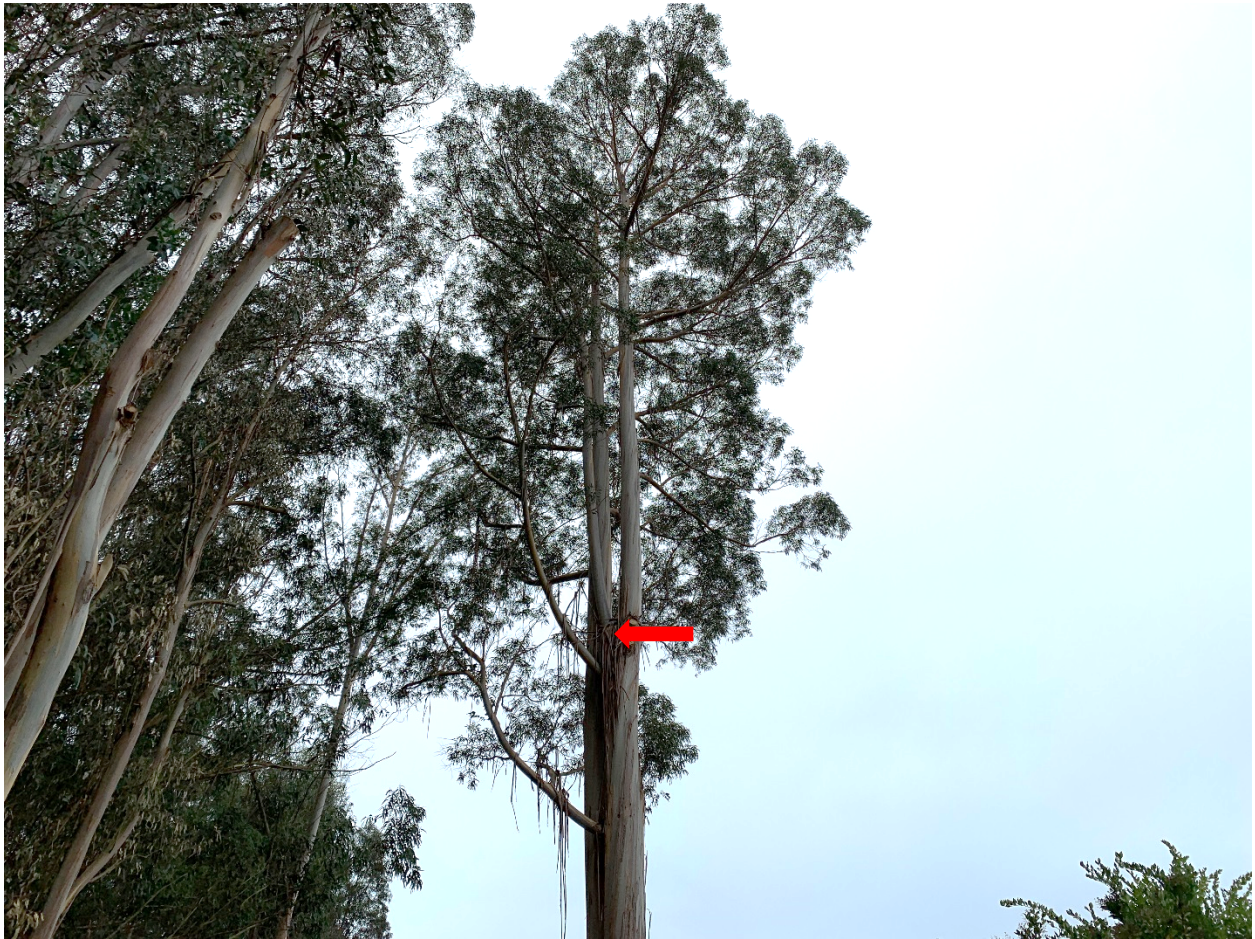
One of the two trunks separate into a second co-dominant trunk at 40 feet above grade (Image #5).

Image #5 – Trunk union (arrow).

The angle of attachment is steep.

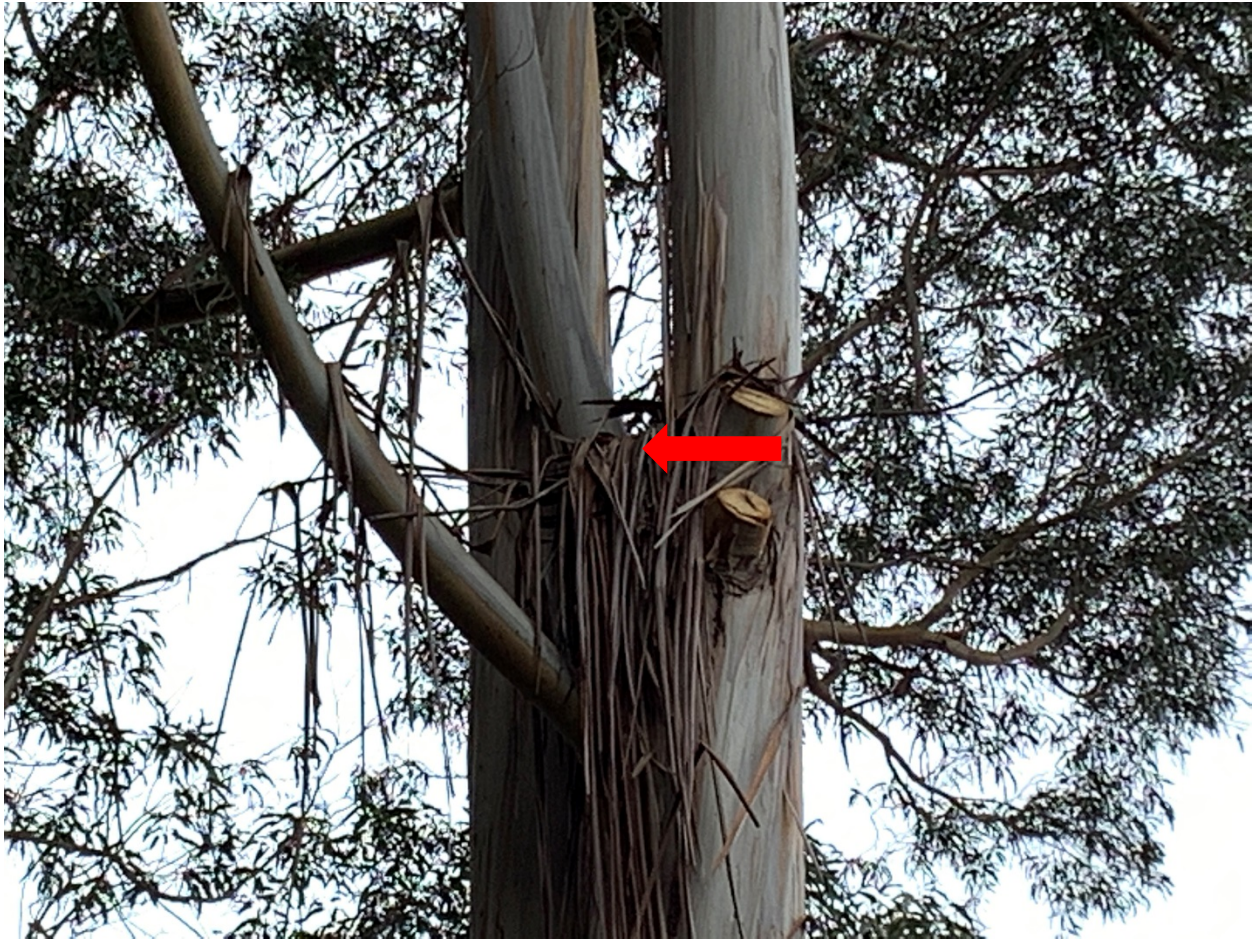
Image #6 – Close up of second union (arrow), shown in image #5. Two pruning cuts can be seen.

The union is obscured by bark debris and the quality of the attachment point cannot be fully assessed.

Two limbs were recently pruned, as indicated by the light-colored wood cut, adjacent to the union (Image #6).

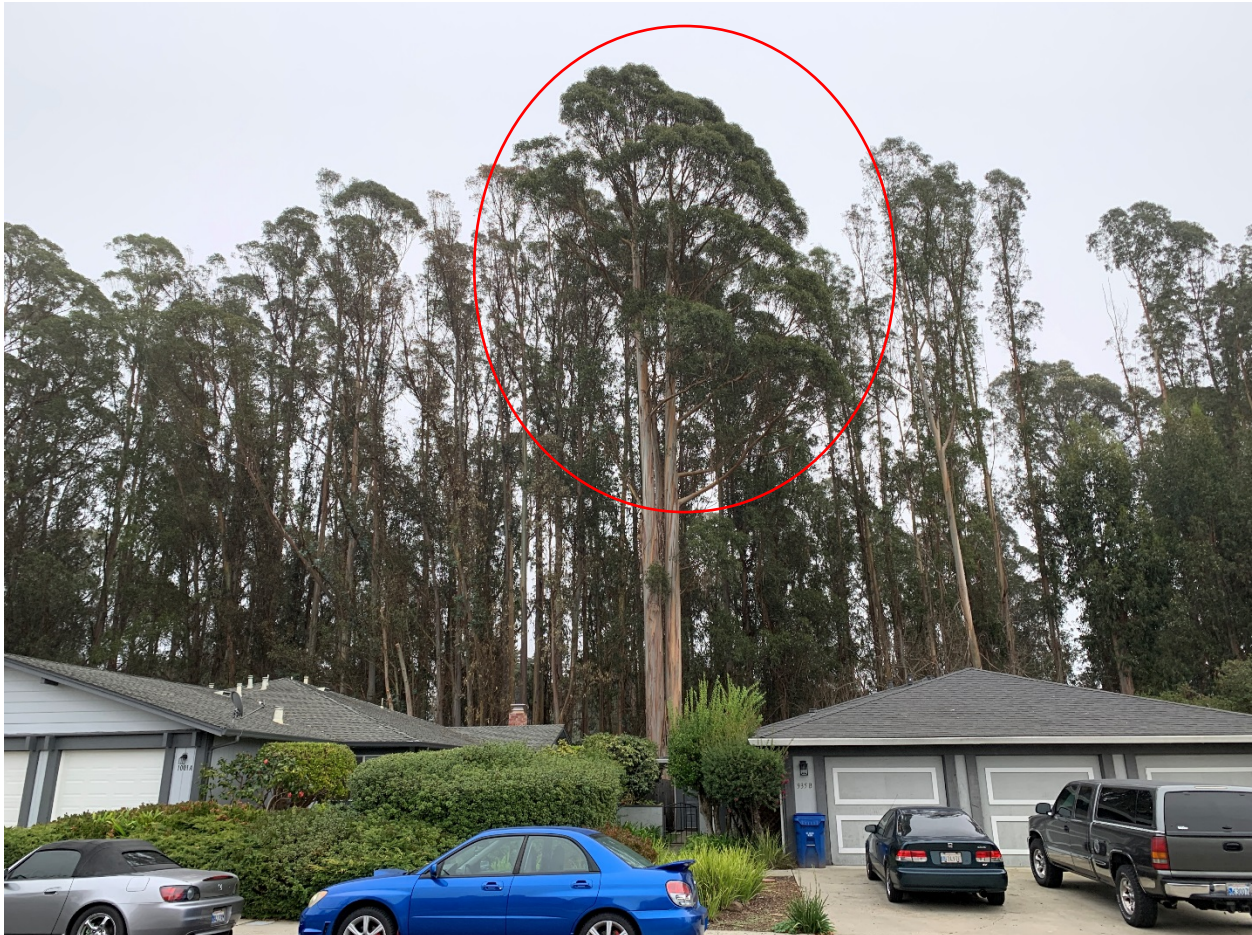
The limb architecture in the main canopy is balanced, limbs are evenly spaced, and the main scaffold limbs are well attached. (Image #7).

Image #7 – Well developed canopy of blue gum (circled).

The tree has developed a rounded canopy often seen in mature blue gum specimens.

Canopy density and vigor (new growth), is normal for the species.
