Subject: [PDF] A SUMMARY OF OBSERVATIONS & RECOMMENDATIONS CONCERNING THE BLUE GUM EUCALYPTUS TREE LOCATED BEHIND THE RESIDENCES AT 935 & 1001 BALBOA AVENUE, CAPITOLA - SITE VISIT ON APRIL 21, 2022:

May 19, 2022

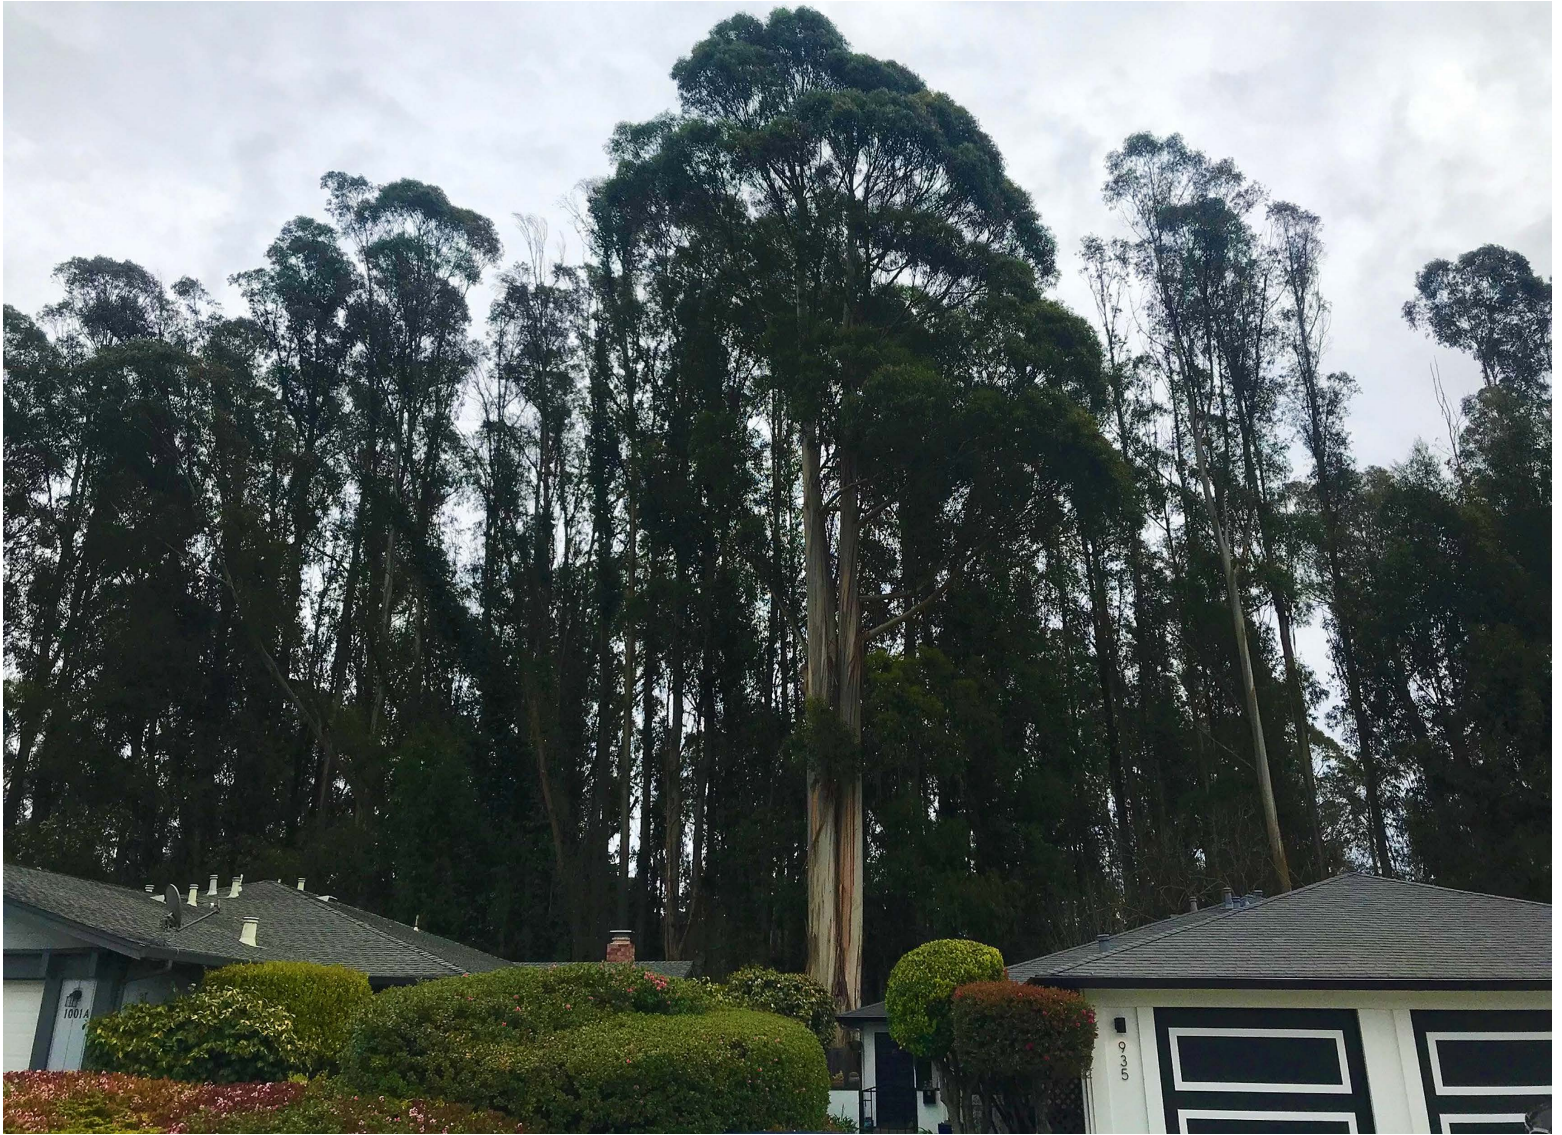
- This tree has a 60-inch diameter trunk, measured at 54-inches above ground and it is approximately 135-feet tall. The tree exhibit's good health and vitality, as evidenced by its good foliage condition.

- I determined that this tree has a fair structural condition, because it has a codominant growth pattern (two codominant stems attached to the trunk at about 12-feet above ground) and because there is some dead wood within its canopy.

- I observed that this tree has two codominant stems (secondary trunks), attached to the trunk at about 12-feet above ground. The area of attachment in between the codominant stems appears to be strong, despite being narrow.

- I observed a number of dead branches within the tree's canopy that are over 1.5-inches in diameter.

- I recommend that all dead branches over 1-inch diameter be removed.
- I also recommend that some of the heavier limbs be thinned in their ends in order to reduce their weight and the possibility of them failing in the future. This is skilled work and it must be done by a competent tree service provider, utilizing thinning cuts, not stub cuts or heading cuts.

- I recommend that consideration is given to installing a support cable in between the two codominant stems at this time, even though I determined the likelihood of them failing to be improbable within a period of three years. The installation of a cable will serve to reduce the chance of them failing the future. Tree support cables must consist of EHS-Grade galvanized cable attached to through rods or approved cable end-stops. I recommend that cables are periodically inspected by an arborist to ensure that they are in good condition.
