AN ASSESSMENT OF THE MONTEREY PINE ON THE PROPERTY OF KIM RODRIGUEZ  
AT 722 ESCALONA DRIVE, CAPITOLA - CALIFORNIA

Site visit by:  
Nigel Belton  
ISA Certified Arborist WE-0410A  
ISA Tree Risk Assessment Qualification  
April 11, 2023

Job – Kim Rodriguez – 5.23.23

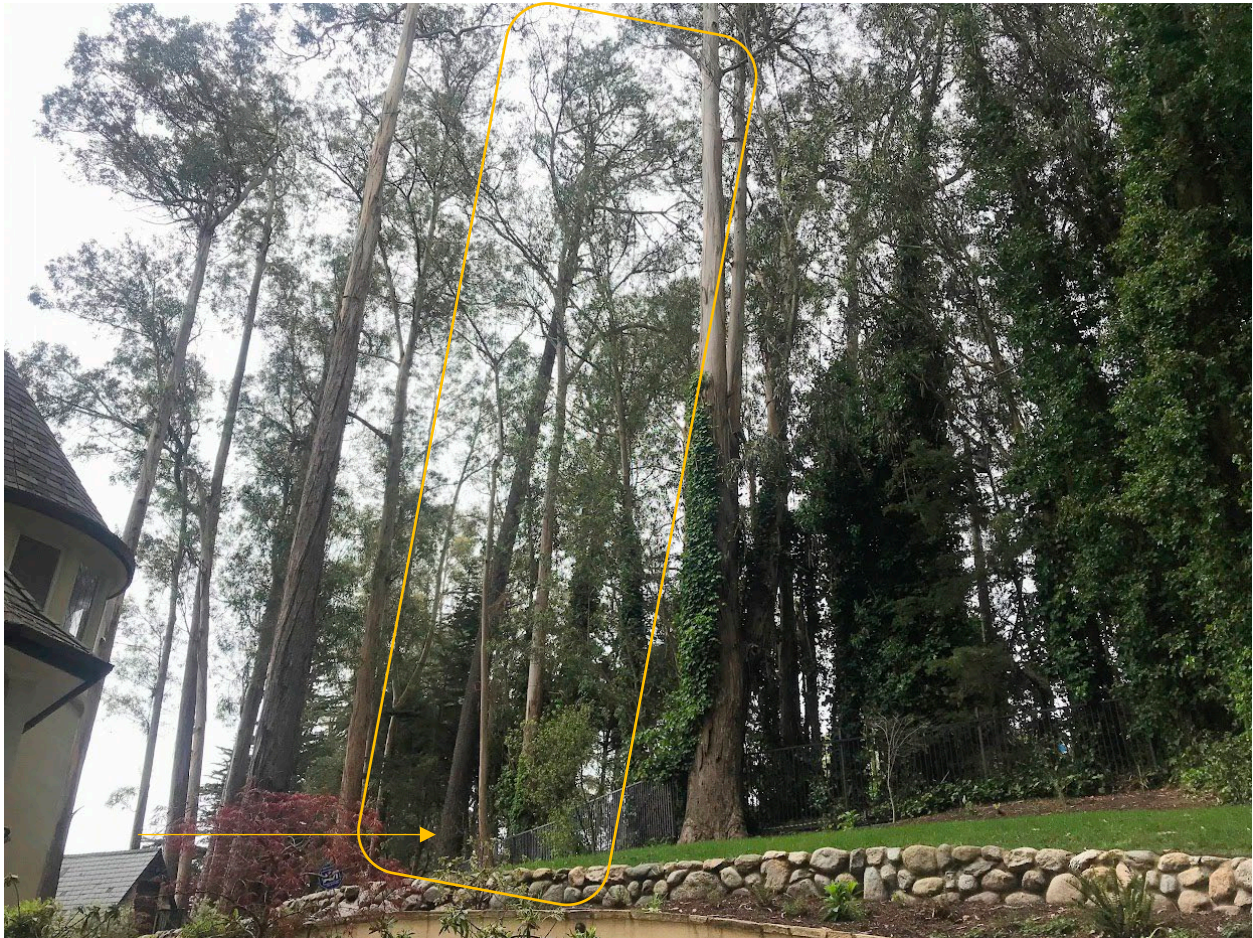
This tree has a trunk that measures 40-inches diameter at 54-inches above ground and it is about 140-feet tall (measured with a device). The foliage condition exhibits poor health and it has poor vitality because it is declining, as a result of being overmature. The live crown ratio is approximately 20% (the percentage of the living crown relative to the tree's height).

This tree has a poor structural condition because of its strong lean and weight bias to the west. The buildings on the adjacent Monarch Cove Inn Property are located within the falling radius of this tall tree.

I determined that this Monterey Pine is vulnerable to structural failure because of its heavy eight bias and its high crown, which is exposed to prevailing winds from the west. The tree will likely fall in storm conditions when the soil is saturated and root adherence is compromised. I utilized the ISA Basic Tree Risk Assessment Form to determine the level of risk this tree represents within a two-year time frame (See the attached Form).

I recommend that this tree is removed expeditiously by a State Licensed Tree Service. This work is best undertaken with the aid of a crane if access is available. I recommend that the stump either be ground out or cut close to grade.
