AN ASSESSMENT OF THE TREES ON PARK AVENUE BETWEEN MONTEREY AVENUE AND WESLEY STREET,
CAPITOLA, AND RECOMMENDATIONS FOR TREE MAINTENANCE WORK TO ENHANCE PUBLIC SAFETY

Site visit by:
Nigel Belton
ISA Certified Arborist WE-041A
ISA Tree Risk Assessment qualification (TRAQ)
October 20, 2023

Job – City of Capitola - Park Avenue 2023
(Revised and updated on March 17, 2024)

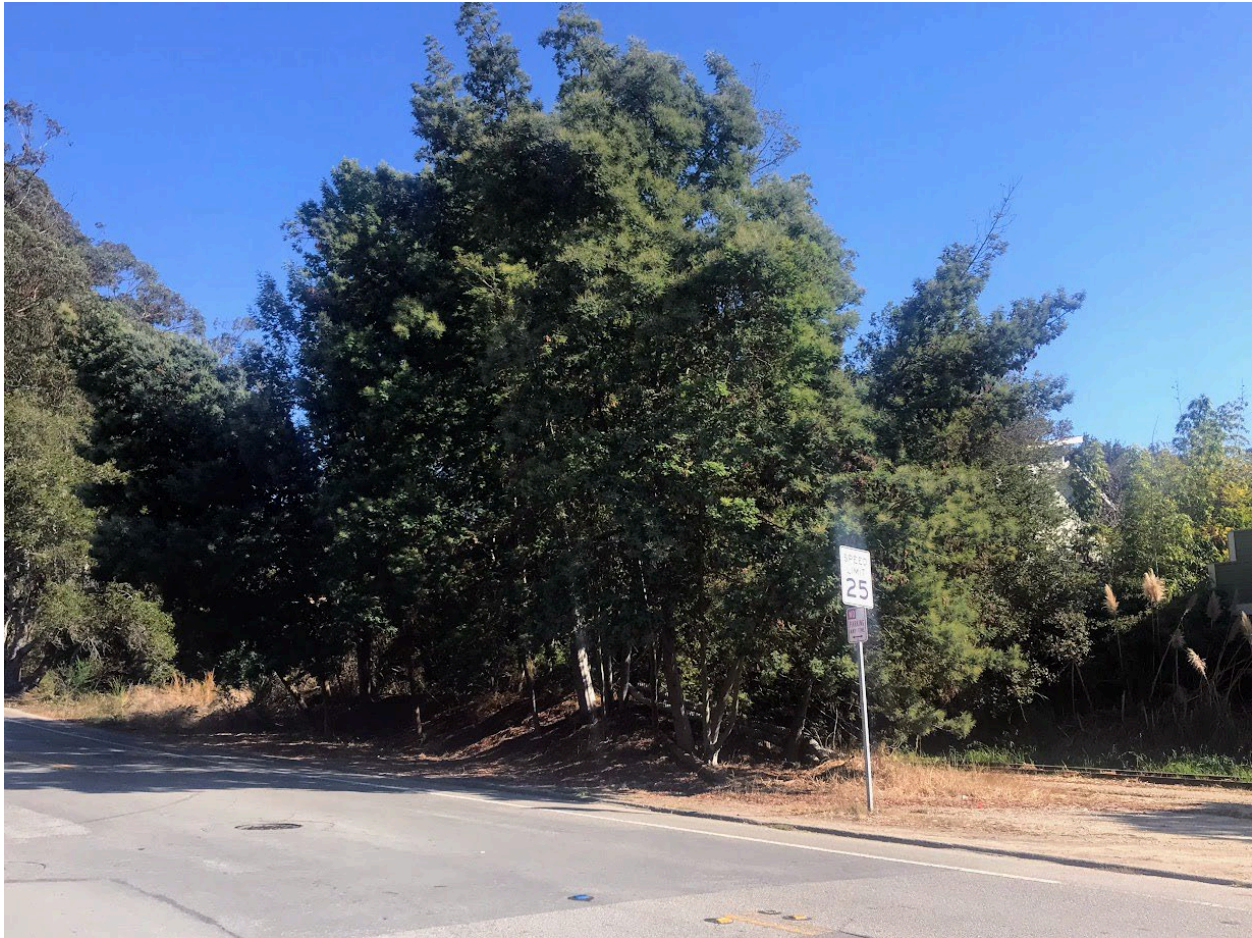
Tree #3 – 12.5-inch DBH Bailey Acacia:

These trees are found within the crowded stand of acacias at the western end of the tree assessment area, near Monterey Avenue. Trees #1 and #2 exhibit strong leans. This species is vulnerable to falling in storm conditions.

Note that I also recommend that all of the Bailey Acacias on this site be removed because this species typically becomes vulnerable to falling when it grows larger over time. It is also an invasive species. I recommend that consideration be given to planting Coast Live Oaks as replacement trees in this location.

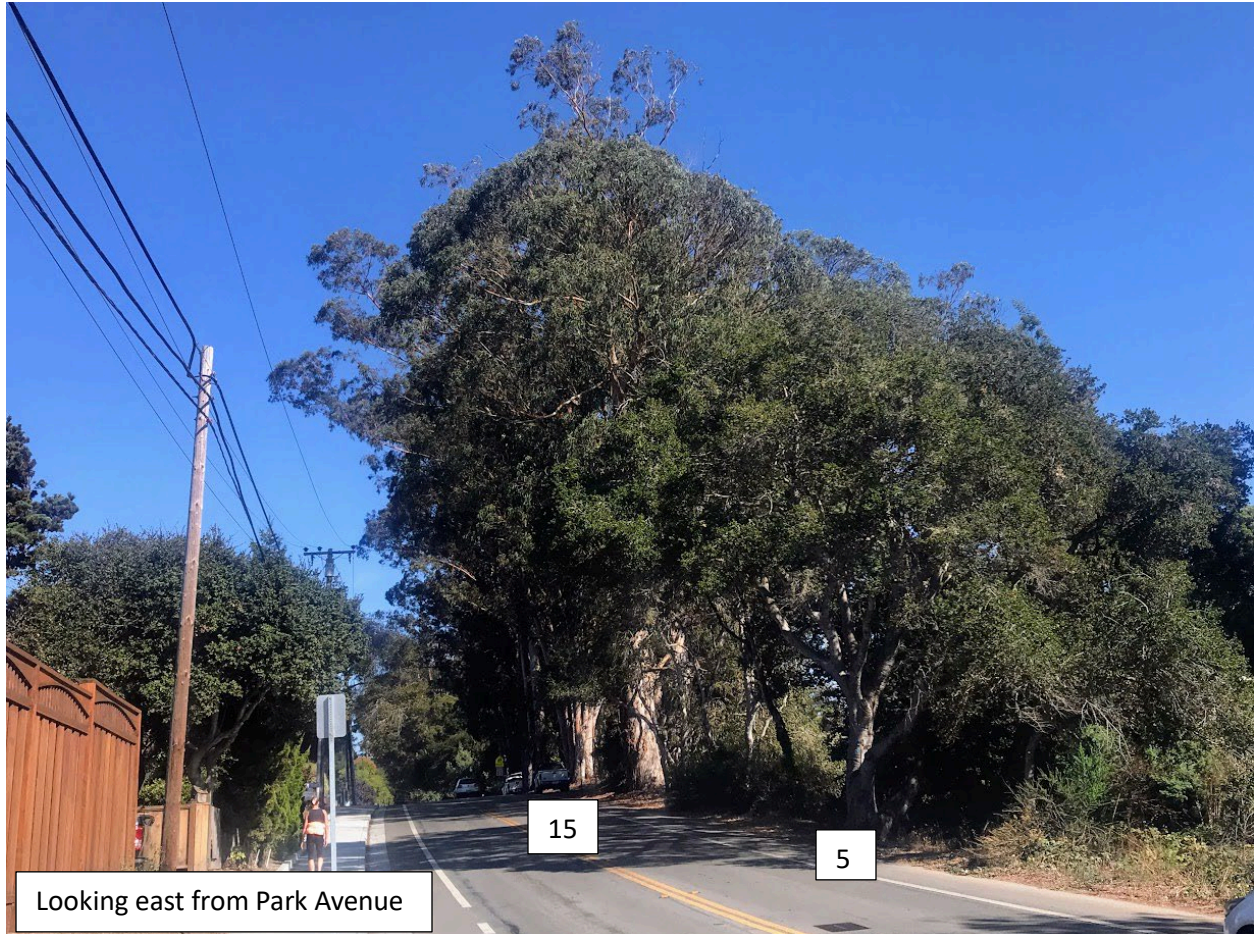
Trees #4 through #15 – Ten Coast Live Oaks (*Quercus agrifolia*) and two Blue Gum Eucalyptus (*Eucalyptus globulus*):

The majority of the Blue Gum Eucalyptus within the assessment area exhibit good health and vitality, as shown by their foliage conditions. The majority of these trees have either fair or poor structural condition ratings because they have large diameter dead branches within their crowns. Many of the Blue Gum Eucalyptus also have overextended branches that encroach out over Park Avenue.

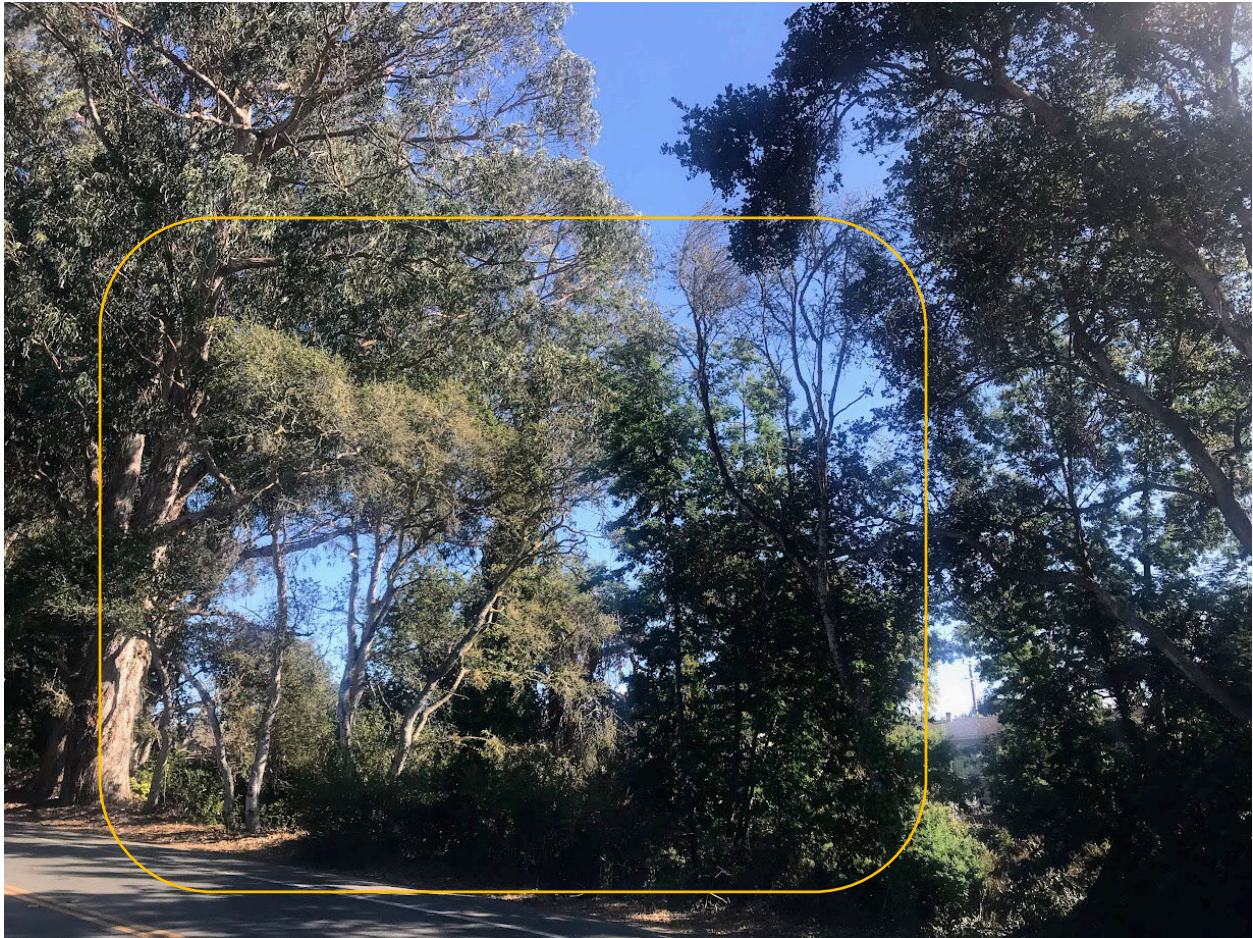
- Trees #6 – 9-inch DBH Coast Live Oak:
- Tree #7 – 12 & 11-inch DBH Coast Live Oak
- Tree #8 – 10-inch DBH Coast Live Oak:
- Tree #9 – 7.5-inch DBH Coast Live Oak:
- Tree #10 – 15-inch DBH Coast Live Oak:
- Tree #11 – 9.5-inch DBH Coast Live Oak:

The Coast Live Oaks identified as number six and number seven are dead and they are vulnerable to falling at this time (whole tree failure is probable within the next two years).

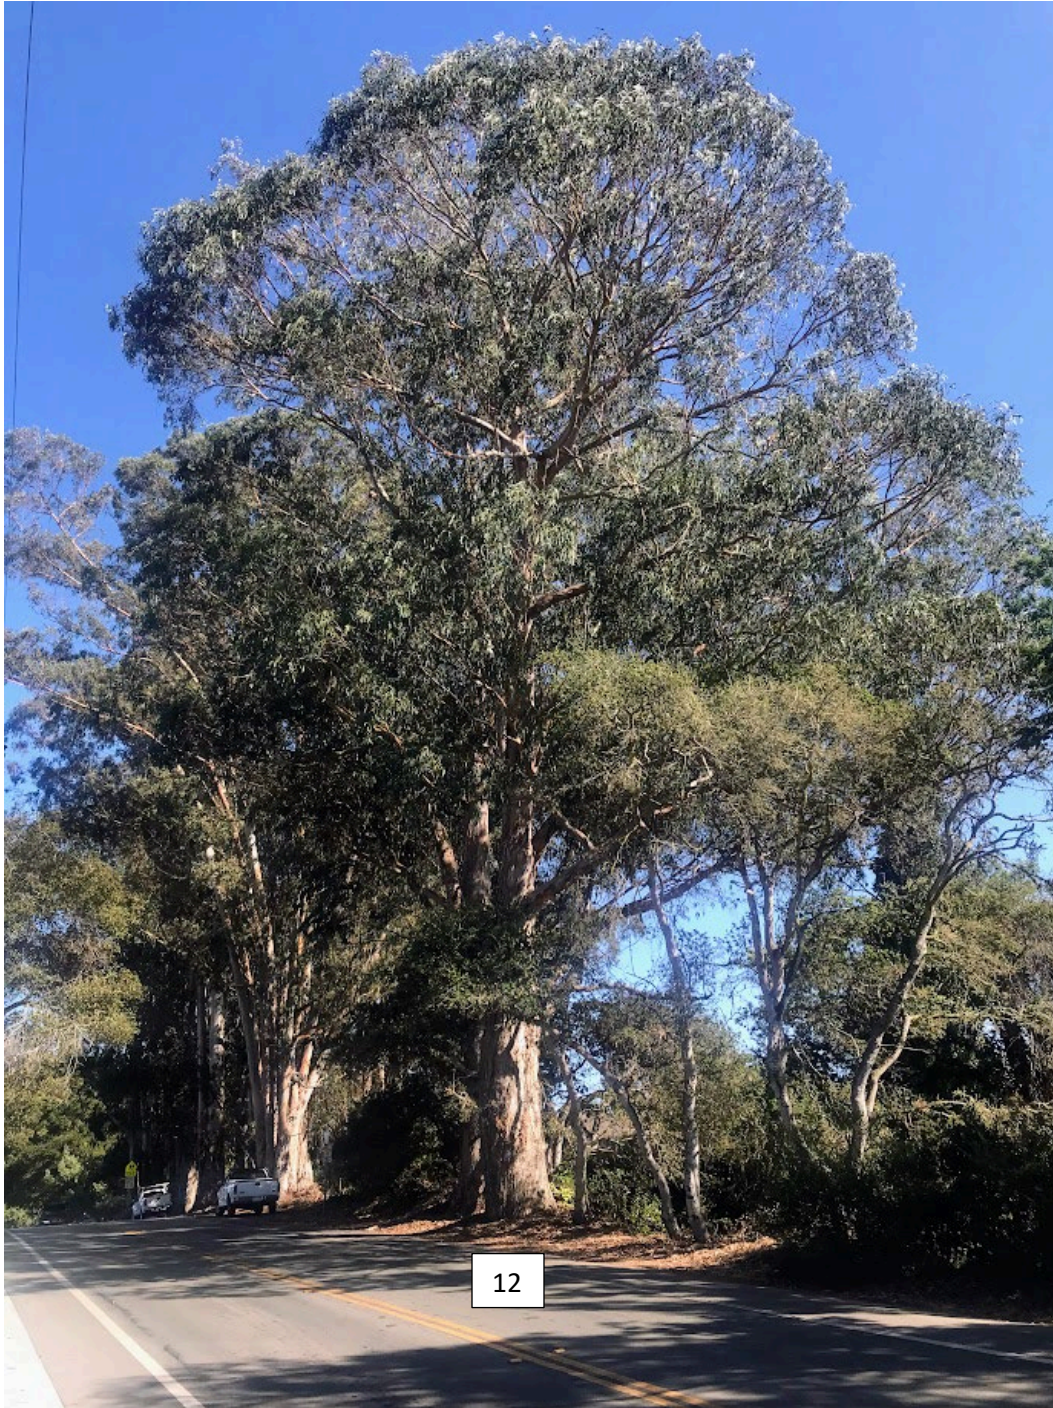
Tree #12 – 57-inch DBH Blue Gum Eucalyptus:

This tall tree has large diameter dead branches within its crown. I also observed overextended branches that extend out over Park Avenue.

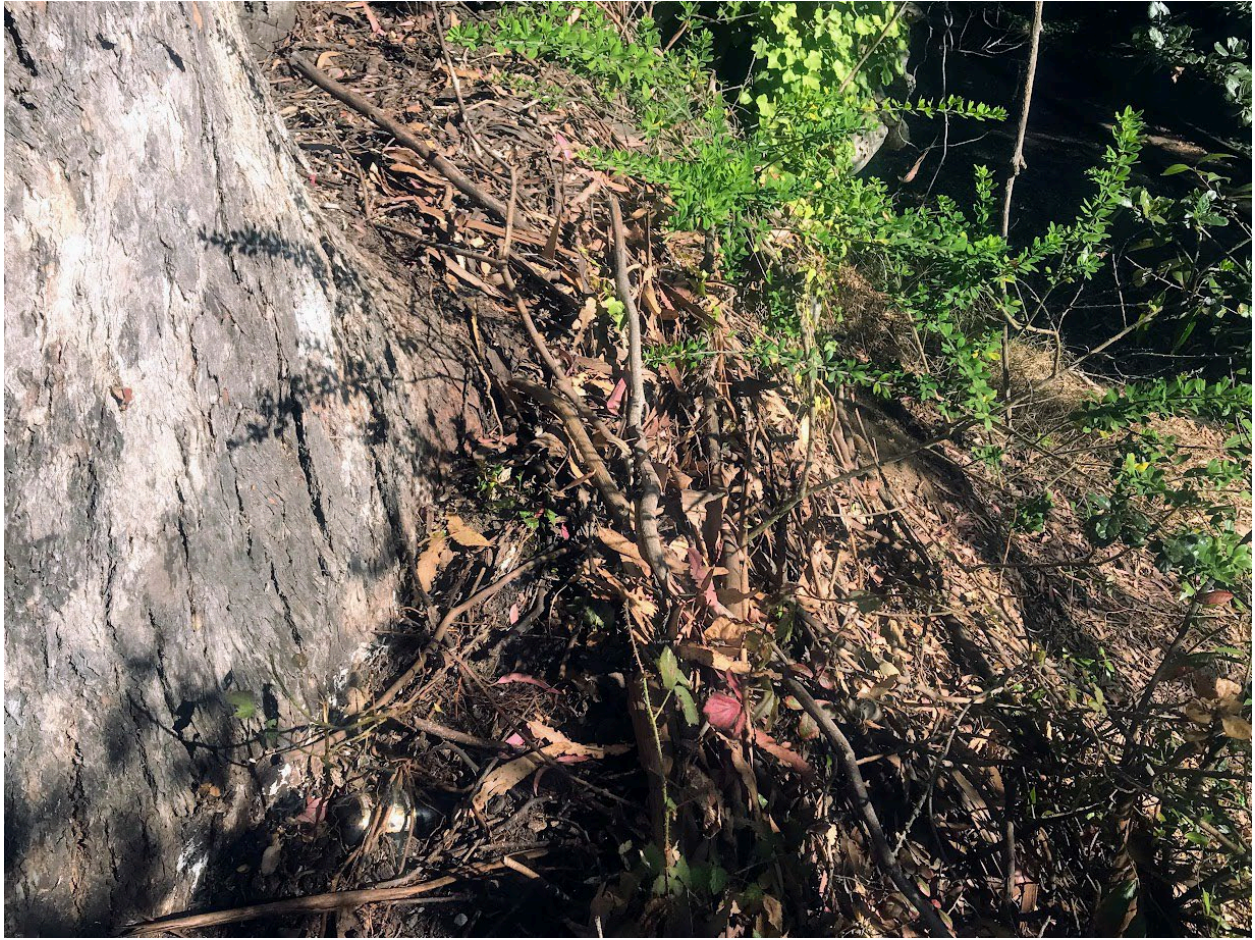
I also observed that the trunk of Tree #12 is set back 12-inches away from the top of the steep bank on its south side. The bank appears to be stable at this time and I determined that this tree is unlikely to fall within the next two years because of this situation.

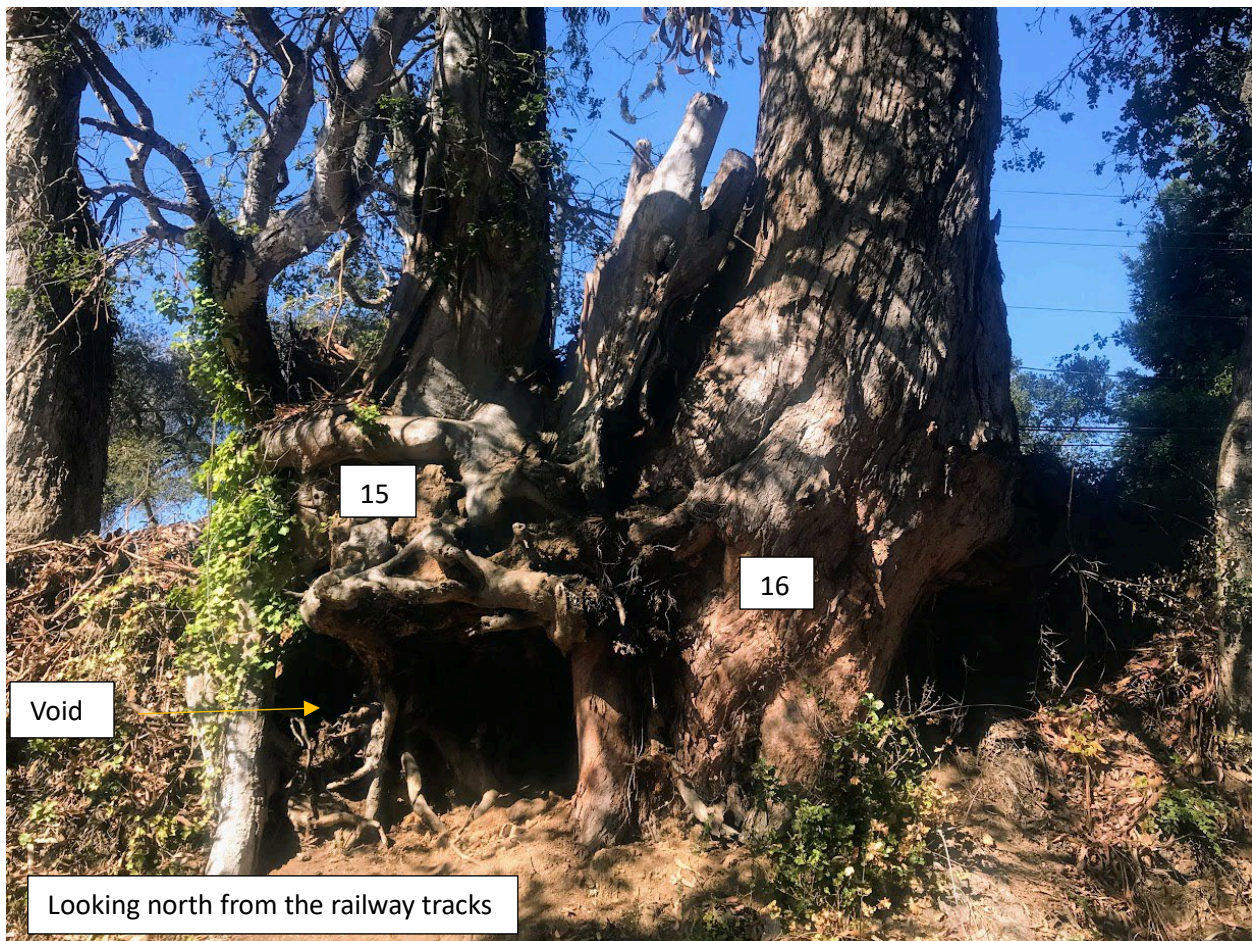
The roots and the base of the trunk of Tree #15 are significantly undermined by erosion. I determined that this tall tree is vulnerable to falling as a result of the loss of structural support in the bank (failure is possible within the next two years).

Tree #16 is partially undermined by erosion. I observed several large supportive roots that extend down the bank and they appear to be well anchored in the ground. I determined the likelihood of this tree falling to be improbable within the next two years. I also observed large dead branches in the crown of this tree.

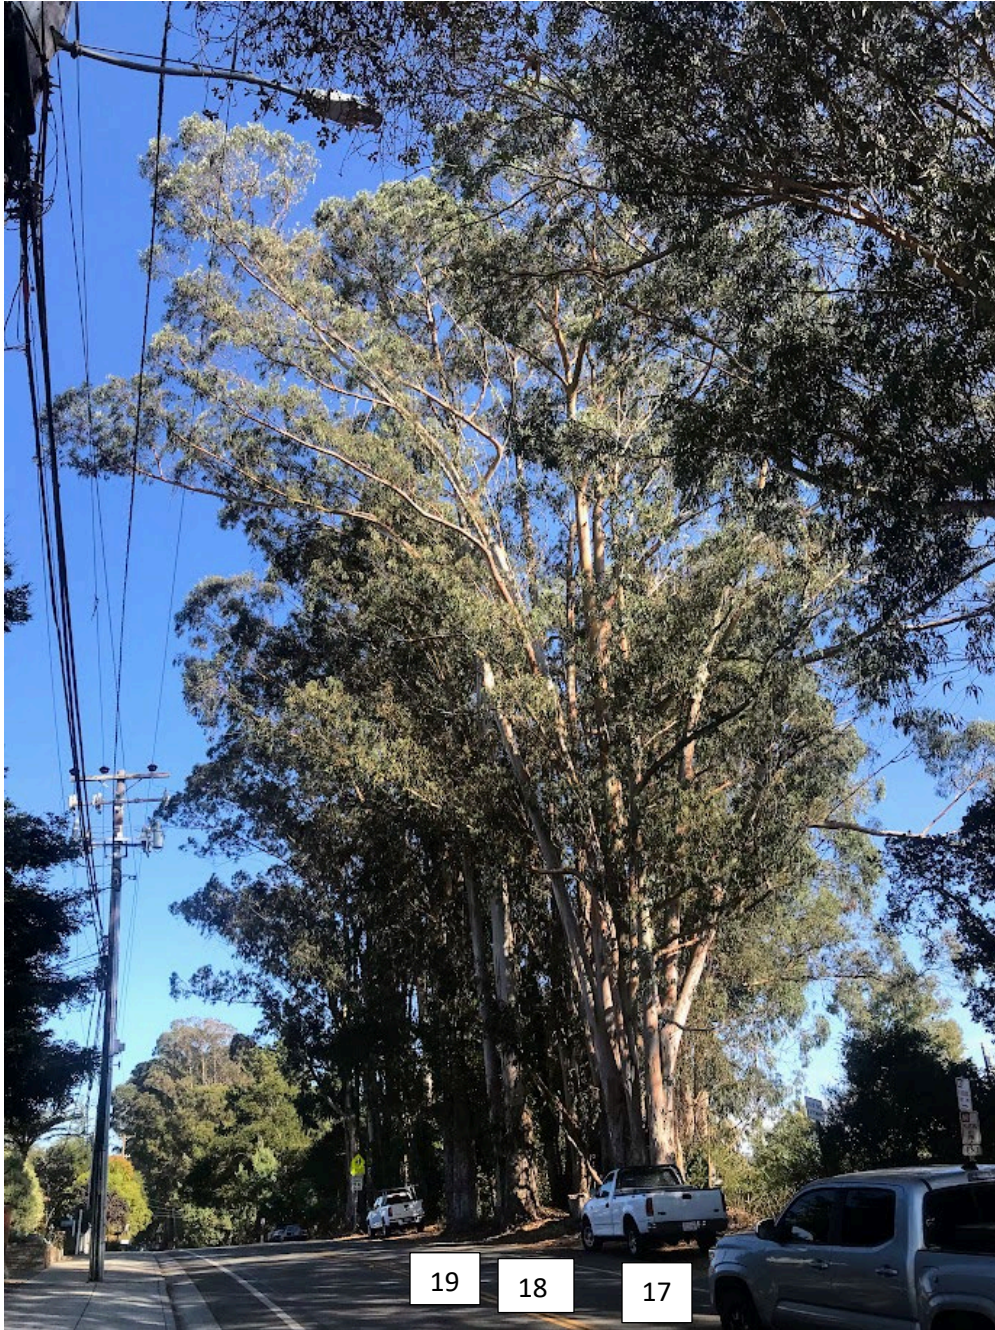
Tree #17 has multiple codominant stems that share narrow areas of attachment. I observed large dead branches in the crowns of these trees. These trees also have overextended branch structures that encroach out over Park Avenue. I determined that the dead branches and overextended branches are vulnerable to failing and falling onto Park Avenue (failure is possible within two years).

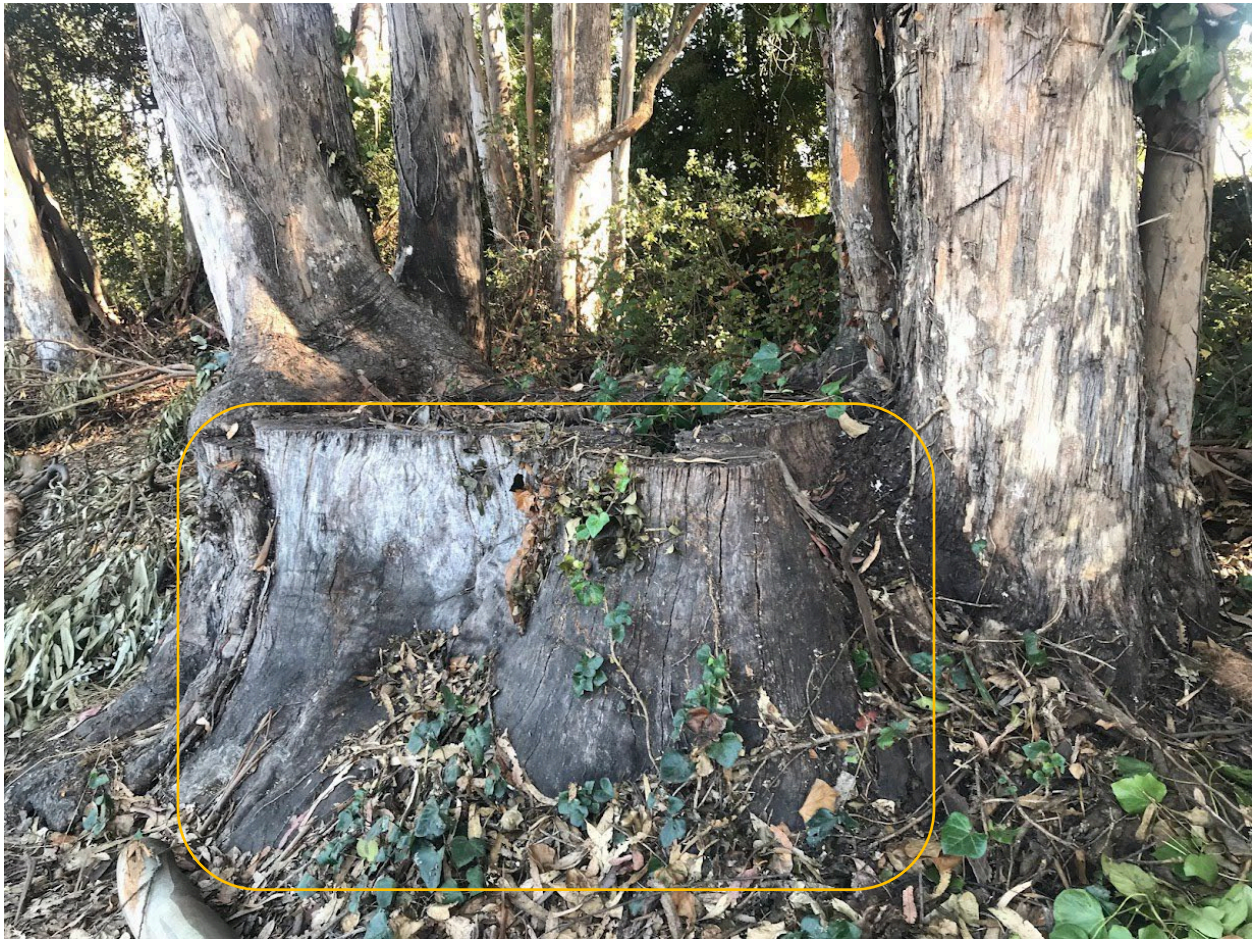
Tree #22 – 29, 19.5 & 8-inch DBH Blue Gum Eucalyptus:

This tree has developed a codominant growth pattern, having three stems that are attached to an original stump. The stump is extensively decayed.

I determined that these codominant stems vulnerable to falling at this time and that they have the potential to strike Park Avenue and the private residences within their falling radius (failure is possible within the next two years).

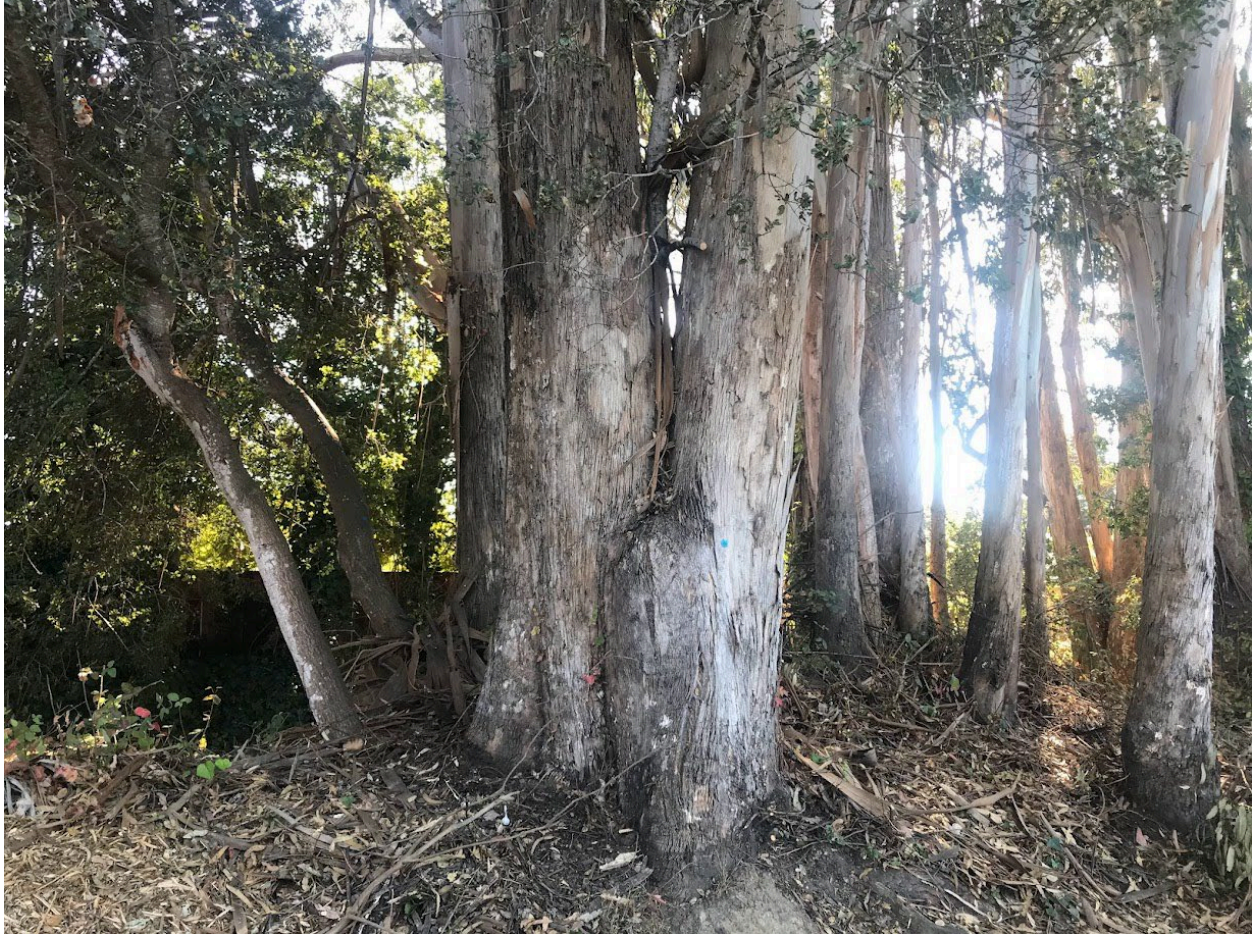
Tree #26 – 46-inch DBH Blue Gum Eucalyptus:

I observed large diameter dead branches and overextended branches in the crown of this tree (failure is possible within the next two years).

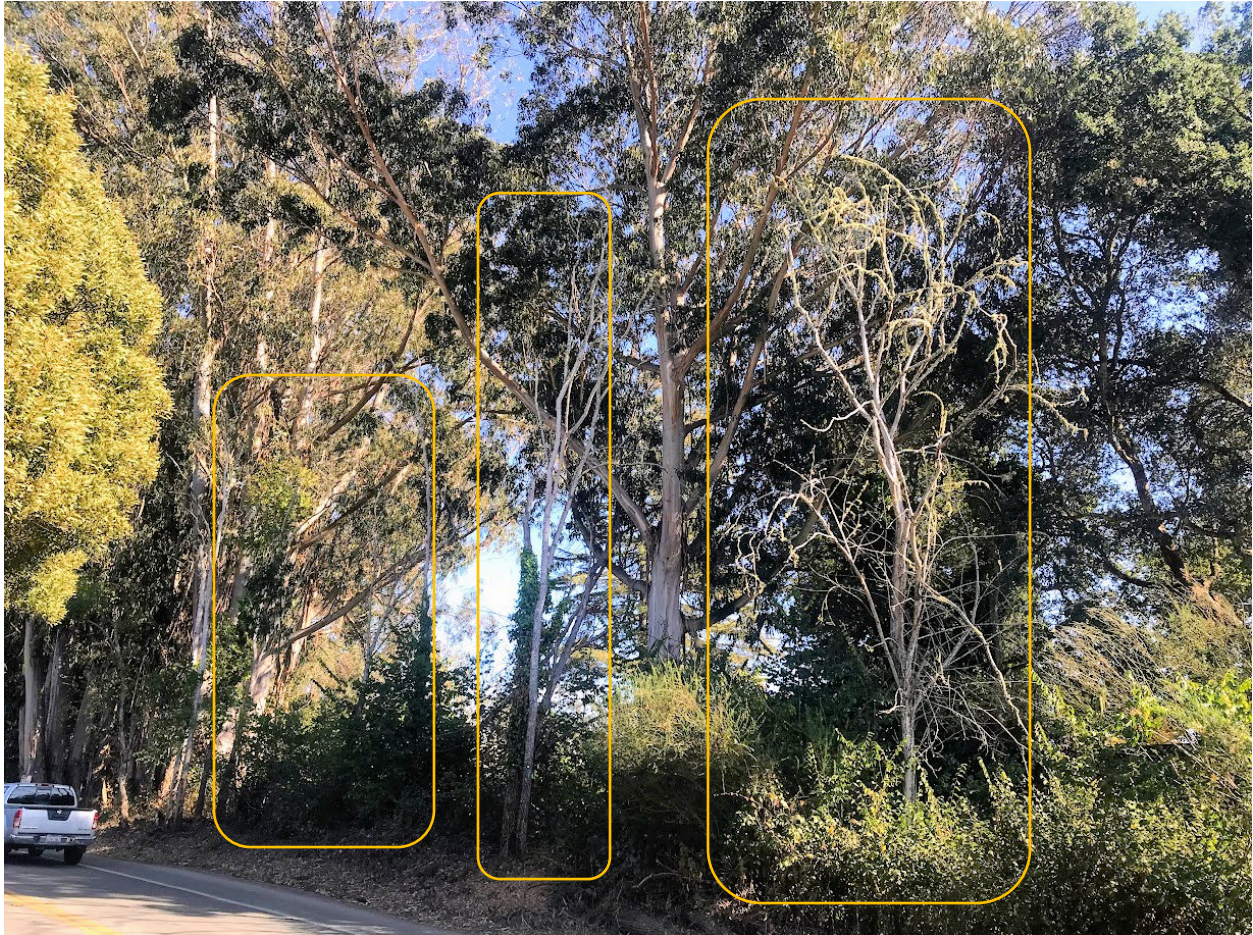
Trees #27 through #31 – Five Elms (*Ulmus ssp.*):

These small diameter trees have likely been infected by Dutch Elm Disease. Trees #27 through #30 are dead and they are vulnerable to falling at this time.

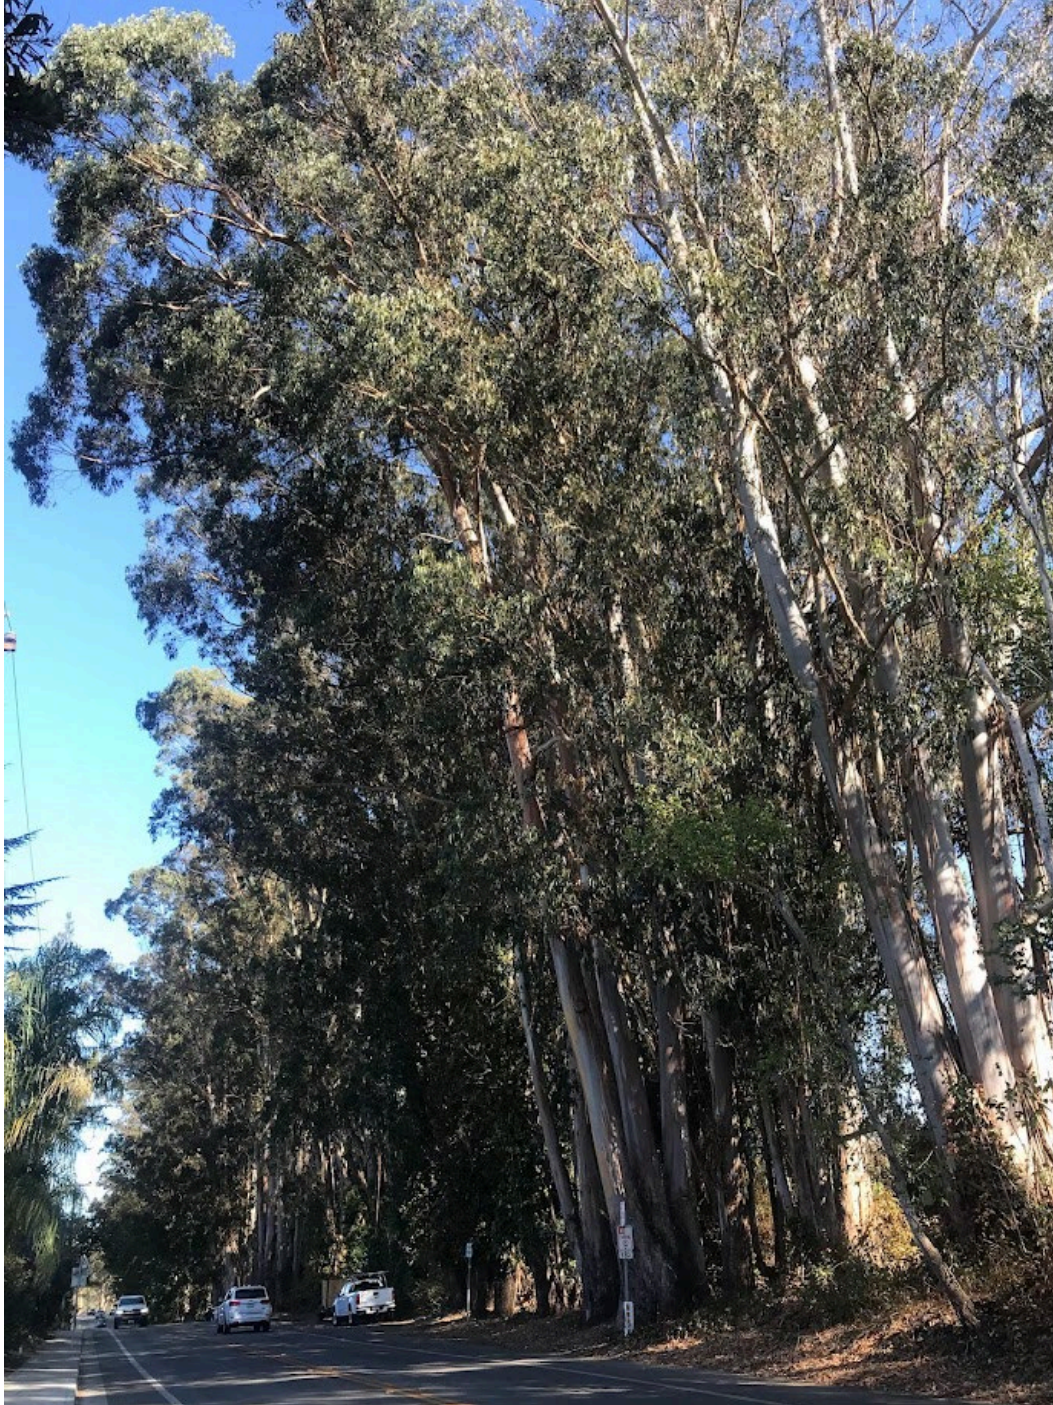
Trees #33 through #40 – Eight Blue Gum Eucalyptus:

These large trees have fair structural conditions as a result of them having large diameter dead branches within their crowns and overextended branches that encroach out over Park Avenue. I determined that these branches are vulnerable to failing in storm conditions (failure is possible within the next two years).

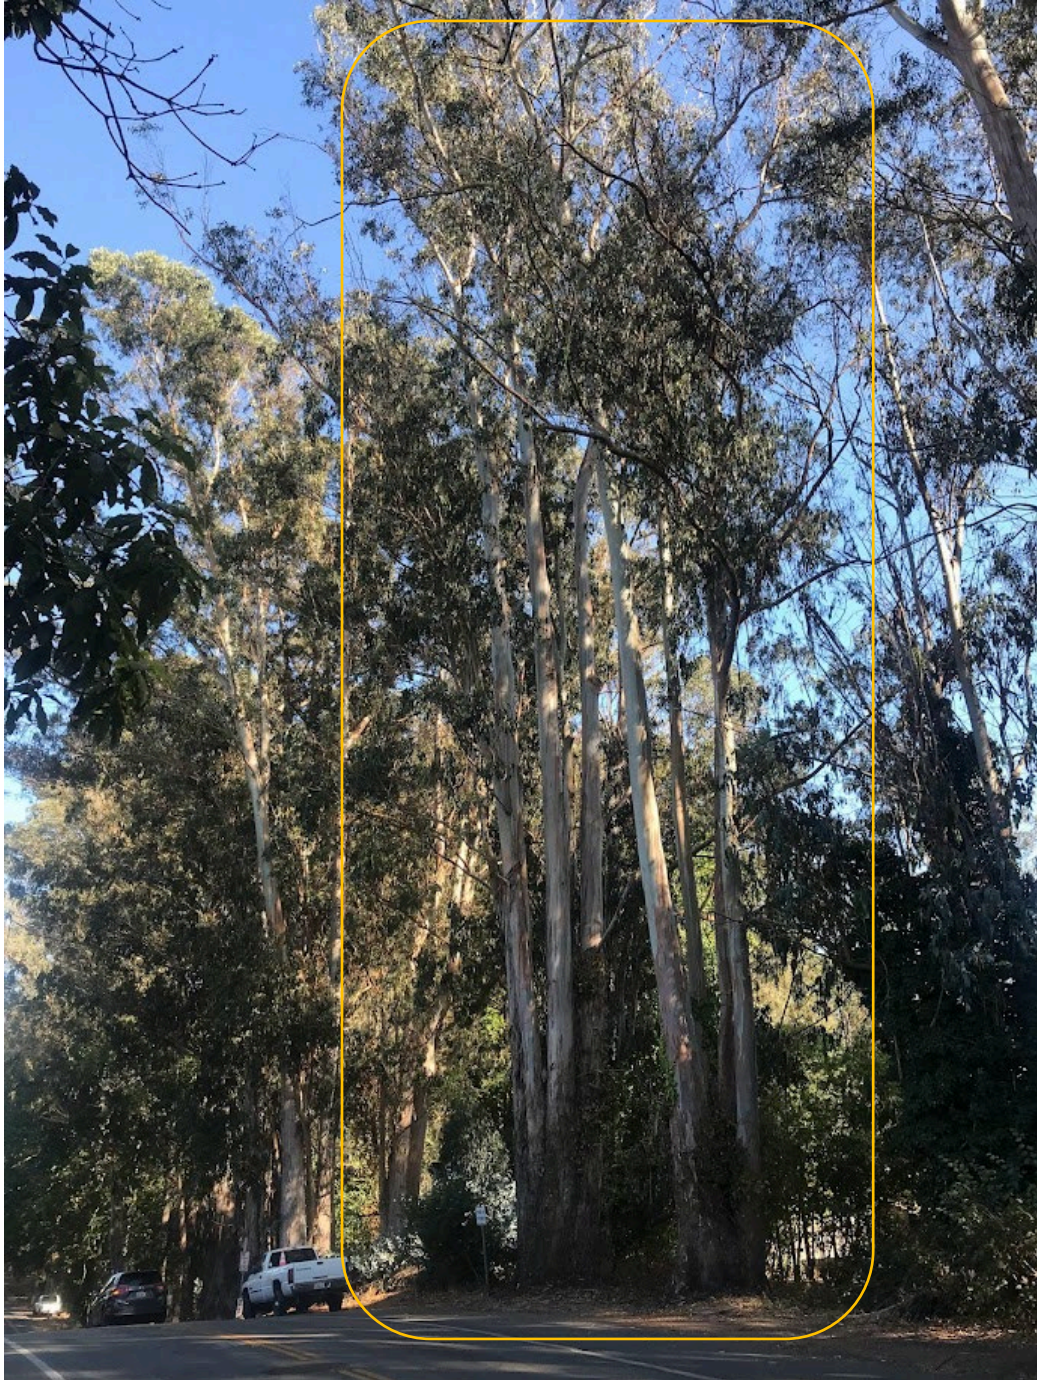
These large trees have fair structural conditions because they have large diameter dead branches within their crowns, and they have overextended branches that encroach out over Park Avenue. I determined that these branches are vulnerable to failing in storm conditions (branch failures are possible within two years).

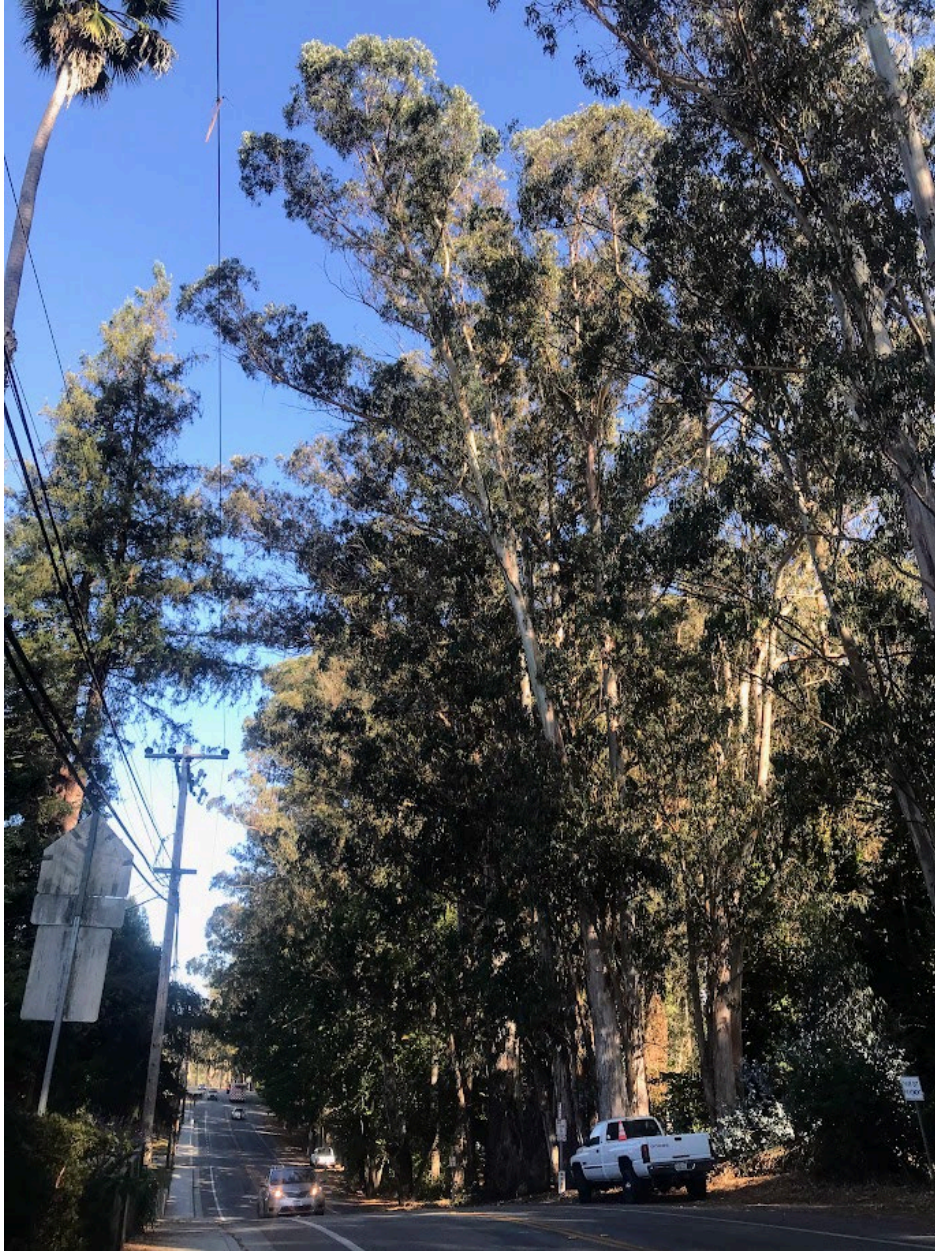
These large trees have fair structural conditions as a result of them having large diameter dead wood within their crowns and they have overextended branches that encroach out over Park Avenue. I determined that these branches are vulnerable to failing in storm conditions (branch failures are possible within two years).

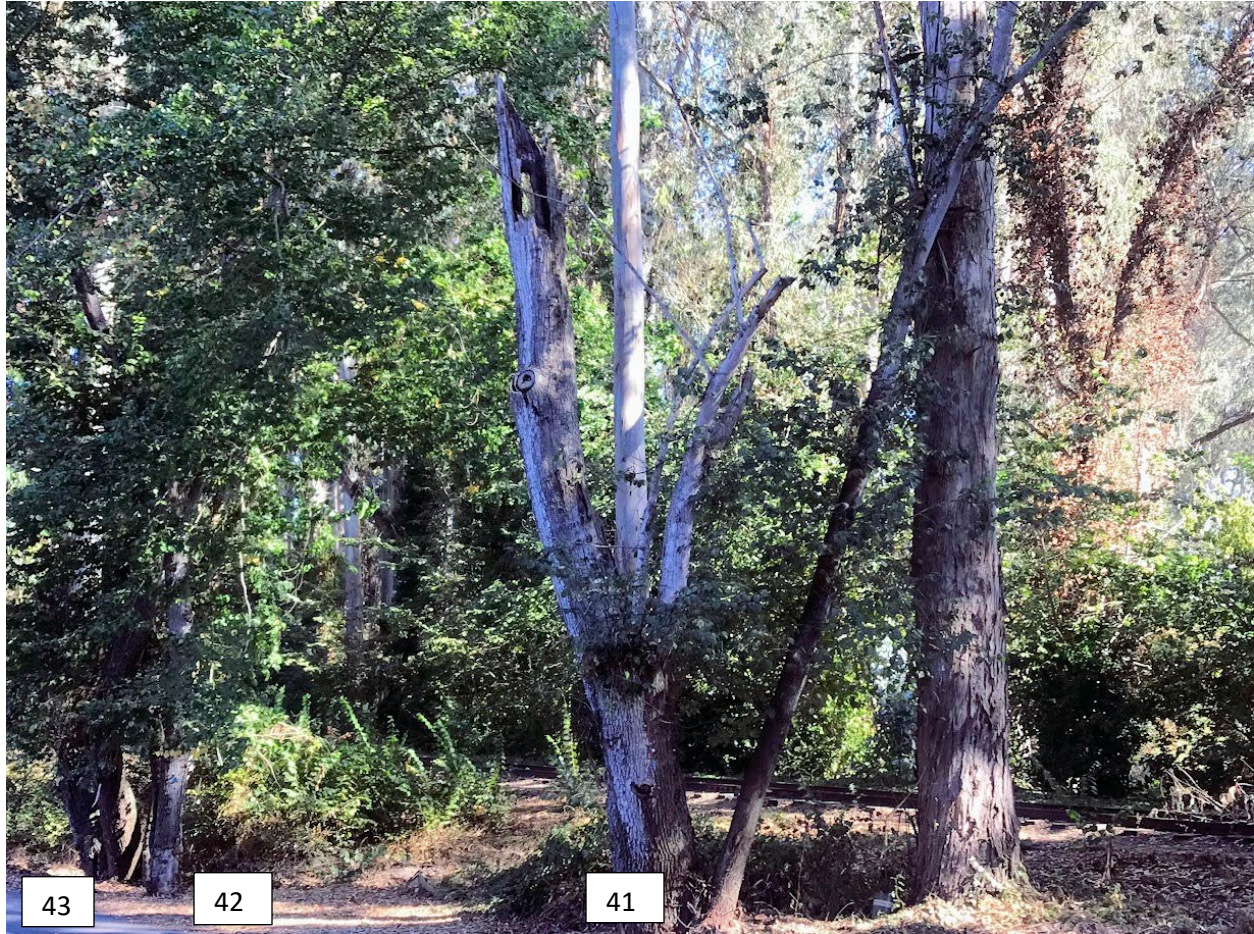
Tree #41 – 40-inch DBH Elm:

This tree is in poor health, and it has an extremely poor structural condition because its trunk is extensively decayed. I determined that it is vulnerable to falling into Park Avenue at this time (whole tree failure is probable within the next two years).

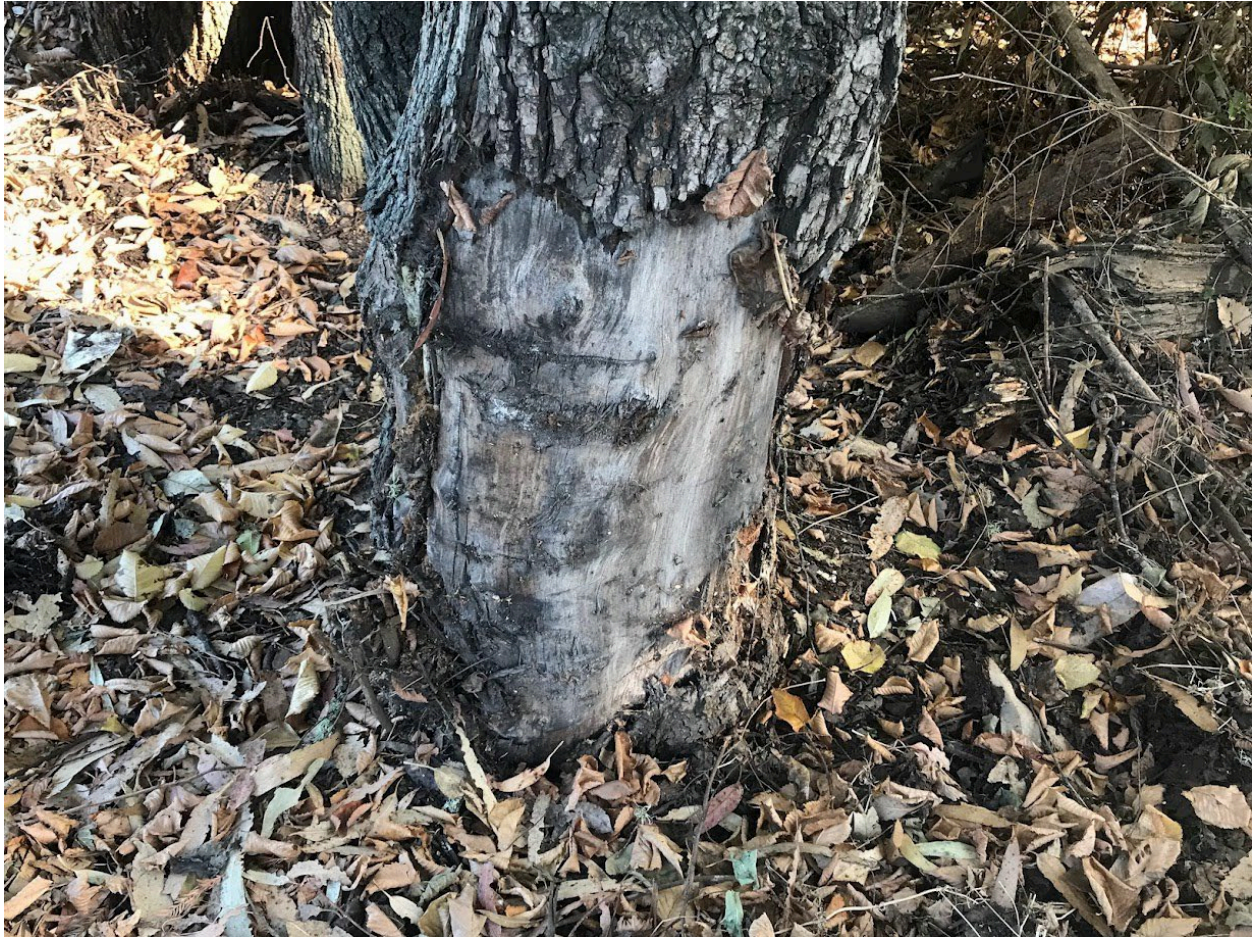
Tree #42 – 16 & 13-inch DBH Elm:

The trunk has been extensively damaged by a vehicle impact. This large wound will become infected by fungal decay. I determined that this tree will become increasingly vulnerable to falling over time (whole tree failure is improbable within the next two years).

I observed large diameter dead branches within the crown of this tree (branch failures are possible within the next two years).

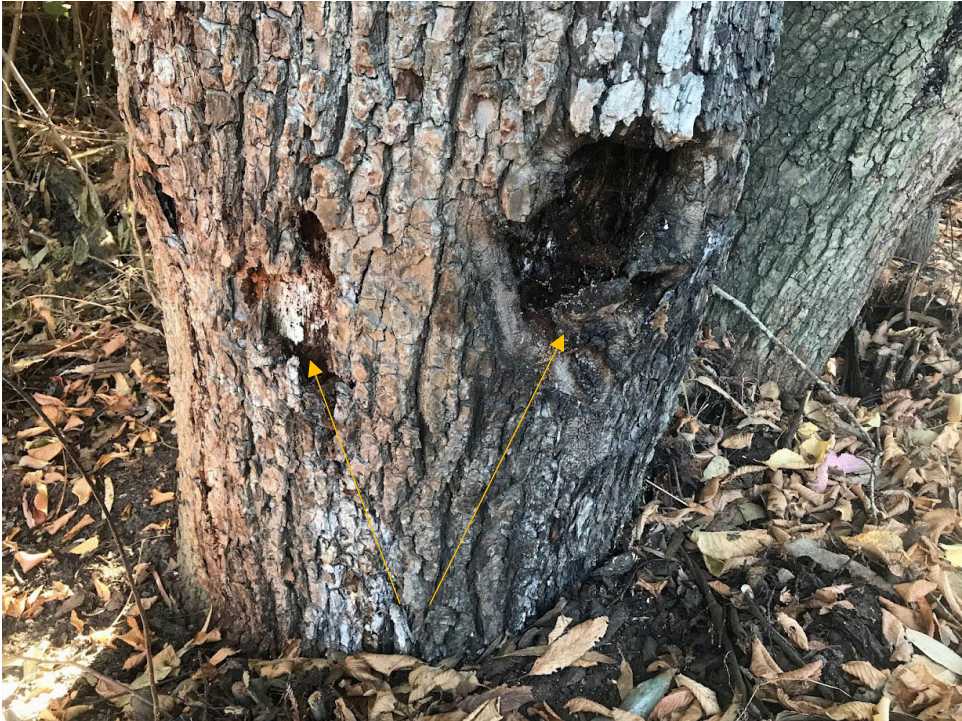
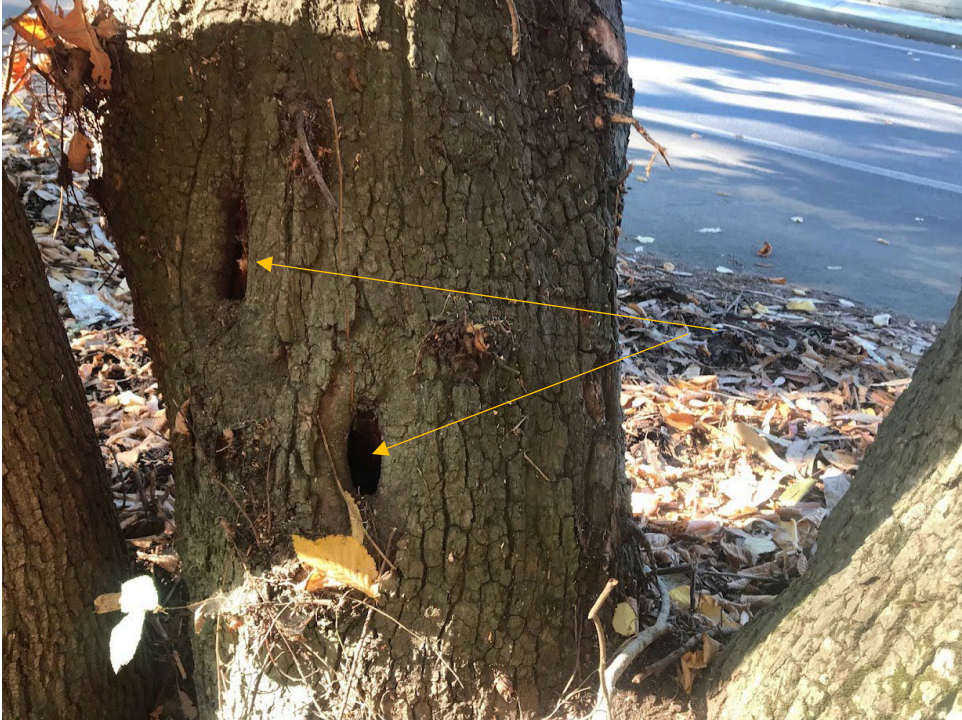
Tree #43 – 22 & 32-inch DBH Elm:

This codominant tree has extensive areas of decay in its stems. I determined that it is vulnerable to falling into Park Avenue at this time (whole tree failure is probable within the next two years).

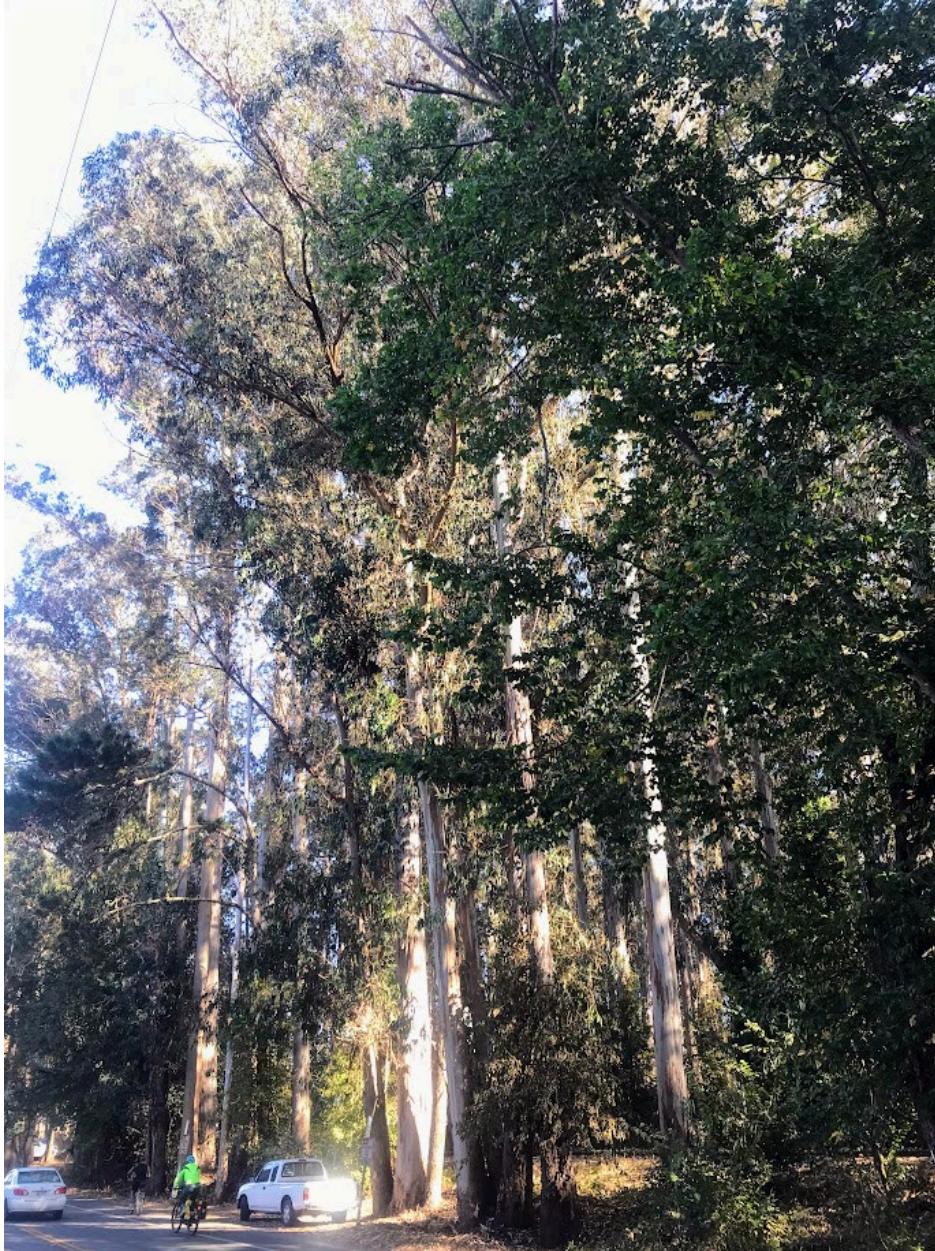
These large trees have fair structural conditions as a result of them having large diameter dead wood within their crowns and overextended branches that encroach out over Park Avenue. I determined that these branches are vulnerable to failing in storm conditions, and that they will strike Park Avenue (branch failures are possible within the next two years). Note that Tree #46 (a 13-inch DBH Blue Gum Eucalyptus is dead).
