AN ASSESSMENT OF THE TREES ON PARK AVENUE BETWEEN MONTEREY AVENUE AND WESLEY STREET,
CAPITOLA, AND RECOMMENDATIONS FOR TREE MAINTENANCE WORK TO ENHANCE PUBLIC SAFETY

Site visit by:
Nigel Belton
ISA Certified Arborist WE-041A
ISA Tree Risk Assessment qualification (TRAQ)
October 20, 2023

Job – City of Capitola - Park Avenue 2023
(Revised and updated on March 17, 2024)

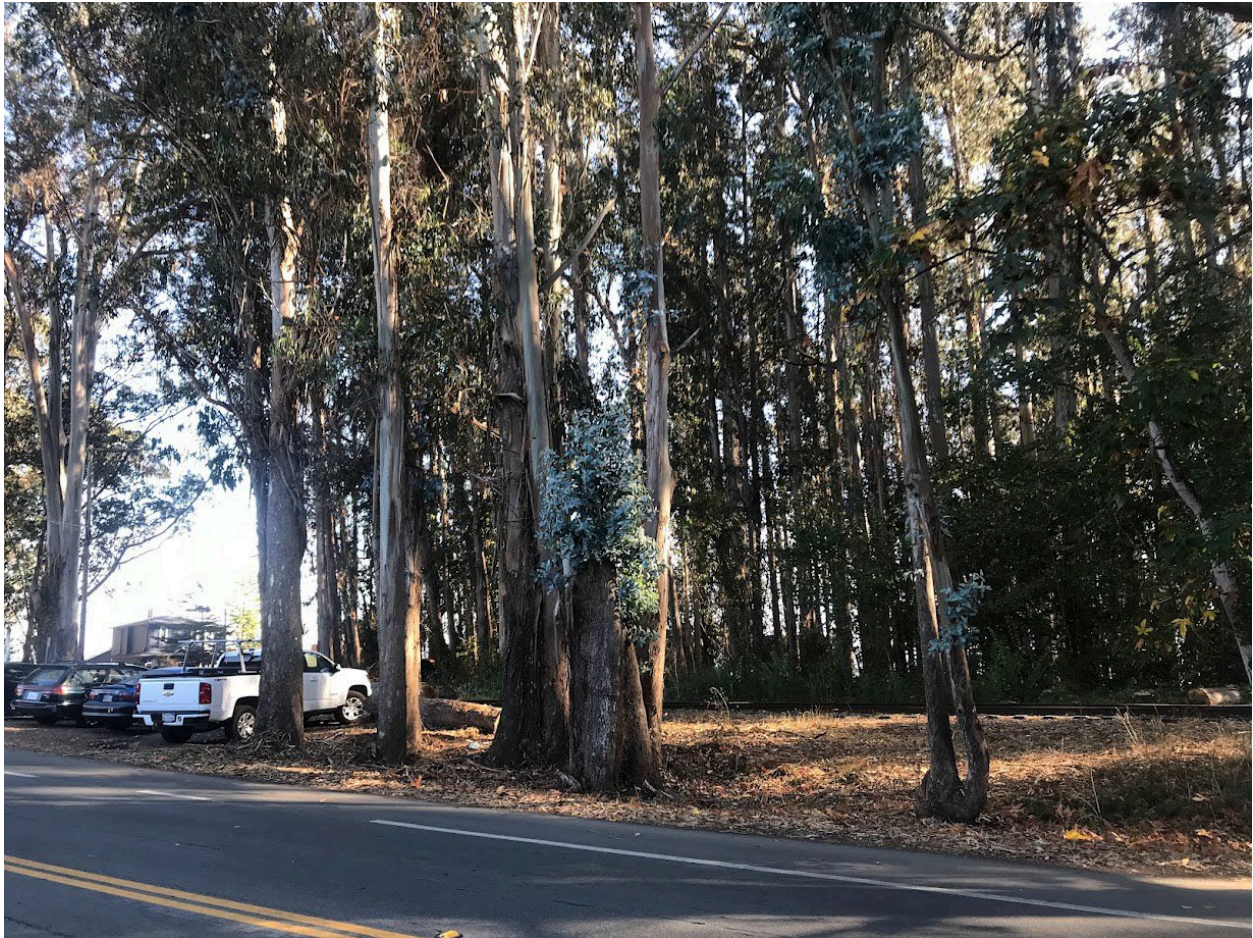
These trees have fair structural conditions because they have large diameter dead wood within their crowns and overextended branches that encroach out over Park Avenue. I determined that these branches are vulnerable to failing in storm conditions, and that they will fall on Park Avenue (branch failures are possible within two years).

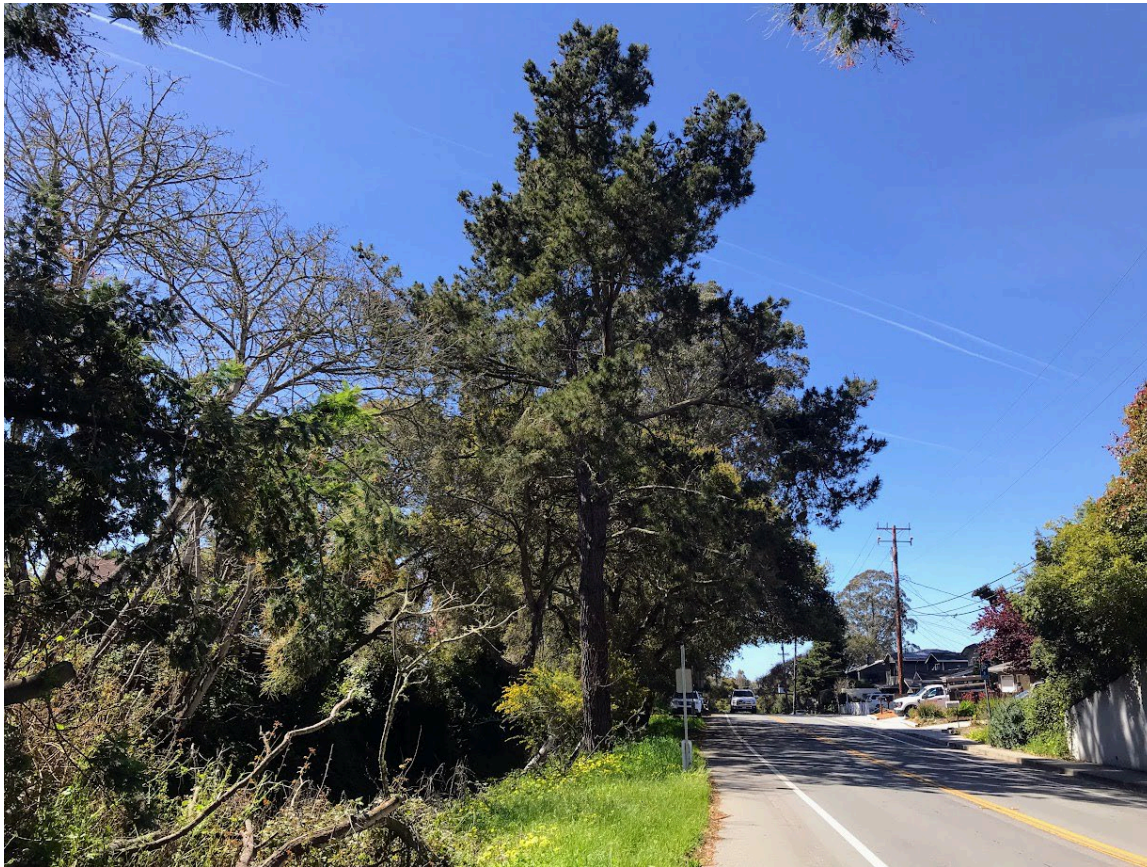
Tree #381 – 35-inch DBH Monterey Pine (*Pinus radiata*):

This tree is located opposite the residence at 414 Park Avenue. It has a poor structural condition, having an overextended branch structure that encroaches out over Park Avenue. This tree also has a codominant growth pattern, having two stems attached to its trunk at about 18-feet above ground. The area of attachment between these stems is poor.

I recommend that five of the lower branches that encroach over the street be removed and that weight is also reduced in the ends of the remaining branches on that side of the tree.

I also recommend that consideration be given to installing a support cable between the two codominant stems that share a poor attachment.

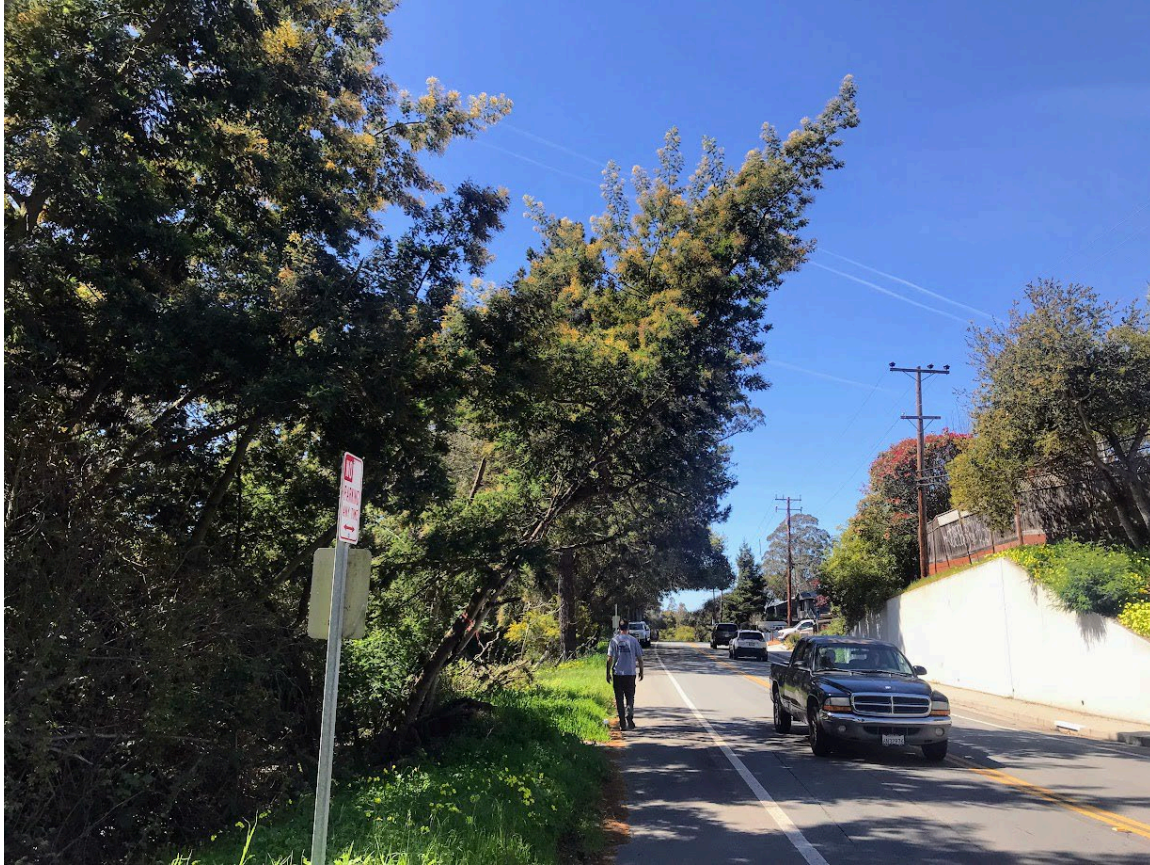
A 10-inch diameter stem on the larger tree and a six-inch diameter branch on the smaller tree encroach over Park Avenue. They are vulnerable to falling onto Park Avenue at this time.

I recommend that the encroaching stem and branch be removed to prevent them from striking the street.

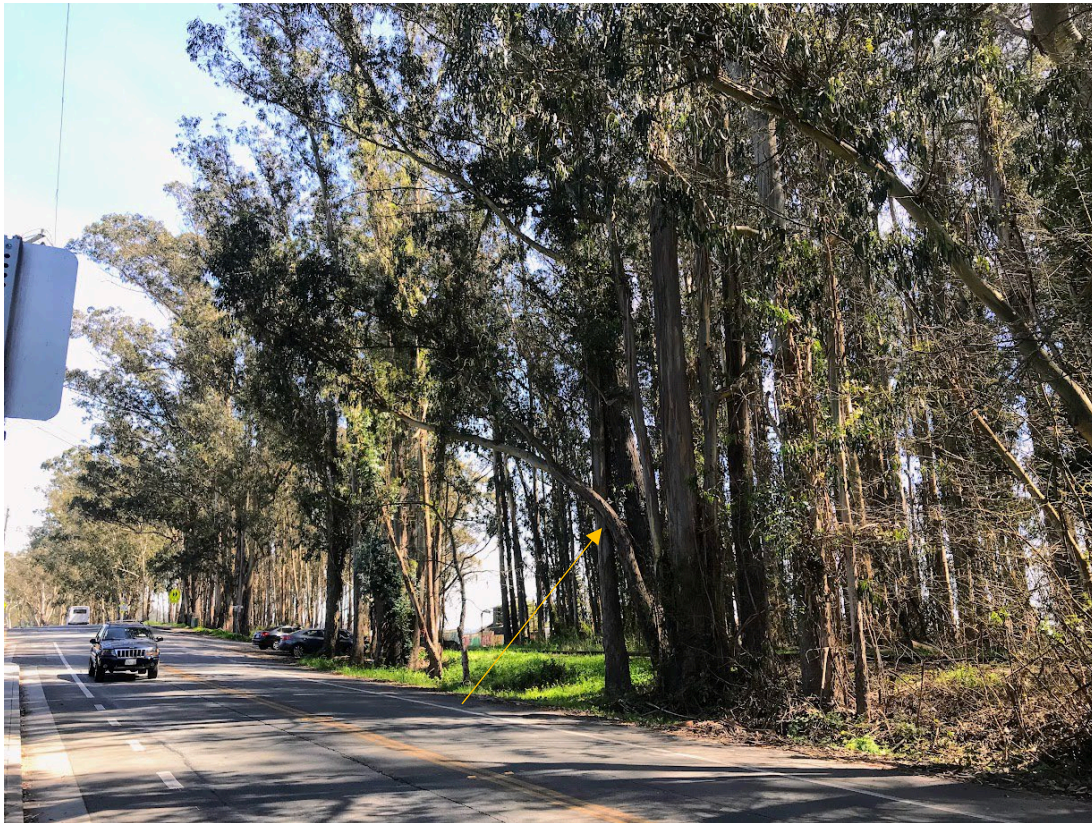
Tree #507 – 41-inch DBH Blue Gum Eucalyptus:

This large tree has a low limb that encroaches out over Park Avenue. This limb crosses the trunk of an adjacent tree on the RTC Property (Tree #508). I recommend that the crossing limb be removed at this time.
