ARBORIST REPORT-
Evaluation and Recommendations for Two Ponderosa Pine
Trees at:

City of Capitola
Wharf Road & Cliff Drive
5/31/2022

Prepared for:
City of Capitola – Public Works
420 Capitola Avenue
Capitola, CA 95010

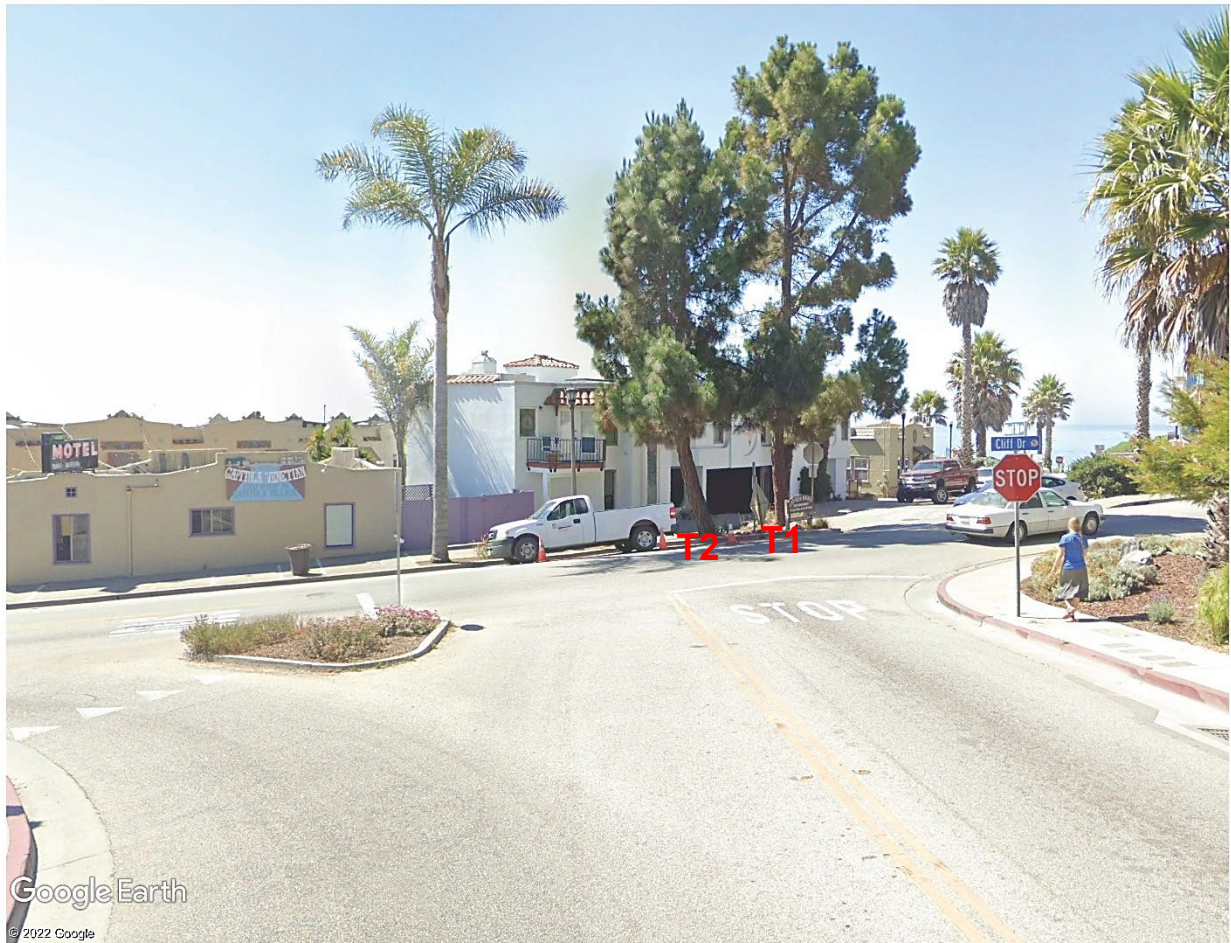
Pines T1 and T2 grow in a sidewalk cutout along Cliff Drive, (Image #1)

Image #1 – Trees T1 and T2 Canary Island Pine, grow in sidewalk cutout along Cliff Drive. Pines as seen from Wharf Road approach to Capitola Village.

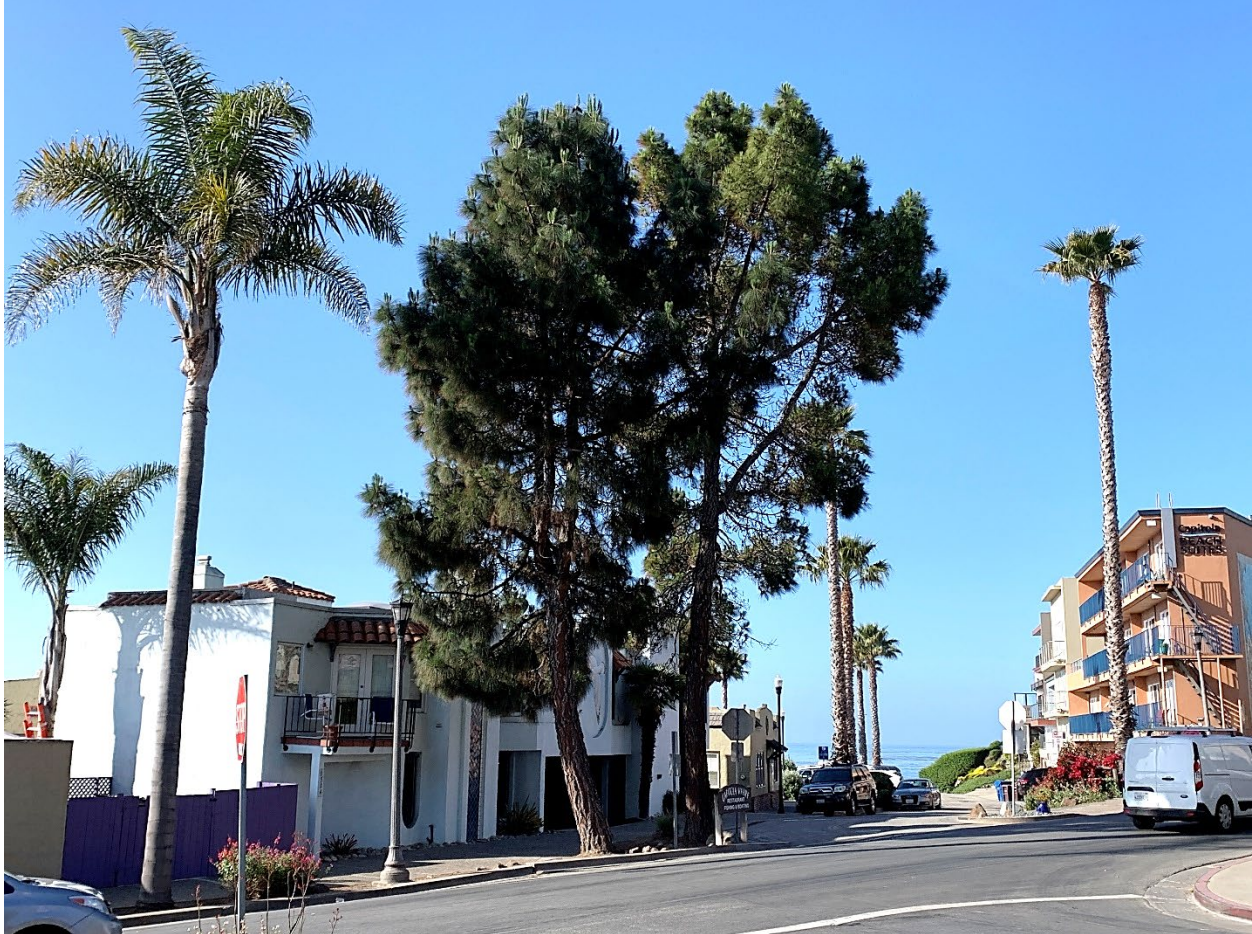
The two trees are planted about 10-feet apart and their canopies overlap, (Image #2).

Image #2 – Trees T1 & T2 seen from corner of Cliff Drive & Wharf Road.

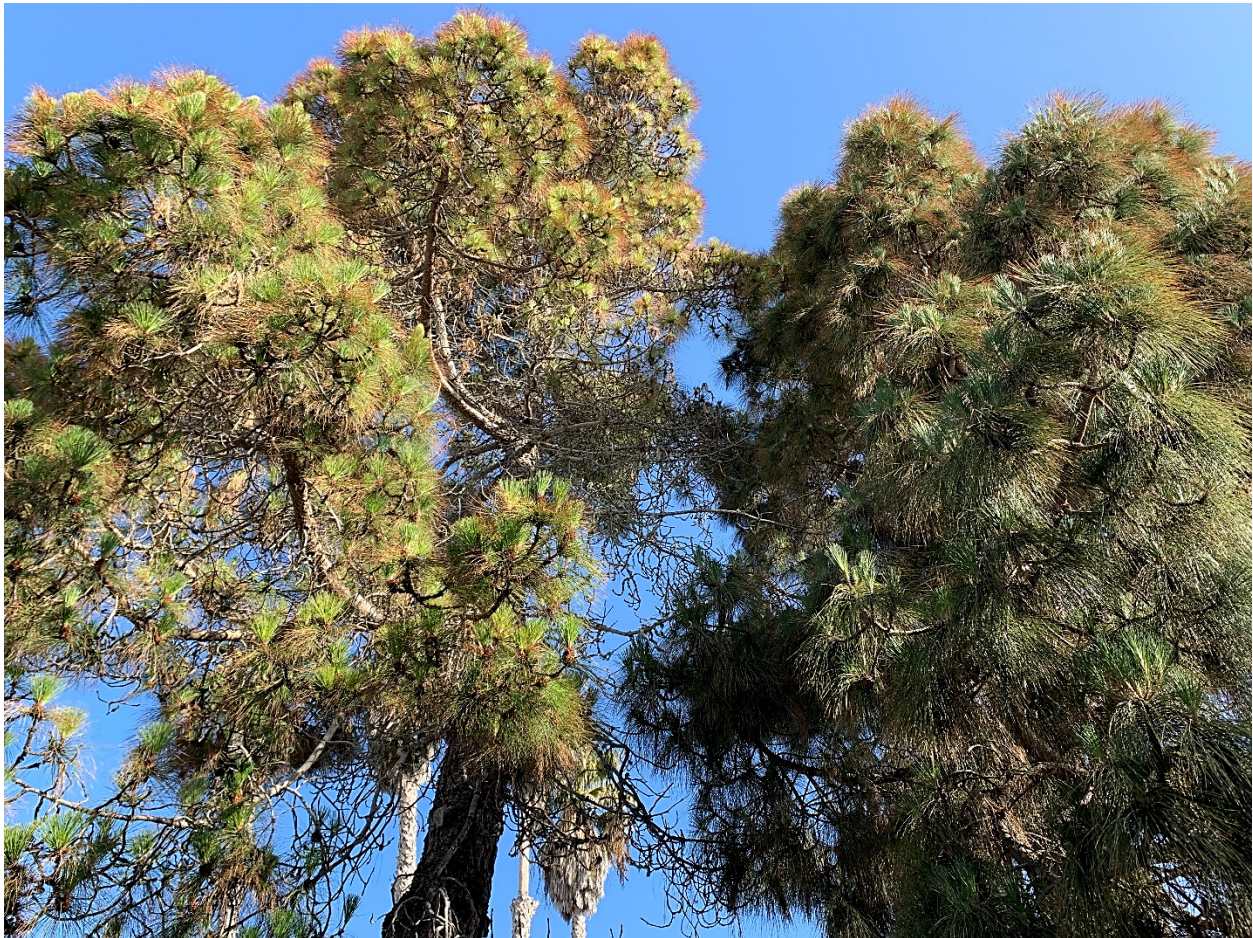
Both pines have some needle browning of older needles, (Image #3). Browning of older needles is normal for pine trees.

Image #3 – Trees T1 (on left), and T2 Canary Island pine. Both trees have some needle browning throughout the canopy. Note lack of branching development on right side of tree T1.

The branching structure of tree T1 is limited on the side adjacent to tree T2.

Tree T1 has not developed much branching structure on the side adjacent to tree T2 due to shading from tree T2. If tree T2 is removed, tree T1 will develop a branching structure on this side. Over time, the new branching structure and canopy will "fill in" the void left by tree T2. The buffer and screening effect of the tree T1 canopy, will eventually equal, (or nearly equal), the current canopy spread both trees.

1. Obtain all necessary permits prior to removing or significantly altering any trees on site.
2. Remove Canary Island pine tree T2.
3. Perform crown reduction and crown cleaning pruning to tree T1.
4. If infrastructure repairs are made to sidewalk curb and gutter, core and dowel into existing sidewalk sections and curb. Install multiple lengths of rebar in an overlapping pattern. Repour new sidewalk as a single monolithic pour to minimize the chances of future root uplifting.

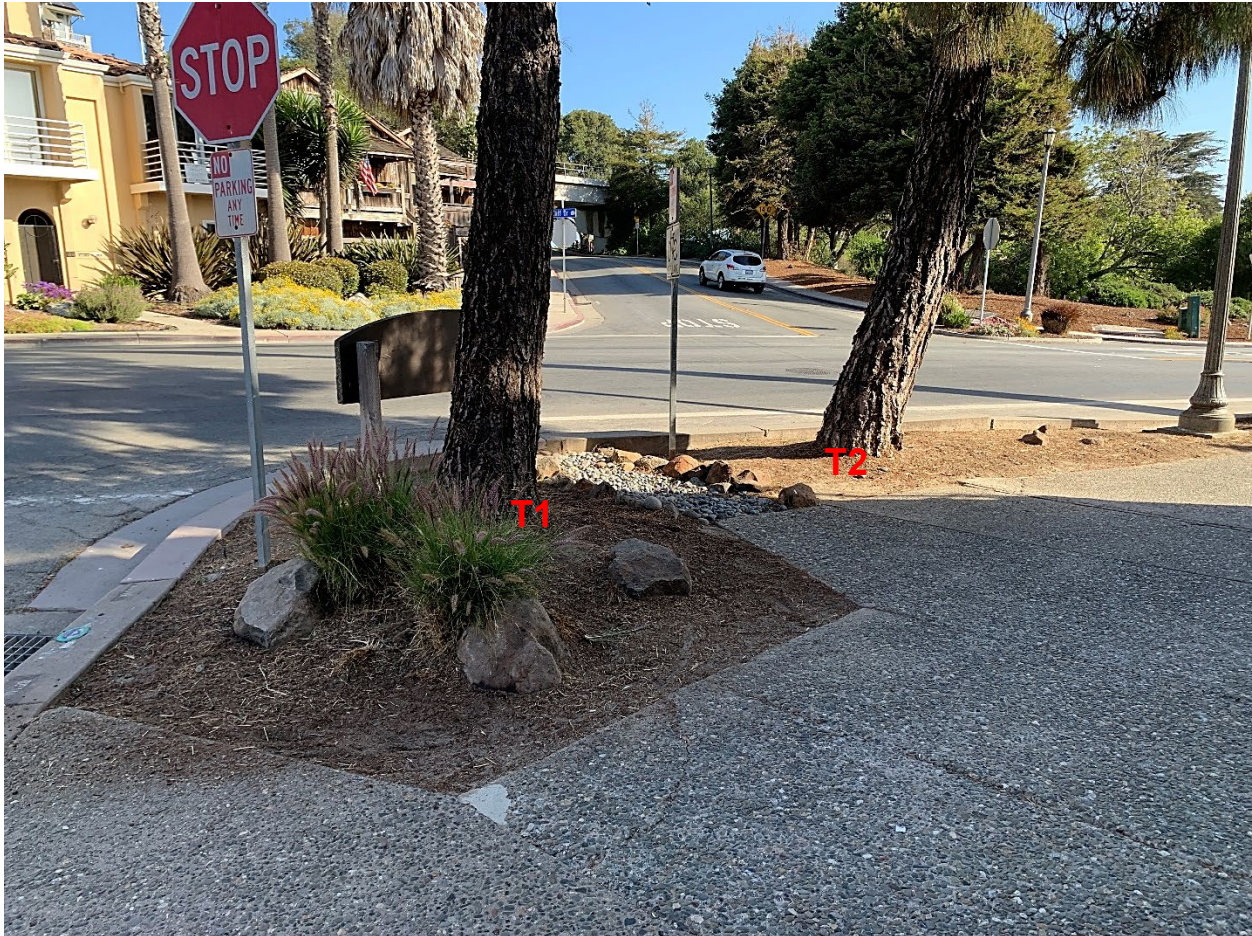
The two trees grow in a sidewalk cutout, (Image #4).

Image #4 – Trees T1 and T2 Ponderosa pine. The rooting area for tree T1 is larger than the rooting area for tree T2.

The rooting area for tree T1 is larger than for T2. Both trees are causing damage to the sidewalk, curb/gutter, and asphalt.

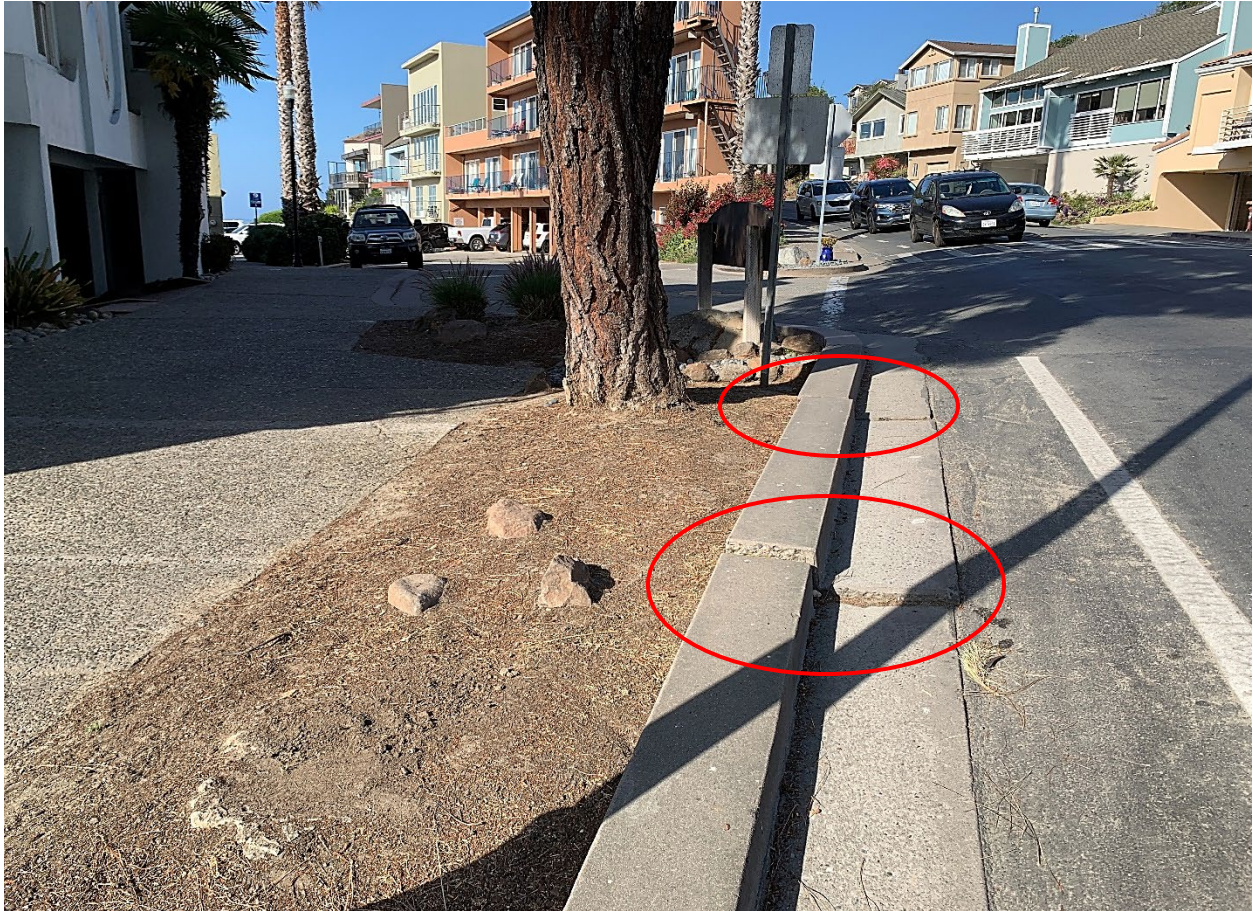
Shallow surface rooting by tree T2 has caused curb and gutter to lift, (Image #5).

Image #5 – Curb and gutter damage from tree T2., (circled). The asphalt connected to the gutter is also showing damage.

Tree T2 is causing the most impact to surrounding sidewalk and curb and gutter. This is due to the small planting area size, its limited rooting area, and the growth pattern of the tree's roots, (Images #5 & #6).

It may be possible to prune roots and make infrastructure repairs for tree T2, but because of the size of this tree relative to the planting area, and its close proximity to the curb and sidewalk, the root problem is likely to re-occur, even with root pruning, root barriers and concrete repairs.

Because of the issues created by the tree that will likely continue even with mitigation, my recommendation is to remove this tree.

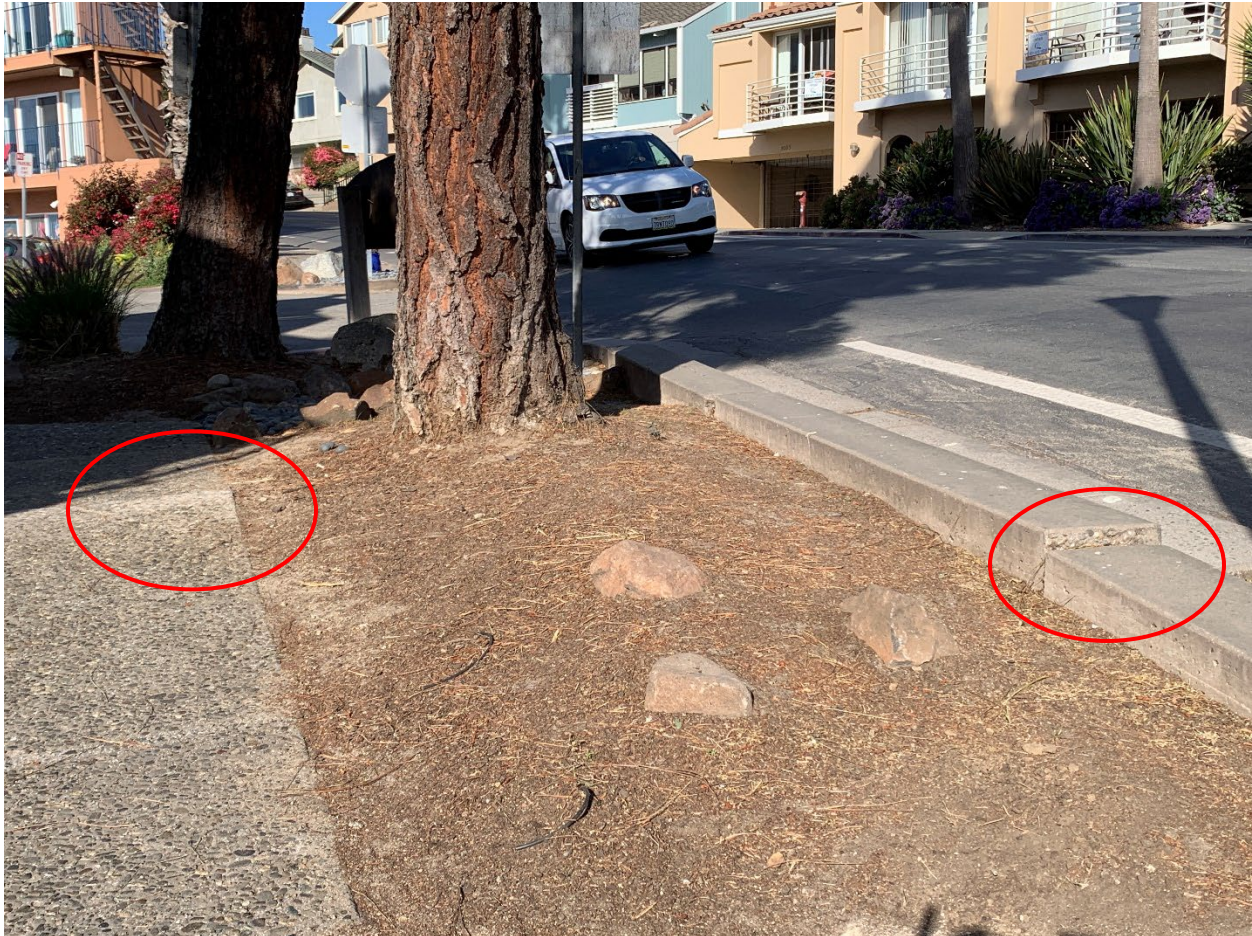
In addition to the curb, sidewalk damage was observed, (Image #6).

Image #6 – Tree T2 sidewalk damage and lifted curb.

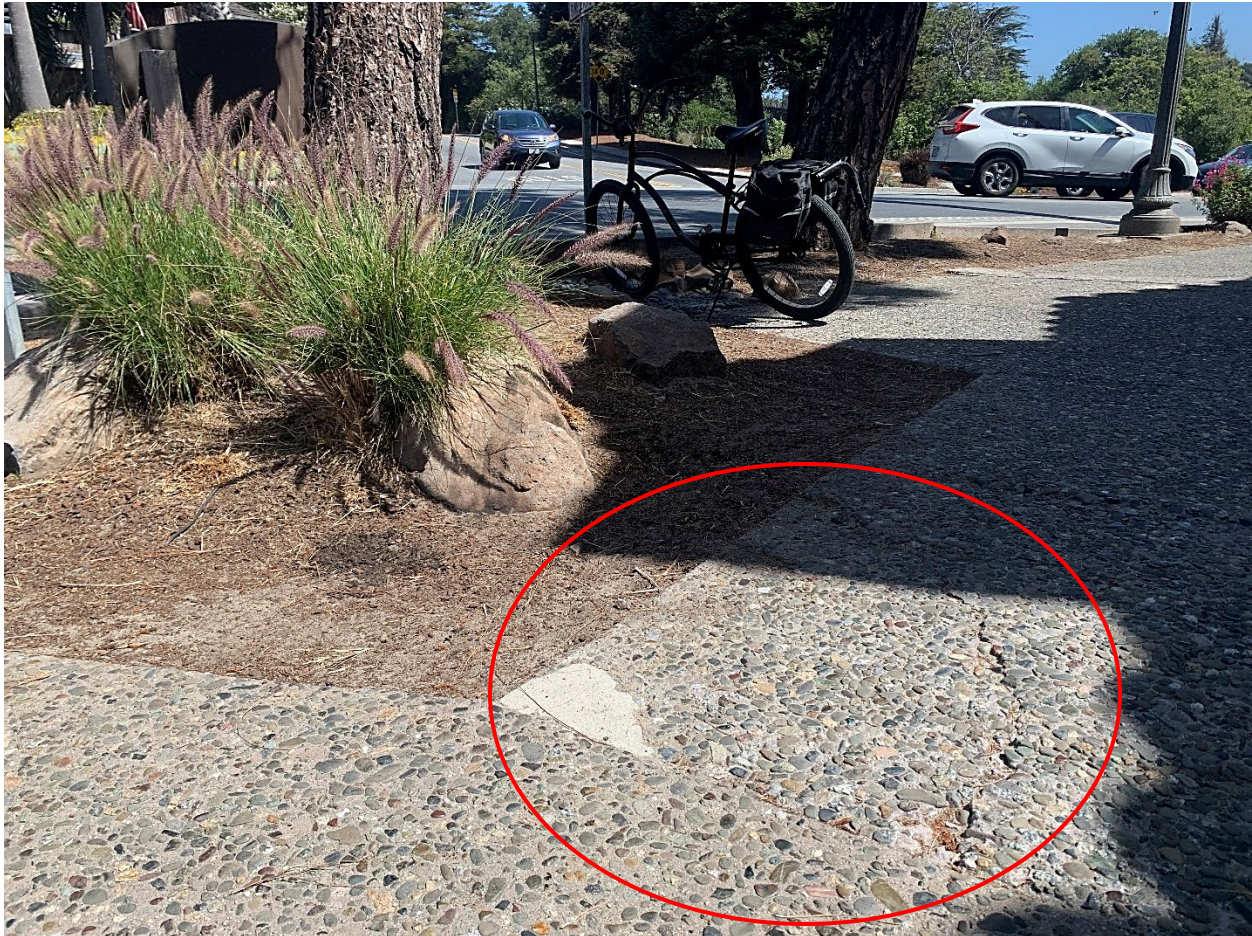
Shallow surface rooting from tree T1 is causing sidewalk damage, (Image #7).

Image #7 – Sidewalk damage from tree T1. Note corner of sidewalk has been repaired

Tree T1 has a much larger rooting area than tree T2 and mitigation methods to reduce root damage impacts are likely to hold for a much longer period. Therefore, I believe this tree should be retained since root problems can be kept at a manageable level.
