City of Capitola City Hall Facility Needs Assessment

DRAFT REPORT | 18 APRIL 2024

EXISTING CONDITIONS REPORT

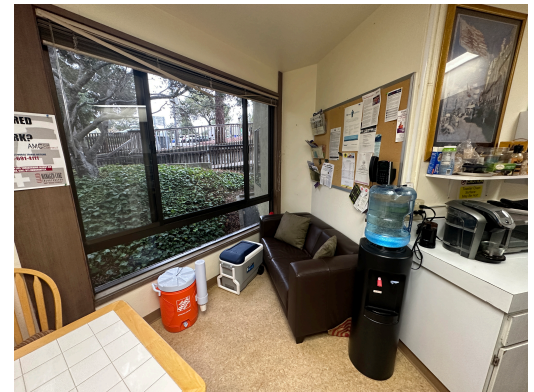
City Hall breakroom.

The room itself is small with only 155 square feet. The layout is awkward, and the room has a non-standard shape. It currently fits a small table, couch, and kitchenette. The breakroom has some maintenance needs, one of the most prominent being that a piece of glass from a slatted window is missing, which lets air flow freely into the space, creating a sometimes cold and unpleasant environment.
