3 April 2025

Project No. 2381

Re: Updated geological investigation of recent coastal bluff failure
Grand Avenue footpath near intersection with Oakland Avenue and Saxon Avenue
Capitola, California 95010

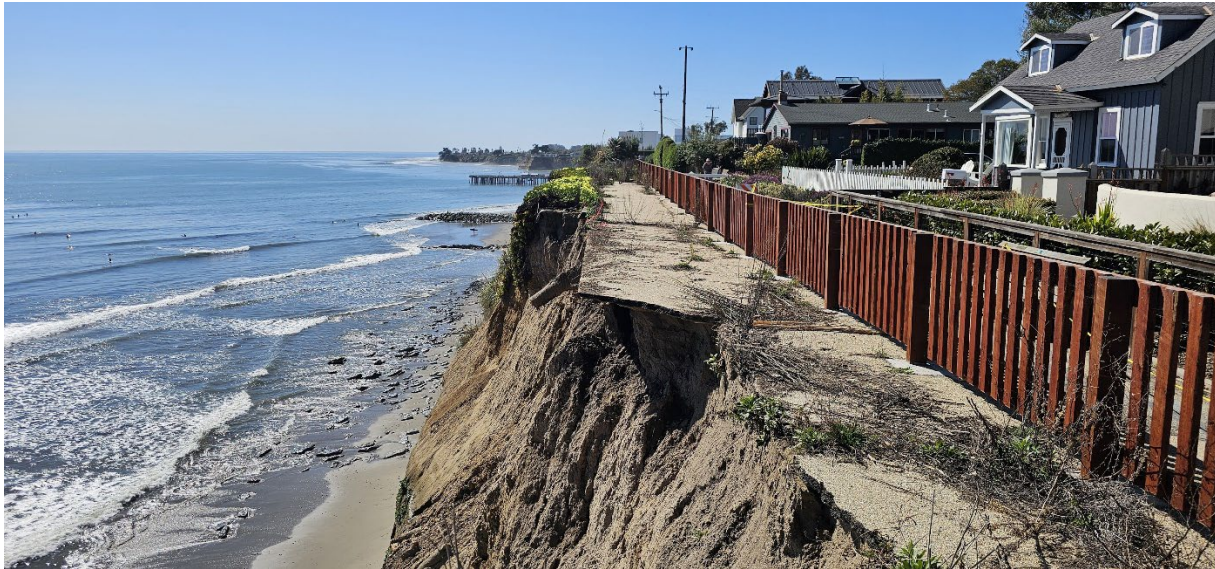
The coastal bluff appears to have recently failed further at this location, centered roughly around where a plastic corrugated CMP daylights out of the top of the bluff face. Pieces of the CMP lie within the landslide debris on the beach, so it is clear that landsliding tore off a portion of the CMP.

An arcuate erosional scar has developed around the remnant of CMP within the blanket of soil (Marine Terrace Deposits) that lies atop the bedrock shelf. This is likely due to ongoing

erosion from storm water out of the CMP hitting the Marine Terrace Deposits soil and eroding them.

The Marine Terrace Deposits are very steep, nearly vertical, at the location of the recent landsliding (see photo below and the geological cross section on Plate 1).

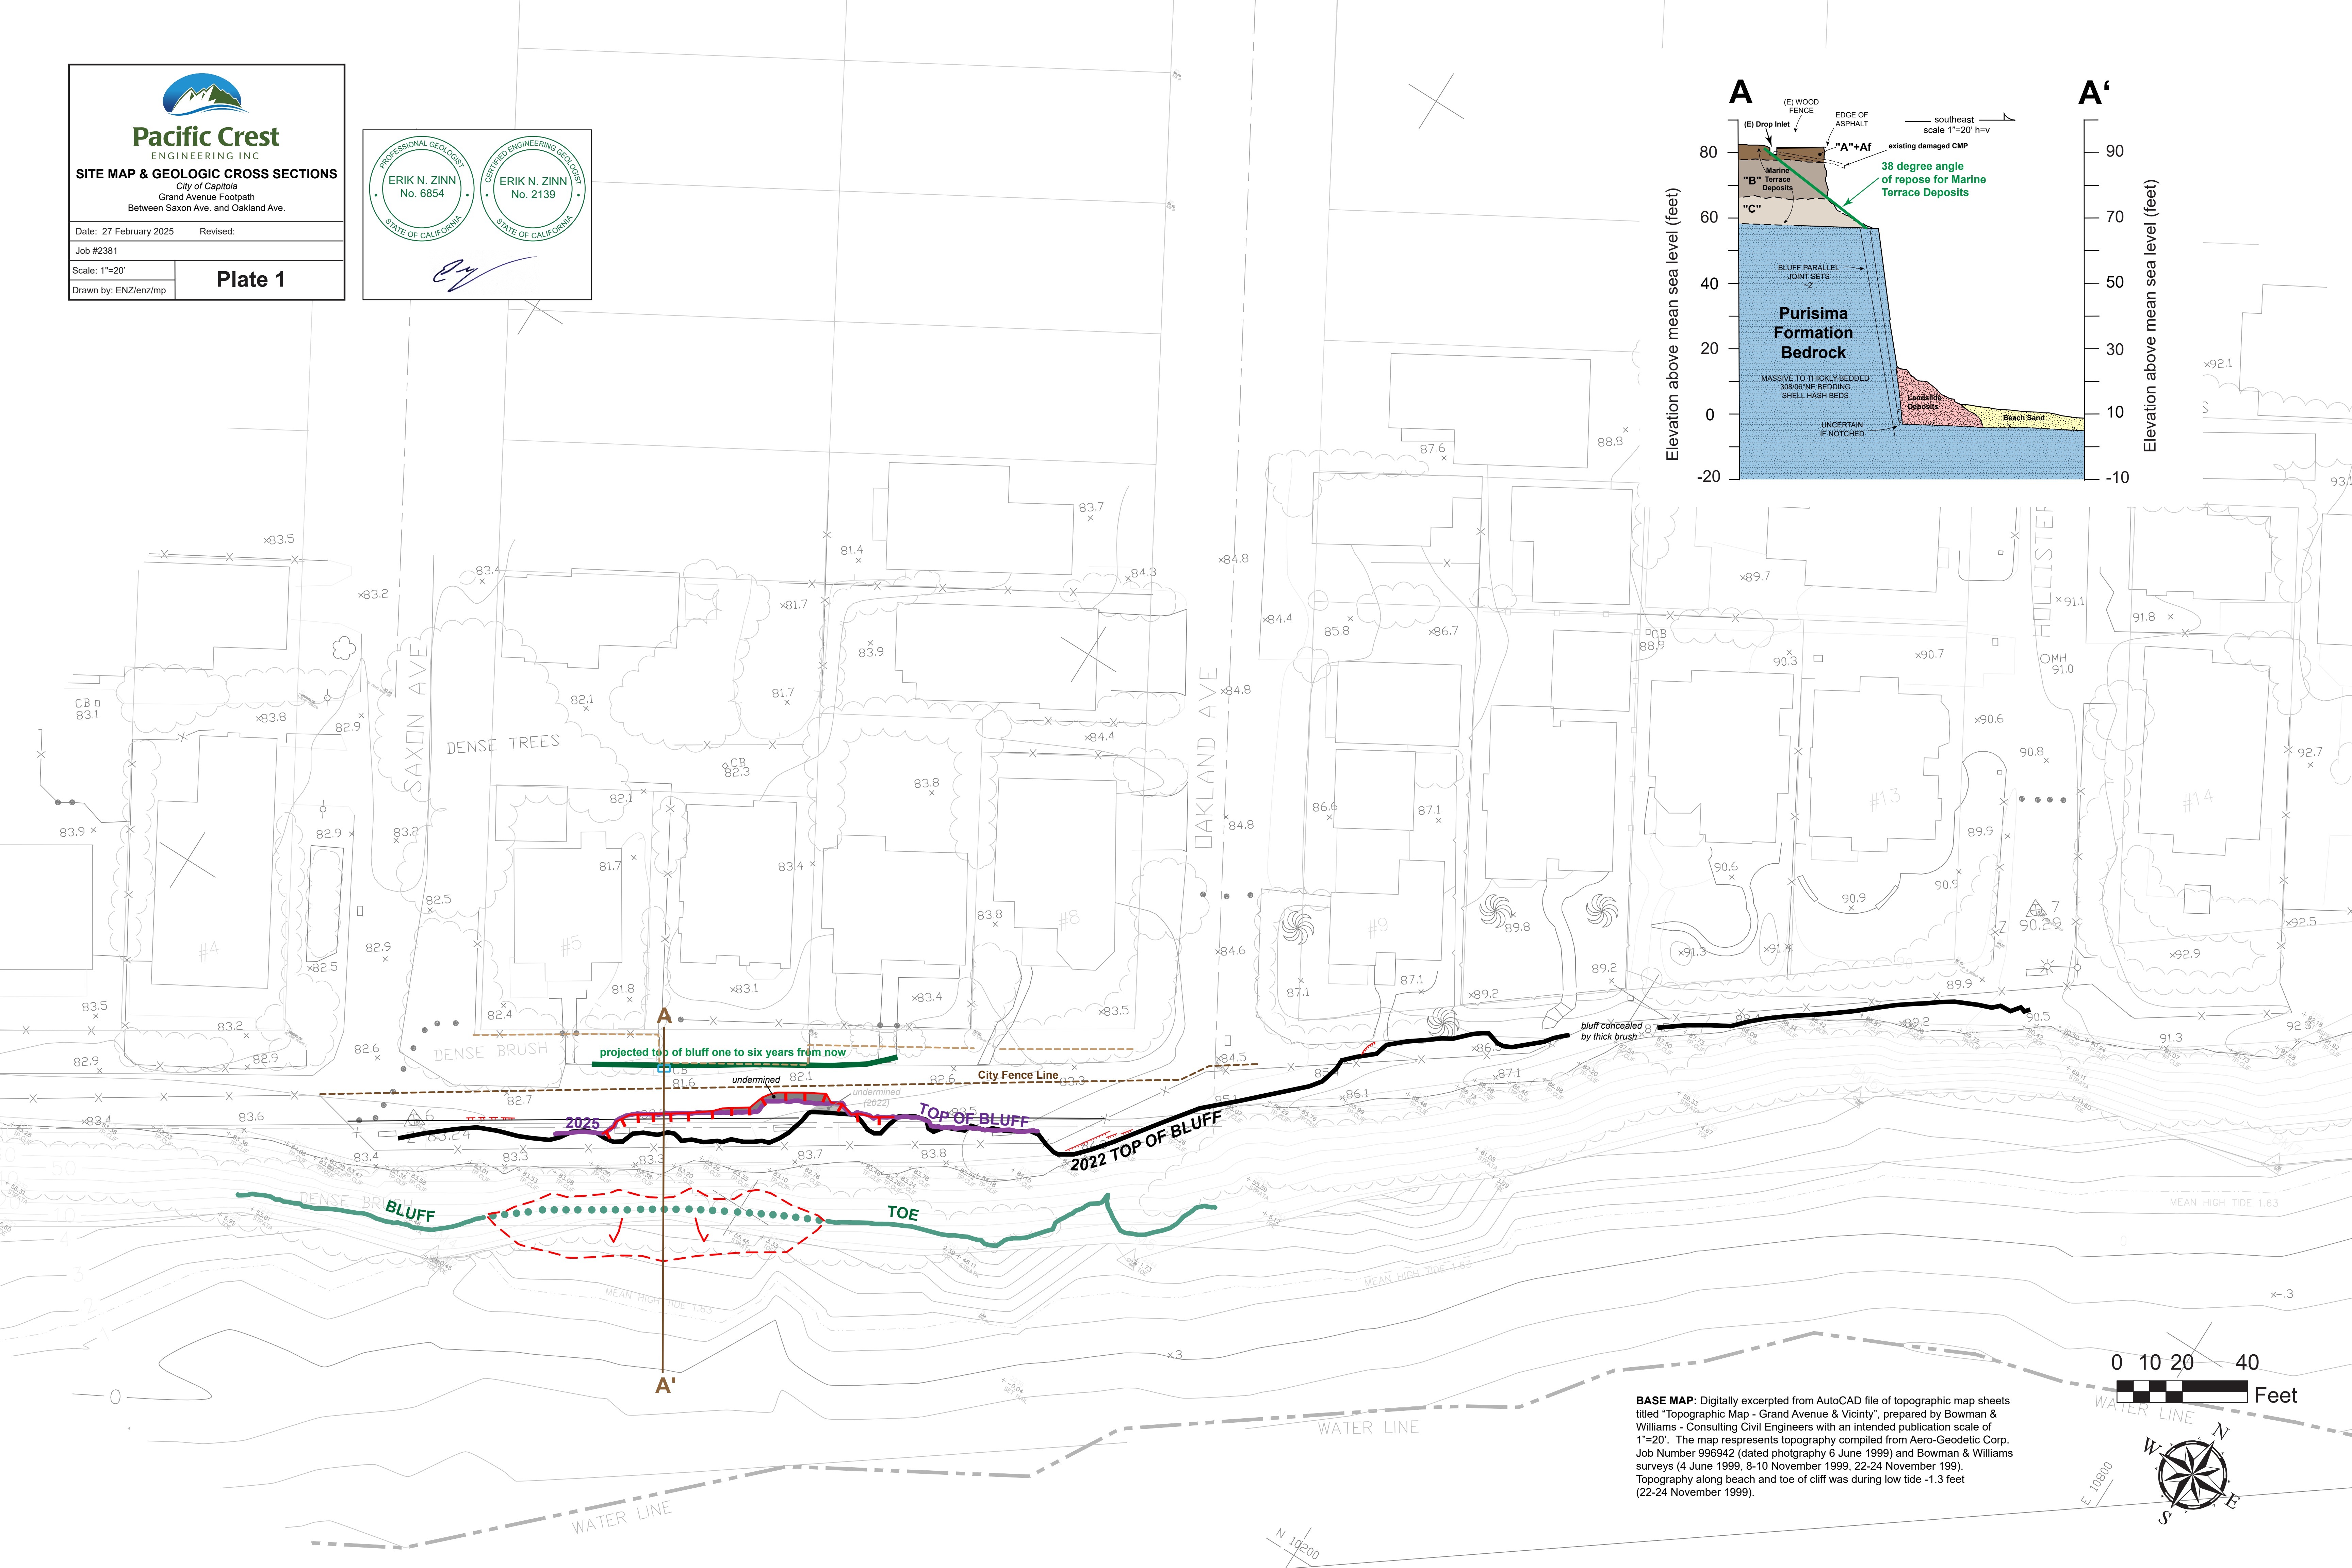
Pacific Crest
ENGINEERING INC.
SITE MAP & GEOLOGIC CROSS SECTIONS
City of Capitola
Grand Avenue Footpath
Between Saxon Ave. and Oakland Ave.

If left alone, the Marine Terrace Deposits at this site will continue to erode back to an average angle of 38 degrees where they are over steepened, laying back to approximately where the drop inlet is located on the landward edge of the footpath. This may come about in one to three rainy seasons, particularly in the area centered on the CMP. Since this region is subject to wet and dry cycles that can last for years, we need to assign a range of years to the concept of one to three rainy seasons. The conservative analysis would assume that we will have back-to-back wet seasons for the next several years, which may lay back the marine terrace deposits to the angle of repose. A more liberal analysis would assume that we will enter a drought period of three to five years, followed by wet year. Using those ranges implies that the top of the bluff may retreat significantly within one to six years.

Turning to Plate 1, the reader may note that our projected one to six year bluff retreat line continues to impinge upon the seaward end of the residential properties. The prior projections in the 2023 letter have only been driven further landward by this recent event. This implies that even if the footpath is pushed landward and snugged up against those properties, it may be undermined and threatened in less than a decade.
