ARCHIVES
ARCHITECTURE

February 18, 2020

RE: Preliminary Historical Evaluation – 1410 Prospect Avenue, Capitola, CA
APN# 034-04-619

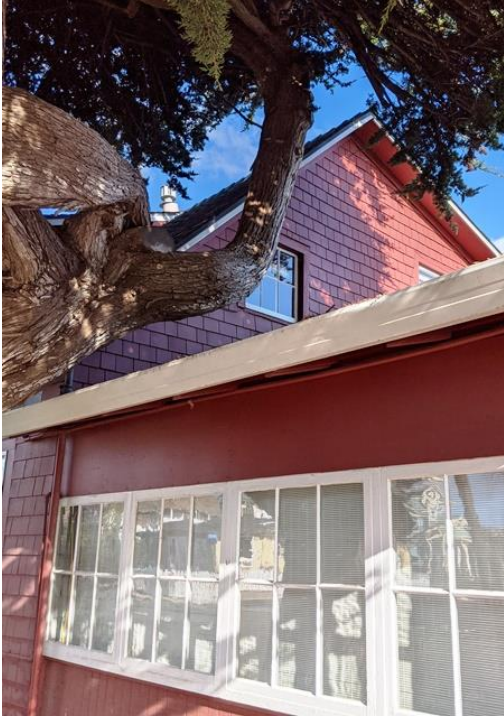
South Elevation. Showing upstairs windows and enclosed former front porch. Viewed facing northeast. January 2020. (Photo by Leslie Dill)

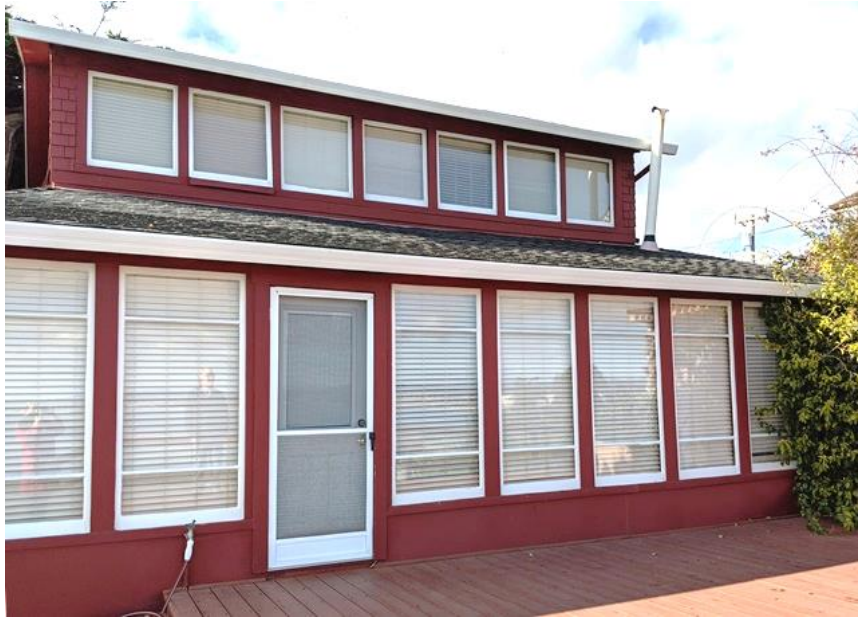
The east-facing (ocean-view) façade is an array of windows, upstairs and down. The upper façade includes seven square windows, evenly spaced across the wall. These are wood 1-lite windows. The downstairs includes an entrance onto the deck flanked by a series of five windows on each side. To the far north corner, lattice and plants conceal the recessed back porch.

Ocean-facing Façade. Viewed facing northwest. January 2020. (Photo by Leslie Dill)

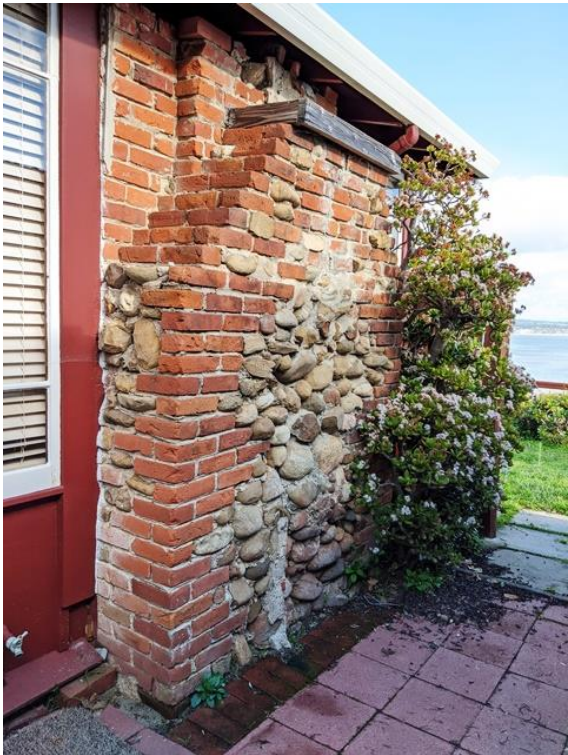
The south end of the house features a brick and stone chimney that is a significant focal feature of the historic design. Its top has fallen or been removed. The outer corners are brick, surrounding an irregularly shaped central stone panel, seemingly randomly placed stones within the brick face, and stone at the inner corners. Its design and wear indicate its age as 1920s or earlier, commensurate with the 1927 footprint on the Sanborn map. The lower level includes a door into the enclosed porch and an array of what are likely mid-century wood windows. The windows are fixed 3-lite units with a single board panel beneath. Three windows and a door are placed together to the west of the chimney; a single window is located at the corner of the house, to the east of the chimney. Upstairs there is a single 6-lite wood window at the front corner of the house and a single-lite hopper window at the rear corner.

Detail of Chimney at South Façade. Viewed facing northeast. January 2020. (Photo by Leslie Dill)

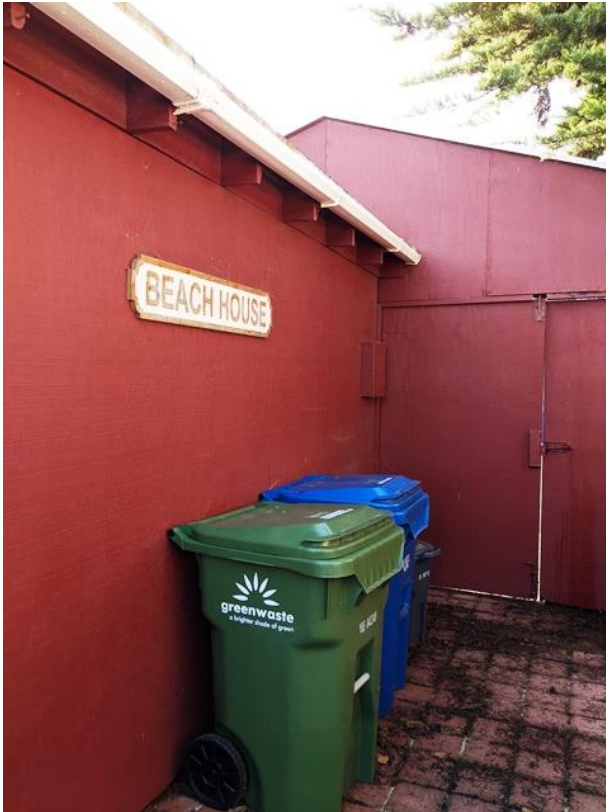
The detached garage was built in 1991, replacing an earlier, smaller garage. It is a vernacular one-car garage with a gable roof, exposed rafter tails, and smooth plywood exterior. The roof slope extends into a false front that frames a gate into the property. The rear garden shed is constructed of exposed wood framing inset with translucent fiberglass panels and plywood bulkhead panels in the proportion of the first-floor main-house replacement windows.

Detached Garage and Rear of False Front. Viewed facing west. January 2020. (Photo by Leslie Dill)

Built in very recent years of form, detailing, and materials that are not conceived to be of high quality, the garage is not reviewed for historic integrity or found to have associations or feelings that add to the potential significance of the property.

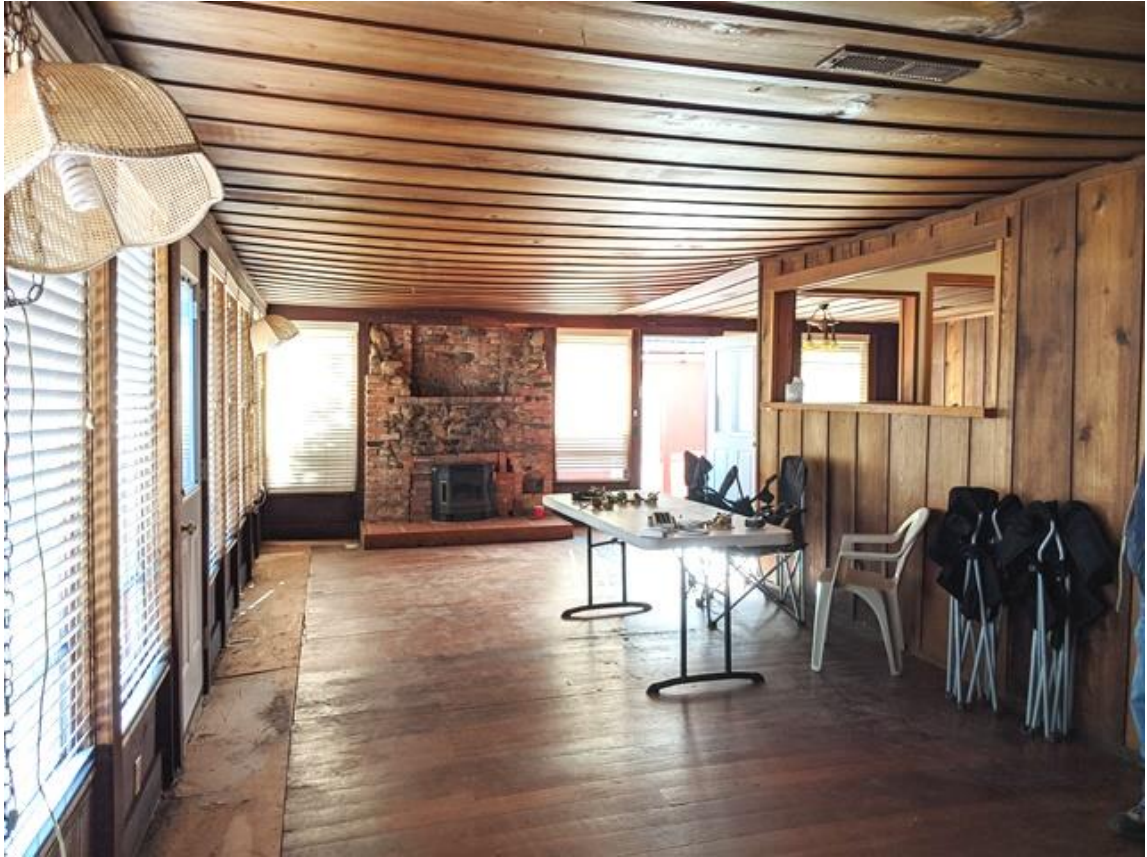
Interior of Living Room and Fireplace. Note sloping floor that may indicate that this was originally a porch. Viewed facing south. January 2020. (Photo by Leslie Dill)

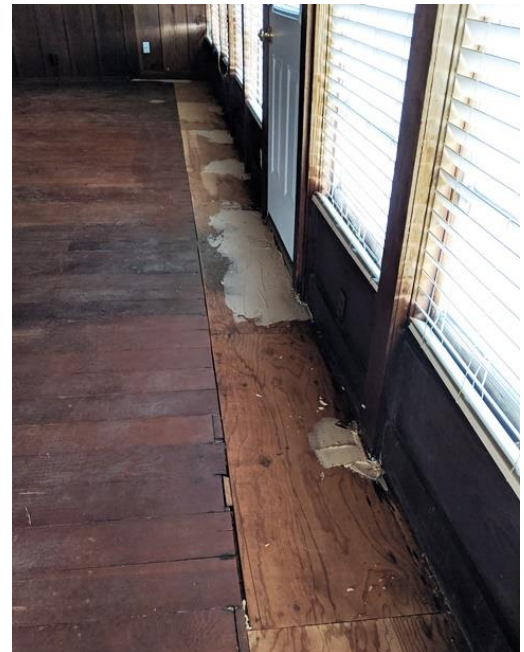
Detail of Living Room Floor Repair. Viewed facing north. January 2020. (Photo by Leslie Dill)

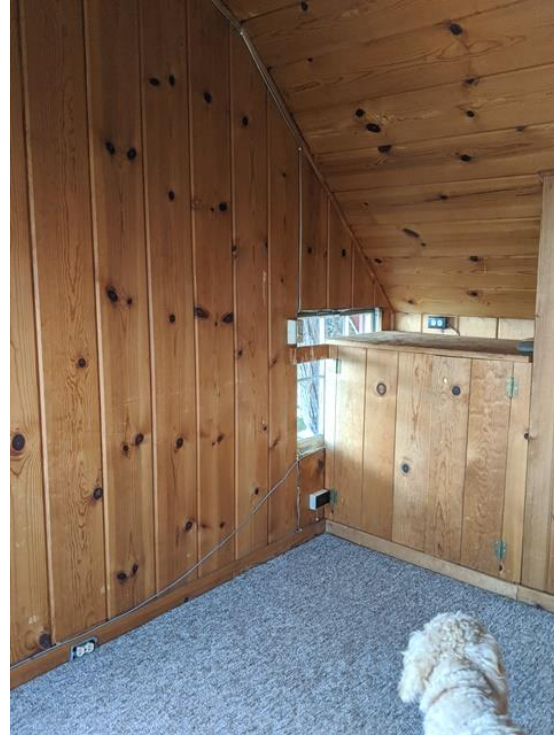
Interior Upstairs with Cabinet and Window Alterations. Viewed facing southwest. January 2020. (Photo by Leslie Dill)
