Project No. SC11778
Revised 9 June 2025

Subject: Inspection Monitoring & Maintenance Report

Reference: Blufftop Retaining Wall and Seawall
4800 Opal Cliff Drive
APN 34-251-05
Capitola, California

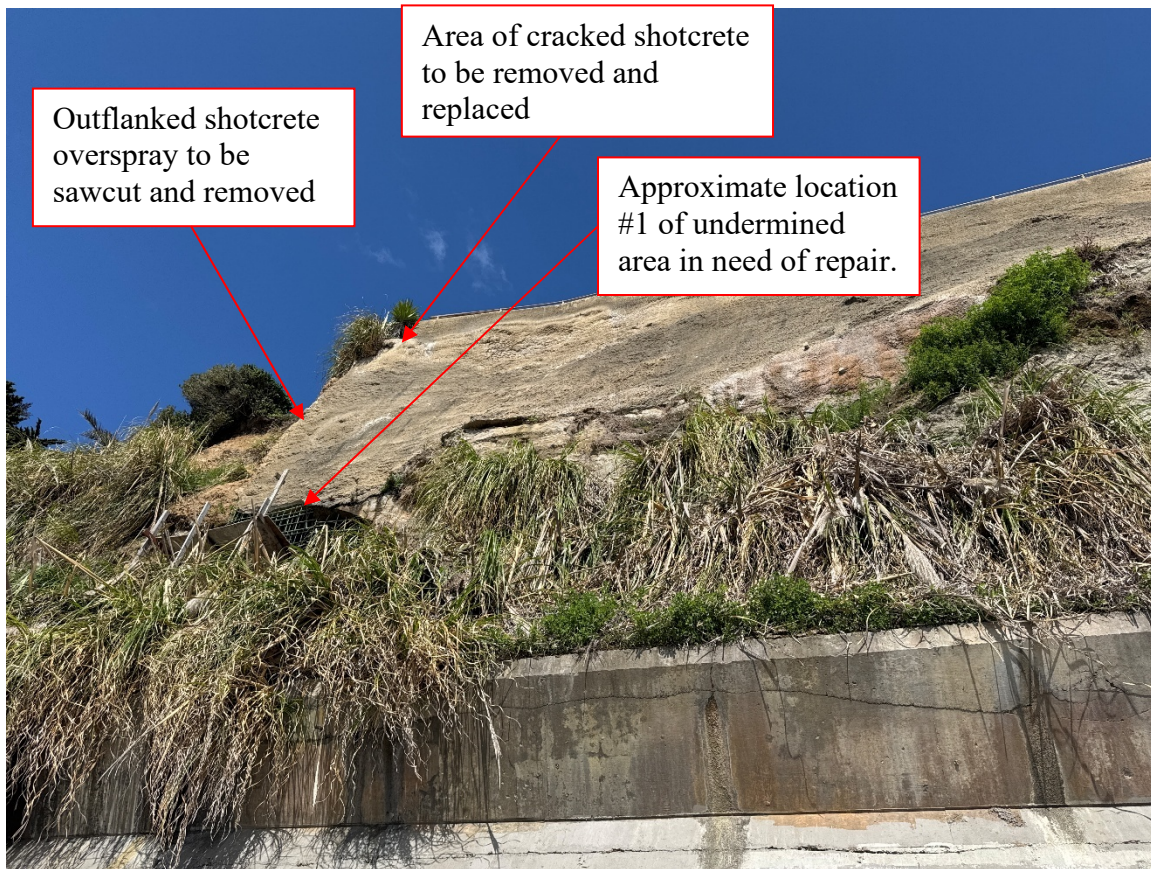
Drive is not protected by a retaining wall system and is subject to ongoing blufftop recession; see Photos 1 and 10 attached to this letter.

At location 1, a large mass of shotcrete, bedrock, and rebar dislodged and fell to the beach as shown in Photo 13. The void left by the mass measures approximately 11' wide x 2' tall x 1.5' deep, which matches the debris mass on the beach as shown in Photo 1. The exposed bedrock/terrace contact is visible along with the existing Miradrain panels and pvc pipes. Active seepage was observed at the bedrock/terrace contact.

Photo 1: 4800/4790 Opal Cliff Drive Upcoast Property Line View - 2 April 2025

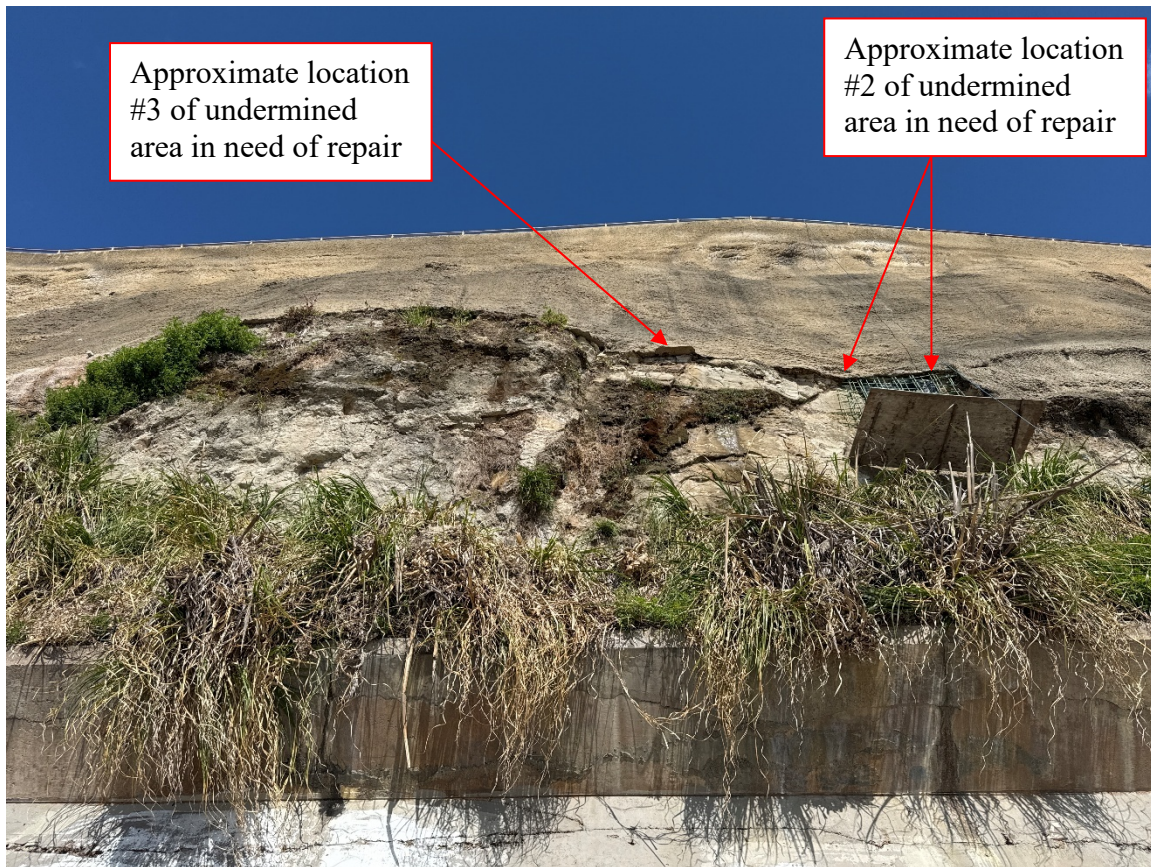
At location 2, blocks of bedrock have been broken off leaving a void measuring approximately 9' wide x 5' tall x 1' deep. Loss of these unsupported, bedrock blocks will expose the base of wall drainage system and the easily eroded terrace deposits, exacerbating the scope of the repair. The area of the repair is shown in Photos 2 and 4.

At location 3, blocks of bedrock have been broken off leaving a void measuring approximately 5' wide x 2' tall x 1' deep. The existing shotcrete is now undermined and risks breaking off or becoming further undermined and exposing the base of wall drainage system and the easily eroded terrace deposits, exacerbating the scope of the repair. The area of the repair is shown in Photos 2 and 5.

Photo 2: Repair Locations #2 & #3 View - 2 April 2025

To facilitate the repair in these three locations, the overhanging shotcrete shell should be trimmed and vegetation cleared. Shallow rock dowels (1 inch diameter min.) should be installed at least 8 feet into the bedrock bluff face below the base of the wall. The repair shotcrete should incorporate steel reinforcement tied to the steel rock dowels to minimize shrinkage crack widths. The repair shotcrete should match the existing shotcrete texture and color. Miradrain panels connected to the existing drainage system and weep holes should be installed prior to shotcrete. All work should be done to conform with HKA's recommendations for this site and confirmed by HKA in the field. The specific extent of the repair should be confirmed by HKA in the field during construction. For cost estimate purposes the contractor should assume a repair area for location 1 of 13' wide x 6' tall x 1.5' deep, a repair area for location 2 of 6' wide x 5' tall x 1' deep, and a repair area for location 3 as 5' wide x 2' tall x 1' deep.

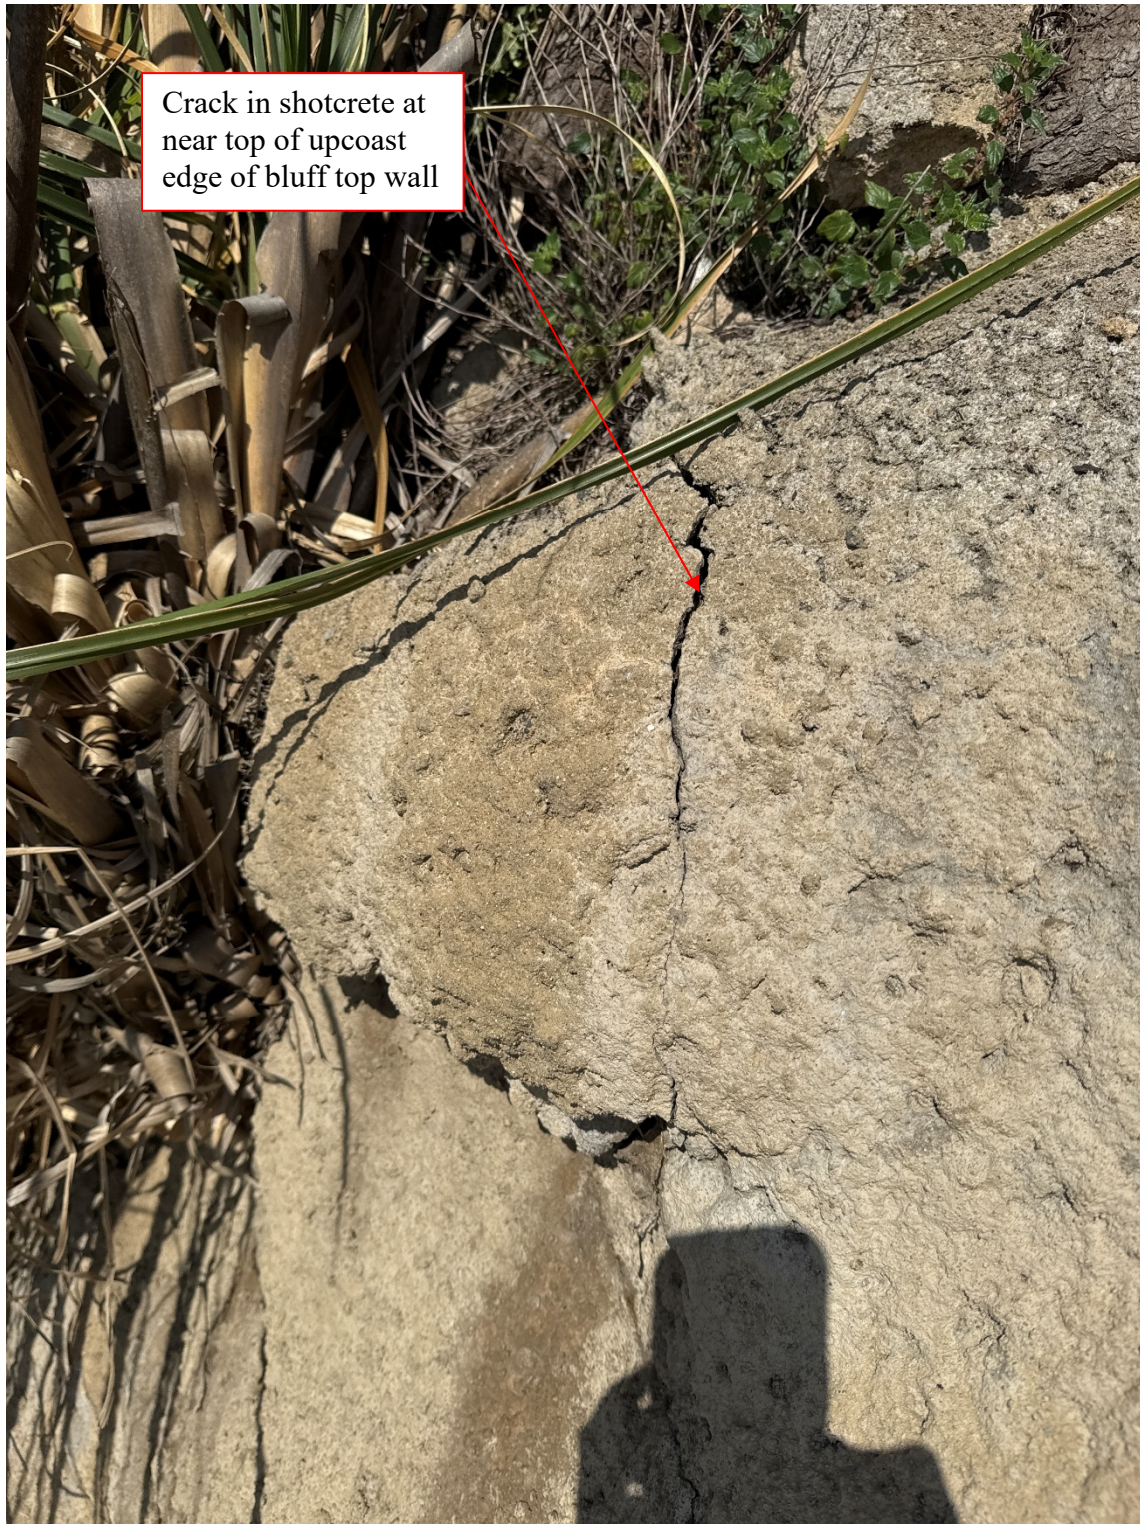
A small section of the blufftop shotcrete wall is outflanked along the 4800/4790 Opal Cliff Drive property line. Shotcrete is the result of overspray from construction and is not a structural component of the blufftop wall. It measures approximately 6' tall x 2' wide. It should be sawcut and removed so the shotcrete is flush with the terrace deposit. Photo 1 shows the location of this overspray shotcrete. Do not disturb the adjacent property terrace deposits during removal of the overspray. Near the top of the blufftop wall along the 4800/4790 Opal Cliff Drive property line there is a portion of the shotcrete that is cracking and could potentially fall off. The cracks within the shotcrete should be infilled with epoxy.

*Photo 3: Crack in Shotcrete near top of upcoast end of bluff top retaining wall - 2
April 2025*

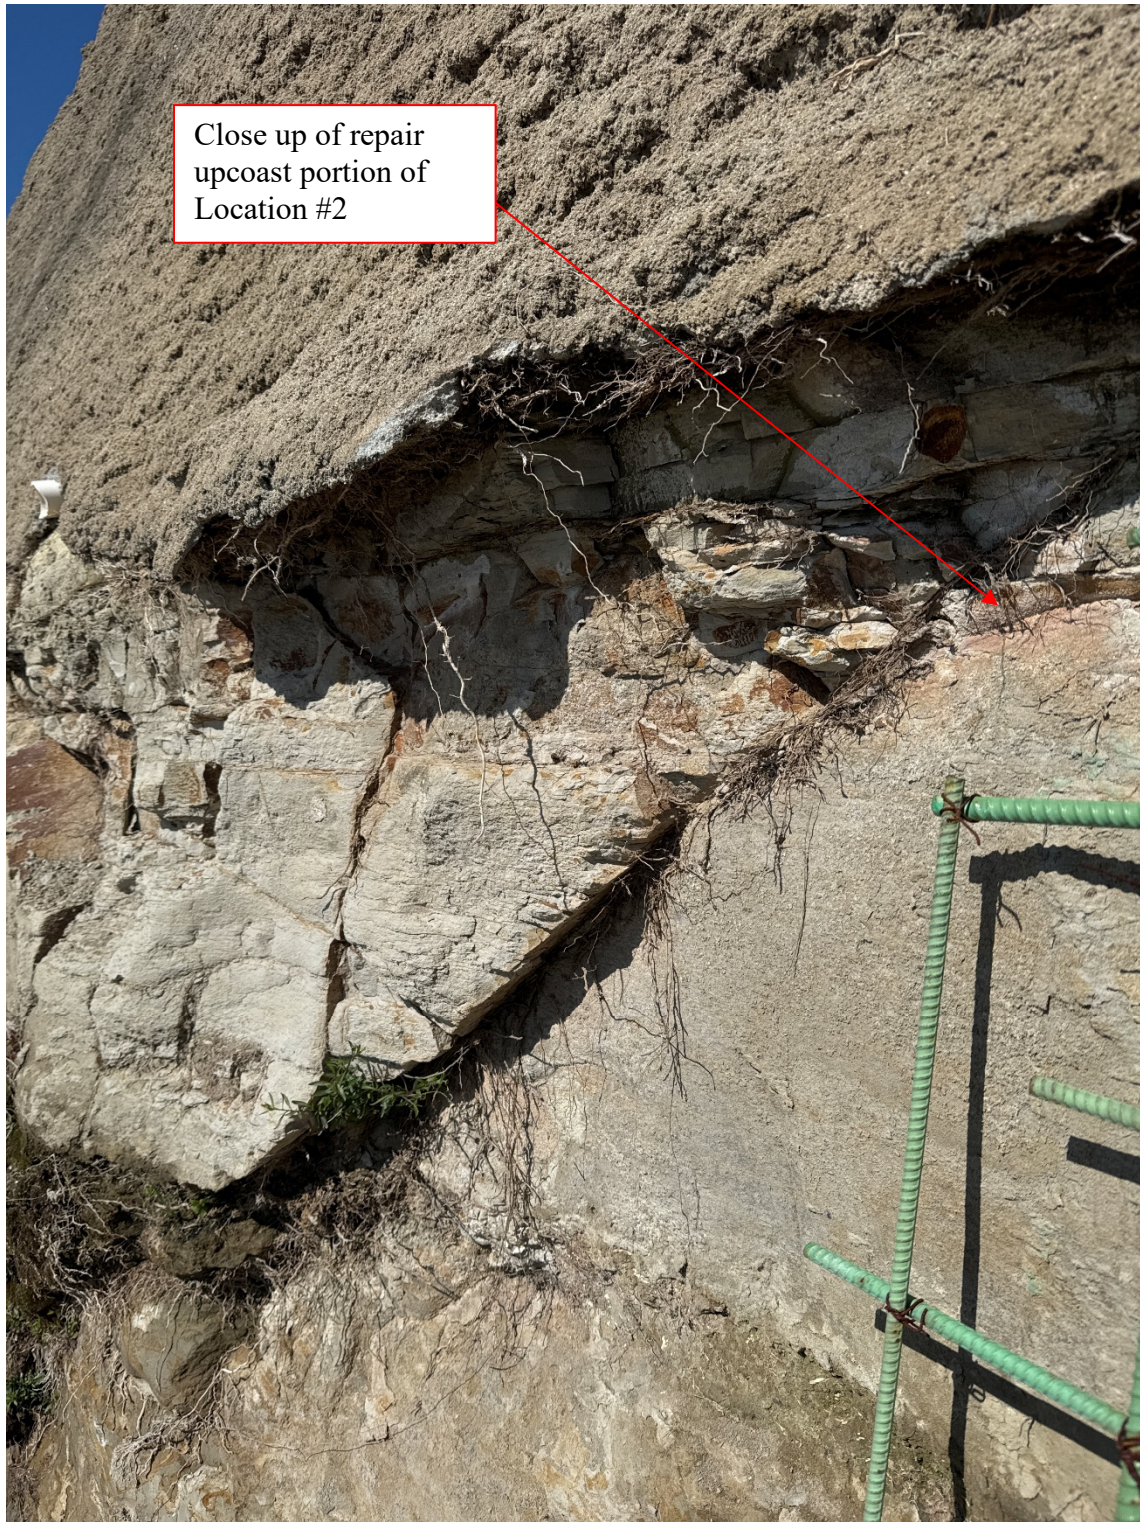
Close up of repair
upcoast portion of
Location #2

Photo 4: Closeup of Repair Location #2 - 2 April 2025

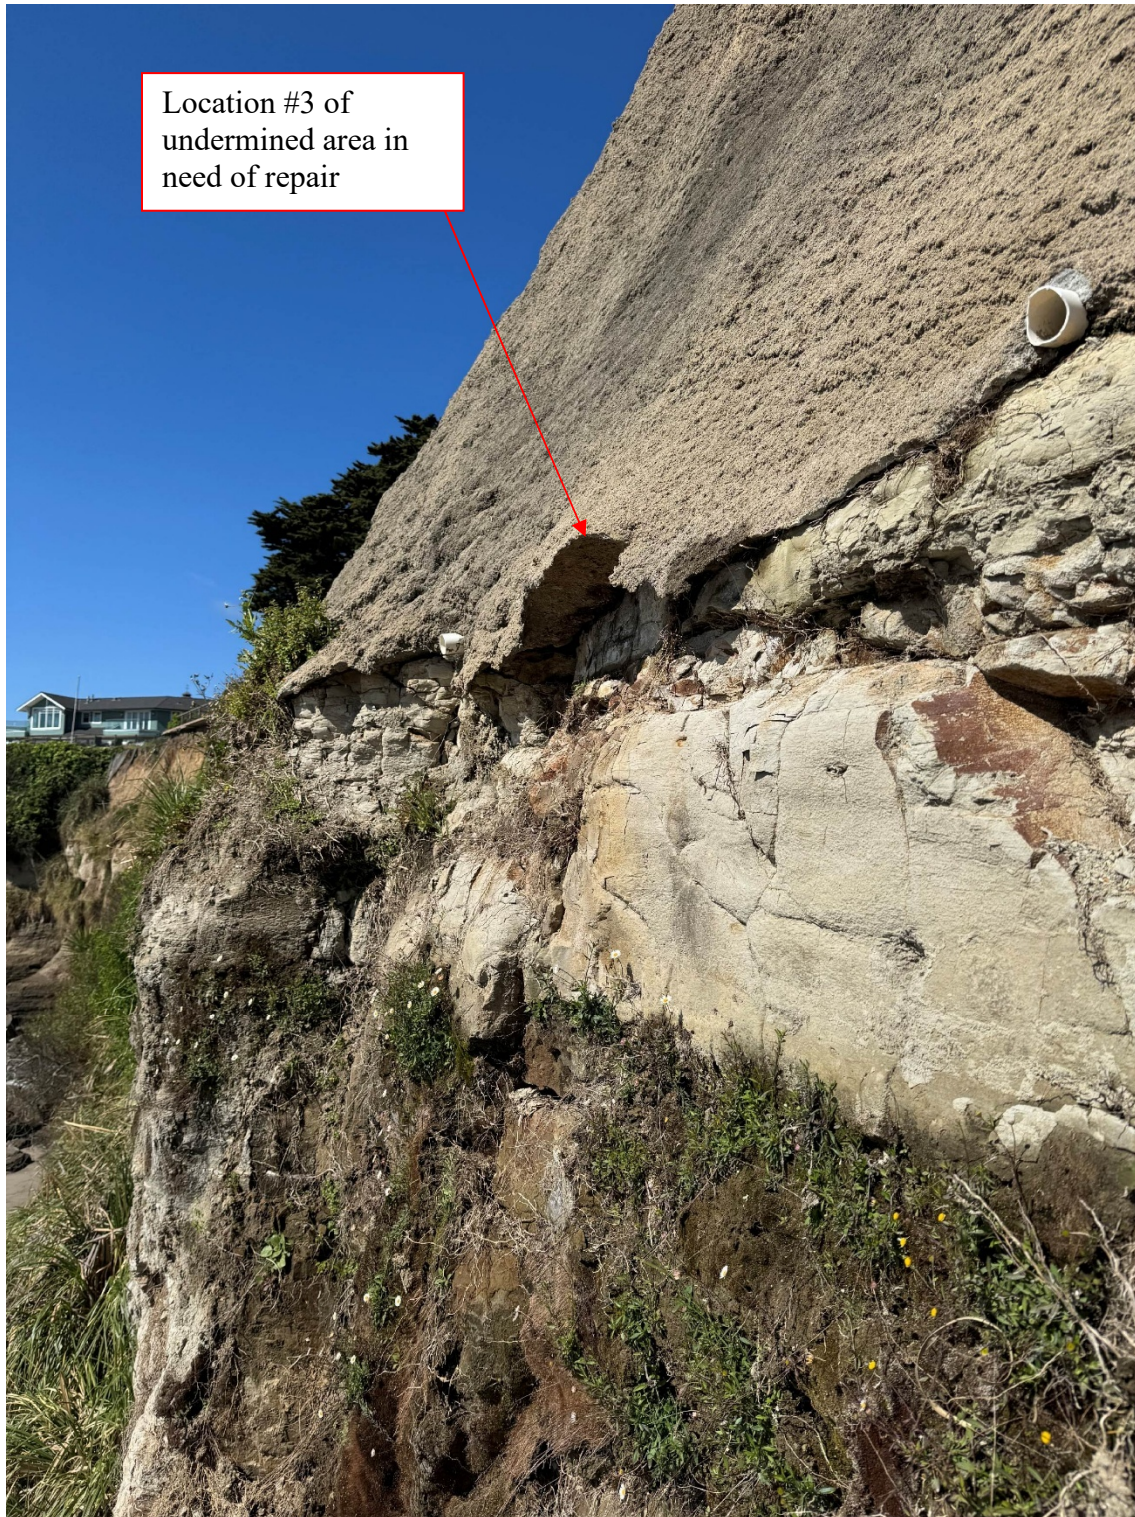
Photo 5: Closeup of Repair Location #3 - 2 April 2025

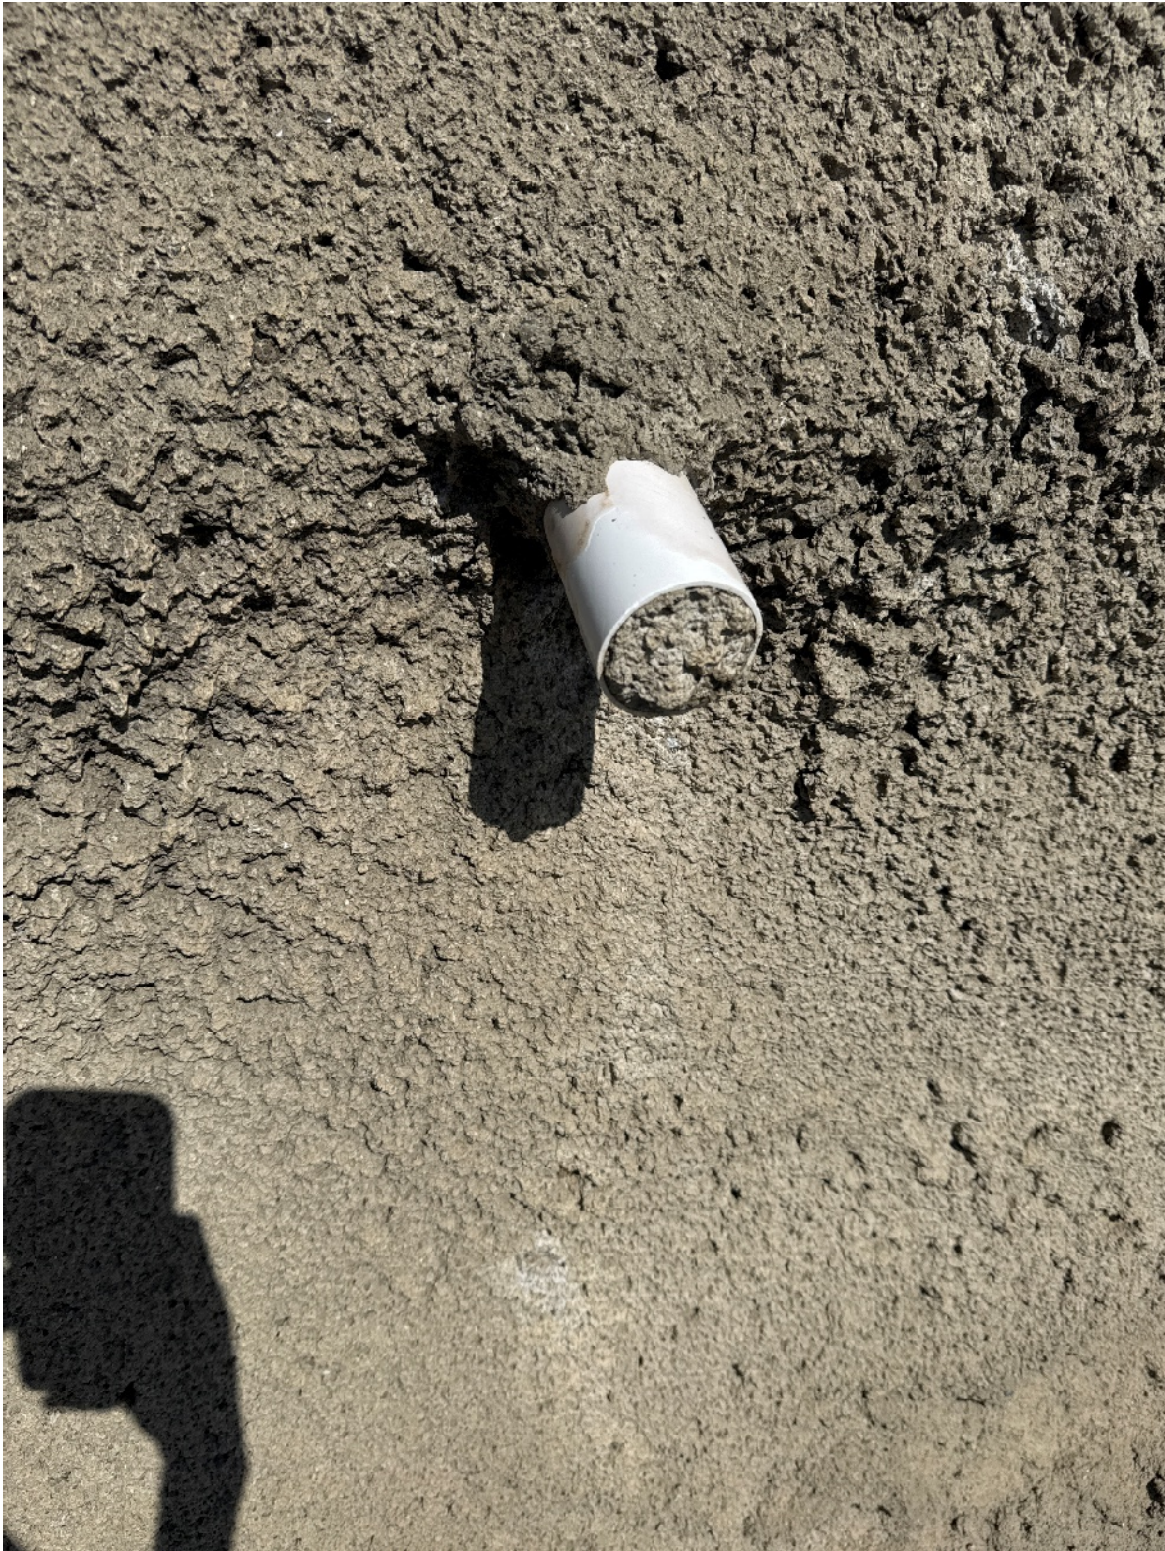
The existing pvc weep holes for the blufftop shotcrete seawall back drainage system were observed to be plugged with shotcrete or soil in multiple locations, Photo 6. All weep holes should be drilled out and cleared of shotcrete or debris. The build-up of hydrostatic pressure behind the blufftop seawall will lead to increased forces on the seawalls and potential failure of the seawall.

Photo 6: Closeup of a shotcrete plugged weephole - 2 April 2025

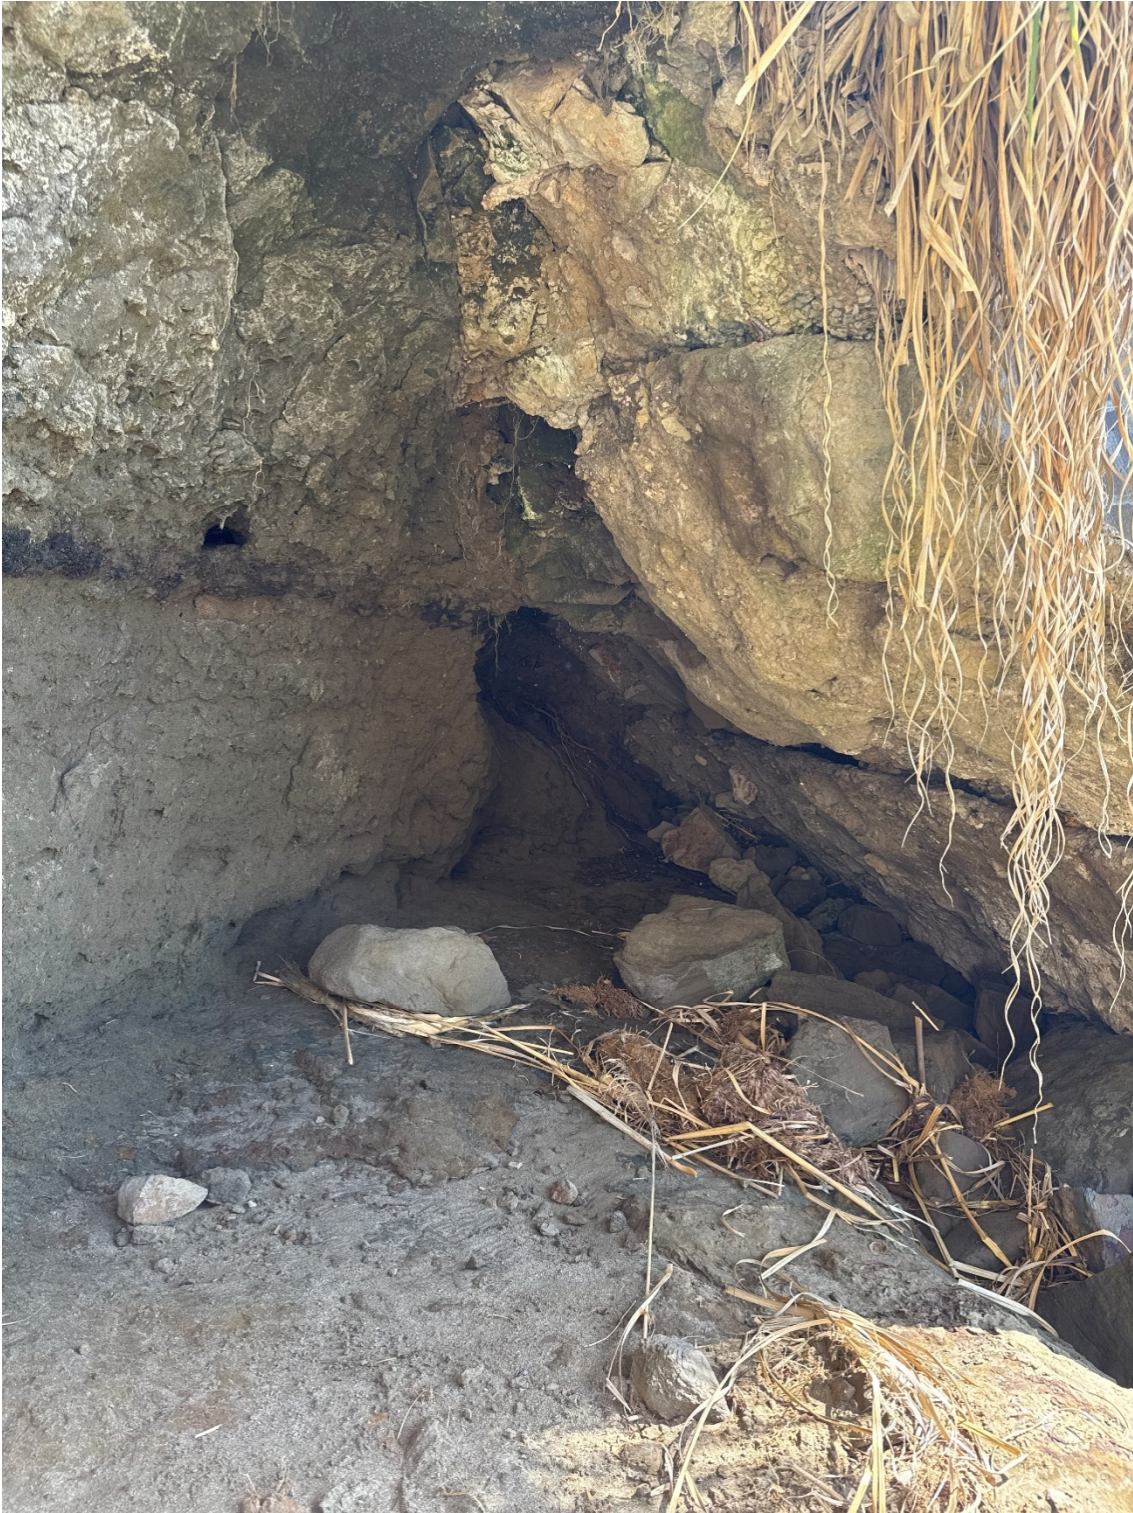
The neighboring parcel at 4790 Opal Cliff has a bluff toe concrete gravity seawall. Their seawall is currently outflanked approximately 10 feet on the upcoast end. There is a cavity measures approximately 10 feet landward, 6 feet tapering to 3 feet in height, and 20 feet along shore behind the concrete gravity seawall, Photo 7. This is far enough away from the 4800 Opal Cliff bluff toe seawall that it is not of concern for 4800 Opal Cliff Drive at present. However, this area should be repaired immediately by infilling with control density fill and placement of a cutoff wall. HKA recommends contacting the owner of 4790 Opal Cliff Drive and informing them of their outflanked bluff toe seawall immediately. The outflanked portion of the seawall should be plugged flush with the bluff face. The governing permit agencies should be notified and authorization in writing obtained by property owner prior to any repair work taking place.

Photo 7: Outflanked Gravity Seawall at 4790 Opal Cliff - 2 April 2025

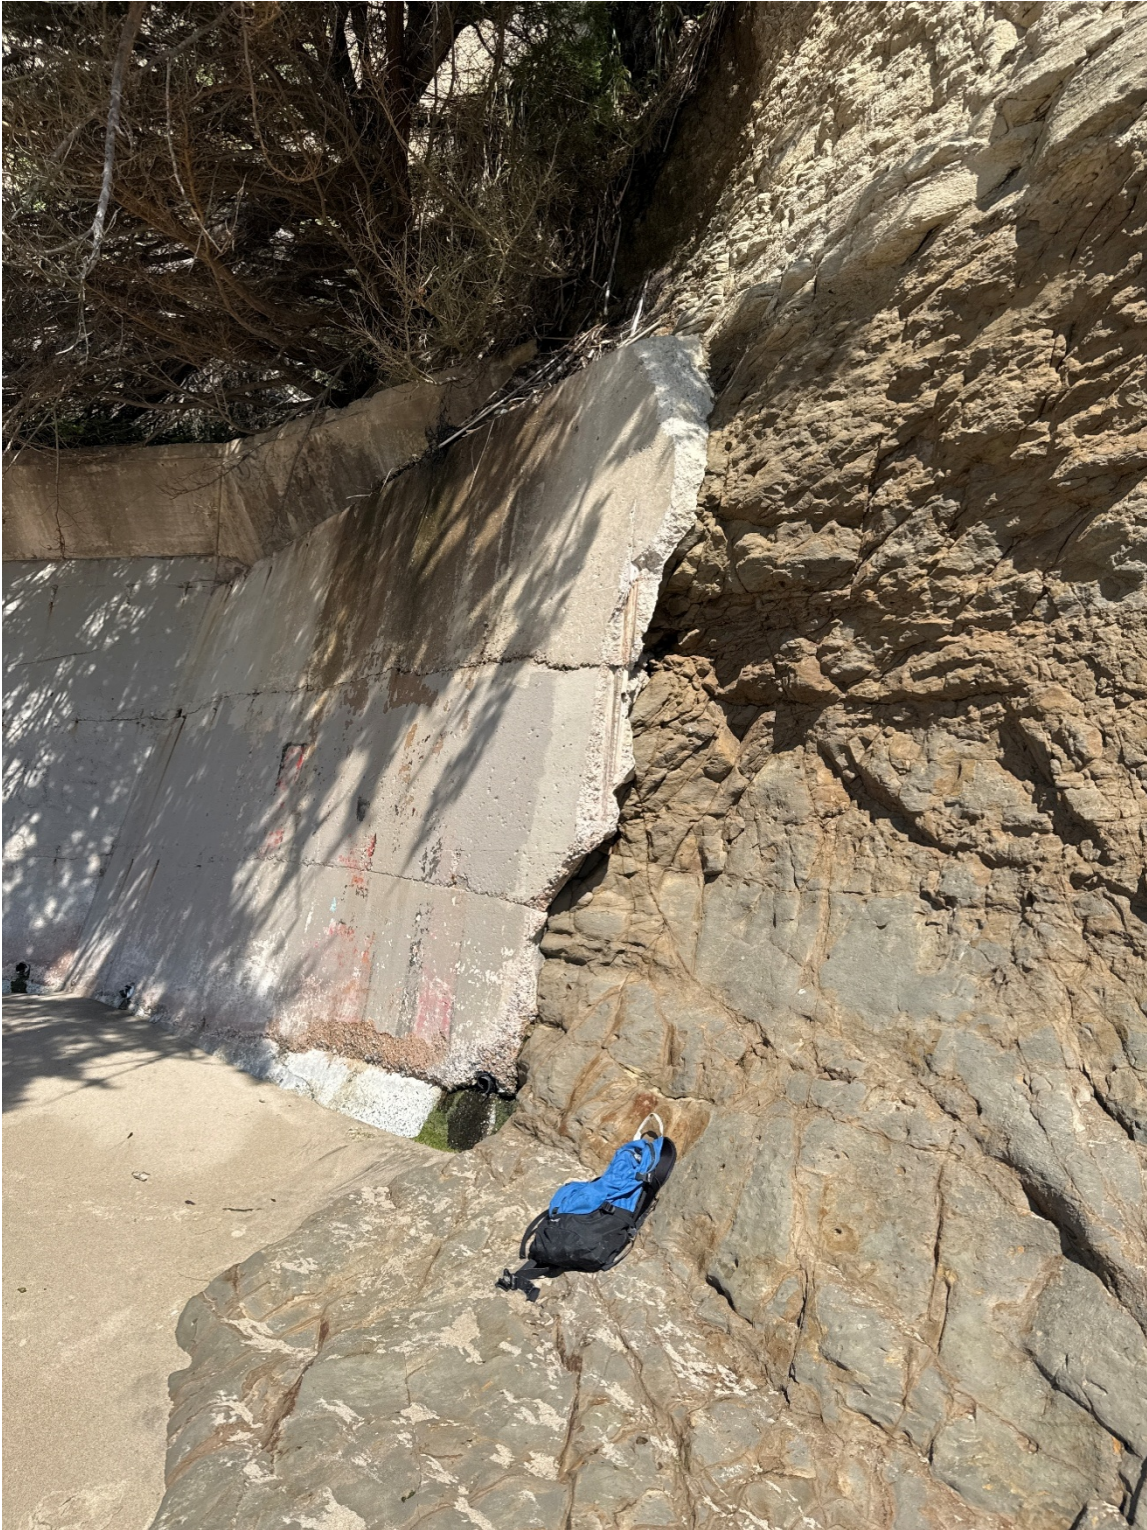
The neighboring parcel 4820 Opal Cliff has a bluff toe concrete gravity seawall. Their seawall is outflanked approximately 18 inches, Photo 8. This is relatively minor and far enough from the 4800 Opal Cliff bluff toe seawall that it is not of concern for 4800 Opal Cliff Drive at present. HKA recommends contacting the owner of 4790 Opal Cliff Drive and informing them of their outflanked bluff toe seawall. The outflanked portion of the seawall should be plugged flush with the bluff face. The governing permit agency should be notified and authorized in writing obtained by property owner prior to any repair work taking place.

Photo 8: Minor Outflanking of Gravity Seawall at 4820 Opal Cliff - 2 April 2025

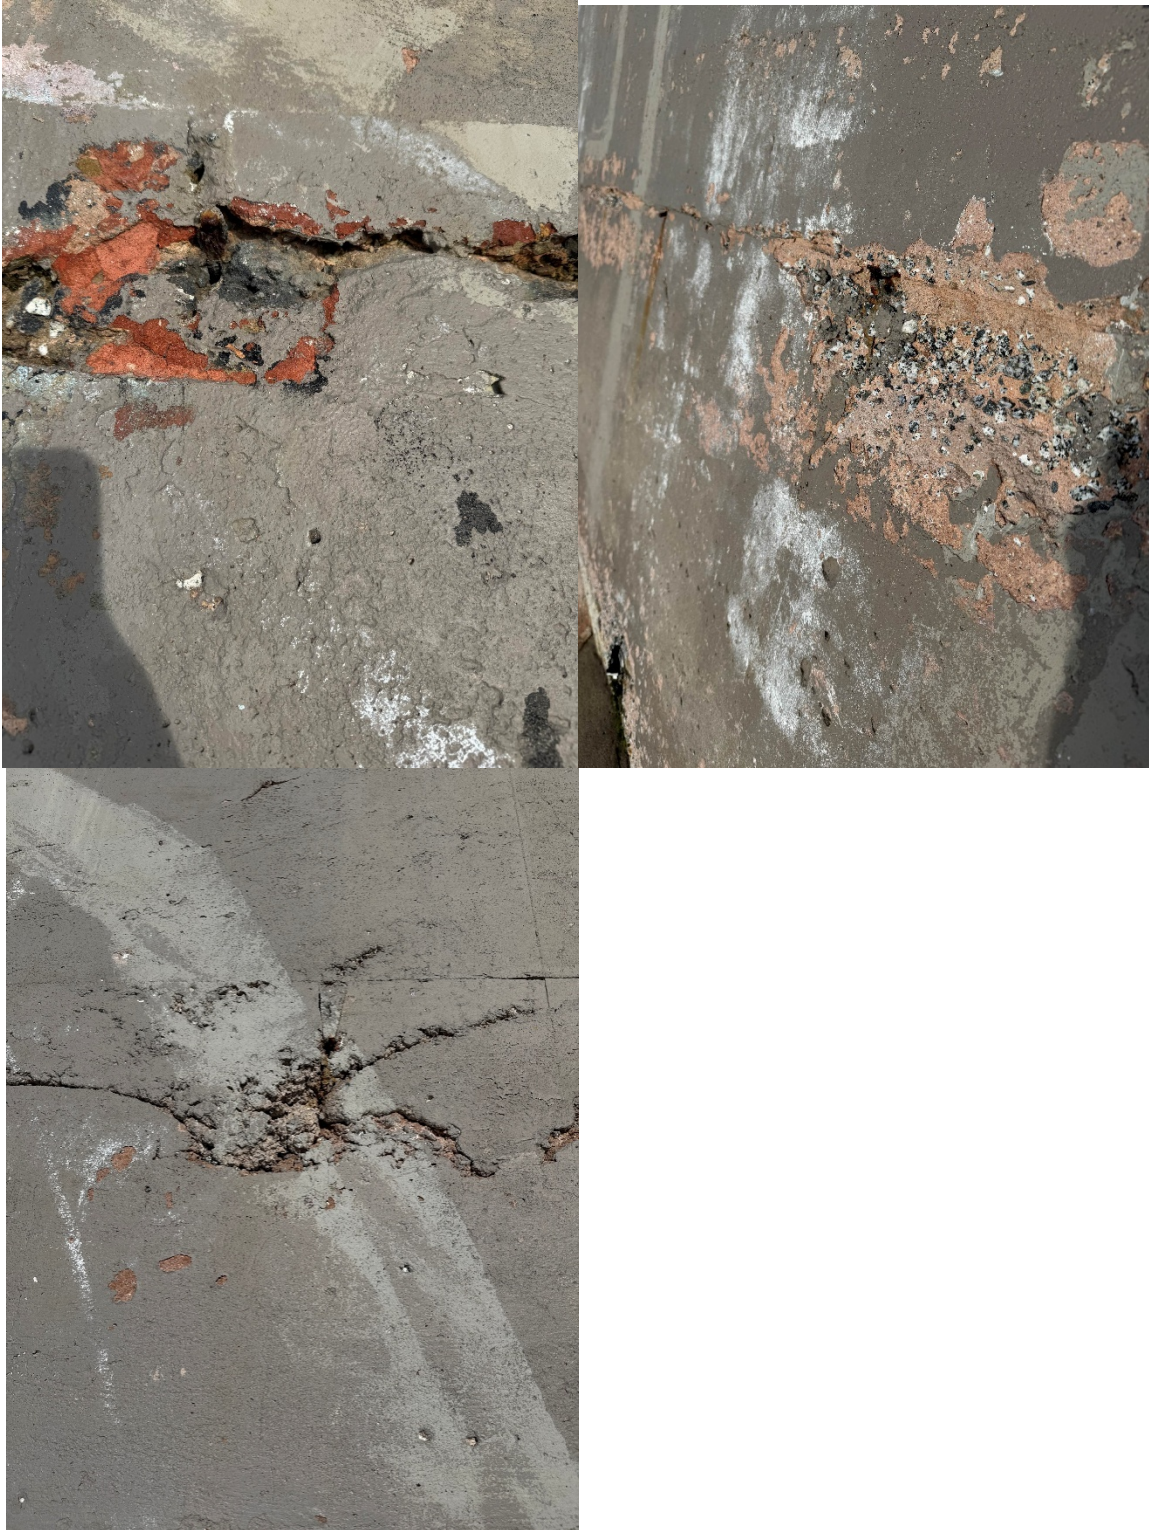
There are multiple instances of concrete spalling along the bluff toe gravity seawall, as shown in Photo 9. The spalled concrete should be patched with similar colored and textured concrete as the existing bluff toe seawall. The materials used to patch the spalled section of the seawall should be of marine environment quality. If a concrete mixture is used it should have a maximum water to cement ratio of 0.40. The spalled area should be properly prepared by cleaning and roughing the surface prior to placement of concrete patch.

Photo 9: Concrete Spalling of Gravity Seawall, Typical - 2 April 2025

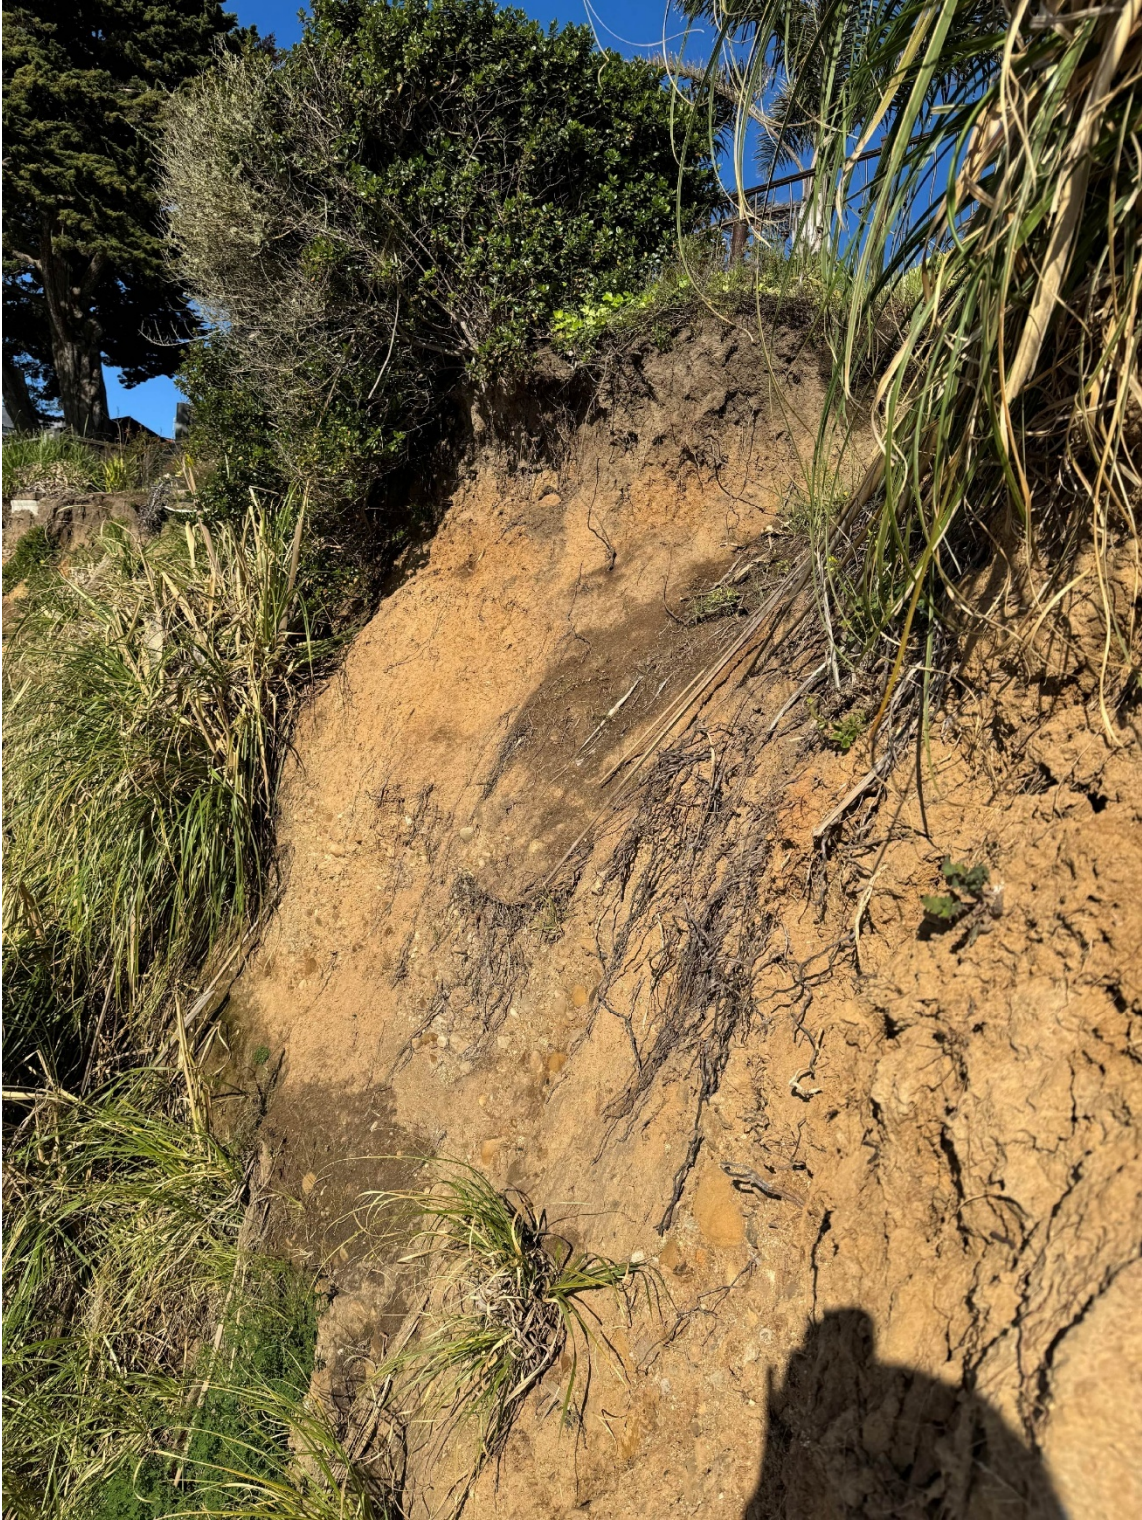
Photo 10: Blufftop recession of 4790 Opal Cliff - 2 April 2025

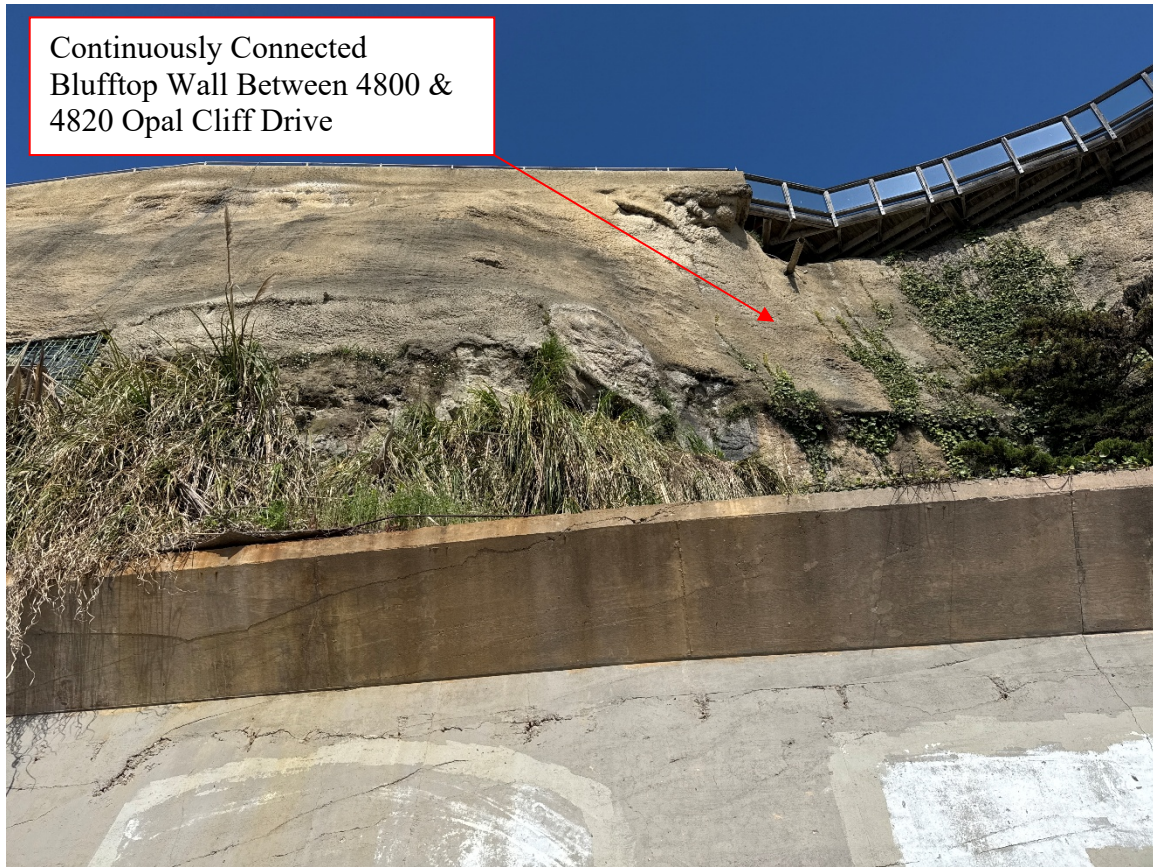
Photo 11: 4800/4820 Opal Cliff Drive Property Line View - 2 April 2025

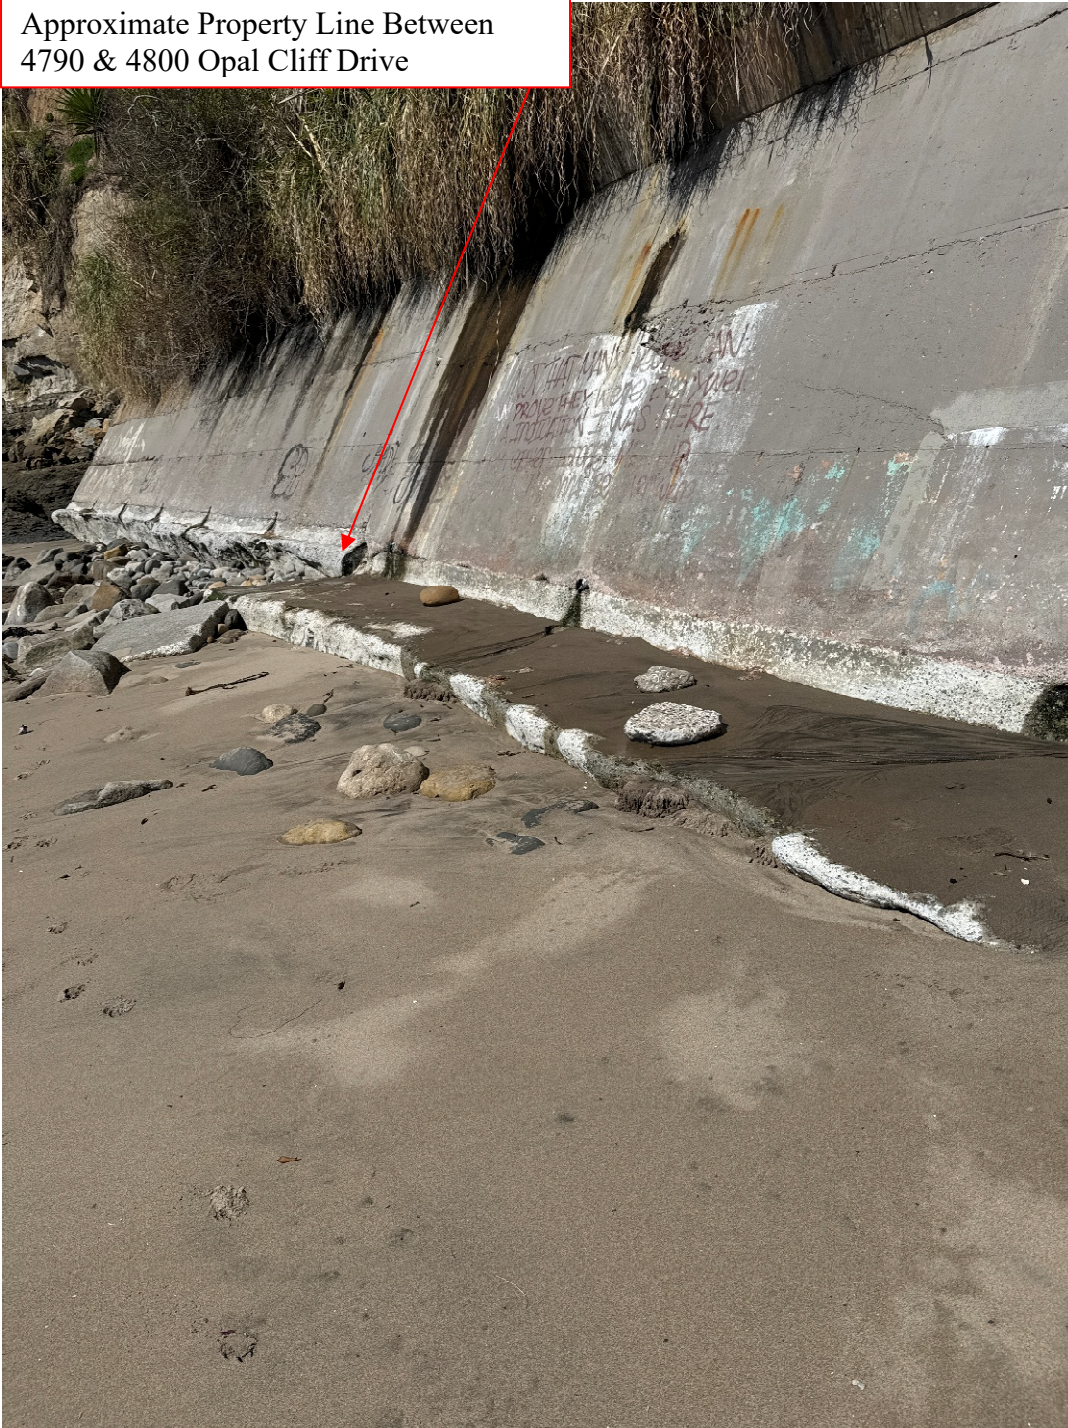
Approximate Property Line Between
4790 & 4800 Opal Cliff Drive

Photo 12: 4790/4800 Opal Cliff Drive Seawall - 2 April 2025

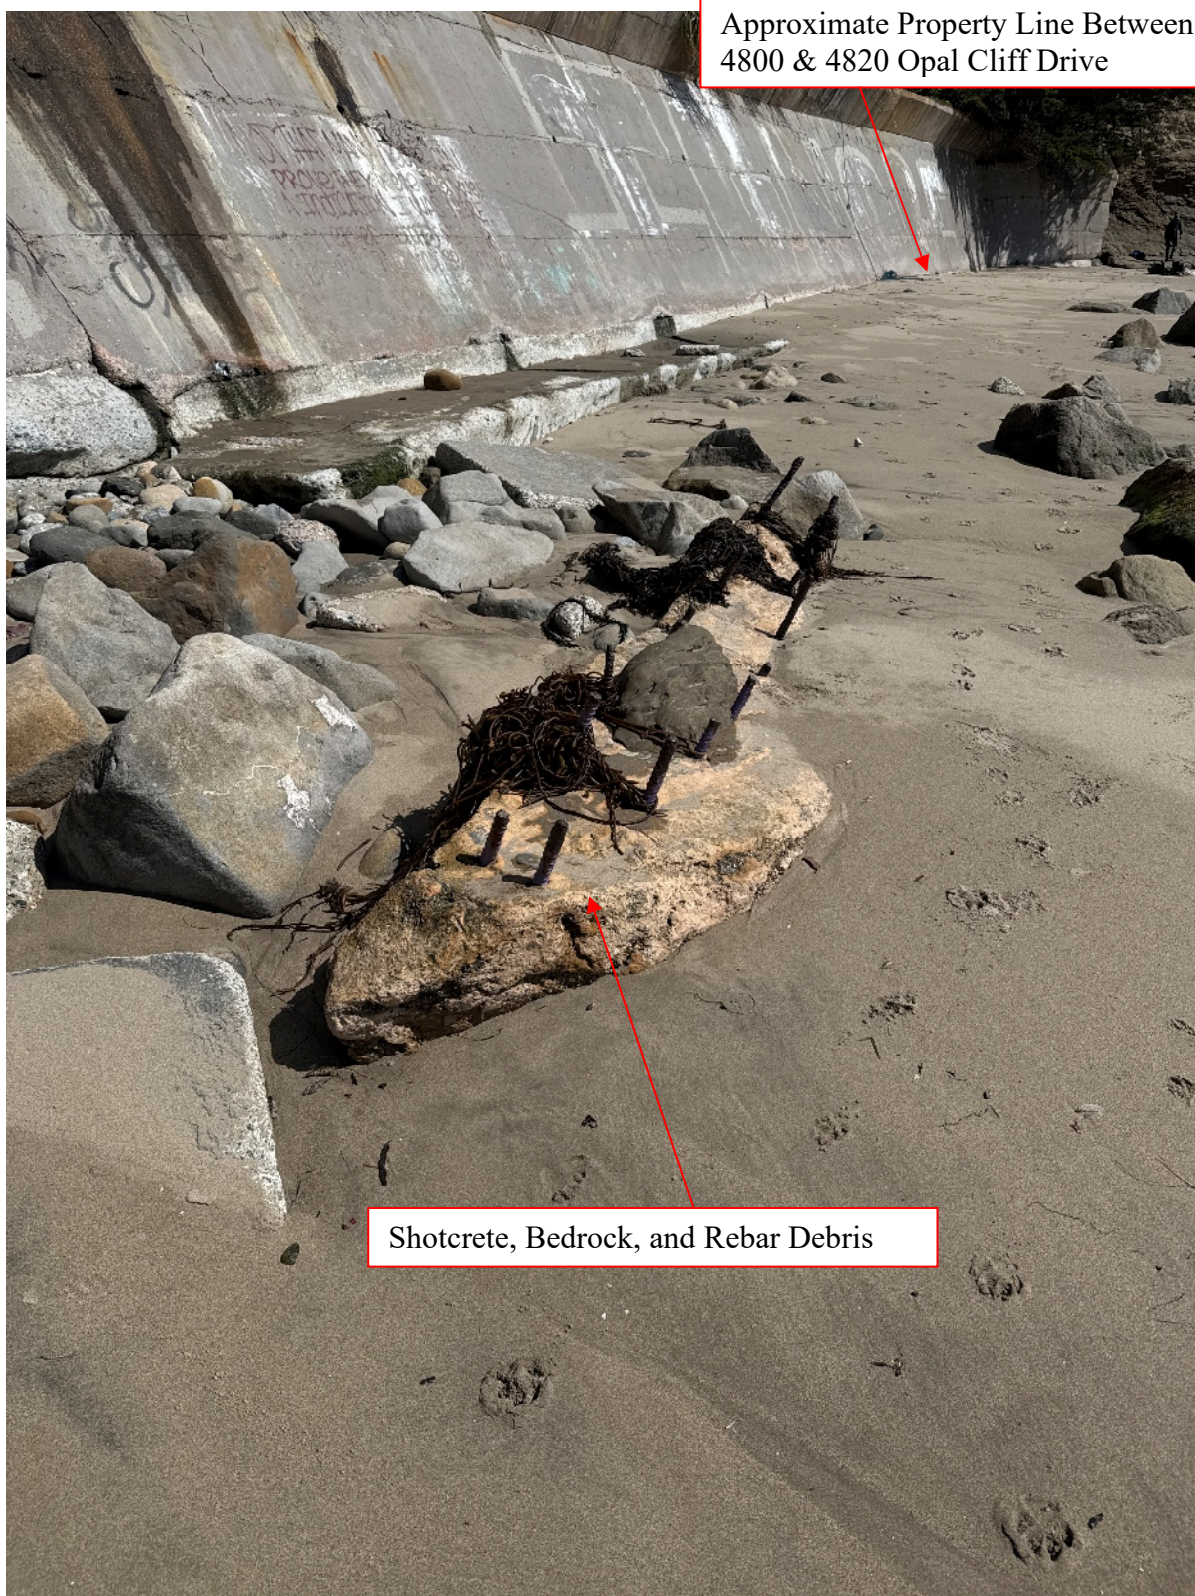
Photo 13: Downcoast View of Seawall - 2 April 2025
