Lincoln/Haney Engineering Associates, Inc.

January 25, 2026

Re: Structural assessment of deteriorated walls
Town of Casco Sand and Salt Shed, Casco, Maine

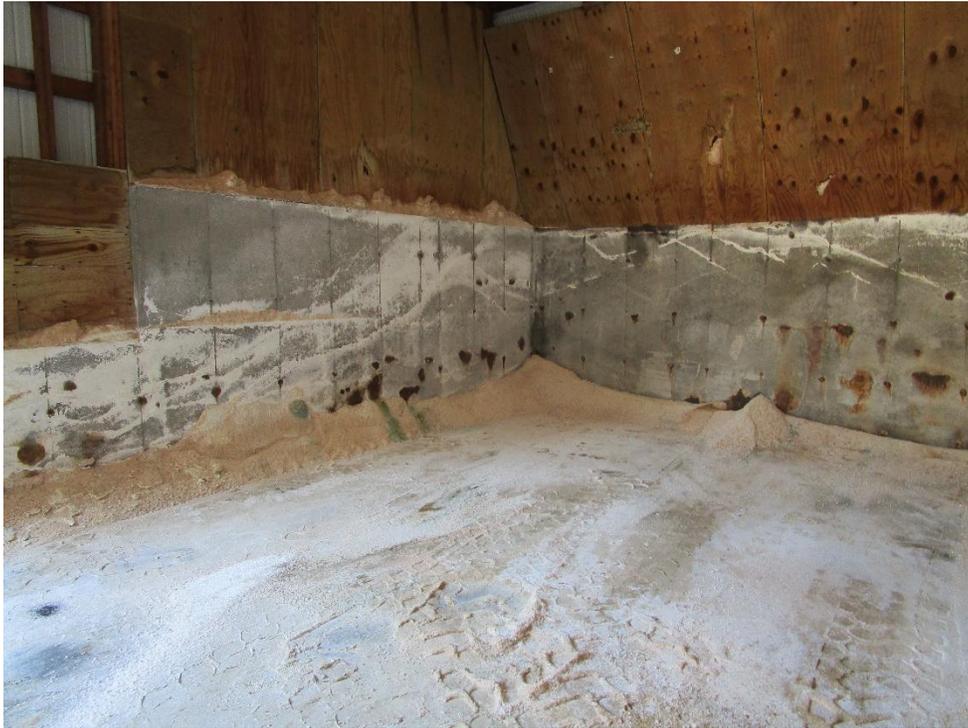
The insides of concrete walls have noticeable salt staining and rust staining. The rust appears largely to come from location of form ties. When ties are cut off, the ends are usually recessed in the concrete but otherwise exposed. The exposed steel may rust easily, and lead to staining. The presence of salt increases the likelihood of rusting. Please see Photos 1 & 2 at the end of this report.

Photo 1: Southwest corner of inside of salt shed

The staining observed during the two visits is not cause for structural concern, at this time. If left unattended, deterioration at horizontal cracks may worsen. The surface of the walls should be cleaned and coated to help protect the walls.

- Concrete walls should be pressure washed to remove salts
- Wire-brush rust stains to remove loose rust and materials
- After walls have dried, apply two consistent thick coats of a bituminous mastic. A continuous coating is important to help prevent salt from reaching the concrete.

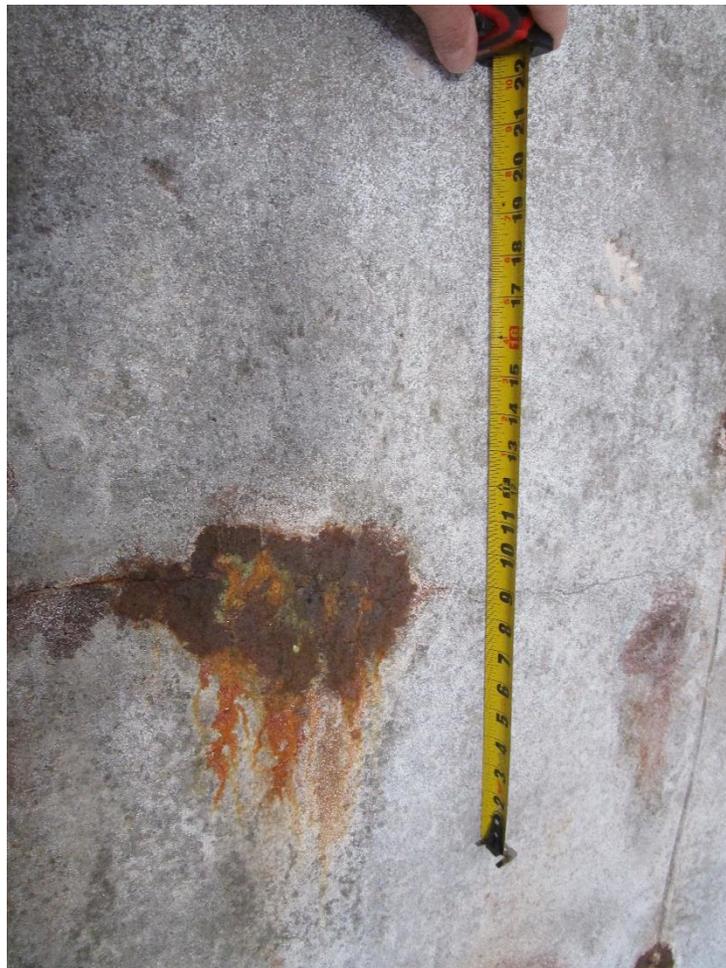
There is some horizontal cracking in the walls, with occasional rust at the cracks (Photo 2). This could be an indication that wall reinforcing is rusting. Cracks can create an opening that allows salt to more easily contact reinforcing. Walls did not have widespread rusting like this, and no spalling was observed. Concrete spalling can occur when reinforcing rusts. The rust expands, cracking concrete and pushing it away from the wall – creating a spall. Again, no spalling was observed during the visit.

Photo 2: Close up of rust staining at horizontal crack

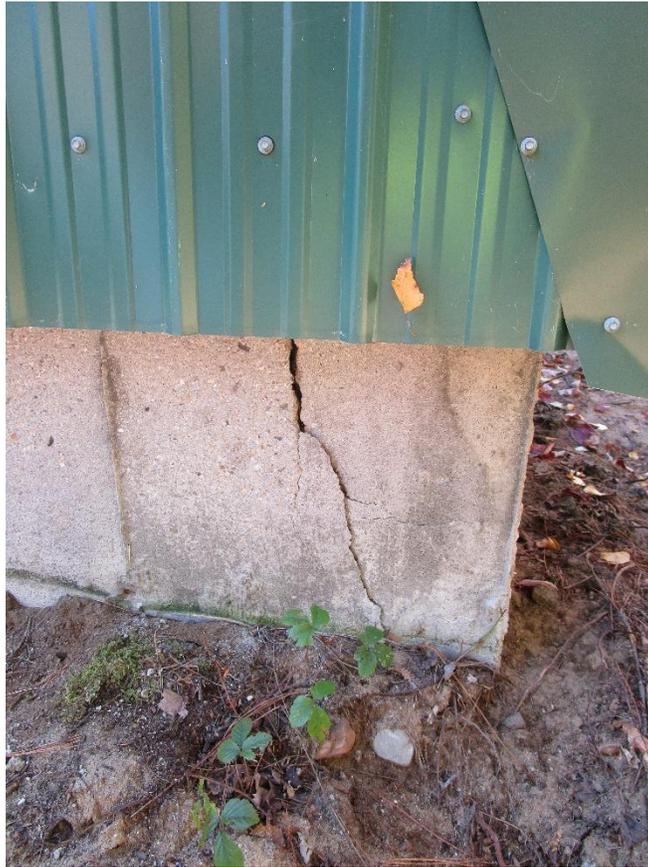
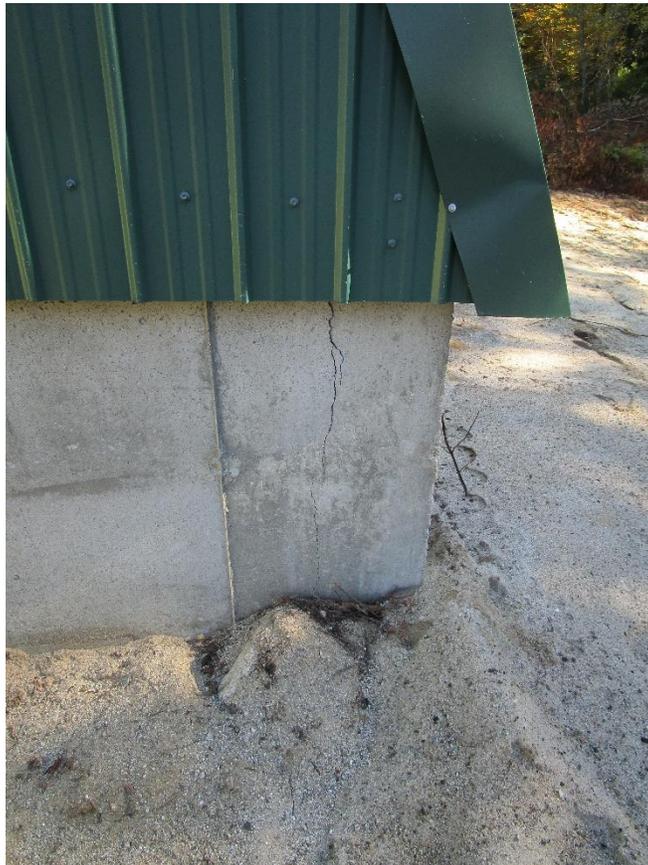
Vertical cracks are visible on the exterior at wall corners (Photos 3 & 4). These cracks may be a combination from shrinkage and some wall movement. The cracks have no staining at them, and do not appear to be of much concern at this time. The cracks may be cleaned of loose material and sealed to help lessen future deterioration from freeze-thaw action.

Photo 3: Exterior crack in corner of wall - 1

Photo 4: Exterior crack in corner of wall - 2

- Clean out cracks. Evaluate if the crack needs to be opened further for successful application of a sealant.
- Calked the prepared cracks with a flexible sealant.

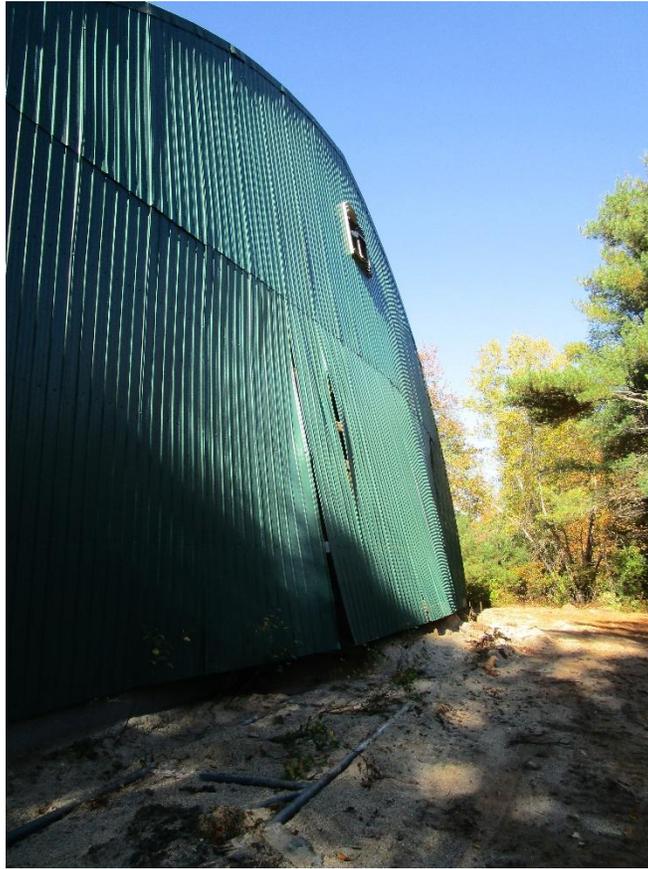
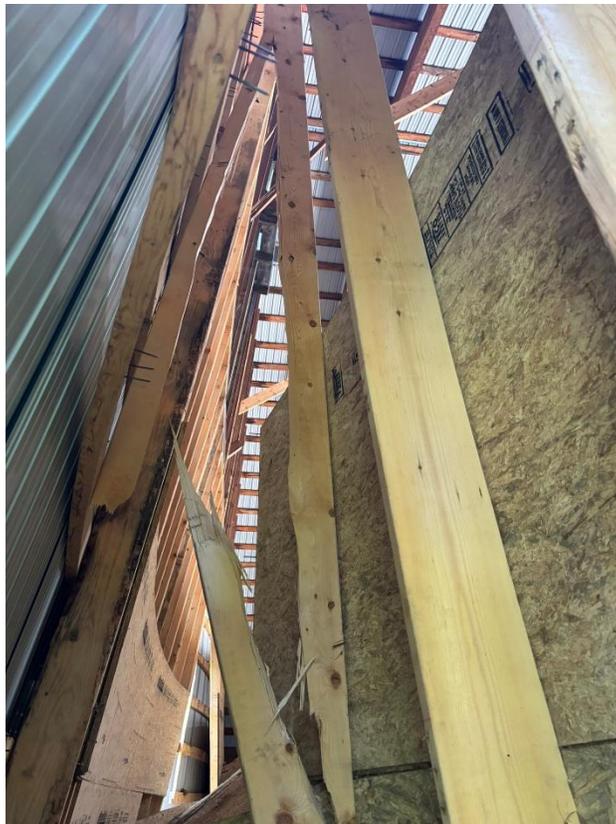
The north gable wall has been damaged, apparently by pushing sand and salt above the concrete wall (Photos 5 & 6). Wood studs and purlins are cracked. Sheathing and siding have all been pushed out and damaged. The stud wall should be repaired or rebuilt to prevent rain water and snow from entering the shed.

Photo 5: Damaged north wall, from exterior

Photo 6: Damaged north wall, from interior

- Reframe all cracked or damaged members at the gable wall
- Re-fasten or replace damaged siding
- Rusted siding should be patched or replaced

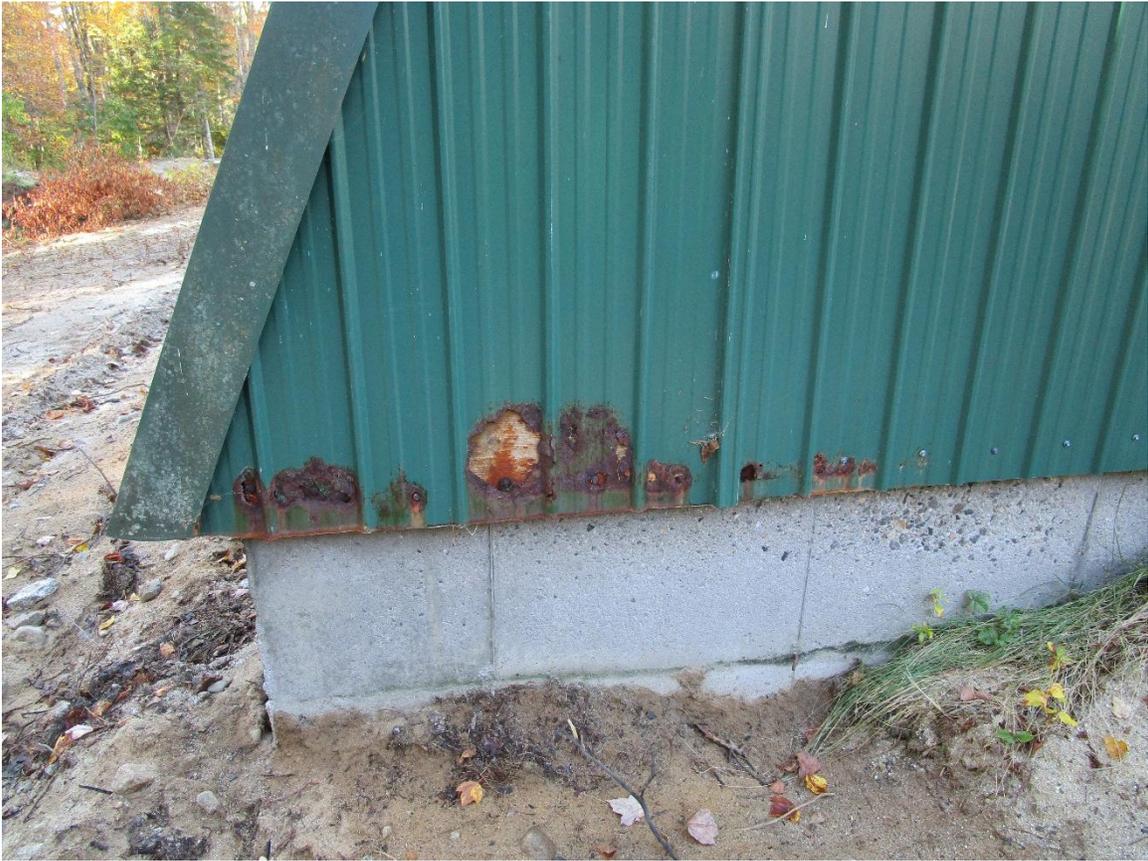
The north east corner siding has rusted through (Photo 7). This has likely occurred because of salts that have contacted the siding, combined with moisture from natural humidity. Siding should be patched or replaced to prevent rain water and snow from entering the shed.

Photo 7: Rust in wall panels

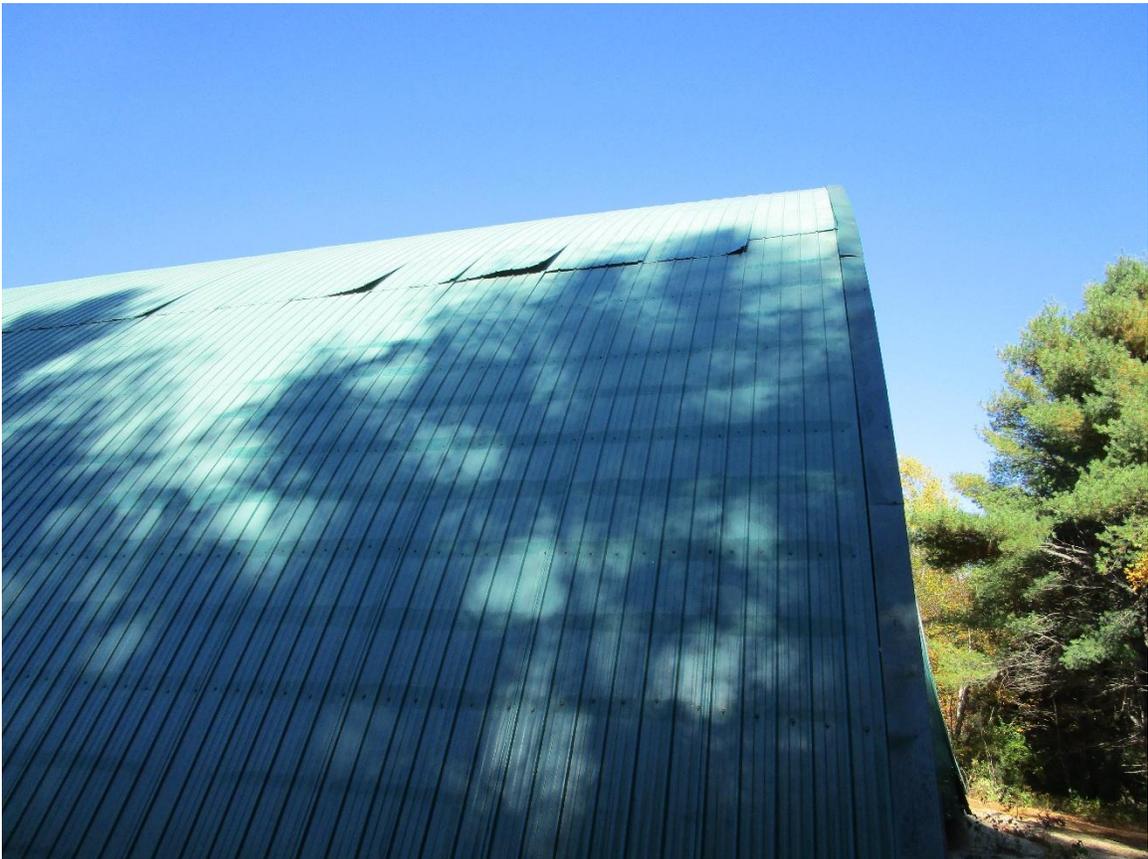
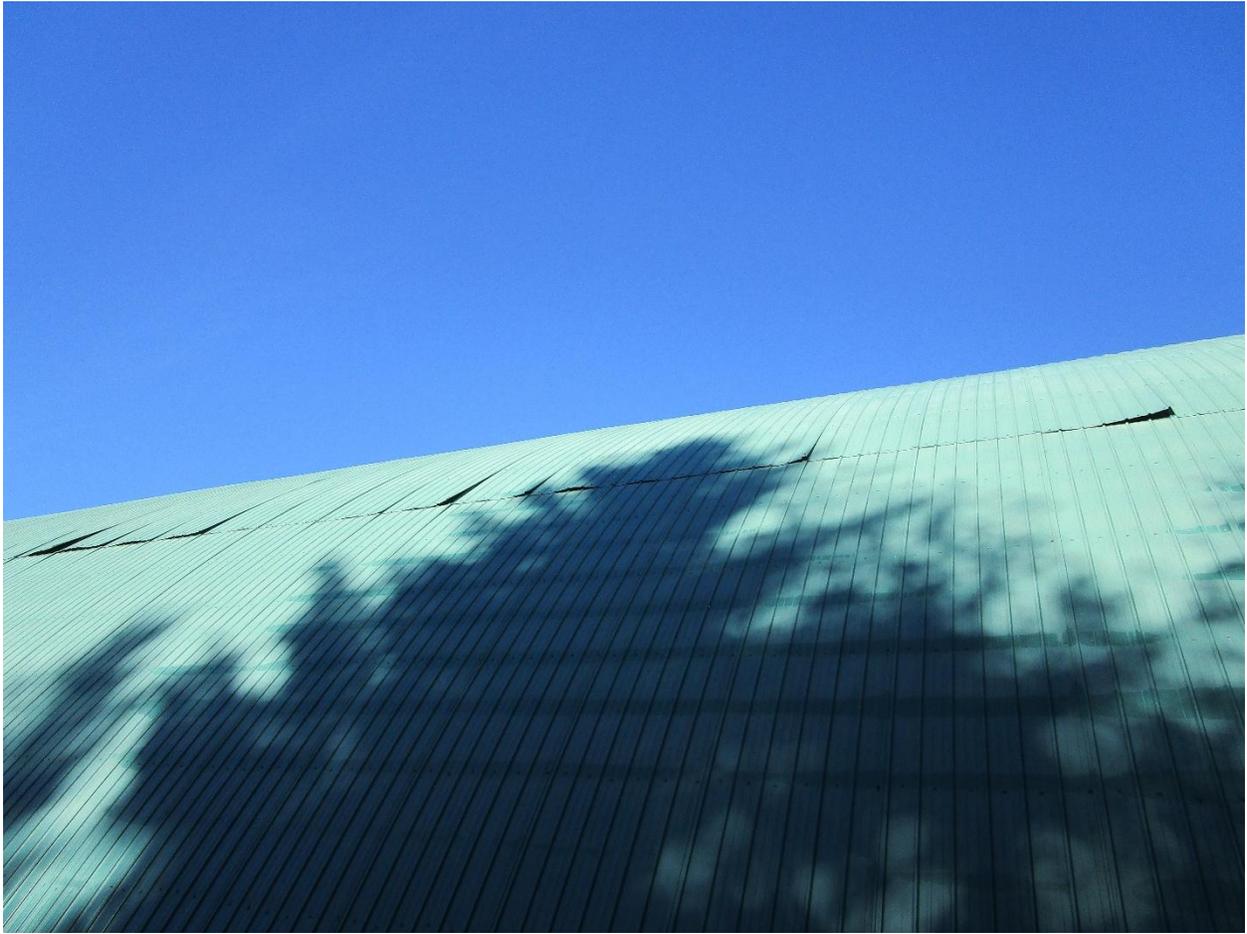
There are areas of metal roofing that have become loose, most notably on the east side of the shed (Photos 8 & 9). This has likely occurred due to years of wind and weather. Over the life of the shed, screw holes may have let some water in, leading to slow deterioration of wood and screws at the purlins. Eventually the wood and/or screws could not resist suction from wind loads, and became loose. In the short term the roofing should be re-secured or replaced, to prevent water and snow from entering the facility. Roofing and fastening should be evaluated for the entire shed. Over time wind may loosen more roofing, making the situation worse.

Photo 8: Loose roof panels, north east end of shed

Photo 9: Loose roof panels, east side of shed

- Refasten all loose roof panels. Evaluate purlins at roof damage, and replace all purlins that are deteriorated
- Have the entire roof, panels and fastening, evaluated. Purlins may also require replacement in locations.
