B. Keith Brenner, P.E  
Structural Engineer  
62 Highland Shores Road  
Casco, Maine

February 26, 2024

Re: Structural Engineering Review  
9 Leach Hill Road Building  
Casco, Maine

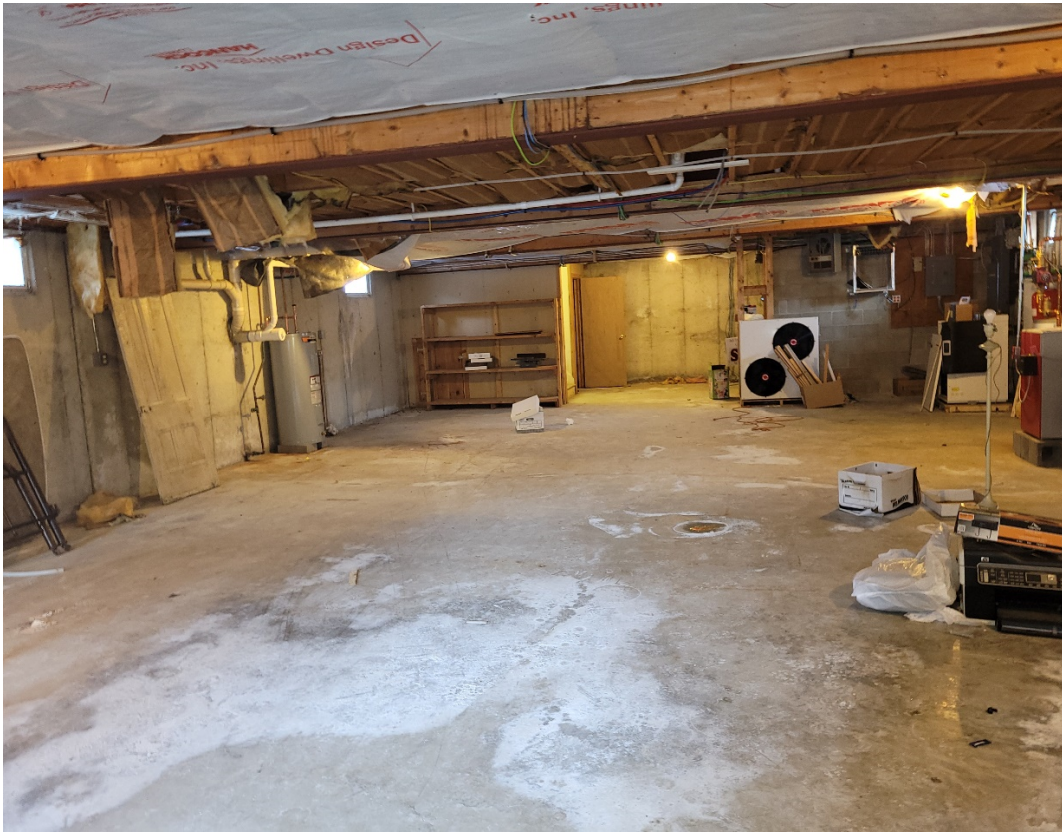
The basement consists of cast-place concrete walls and a concrete floor slab. It is an open space with no intermediate columns or bearing walls. The concrete appears to be in good condition with no major cracking noted. The clear distance to the underside of steel beams above is approximately 7’-0 ½”.

*View of Basement*

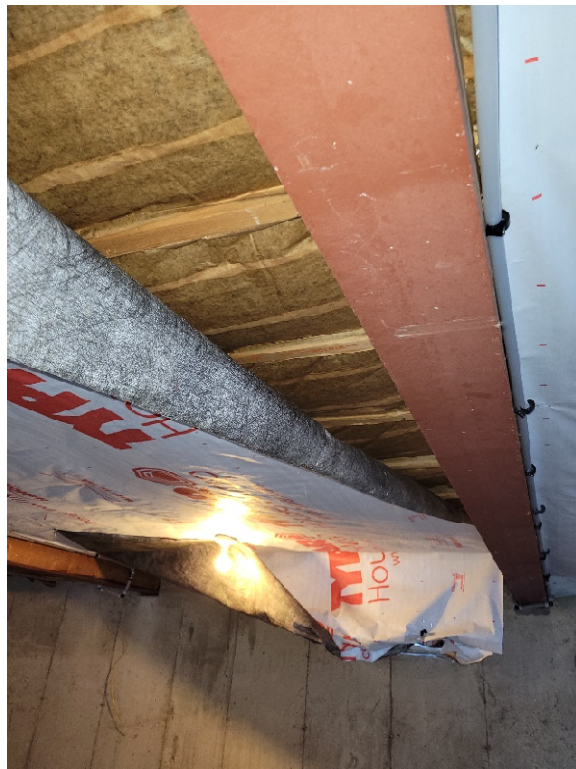
*Bottom of Steel Beam*

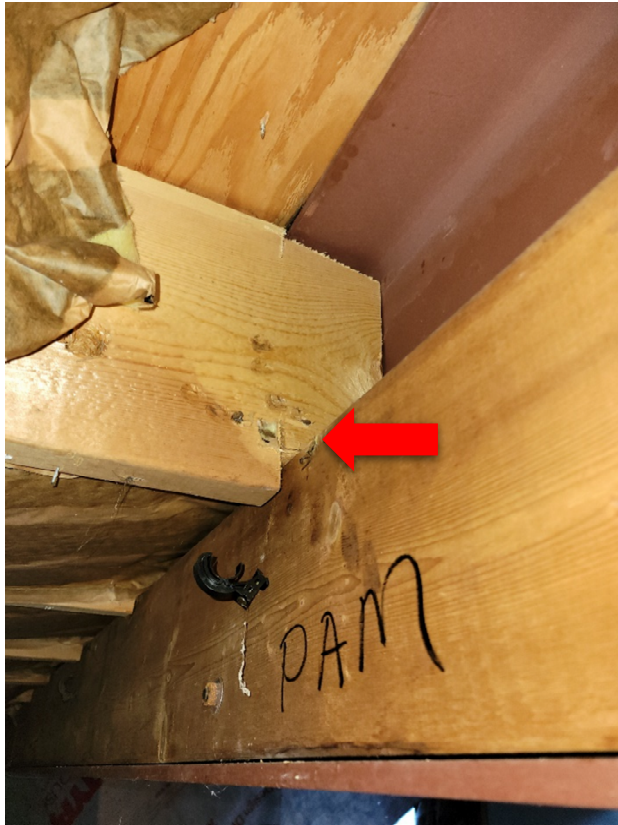
The floor framing consists of 2x10 wood joists spaced at 16" on center. These joists span to 16" deep steel beams that are at 10' on center. The steel beams span the entire width of structure and have wood blocking bolted to the webs of beams that the wood joists connect to. The end of each joist is notched top and bottom to allow it to bear on the double blocking at the beams (see photos). This is not an ideal detail as it reduces the depth of the member at the bearing. The steel beams sit on steel bearing plates into pockets in the concrete walls.

*Notched Joist at Steel Beam*

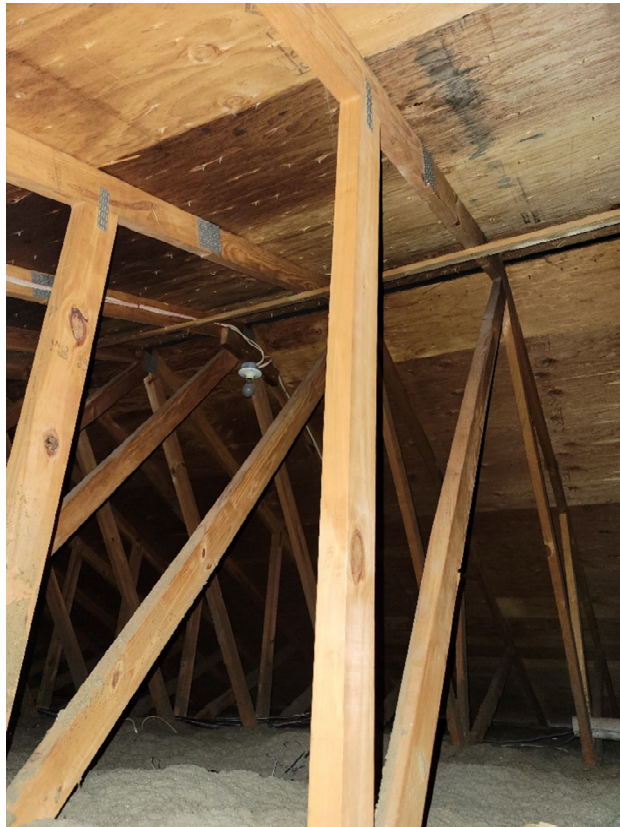
The roof framing consists of prefabricated wood trusses spaced at 2'-0 on center. The trusses appear to span the full width of the building. However, due to the finishes and insulation, this would need to be verified after some demolition has occurred.

No specific analysis of the roof trusses could be performed as these are a proprietary structural elements that are designed by the truss manufacturer. Without the wood truss shop drawings, it is not known what was used for the snow load on the roof. The code required snow load on this roof would be 62 psf.

*Wood Rood Trusses*
