MEMORANDUM FOR RECORD

SUBJECT: Site visit to Ceredo-Kenova LPP for slope instability near Jordan Branch ponding area.

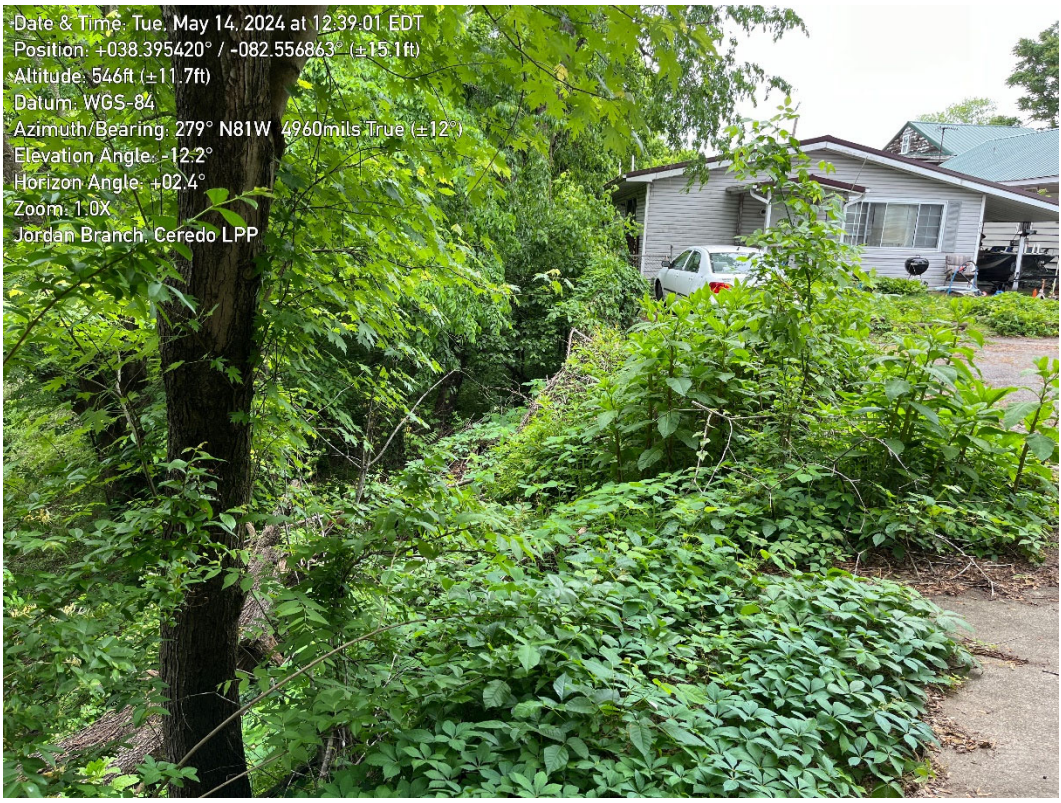
Figure 2. View along top of slope.

3. If the parties that are responsible for this property, such as the City or homeowners, wish to stabilize the slope, then they should retain a qualified engineering firm to design short- and long-term stabilization measures. Short-term concepts that could be undertaken more quickly may include surface drainage improvements to prevent stormwater runoff from infiltrating the slope. Ensure gutters and downspouts flow properly and water doesn't discharge uncontrollably over the slope. Driveway concrete slabs could be raised, and any cracks or gaps sealed. Long-term concepts might include underpinning of the houses and structural measures to stabilize the slope, such as construction of a retaining wall. Another structural measure could include excavation of the slope to remove vegetation and failed soils and construction of a stone buttress. However, this may necessitate impacts to the houses.

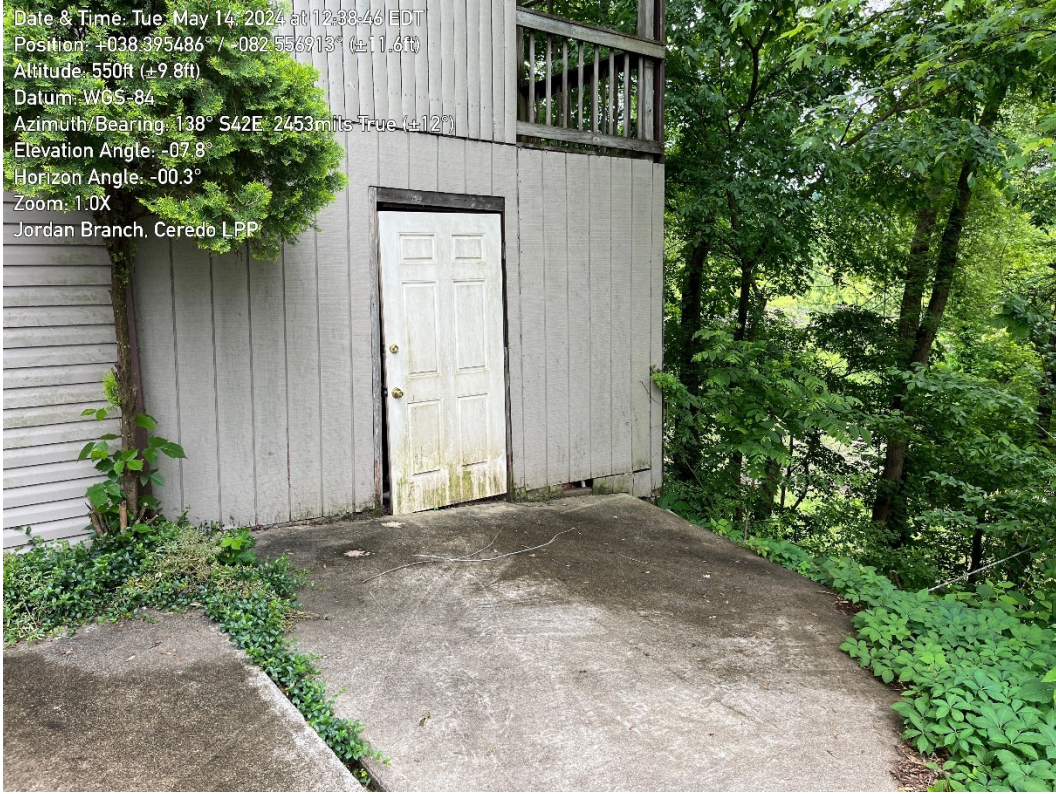
2. Several indications of long-term slope instability were observed. Figure 2 includes a view at the top of the slope. The soil slope is oversteepened (estimate steeper than 1V:1H), pavement is displaced several inches (Figures 3 and 4), tree trunks are misaligned (Figure 5), and bulging at the base of slope could be the toe of a slip surface or simply accumulated talus. There is no visible head scarp, but this might be masked by pavement. These issues are not impacting levee or pump station operations.

Figure 3. Concrete slab is tilted from left-to-right.

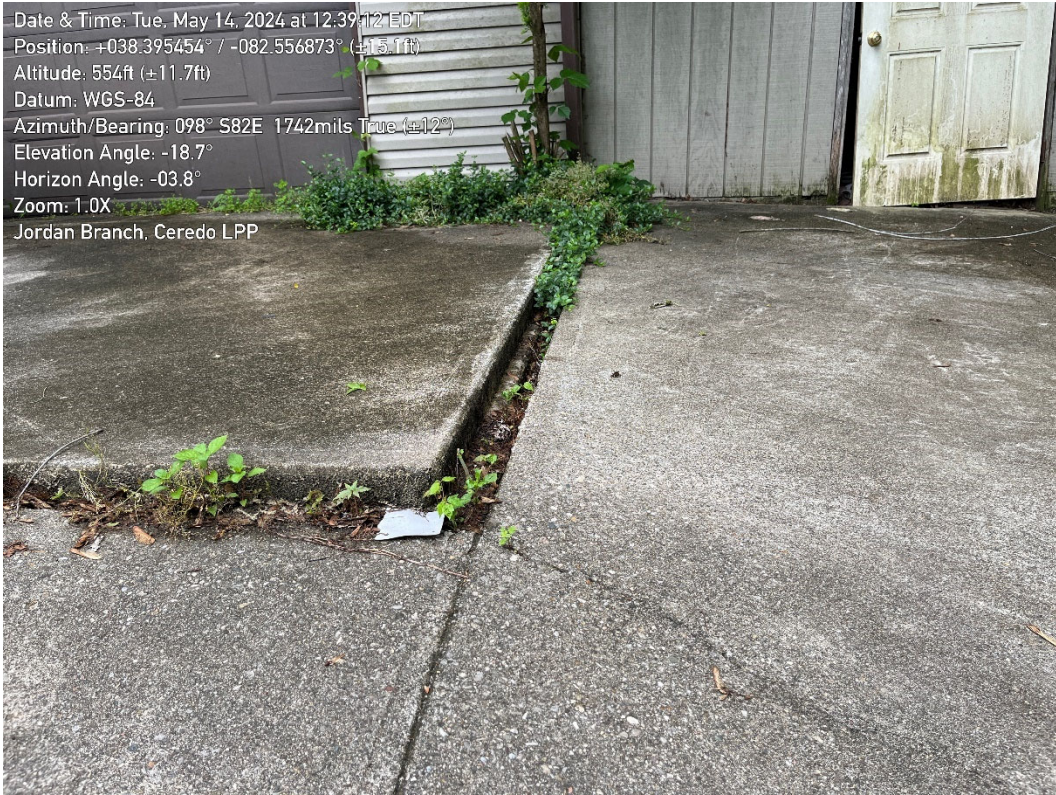
Figure 4. Concrete slab is displaced.

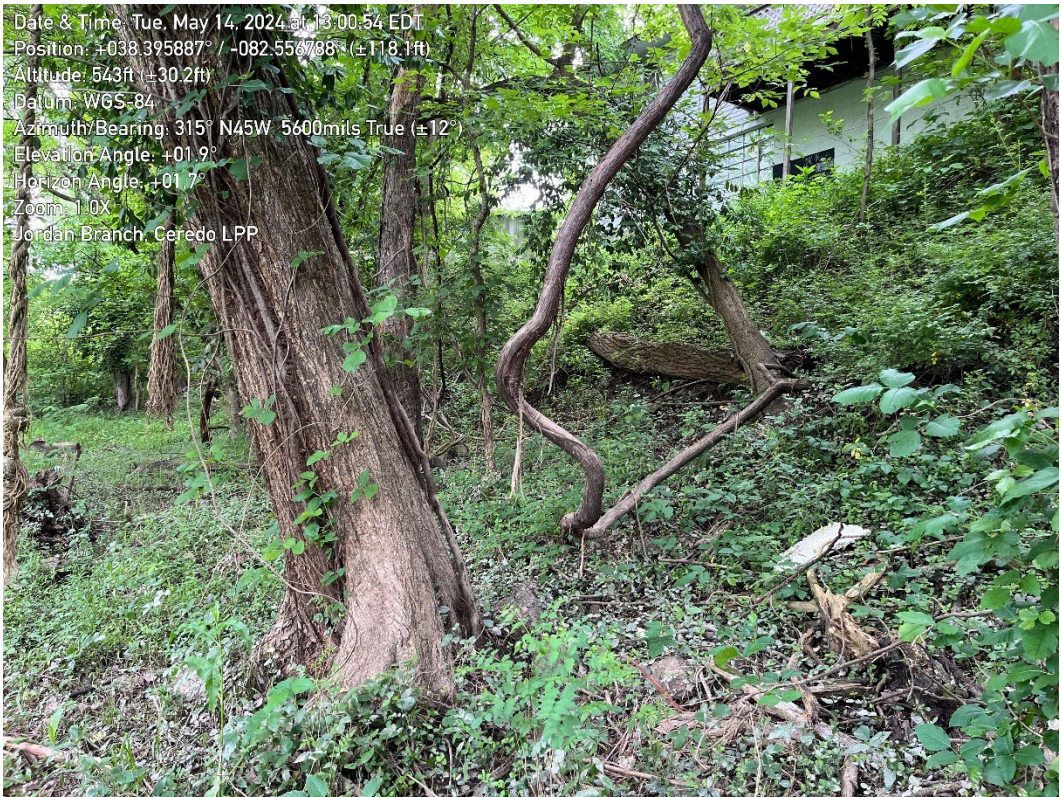
Figure 5. Trees within the slope are misaligned.
