Building Assessment Report

07/02/2025 “FINAL Submittal”
Old Chipley City Hall

Old Chipley City Hall

Final Submittal – July 2, 2025

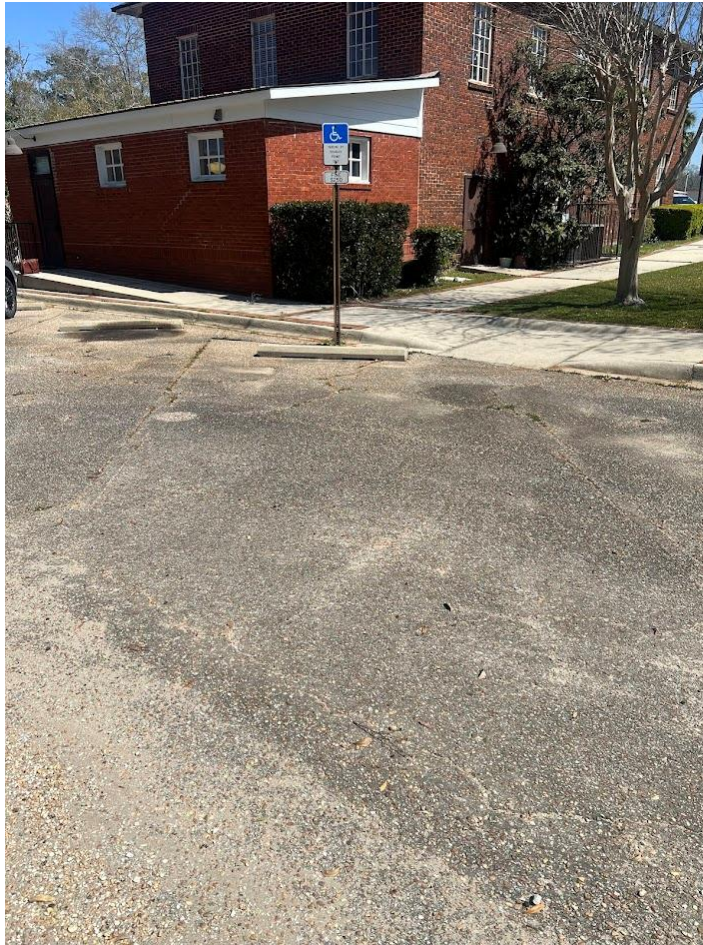
Re-stripping

1. There is one accessible parking space located in the existing parking lot behind the building.
2. The number of Parking Spaces in the rear parking lot along Church Street and on both sides of 5th Street is (26). Therefore, (2) accessible spaces are required.

1. Re-stripe and add the wheelchair decal to the existing parking space with the access aisle centered on the existing curb cut by FDOT Standards. See page # 4.
2. Relocate the FDOT Parking Sign to the center of the Parking Space and on to the sidewalk. See the following plan.
3. Adding another Accessible Parking Space at the front of the facility on 5th Street is recommended. See the following plan on page # 5.

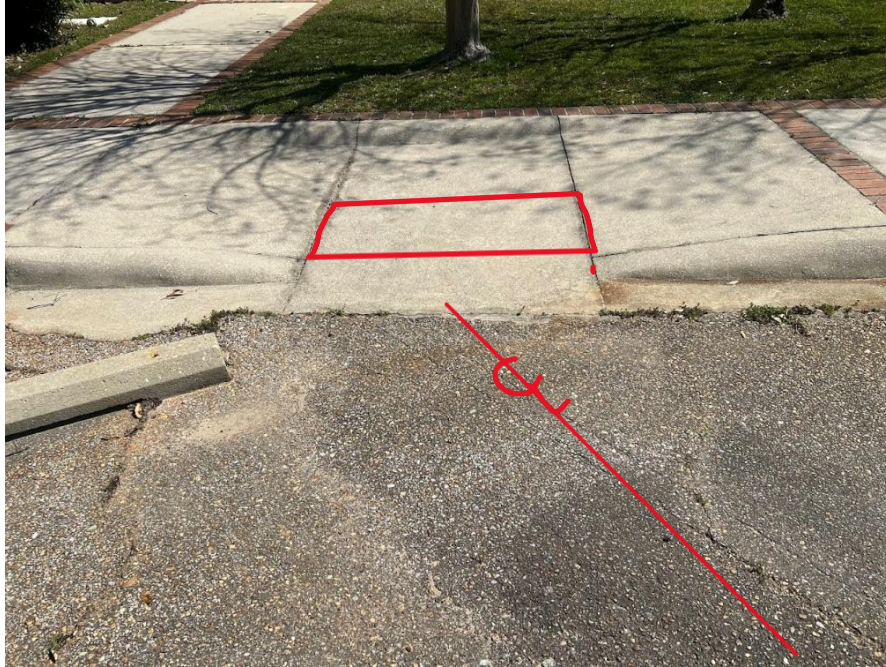
1. Existing Curb Cut at rear parking.

1. Center on the curb cut and mark the accessible aisle with white diagonal striping per FDOT Standards. Set the 12-foot parking space to the left of the access aisle per the following plan.
2. Provide 24" deep by the width of the curb cut ramp detectable warning per FDOT.

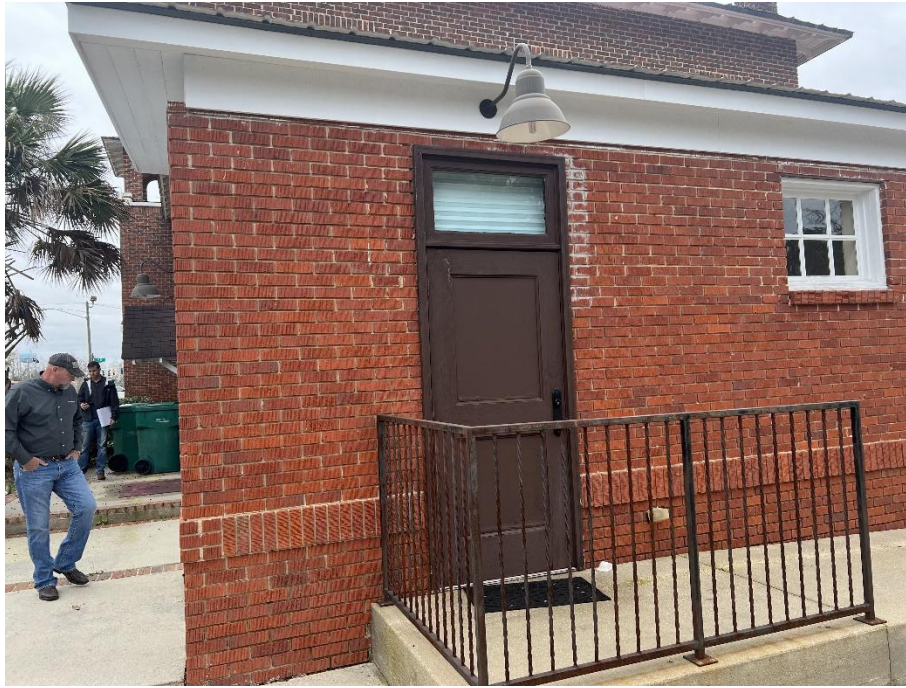
EXISTING RAILING AND ENTRY DOOR

1. Railing does not extend the full length of the Ramp.
2. Out swinging door has a round knob.
3. There is no signage to identify this entrance as an accessible entrance.

1. Add Handrail to the existing Brick Wall with 12" extensions beyond the ramp at each end. The top of the rail mounted between 34" -38".
2. Add a handrail outside of the ramp with a 12" extension at the bottom beyond the ramp. Mount @ 34" – 38". The Ramp is part of the egress path and therefore must maintain a minimum of 44" wide.

5. Change threshold to meet ADA Requirements.
6. The door was locked due to damage, so we could not check the operating pressure to open it or the closer delay. Also, the round knob needs to be changed to a lever handle.

7. Add a sign "Accessible Entrance".
8. Add "Exit" sign on the latch side of door @ 9" to center of tactile copy. 48" minimum to base of lowest line and 60" maximum to base of top line.

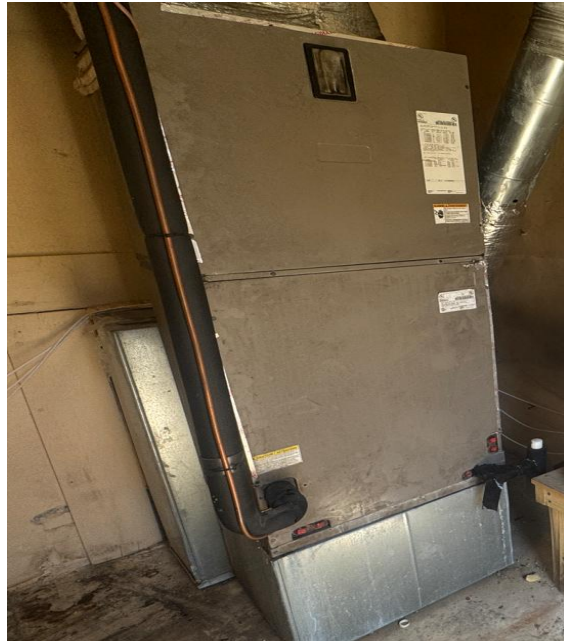
Figure 1 – Air Handling Unit (AHU-1)

The air handler and heat pump serving the first floor are past its life expectancy and is showing signs of major wear and tear. The electrical wiring inside the heat pump is exposed and zip tied. See Figures 1 & 2.

It is recommended to remove and replace all existing ductwork, air distribution devices, exhaust fans & grilles, accessories, etc. It is also recommended to remove and replace AHU-1 & HPU-1 (serving 1st floor). Other than AHU-2 and HPU-2 (serving 2nd floor), the mechanical equipment is past its life expectancy and most items do not meet the current Florida Mechanical Code requirements. It is recommended that AHU-2 and HPU-2 be thoroughly cleaned, disinfected, sanitized and maintained. It is recommended to replace the air handler filter as well. Wear and tear items are evident throughout the mechanical systems. The refrigerant lines & condensate lines shall be properly supported & insulated. See new mold report by others.

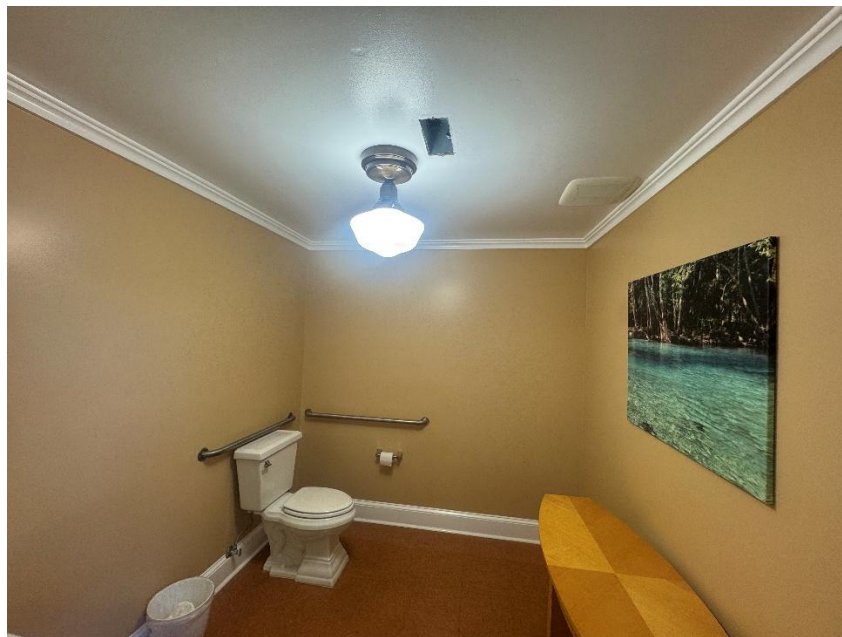
Figure 6 – Missing Ceiling Grille

The ductwork shows major wear and tear and is past its life expectancy. According to the building representative, portions of the ductwork on the second floor have been replaced due to leaks and mold issues. Most of the air distribution devices seem to have been replaced at some point. Some air distribution devices currently have black spots on them which suggests mold growth. See Figure 5 for a sample location. The building representative has stated that there were mold issues previously. See new mold report by others. A missing grille was noted in the 1st floor restroom, next to the conference room, see Figure 6.

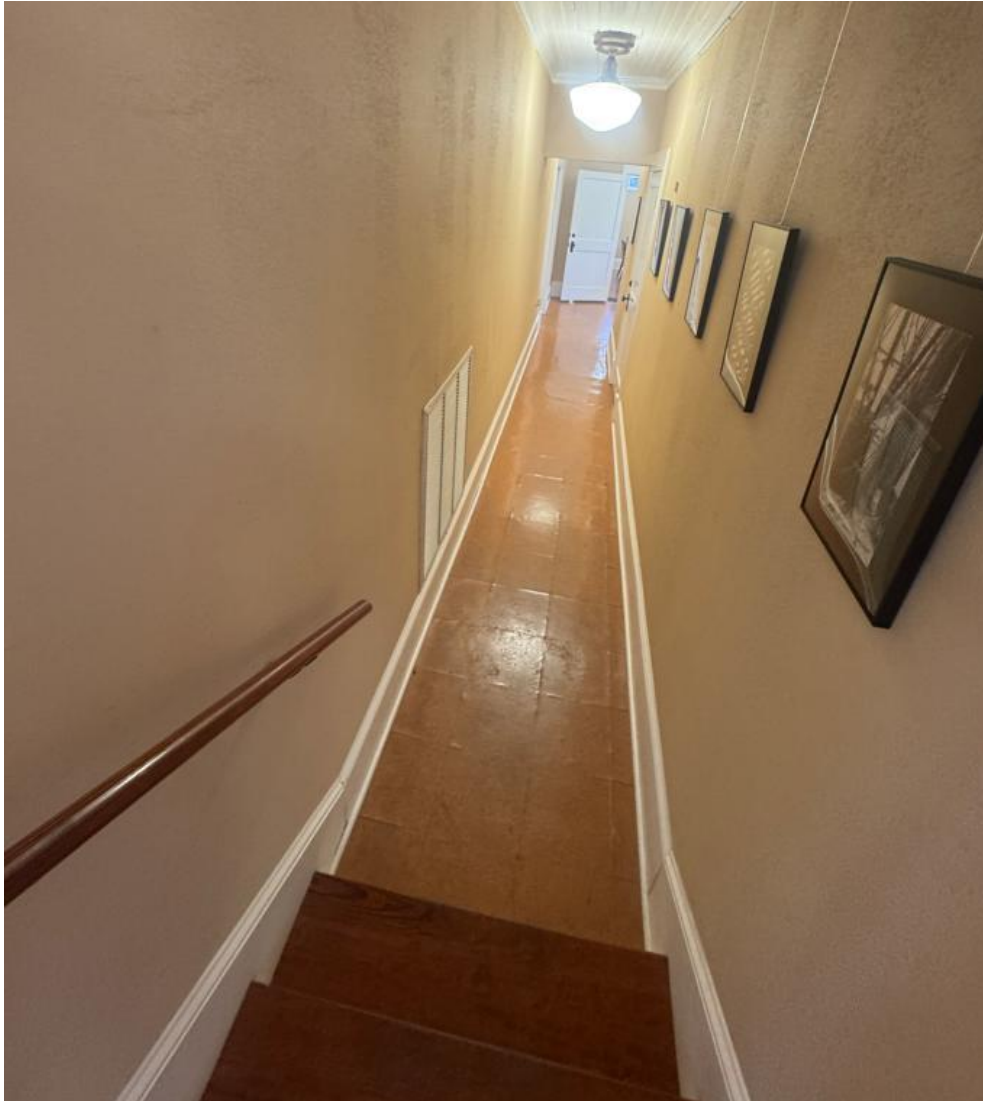
Figure 7 – Sidewall Return Grille in Corridor

The corridor of both the 1st and 2nd floor is being used as a return air plenum which is not permitted per the current Florida Mechanical Code, See Figure 7. The return duct back to AHU-1 was not properly sealed. It is unclear if the return plenum box under AHU-1 is properly connected to the return duct and sidewall return grille. There is a beehive in the wall cap behind the exterior heat pump units, which need to be removed & cleaned.

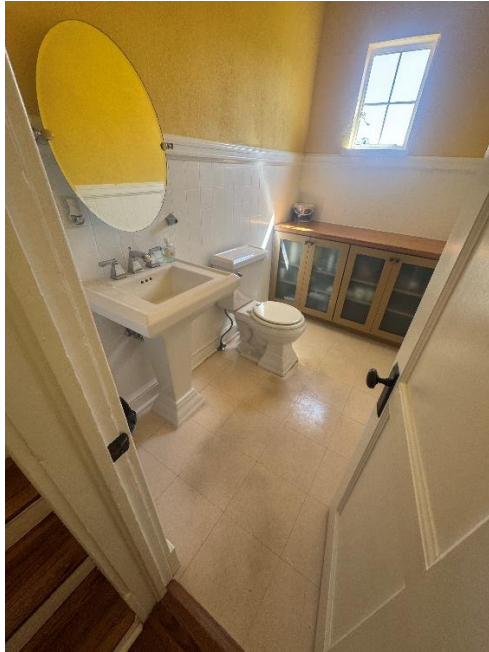
Figure 8 – Typical Restroom

The building currently has a total of four restrooms. Two restrooms are on the first floor and the other two restrooms are on the second floor. Each restroom consists of one water closet and one lavatory, see Figure 8. Plumbing fixtures were operational at the time of the site visit. Faucets were the two handle types and operational at the time of the site visit. Some of the sinks were missing P-trap covers. The water drainage in some of the sinks took a long time to drain. This could possibly be due to having a high flow faucet with a small bowl sink and possible small drain size, see Figure 9. This could also be due to clogs or undersized piping systems. A single water cooler was noted, see Figure 10. See Architectural report for ADA requirements.

It is recommended to replace the sanitary, vent and domestic water piping throughout the building. The plumbing fixtures are in good condition. P-trap covers should be added where necessary. The faucets shall have the water flow adjusted as required. Due to the age and wear and tear to the existing water heater, it is recommended to replace the electric tank water heater and accessories. All plumbing lines shall be properly supported and insulated as required. See Architectural report for ADA requirements.

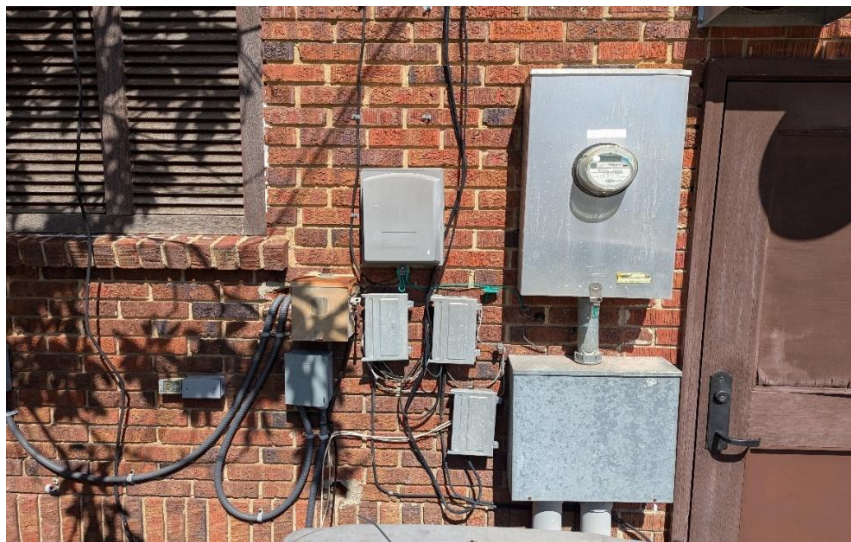
Figure 1 – Exterior Electrical Meter and Service Junction Box

The electrical meter on the outside of the electrical room is not completely sealed, refer to (Figure 6). There is also no clearance in front of the electrical equipment outside as the A/C units sit in front of it as shown in (Figure 1).

- Replace main power distribution system.
- Fix or replace all exposed wires, electrical terminations, loose wires, and/or provide new wiring for all electrical circuits. (For the entire building.)
- Replace all the wiring that fails insulation testing.
- Fix or replace all exposed electrical junction boxes and terminations.
- Organize and support all pathways and cables.
- Fix or replace any damaged and exposed outlets. Fix wiring for nonoperational outlets.
- Remove all abandoned cabling and its associated pathway.
- Remove any abandoned circuits that are no longer in use.
- Provide updated circuit labels.
