**LAKE COUNTY SOUTHEAST REGIONAL WASTE DISPOSAL FACILITY  
COLLECTION SYSTEM  
COMPLIANCE EVALUATION INSPECTION REPORT**

**Name/Location of Facility Inspected:**  
Lake County Southeast Regional Waste  
Disposal Facility Collection System  
230 North Main Street  
Lakeport, CA 95453

**Date:**  
11-08-2023 Field Inspection  
Start: 0852  
End: 1433  
Consent given by Scott Harter at 0856

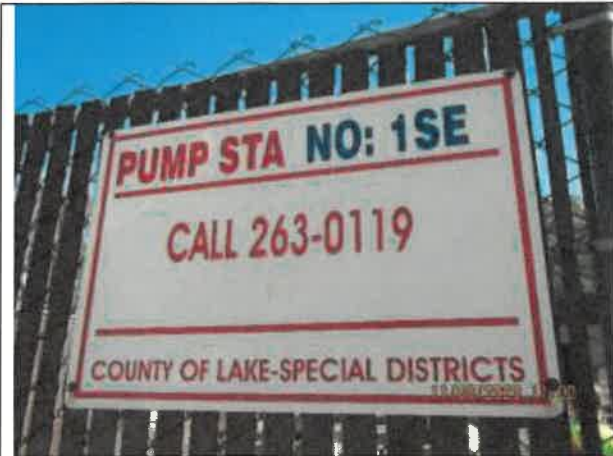
Photo 1: A photo of emergency signage posted at Pump Station No. 1.

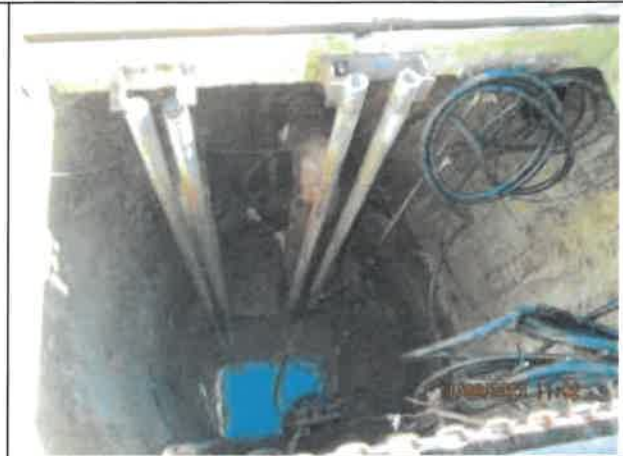
The wet well on the south side of the pump station had a minor FOG mat, minimal corrosion, a coated barrel, and some rags on the components (**Photo 2**). The wet well on the north side of the pump station had minimal FOG and a lot of rags on the components (**Photo 3**). Both dry wells were not covered, had minimal debris, and some chipping on the painted components (**Photos 4 & 5**). A logbook was kept on site and showed that a monthly load test and maintenance was done the day prior on November 7, 2023 (**Photo 6**).

Photo 2: A photo of the wet well on the south side of Pump Station No. 1 with minor FOG, rags, and corrosion.

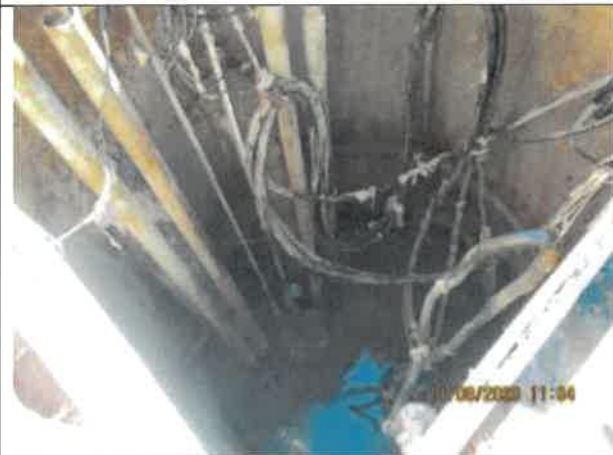
Photo 3: A photo of the wet well on the north side of Pump Station No. 1 with rags, minor FOG, and minor corrosion.

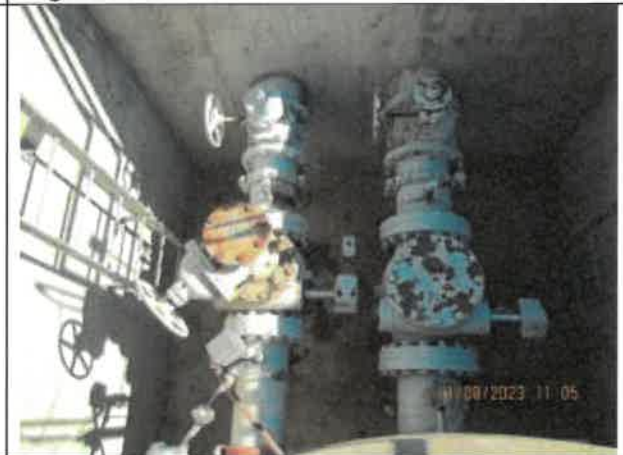
Photo 4: A photo of the one of the uncovered dry wells with minimal debris and paint chippings.

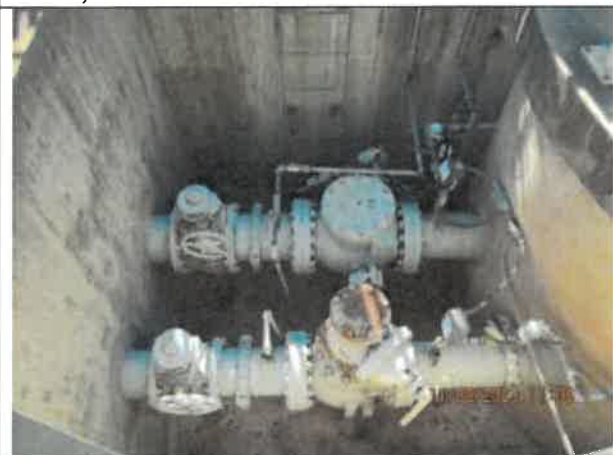
Photo 5: A photo of the one of the uncovered dry wells with minimal debris and paint chippings.

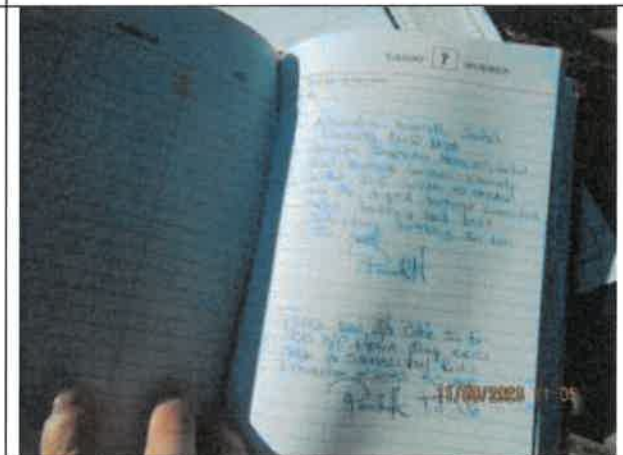
Photo 6: A photo of the logbook at Pump Station No. 1 showing maintenance and a monthly load test was done on November 7, 2023.

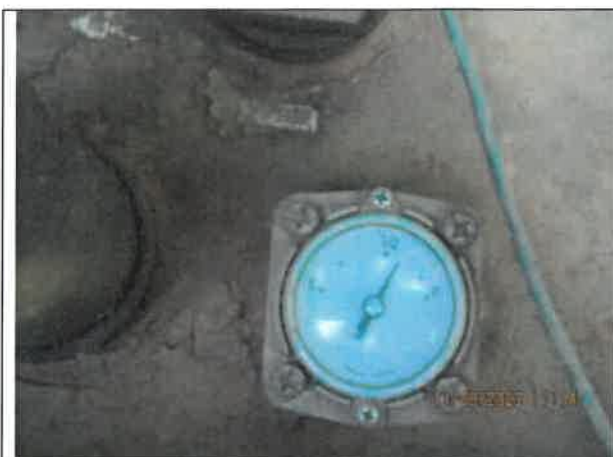
Photo 7: A photo of the fuel level of the generator at Pump Station No. 1 showing over 50 percent full.

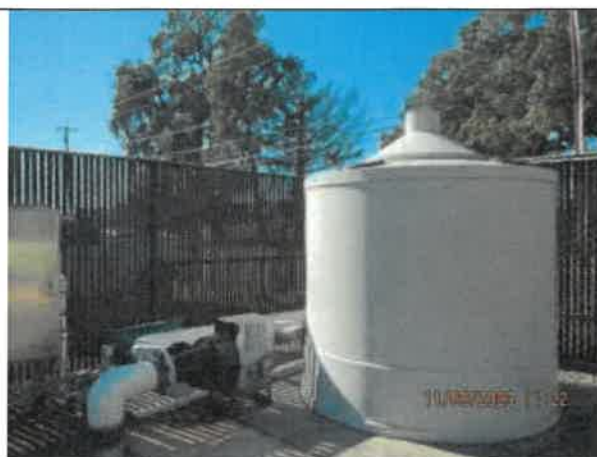
Photo 8: A photo of the carbon filter system at Pump Station No. 1 for odor control.

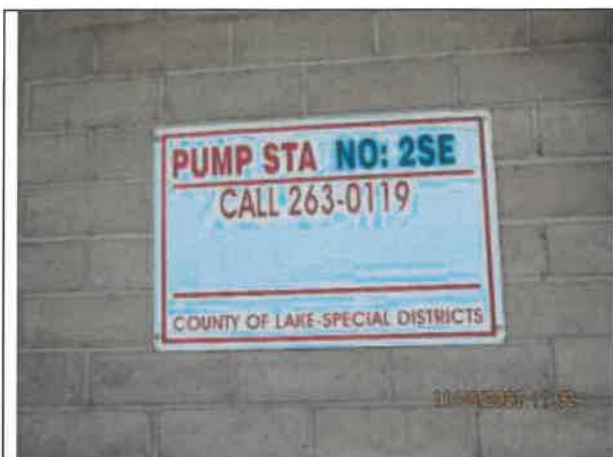
Photo 9: A photo of emergency signage located on the building inside the fence of Pump Station No. 2.

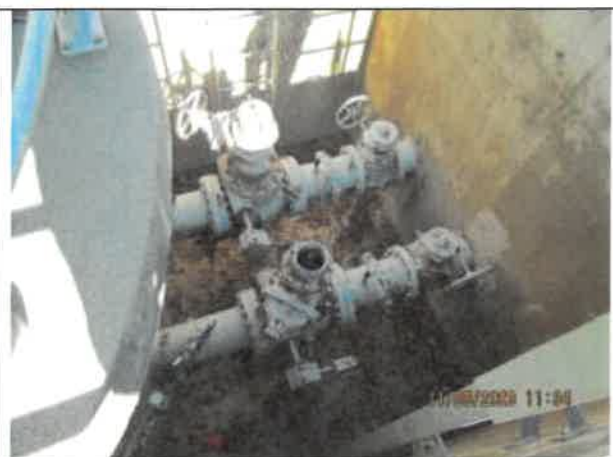
The dry well on the south side of the pump station was uncovered, contained debris, and was missing a cap on one of the connections (**Photo 10**). The dry well on the north side was uncovered and had debris and minor trash in it (**Photo 11**). Mr. Spooner stated that they need to order a new cap and would think about installing a mesh covering over the dry wells to prevent debris and trash from getting in.

Photo 10: A photo of the uncovered south dry well at Pump Station No. 2 showing debris and a missing cap on one of the connections.

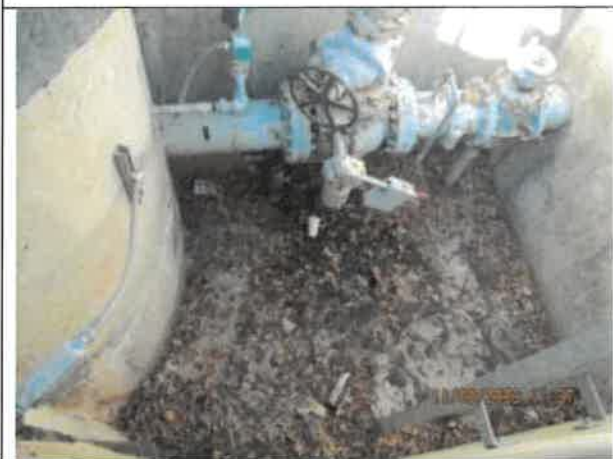
Photo 11: A photo of the uncovered north dry well at Pump Station No. 2 showing debris and minor trash.

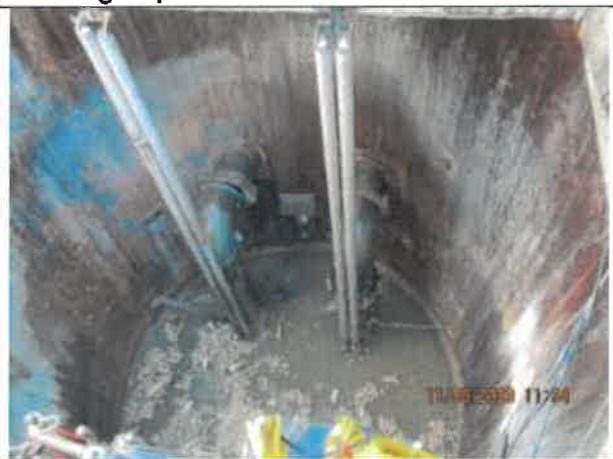
The wet well on the south side of the pump station had a disconnected pipe, staining on the walls, and minor FOG and debris (**Photo 12**). Mr. Higdon stated that the disconnect is currently being repaired and they had just replaced the coupler on the other pipe as seen in the photo. The wet well on the north side of the pump station had minor corrosion, debris, and staining on the walls (**Photo 13**). The logbook for the pump station showed that staff was there two days prior, on November 6, 2023, and Lake County is currently getting quotes for a variable frequency drive (VFD) control board to repair the interface screen (**Photo 14**). A check sheet for pump station maintenance was filled out on November 6, 2023 (**Photo 15**).

Photo 12: A photo of the south wet well at Pump Station No. 2 showing minor debris, FOG, and staining on the walls. The disconnected pipe in the photo is currently under repairs.

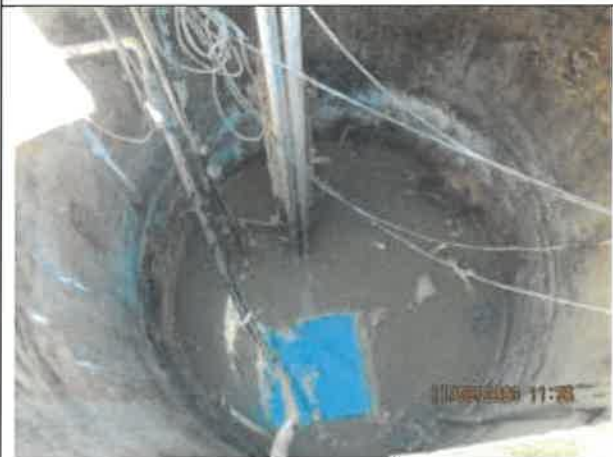
Photo 13: A photo of the north wet well at Pump Station No. 2 showing minor debris, trash, and staining on the walls.

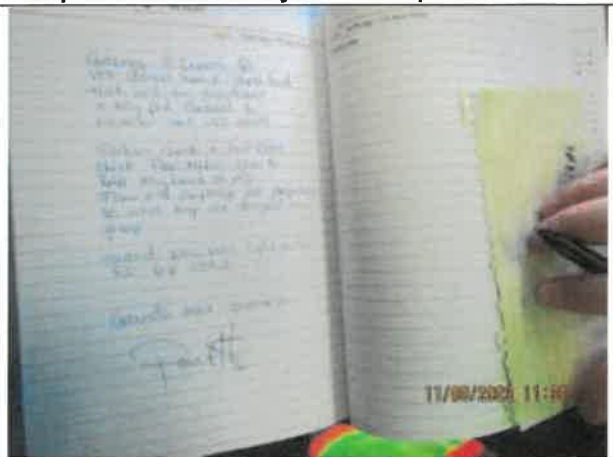
Photo 14: A photo of the logbook at Pump Station No. 2.

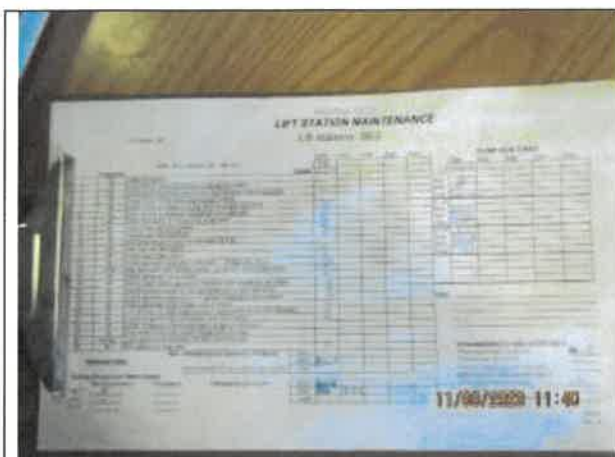
Photo 15: A photo of the November 6, 2023 maintenance check sheet at Pump Station No. 2.

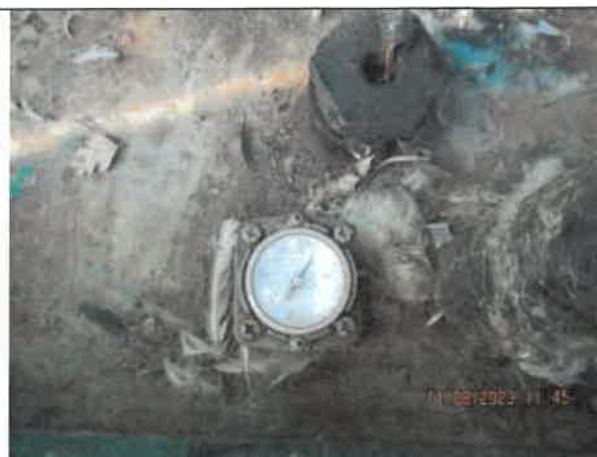
I then asked if an alarm could be triggered. Mr. Higdon triggered an alarm, and an audible alarm was heard. Mr. Spooner explained that the alarm-answering, third-party company is staffed 24/7 and has a list of people to call. Mr. Spooner received the call that an alarm was triggered approximately five minutes after the alarm. Mr. Spooner stated that they typically receive the alarm call within five to ten minutes but that it previously had been up to two hours. Mr. Spooner added that they are looking into a better backup alarm system that will call Lake County directly. I checked the generators fuel level which showed the fuel level to be a little over half full (**Photo 16**).

Photo 16: A photo of the fuel level of the generator at Pump Station No. 2 showing the fuel level to be over half full.

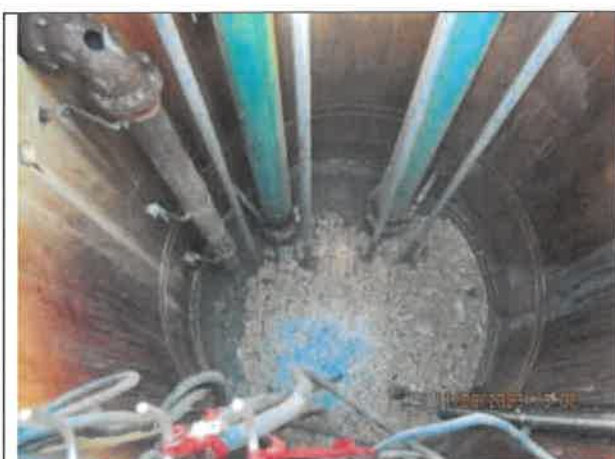
Photo 17: A photo of the wet well at Pump Station No. 3 showing a FOG mat, rags on the pipes, corrosion, and staining on the walls.

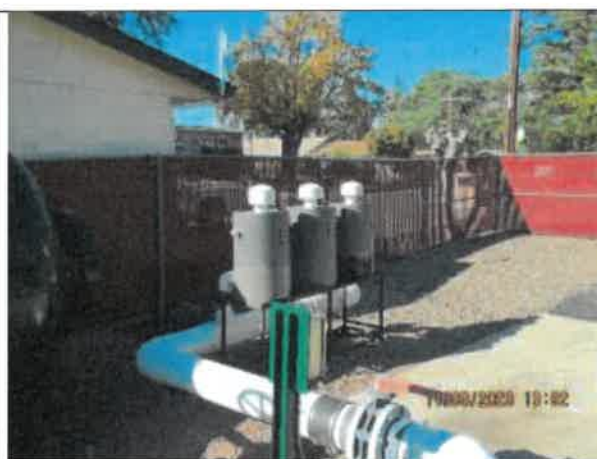
Photo 18: A photo of the carbon odor control system at Pump Station No. 3.

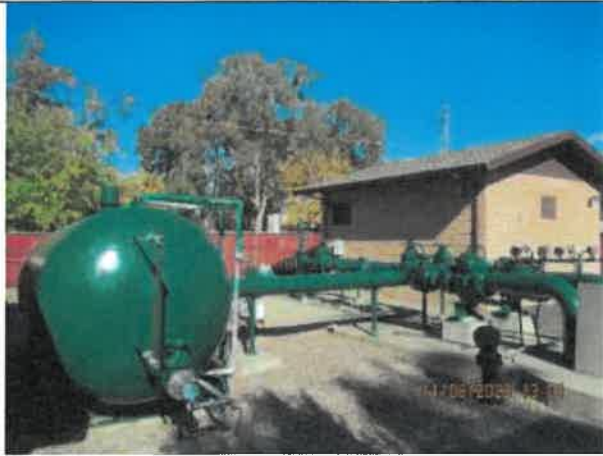
Photo 19: A photo of the recently painted aboveground pumps and piping system at Pump Station No. 3.

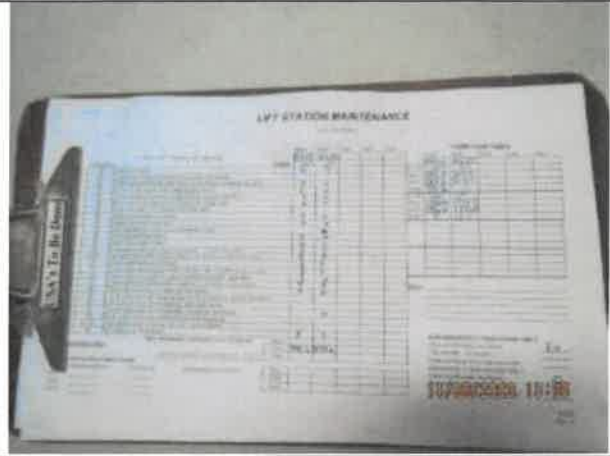
Photo 20: A photo of the November 6, 2023, maintenance check sheet at Pump Station No. 3.

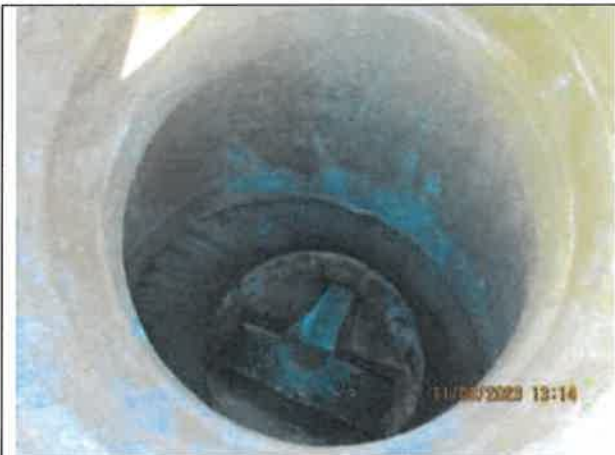
Photo 21: A photo on the manhole located at the intersection of Bay Street and Lakeview Way with fast flow.

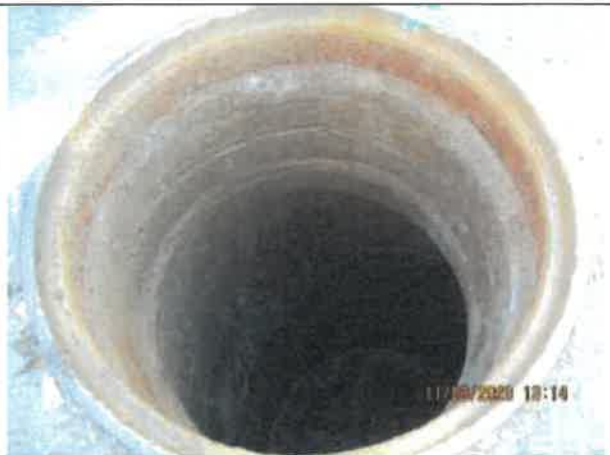
Photo 22: A photo on the manhole located at the intersection of Bay Street and Lakeview Way with corrosion around the rim and staining in the barrel.

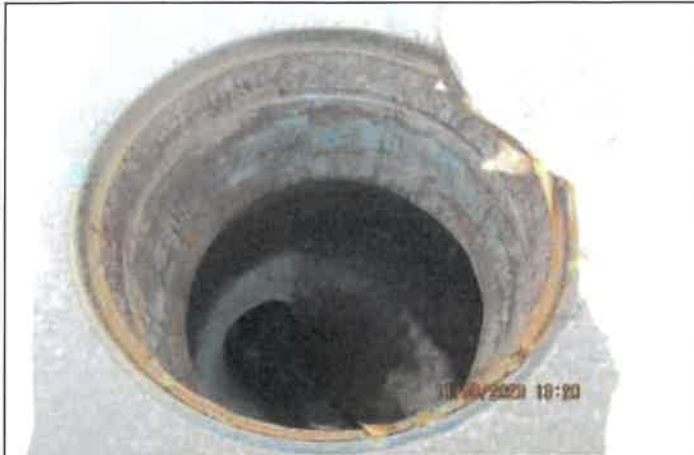
Photo 23: A photo on the manhole located in front of 6825 Meadowbrook Drive with corrosion around the rim.

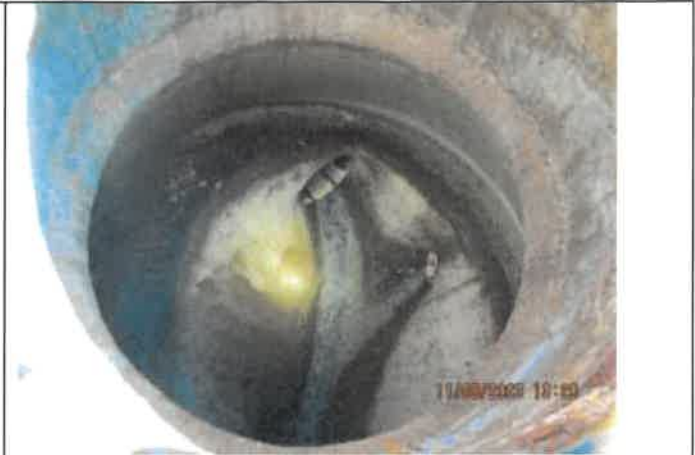
Photo 24: A photo on the manhole located in front of 6825 Meadowbrook Drive low flow and FOG on the sides of the manhole channel.

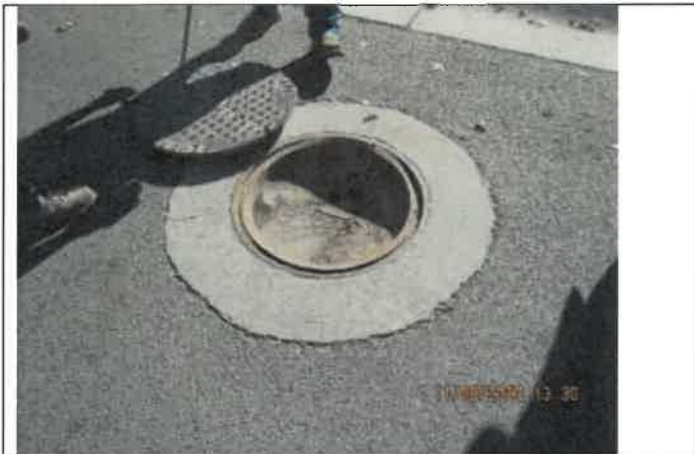
Photo 25: A photo on the manhole located in front of 6925 Meadowbrook Drive with a manhole barrier lid and cracking in the concrete around the manhole.

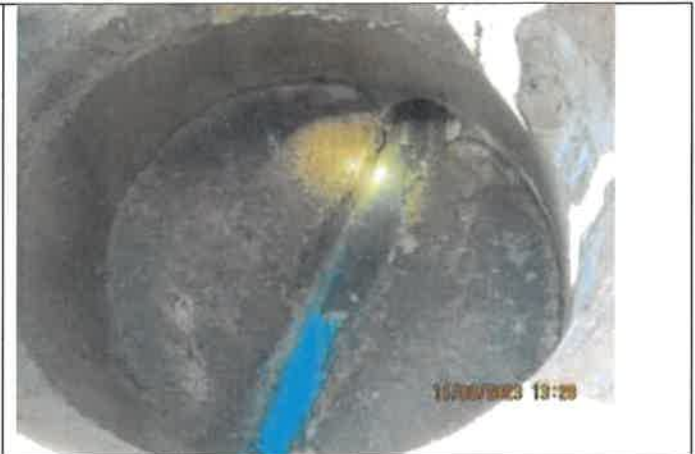
We then traveled to another manhole in the Meadowbrook area, located in front of 6925 Meadowbrook Drive, where we arrived at approximately 1328. The manhole had a manhole barrier lid and cracks in the concrete around the manhole (Photo 25). The manhole had a vertical crack in the barrel, no flow, and standing water in the channel (Photo 26).

Photo 26: A photo on the manhole located in front of 6925 Meadowbrook Drive with a vertical crack in the manhole barrier and no flow in the channel.

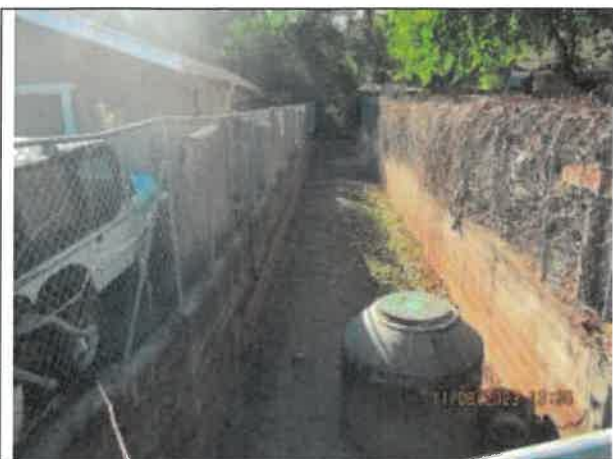
Photo 27: A photo of the manhole in the canal on Stonybrook Drive.

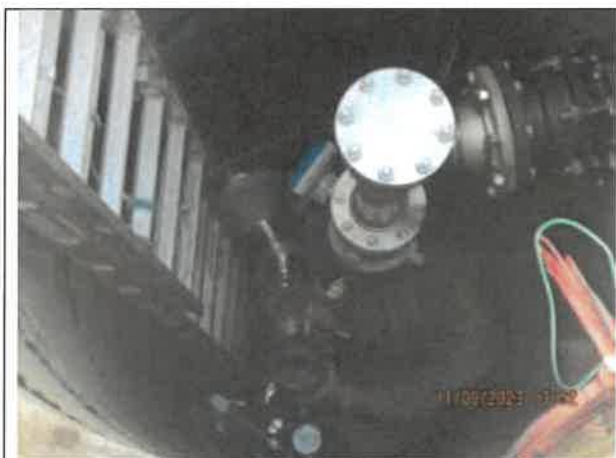
Photo 28: A photo of the direct in-line pumping system being put into place at Pump Station No. 6.

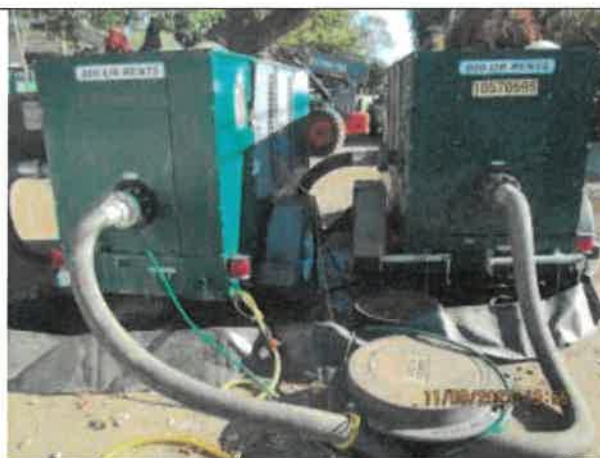
Photo 29: A photo of the portable bypass system being used while Pump Station No. 6 is under construction.

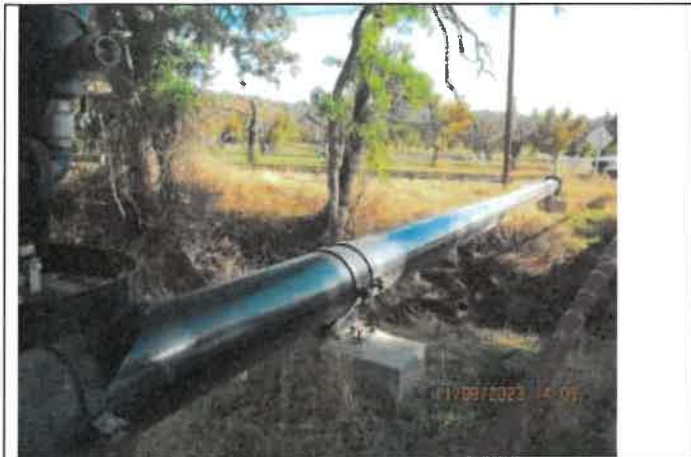
We then traveled to the aerial crossing over Burns Valley Creek, located at the intersection of Rumsey Road and Pamela Lane, and arrived at approximately 1406 (Photo 30). Mr. Harter stated that the aerial crossing is a force main and does not have any secondary encasement. The lock on the ARV was broken and was replaced by Mr. Spooner at the time of the inspection. Mr. Spooner

Photo 30: A photo of the force main aerial crossing located at the intersection of Rusmey Road and Pamela Lane with no secondary encasement.

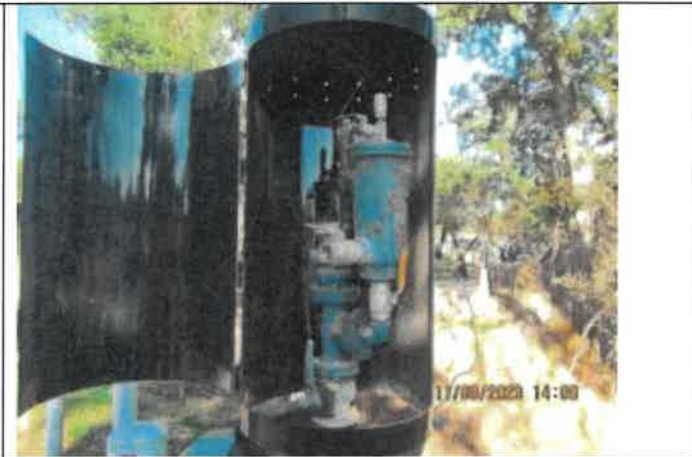
opened the encasement around the ARV and the ARV had a lot of cobwebs around it (Photo 31). There was no emergency signage for the aerial crossing or the ARV.

Photo 31: A photo of the ARV located at the aerial crossing with cobwebs around the ARV.

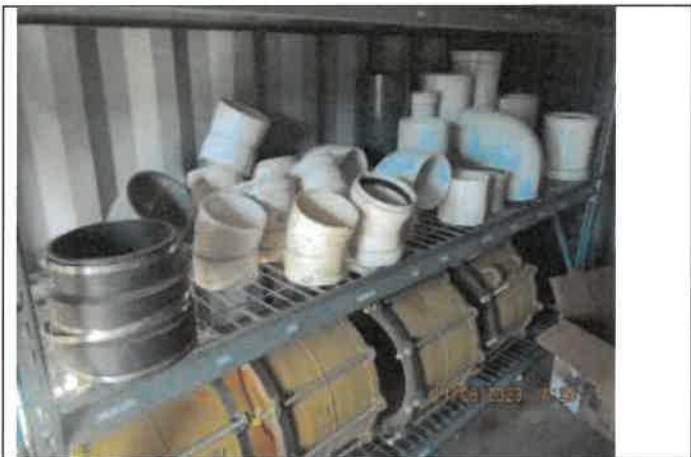
Photo 32: A photo of spare parts at the utility yard.

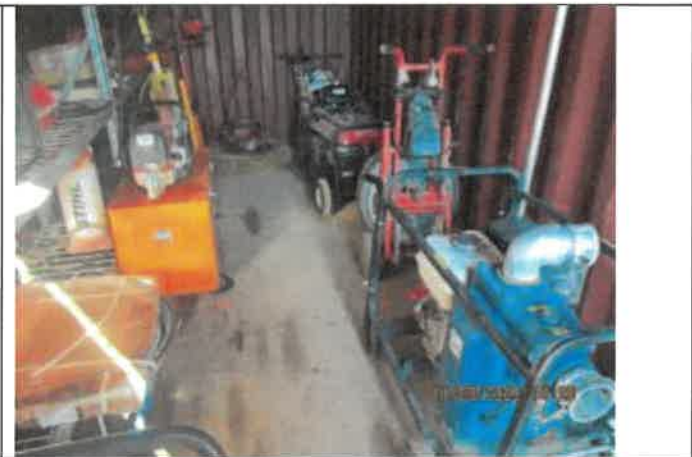
Photo 33: A photo of the portable generators at the utility yard.

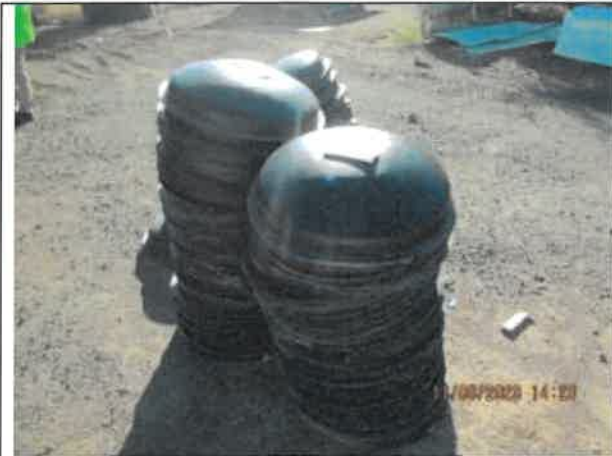
Photo 34: A photo of spare manhole barrier lids at the utility yard.

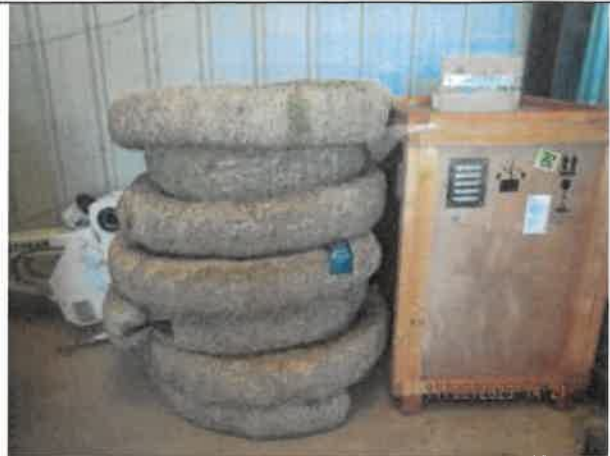
Photo 35: A photo of waddles for SSO response at the utility yard.
