Certified Spill Report for Category 1 Spills

Spill Event ID:	904788	Spill Location Name:	2735 Robin Lane, Clearlake
Sanitary Sewer System:	Southeast Regional Waste Disp Fac CS	Agency:	Lake Cnty
Spill Report Type:	Category 1 Spill	Spill Report Status:	Certified
Initial Draft Submitted On:	01/14/2026	Certified On:	04/10/2026
Spill Report Version Number:	2.2

Summary Report of Cause and Circumstances of the January 11-12, 2026 Event:

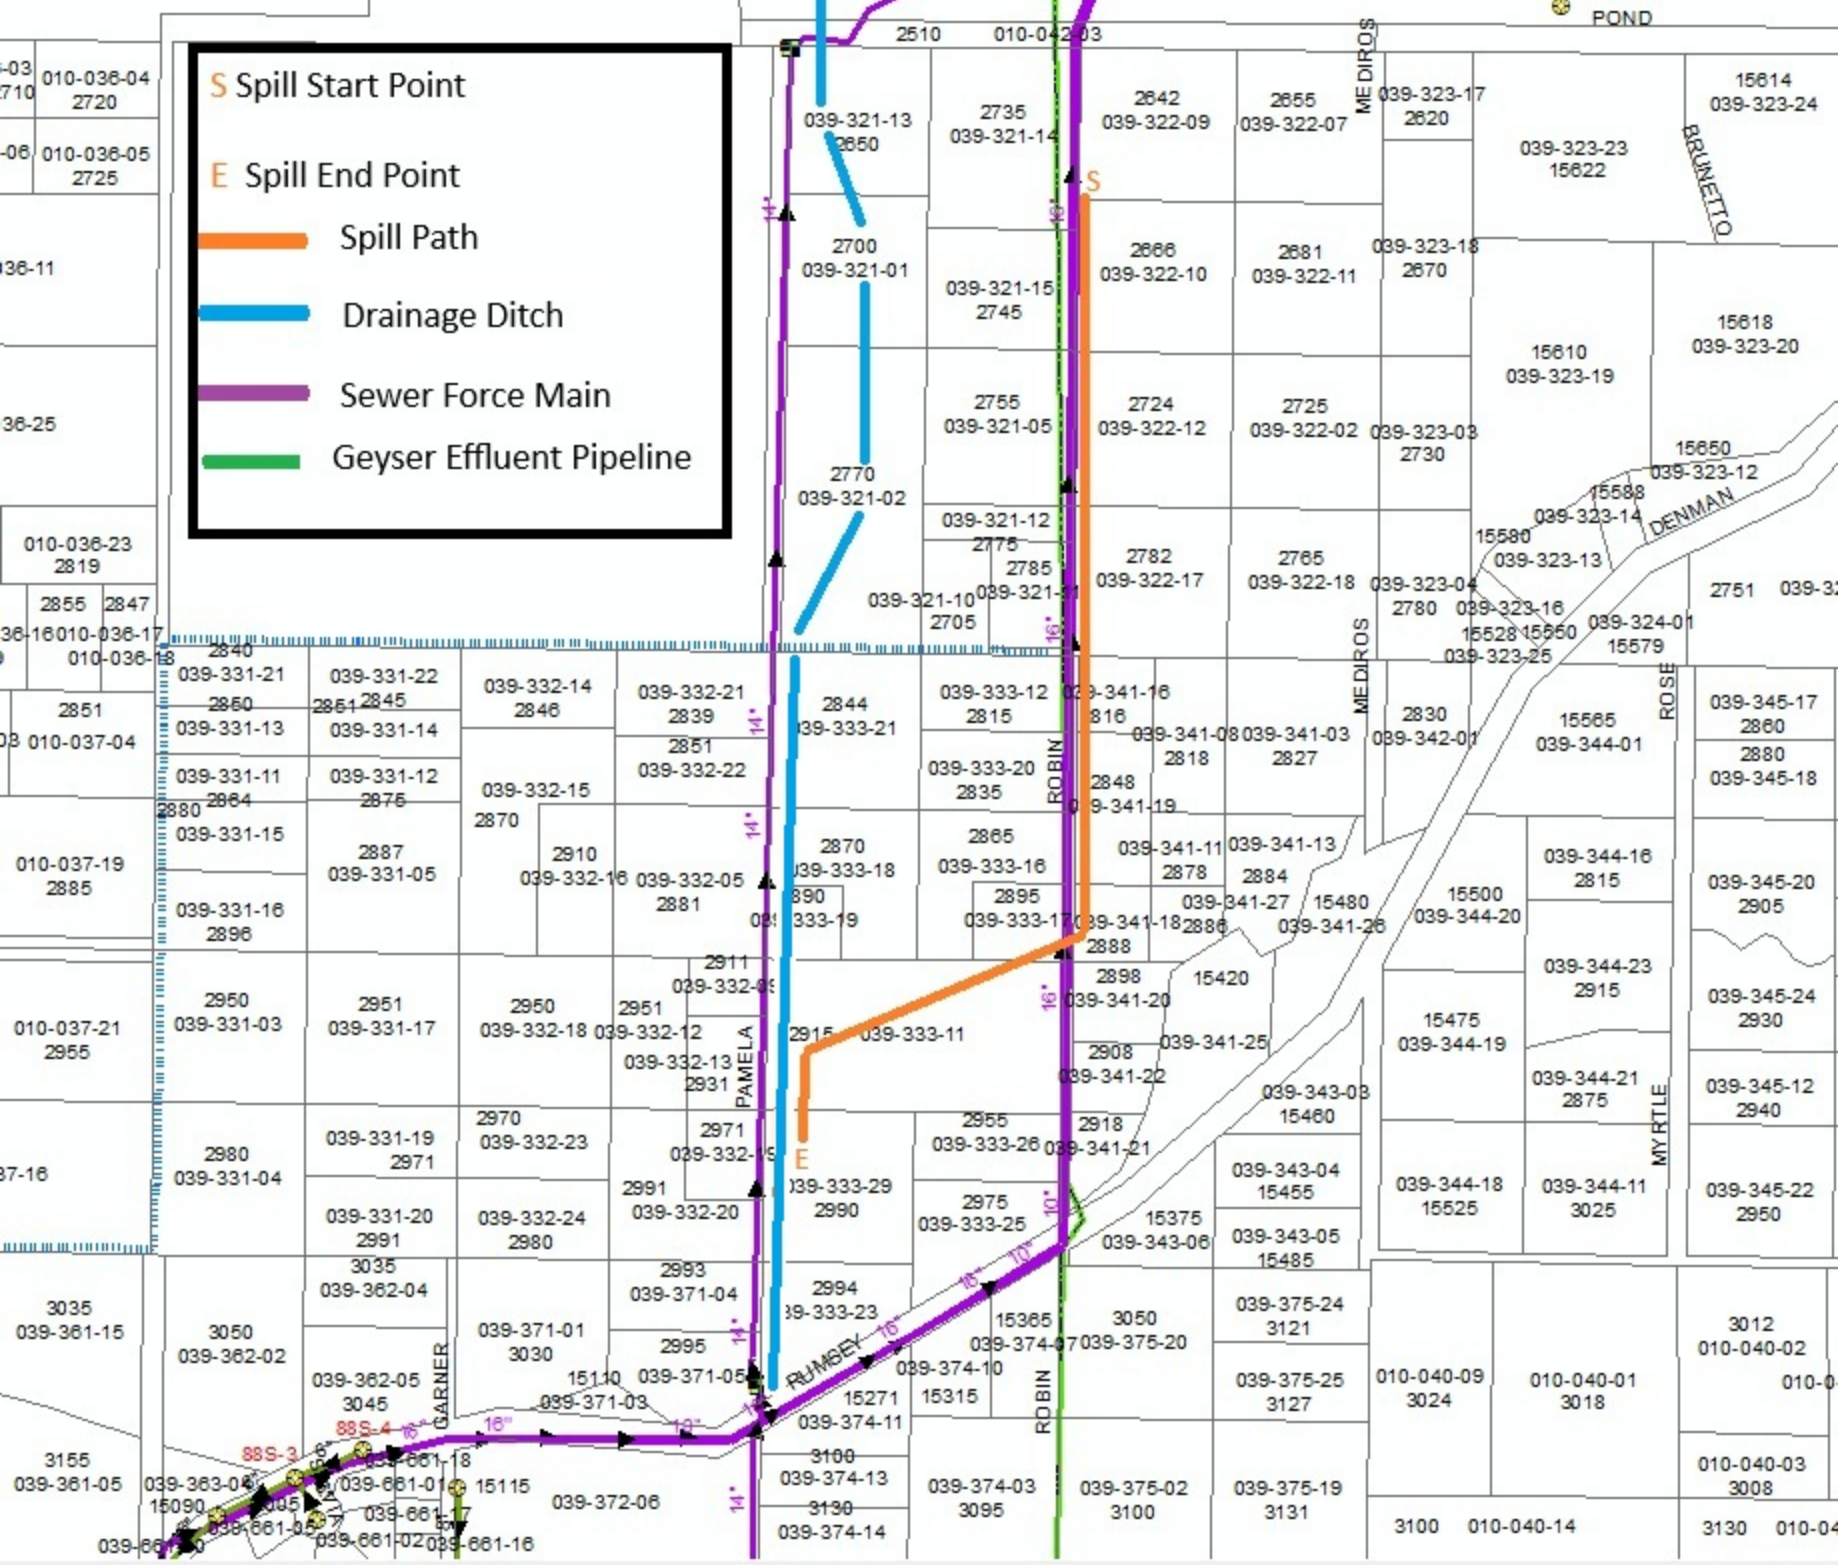
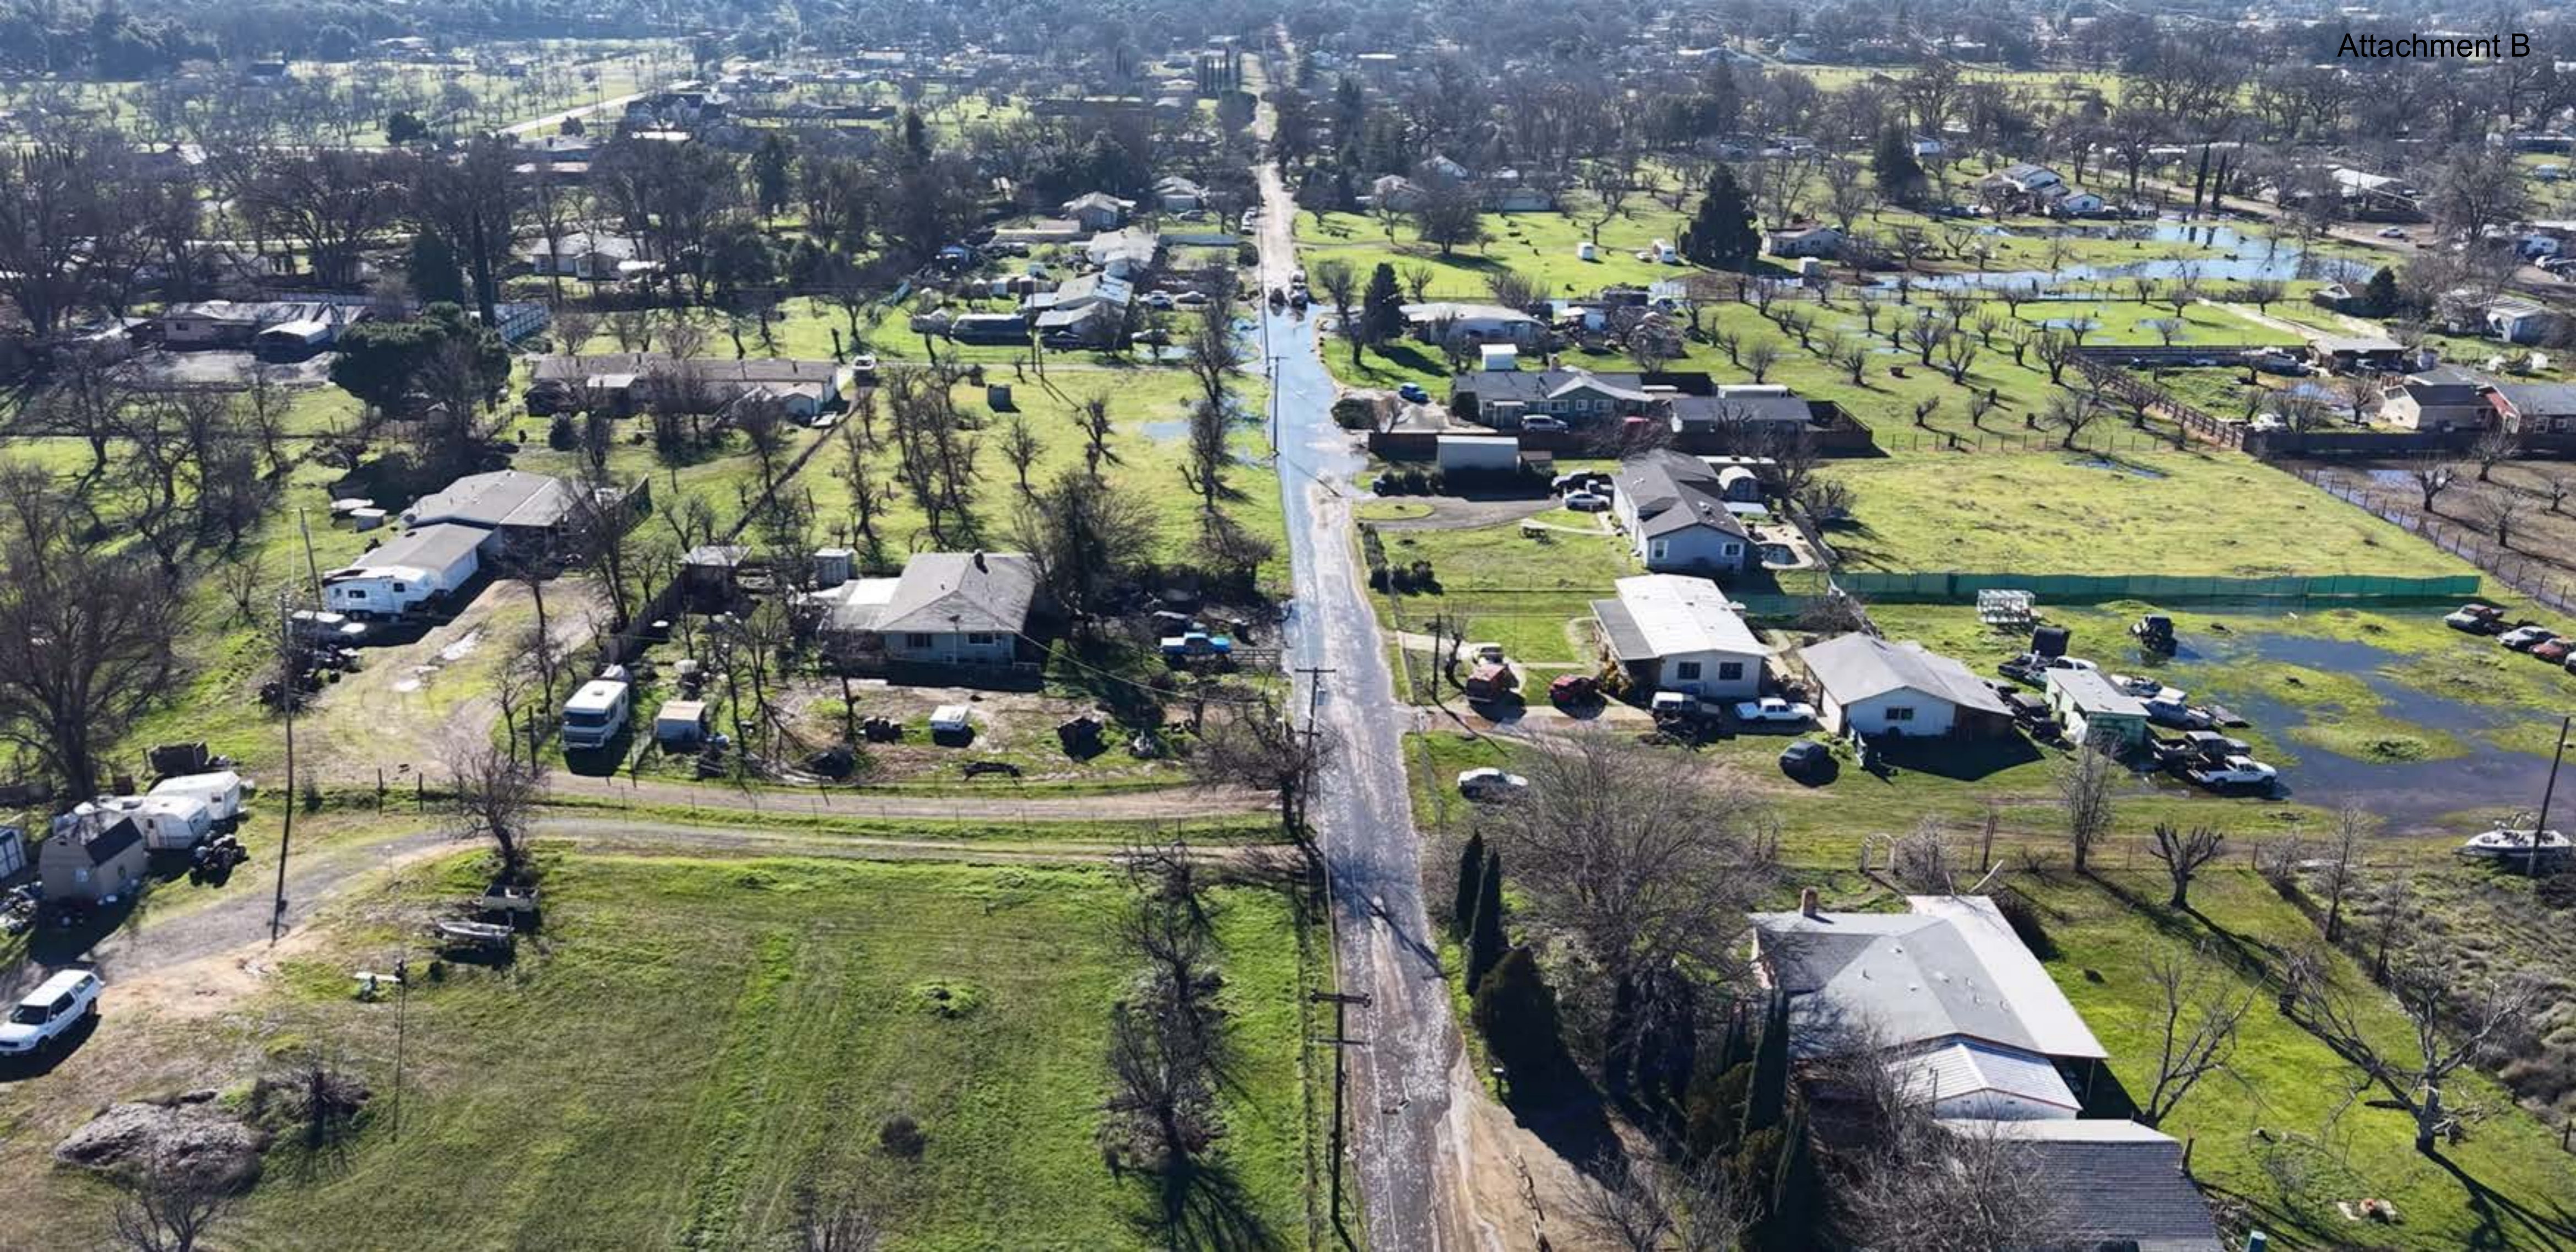
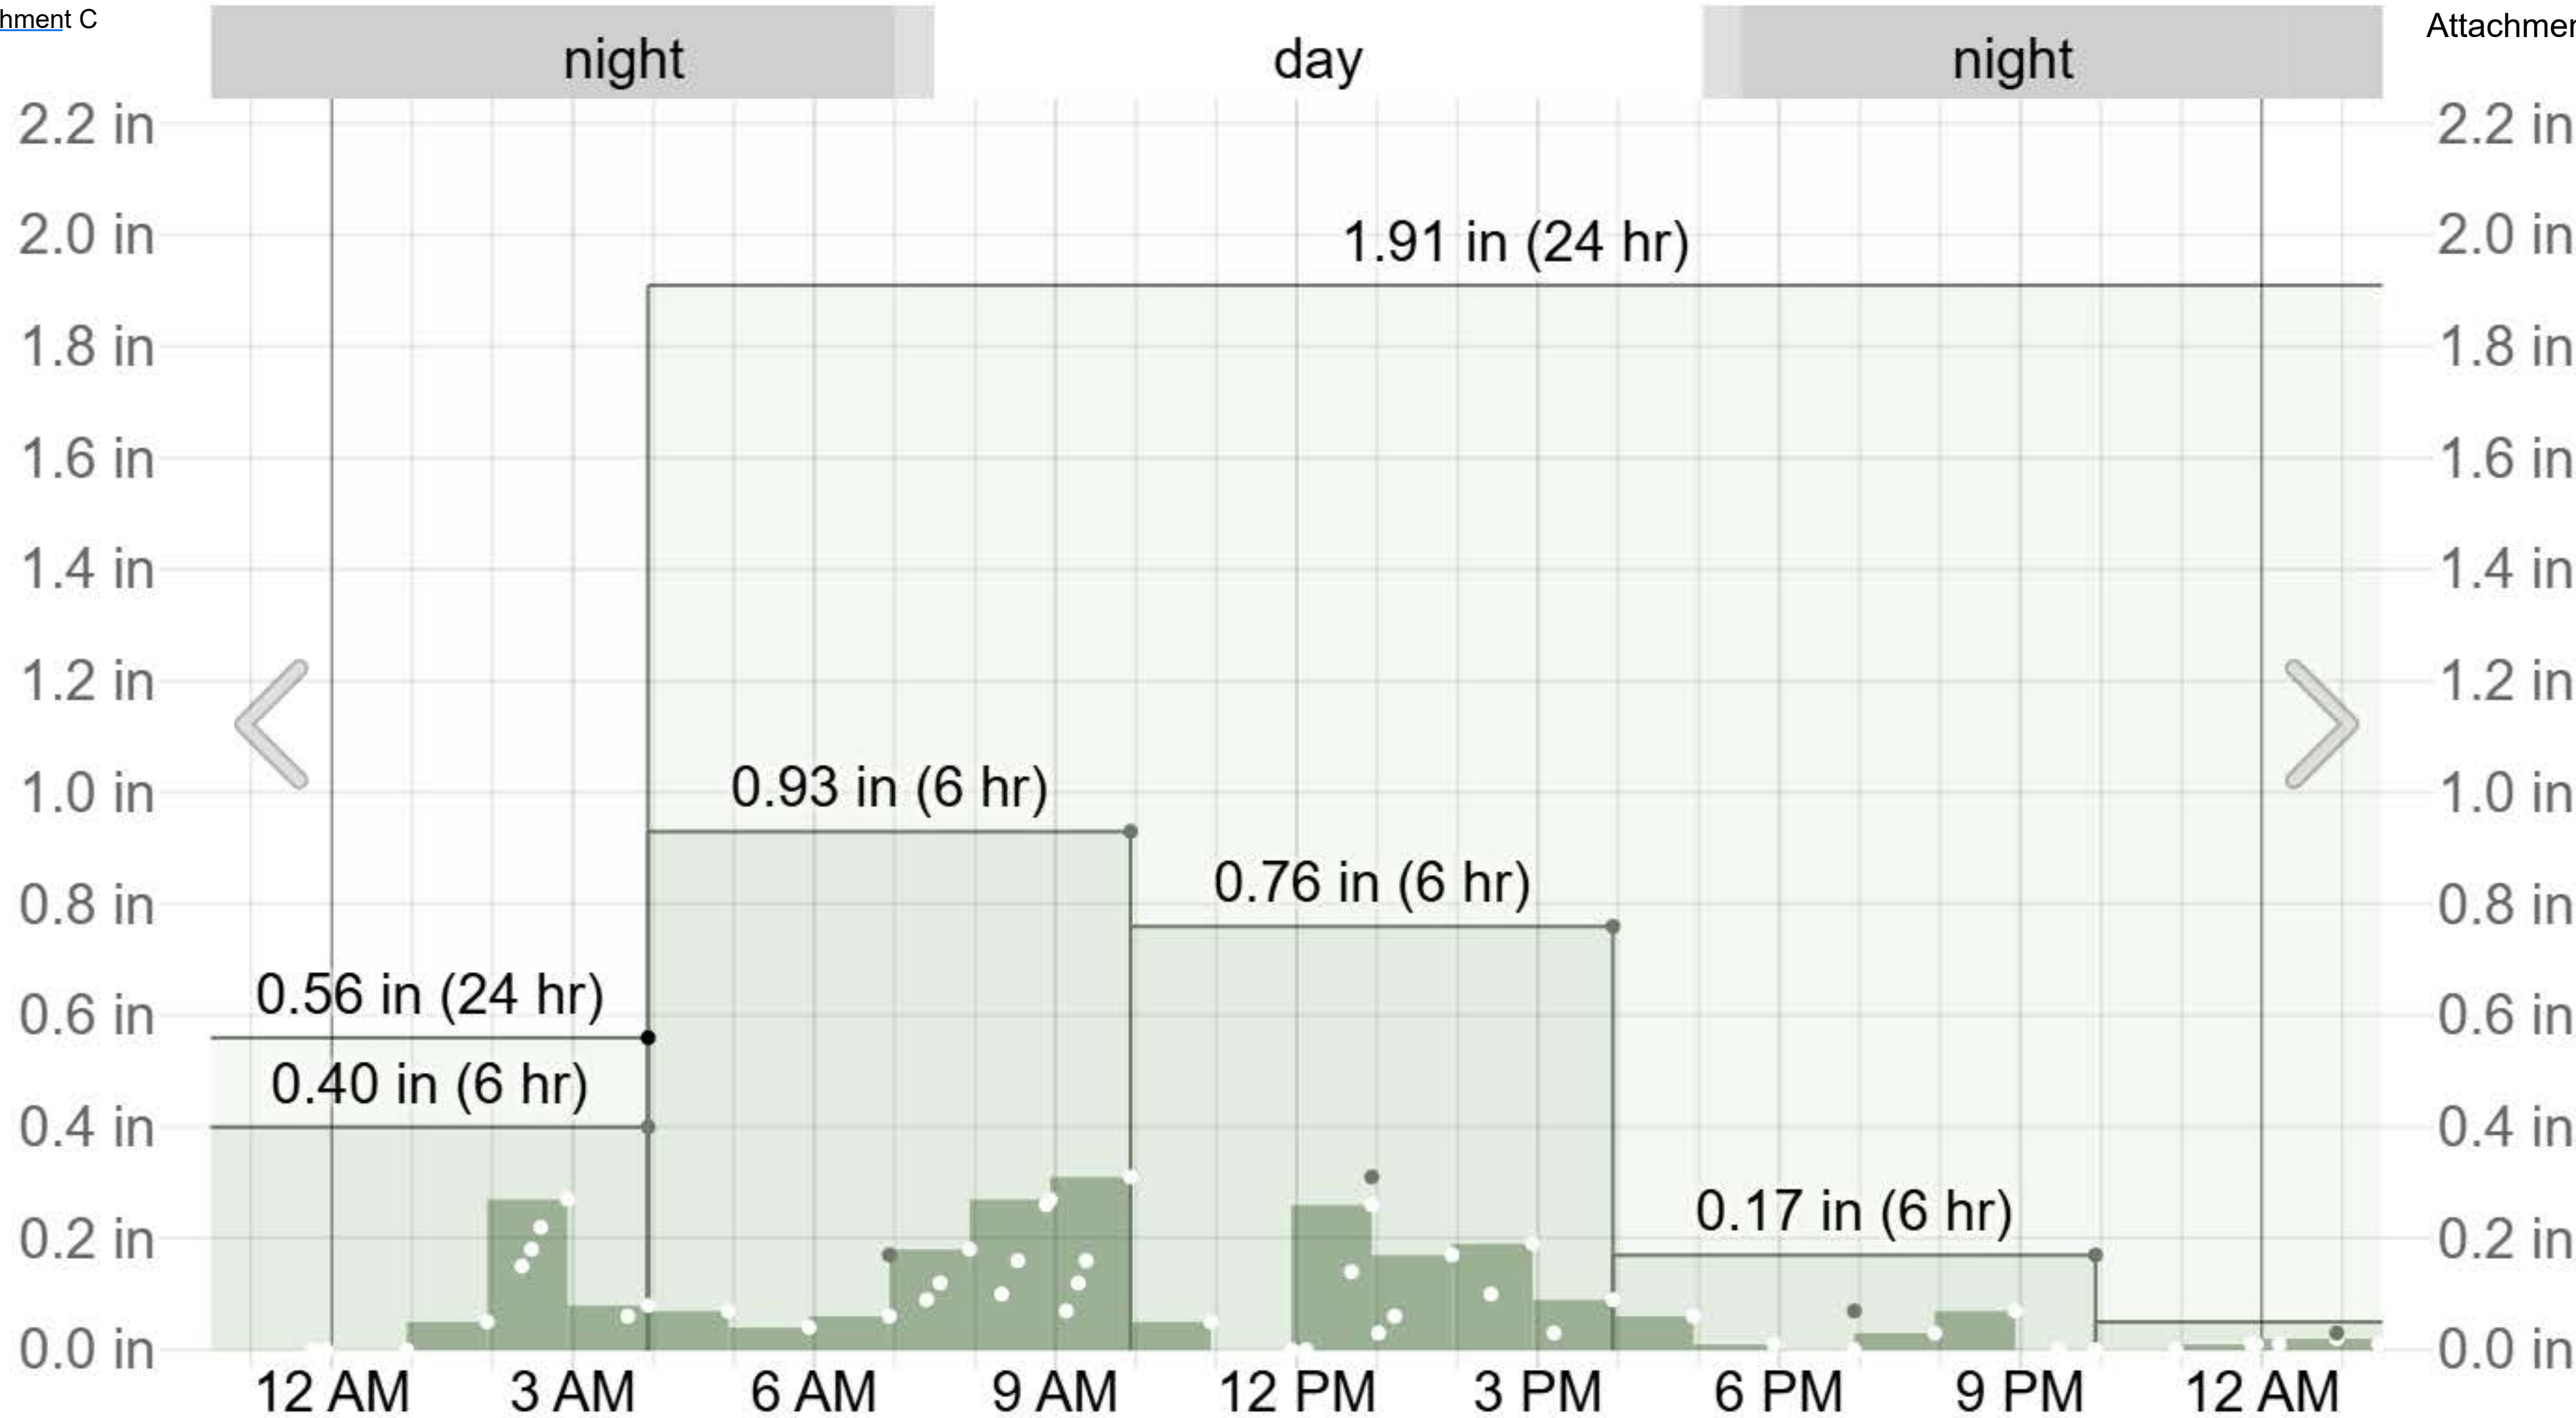
The attached aerial view photos and GIS mapping photos show the failure location, appearance point, and flow pathway. (See Attachments A and B.)

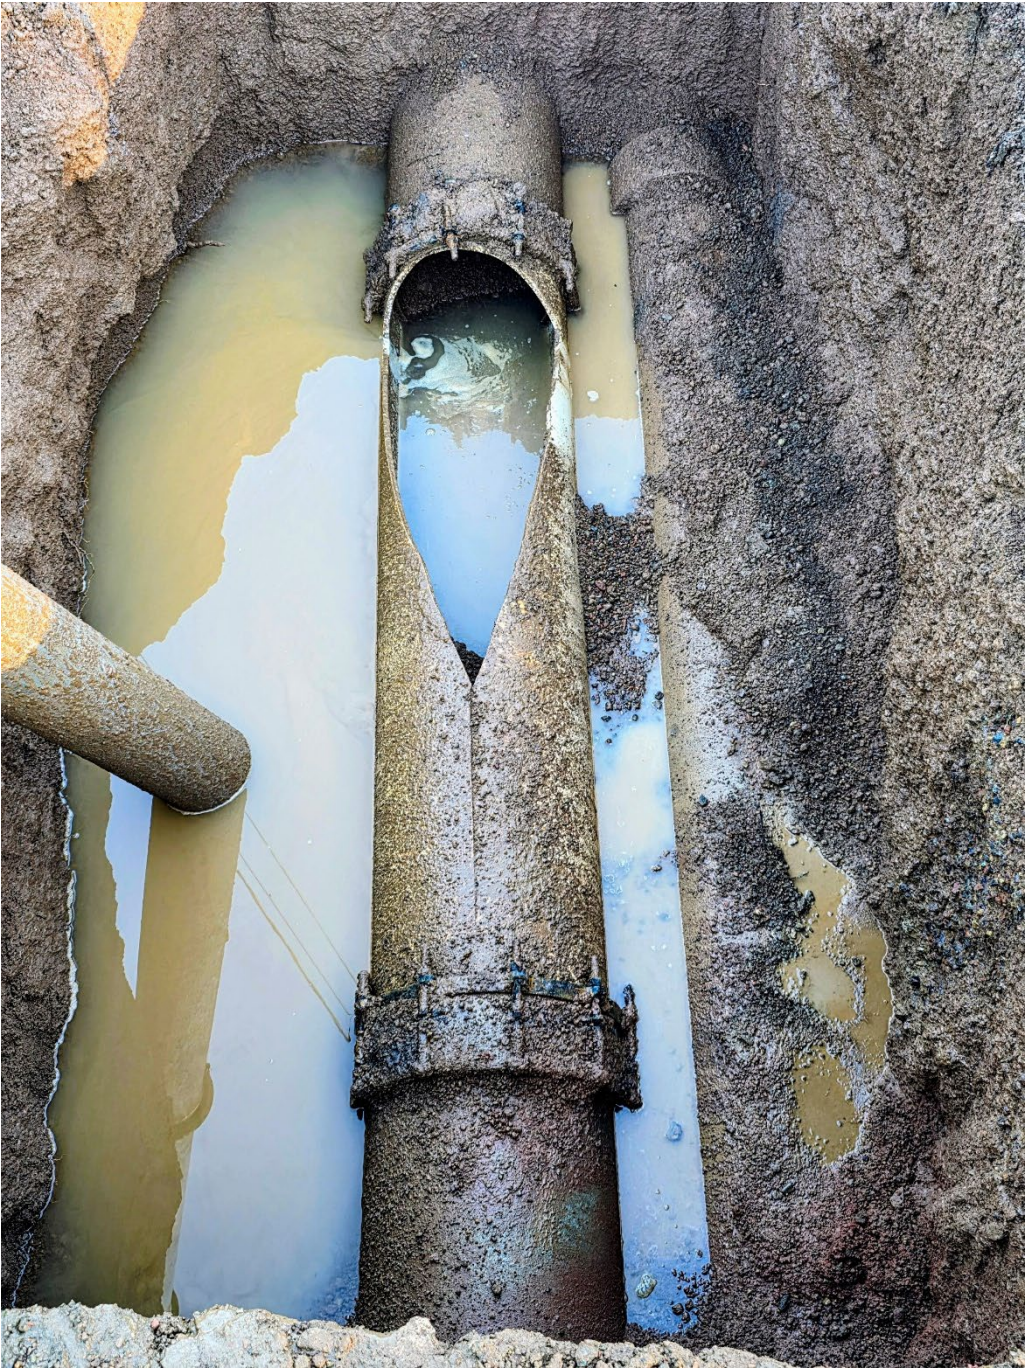
Failure Point

The cause of the spill was the failure of the force main pipeline at the site of a previous repair performed in 2003. Upon excavation, District staff identified that a section of pipe associated with the historical repair had deteriorated and failed, allowing wastewater to escape. (See photos at Attachment D.)

The damaged pipe was replaced with new pipe and appropriately sized couplers designed for the 16-inch force main. After installation, the replaced section was inspected, and the force main was returned to service.

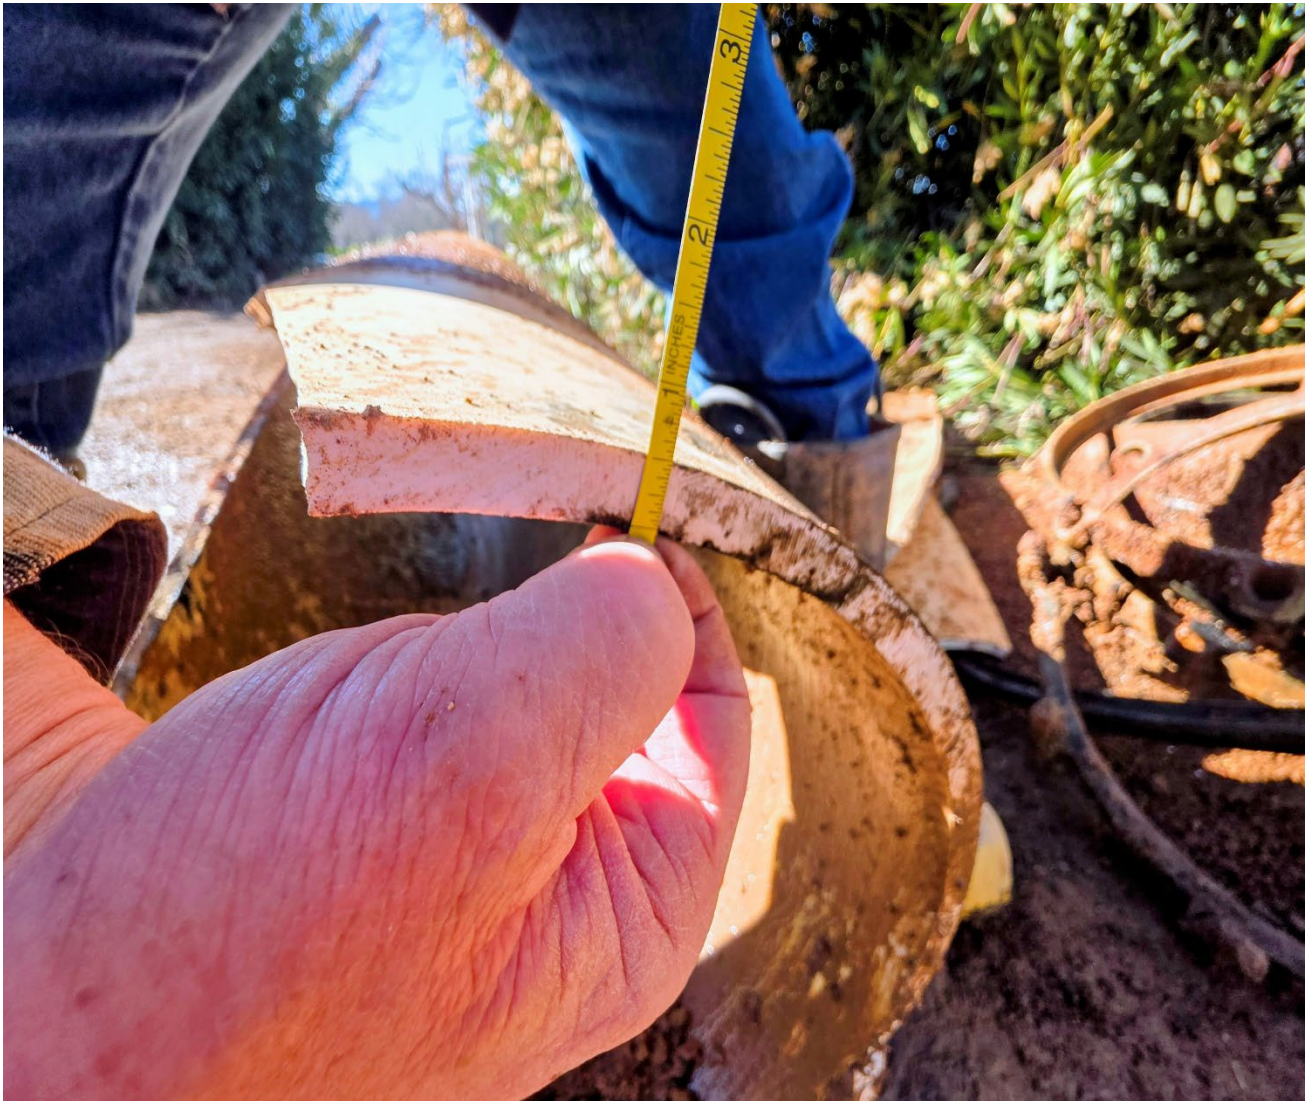
Up close view of failed pipe
