September 8, 2022

Coburg 500K Gallon Steel Reservoir Seismic Evaluation

Seismic Evaluation

PSE Project Number: 2101-0181

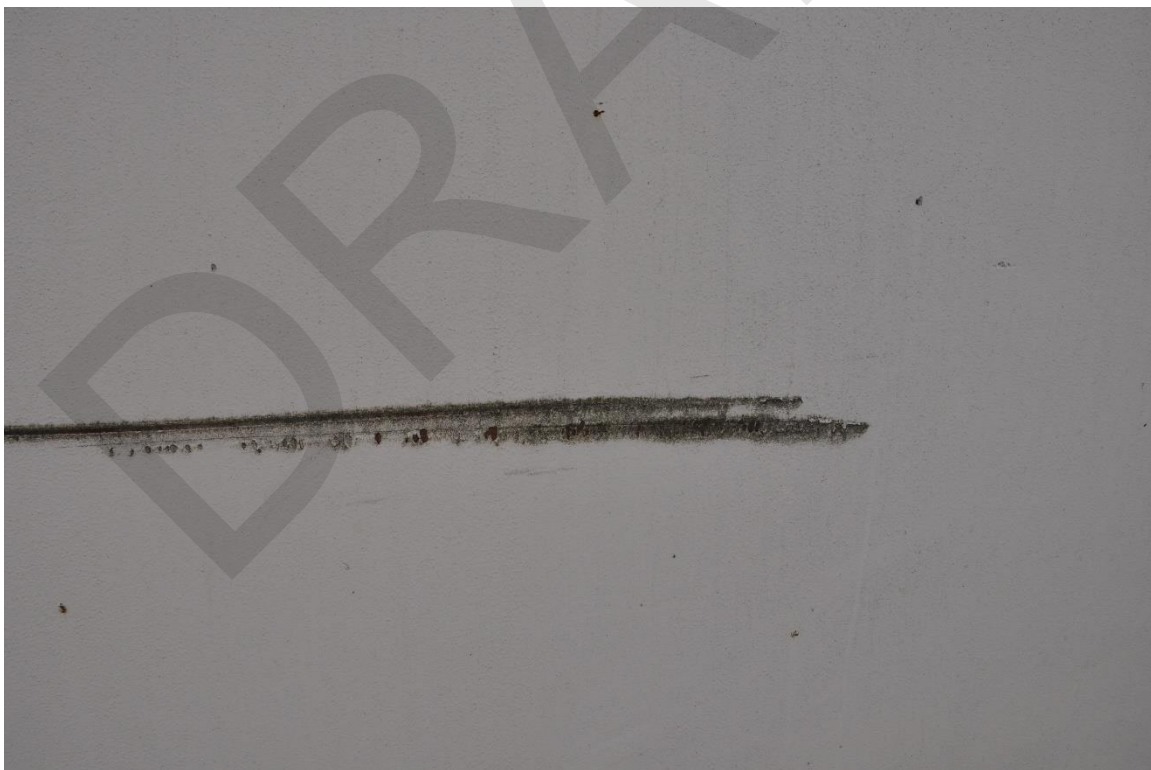
The general exterior condition of the north tank appeared to be in sound structural condition. No significant cracking or weathering of the ring footing concrete was observed. Some minor areas of corrosion were noted at the base of the shell, as well as some areas of flaking in the exterior coating but neither observation appears to present an immediate structural issue. The exterior surface of the roof was free of debris build up but appeared to have some minor areas of corrosion and flaking coating. The interior of the reservoir exhibited areas of corrosion staining at the typical operating level, roof plate seams, rafter flanges, and connection points but it is not a structural concern at this time.

Photo 6 – Tank Exterior Coating Deterioration

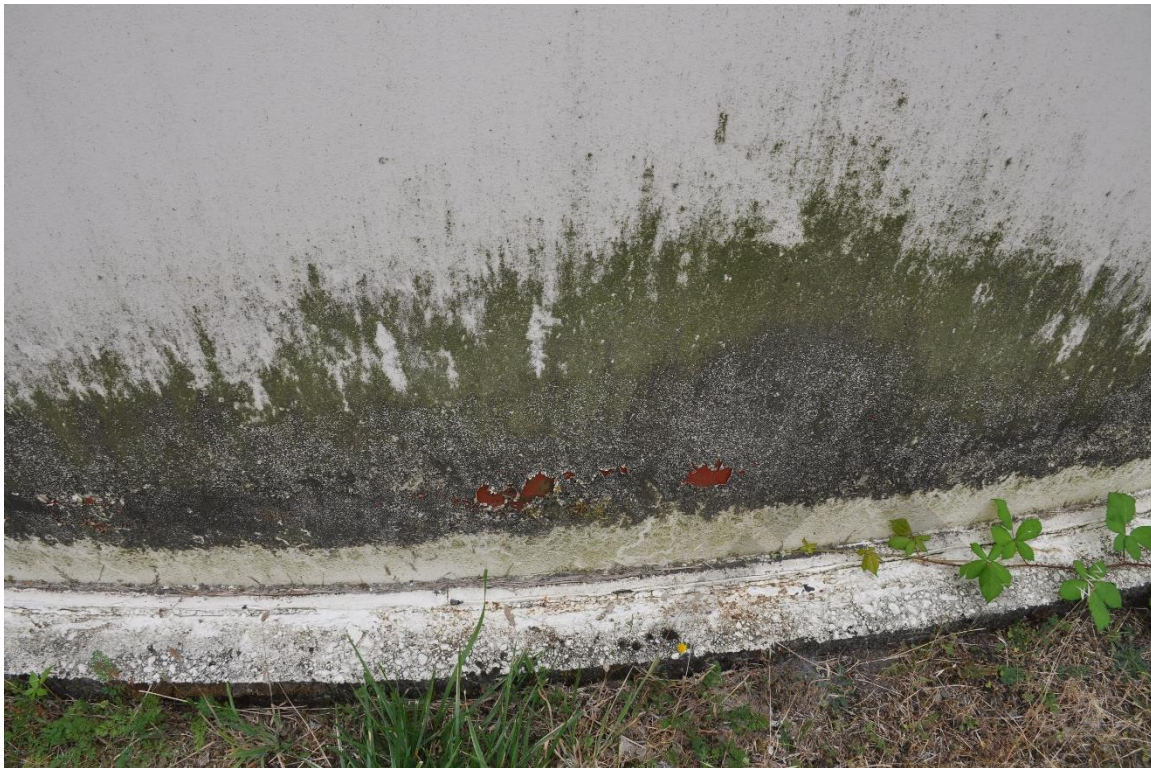
Photo 7 – Tank Exterior Coating Deterioration

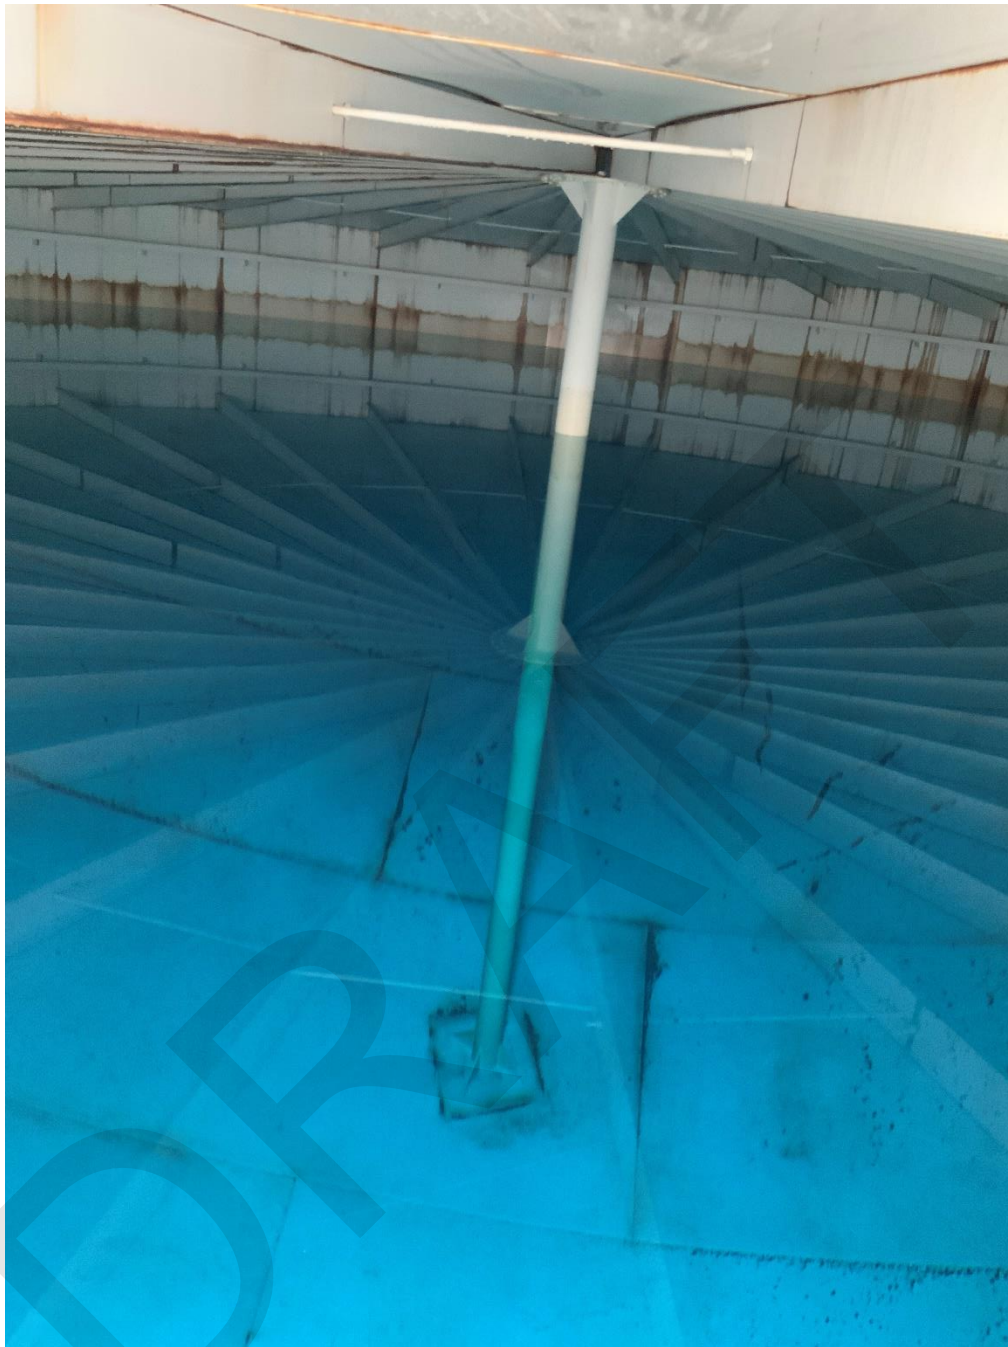
The center column is assumed to be a 6-inch diameter Sch 40 pipe section based on scaled photos and typically specified member sizes. Using A53-B pipe steel, analysis shows the column has adequate capacity for current code gravity loads.

Photo 9 – Tank Interior Center Column

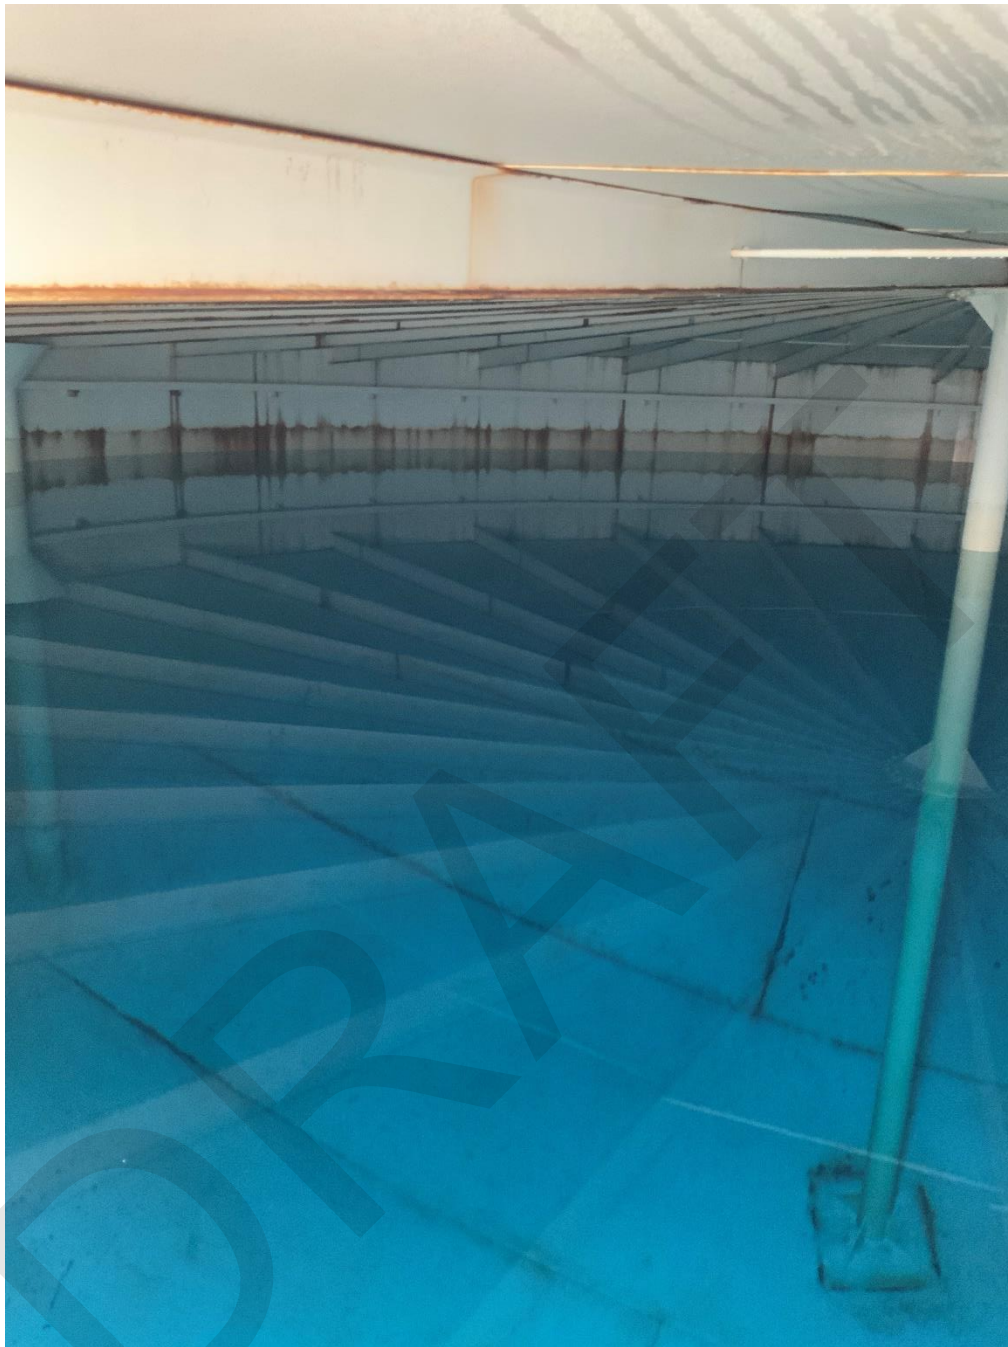
While the roof rafters did not appear to be continuously attached to the roof plate, D100-21 allows for a rafter with a depth less than 15-inches to be evaluated as being continuously braced. If we consider the rafters to be continuously braced per the AWWA code, the rafters are adequate for flexure and shear loading. The maximum deflection is also within the allowable serviceability limits. The roof rafters are anticipated to meet the requirements for ASCE 7-22 in terms of strength but may exceed the deflection limits.

Photo 10 – Tank Interior Roof Framing

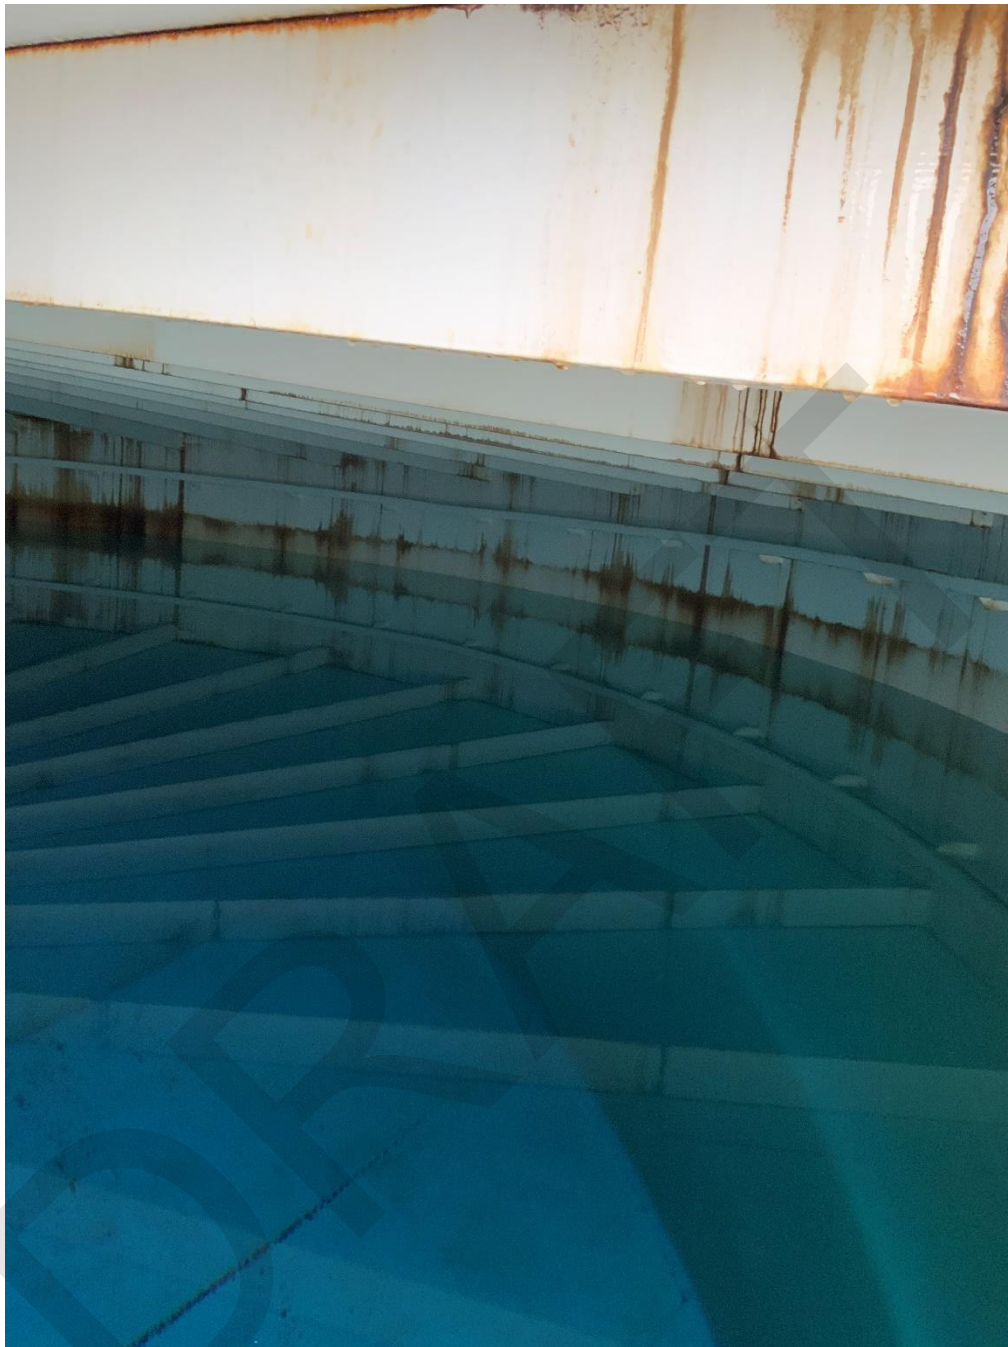
Photo 12 – Tank Interior Roof Framing Corrosion

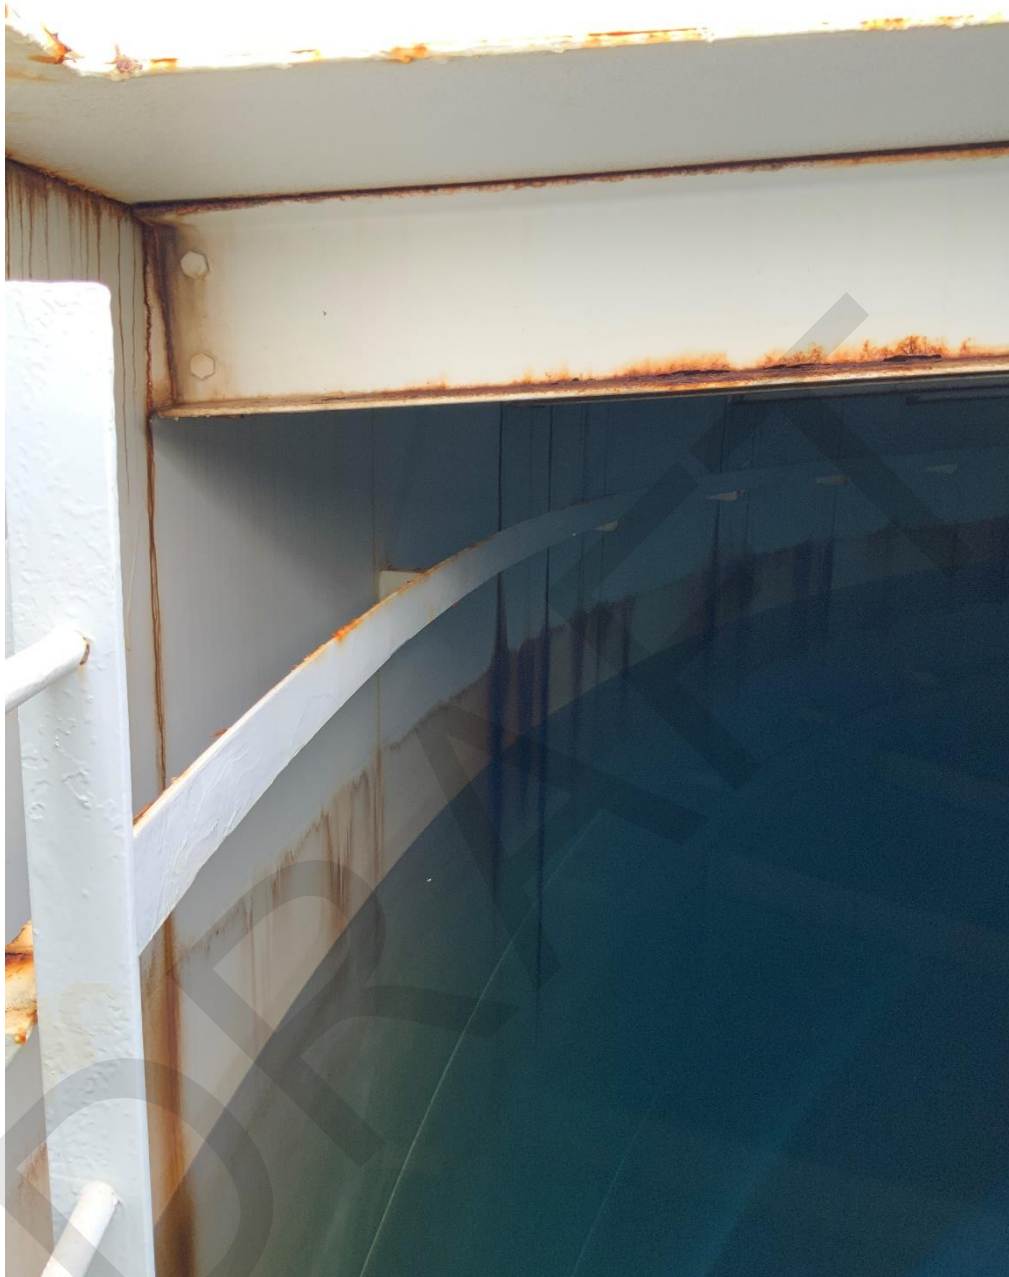
Photo 13 – Tank Interior Roof Framing Corrosion

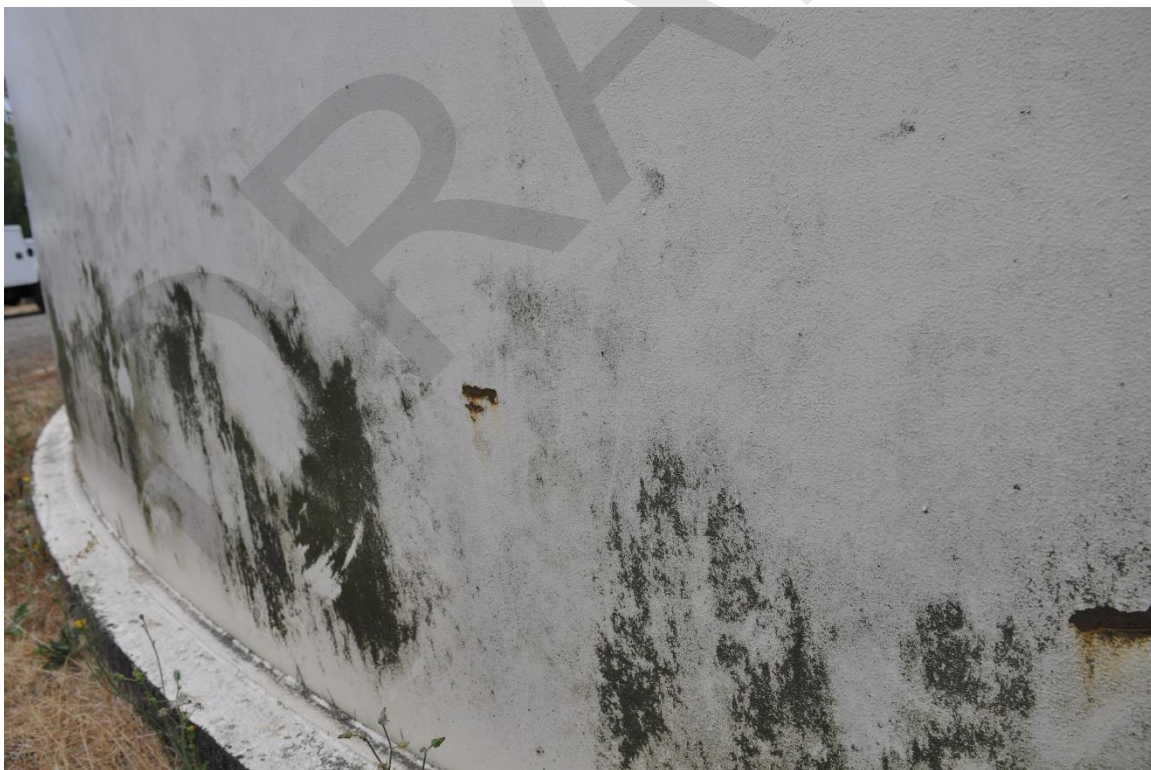
The exterior condition of the south tank generally matched that of the north tank. No notable structural concerns were observed with the visible portion of the footing or wall shell plates. Similar to the north tank, some minor areas of corrosion were noted in the bottom shell course, as well as some areas of flaking of the coating. The exterior surface of the roof was free of debris build up but appeared to have some minor areas of corrosion and flaking coating. The interior of the reservoir exhibited minor areas of corrosion staining, primarily occurring at the roof plate seams and bolted connections but it is not a structural concern at this time.

Photo 19 – Tank Exterior Coating Deterioration

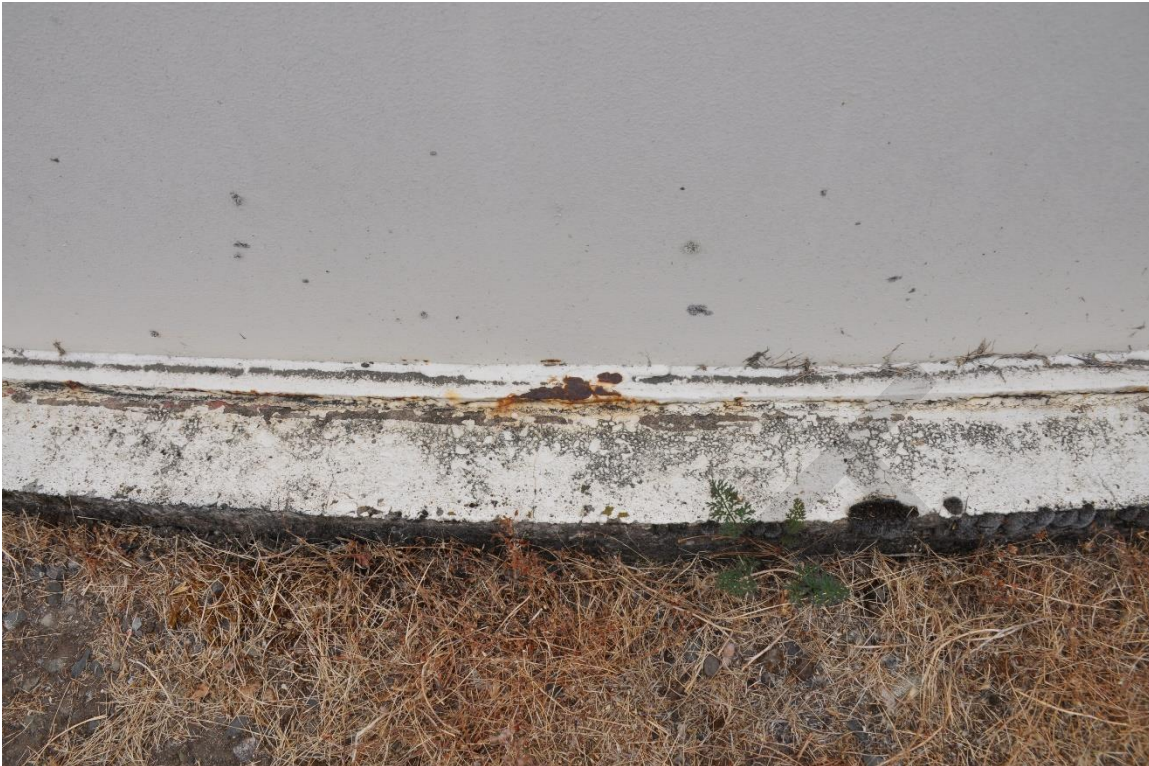
Photo 20 – Tank Exterior Coating Deterioration

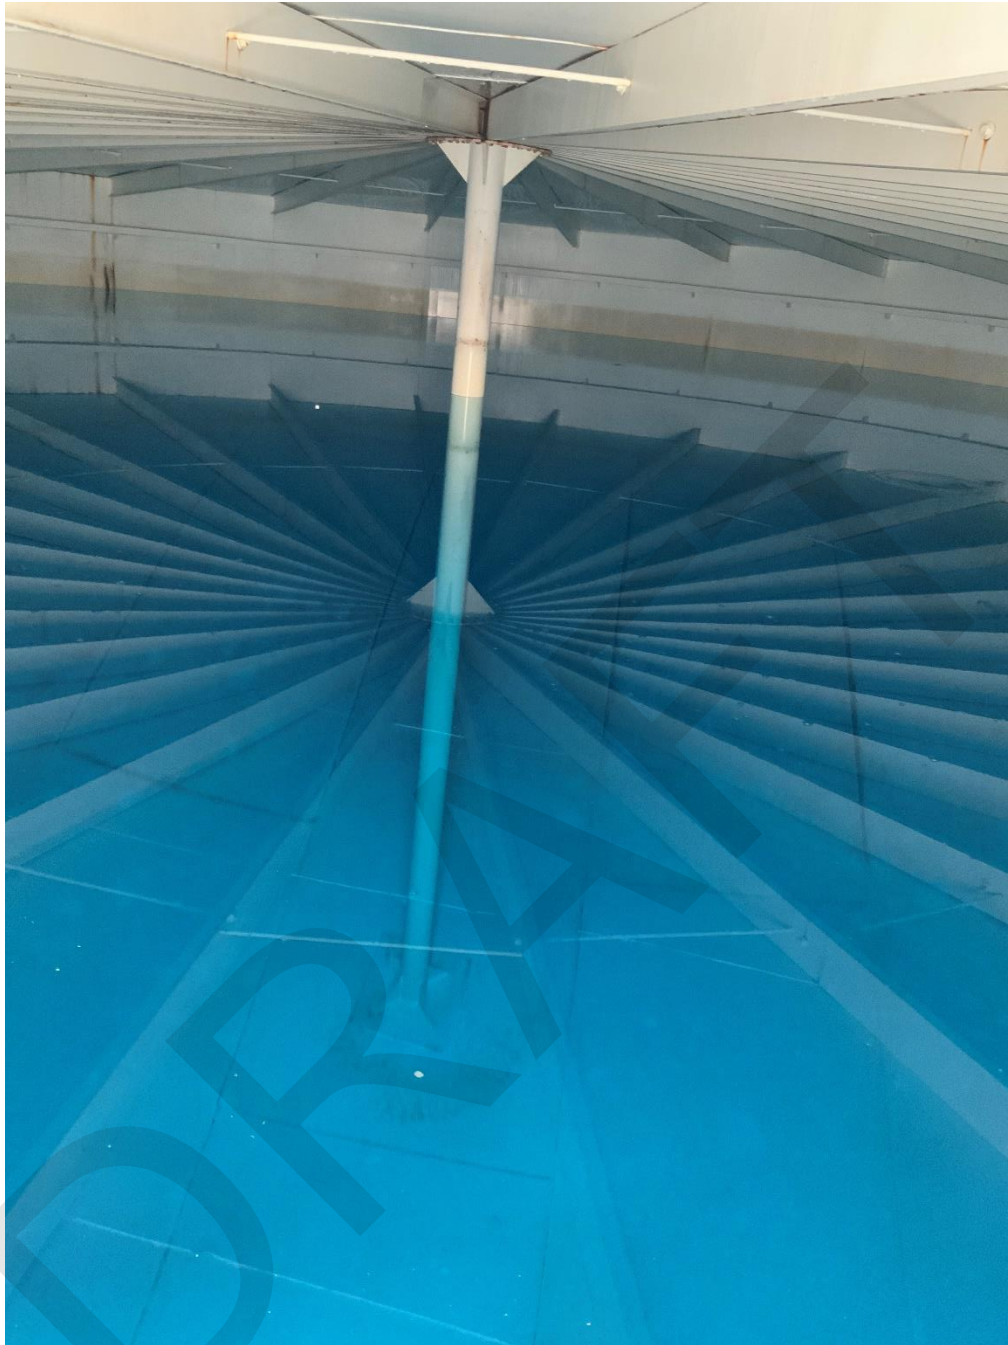
Photo 22 – Tank Interior Center Column

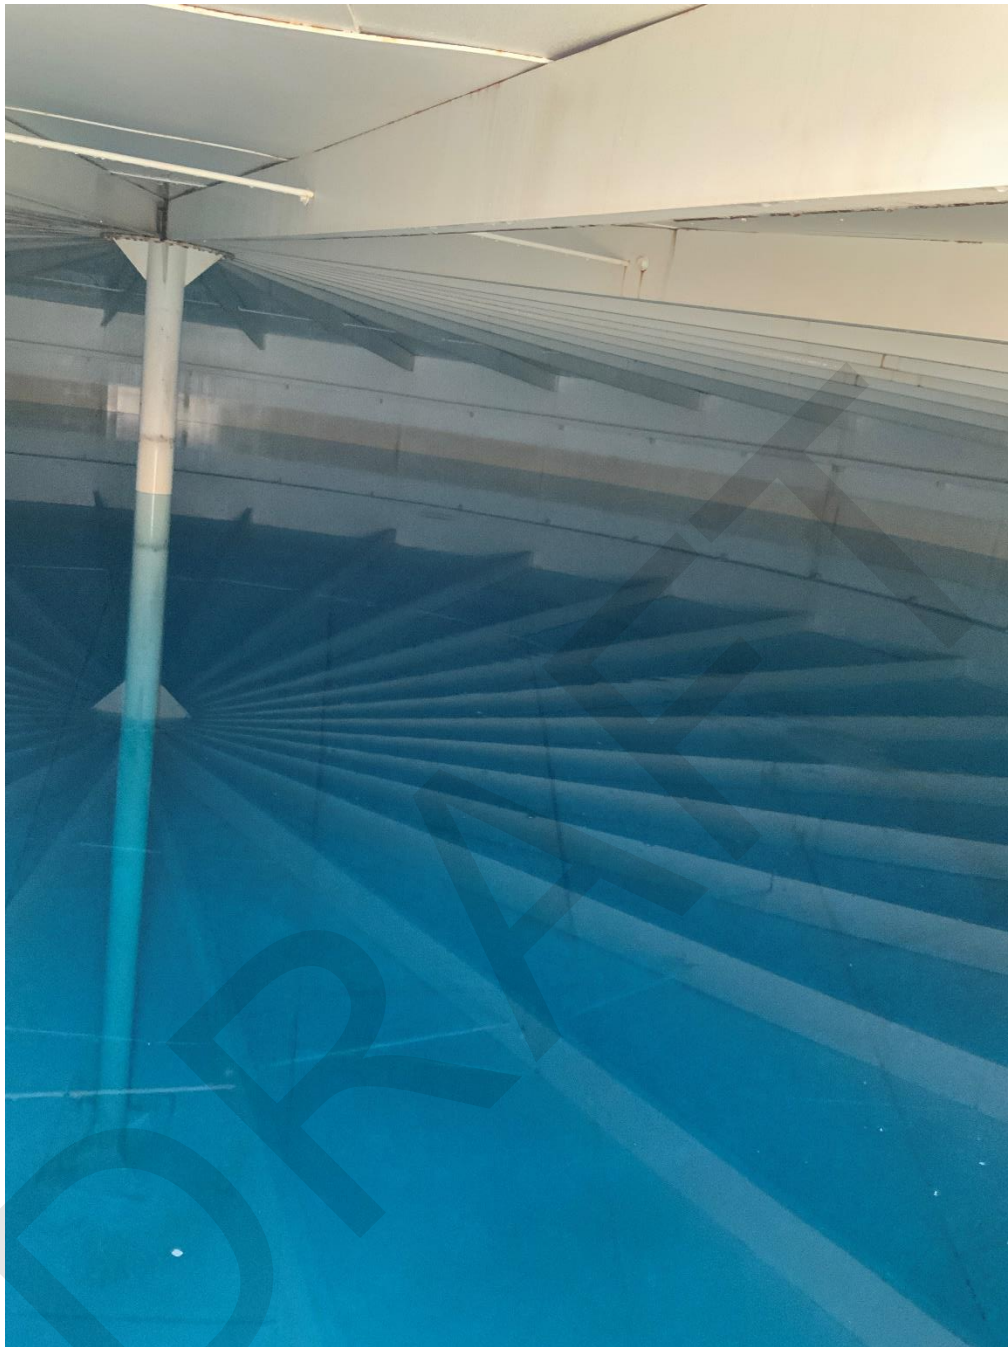
Photo 23 – Tank Interior Roof Framing

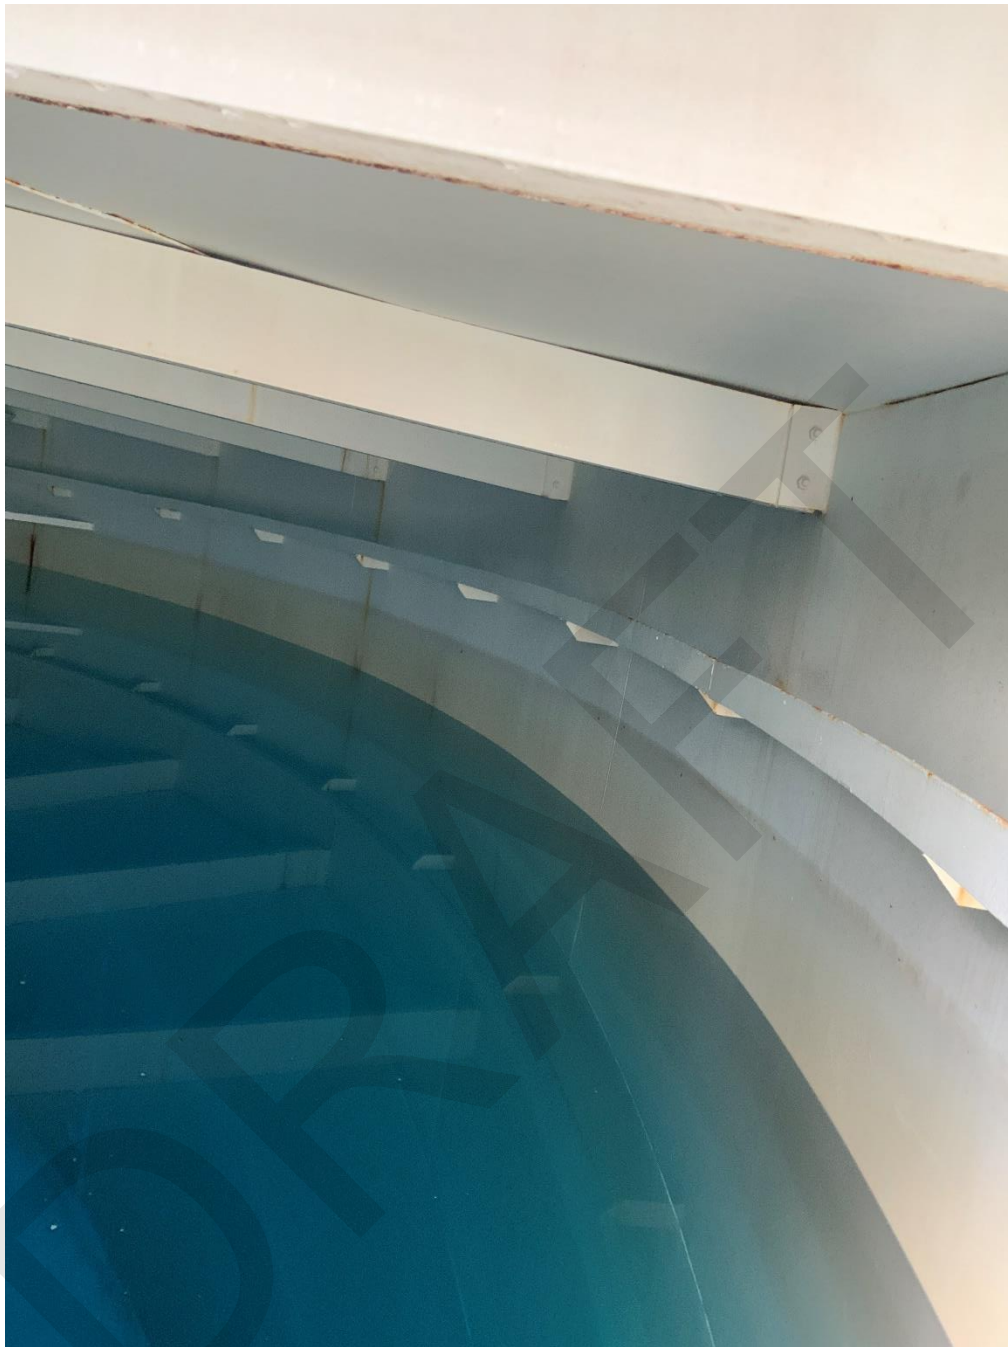
Photo 25 – Tank Interior Roof Framing Corrosion

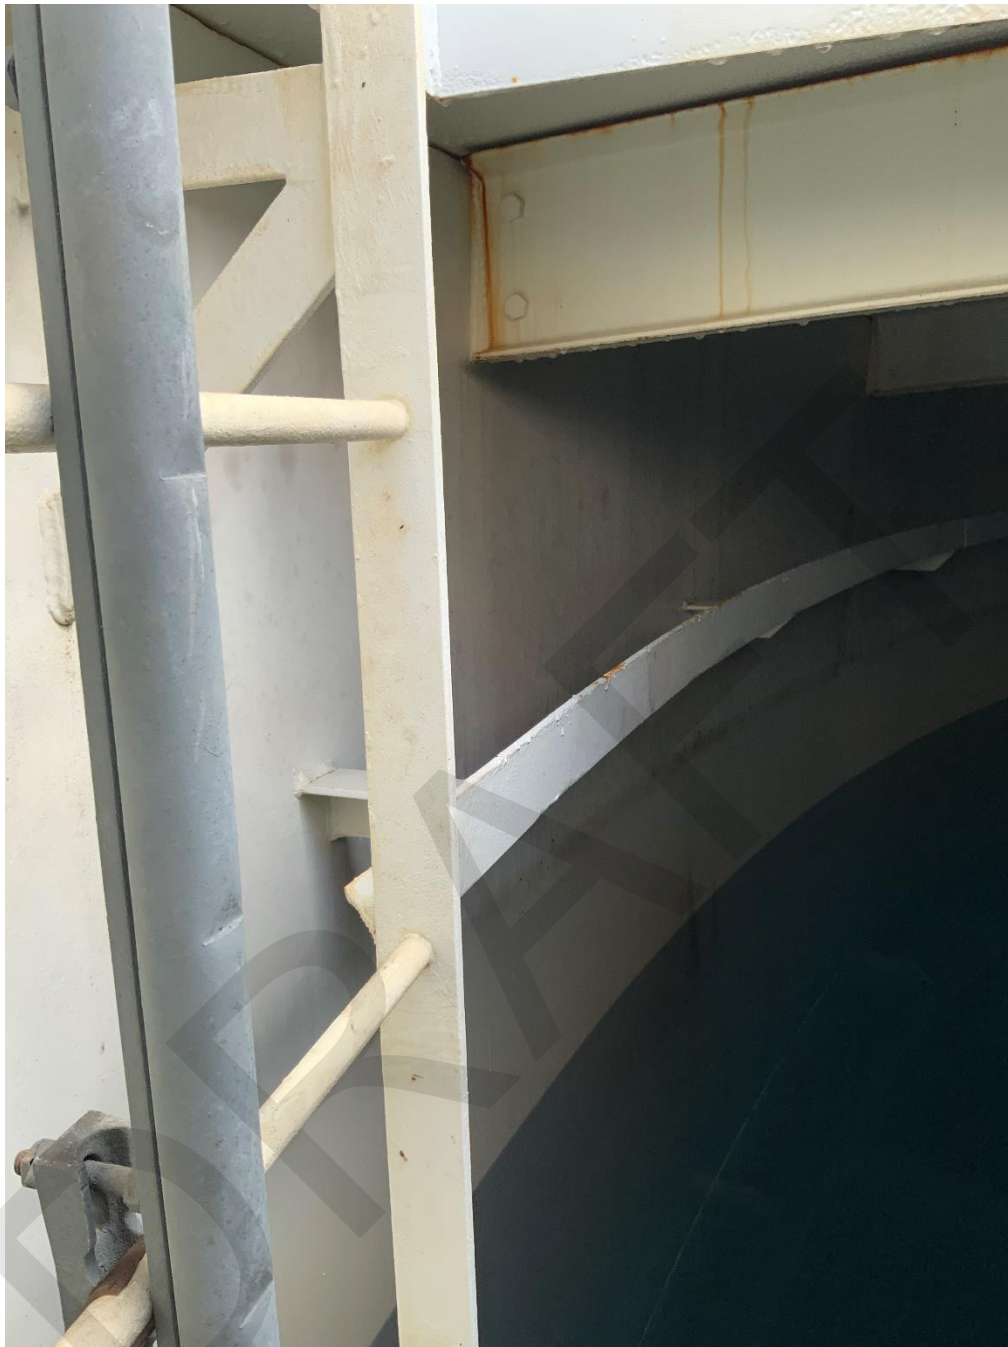
Photo 26 – Tank Interior Roof Framing Corrosion
