**ASBESTOS SURVEY
OF**

10515 Antcliff Rd
Fowlerville, MI 48836

June 9, 2025

DEMOLITION ASBESTOS SURVEY REPORT

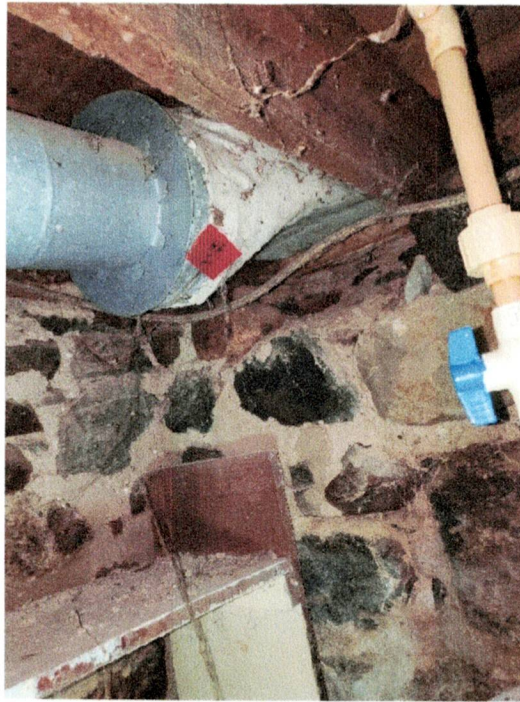
NUMBER	LOCATION	SQ/FT	ASBESTOS	TYPE/MAT/COND/PERCENT
HA1	Duct wrap	3	YES	Chrysotile, friable, Good, 40%
HA8 B	Basement Laundry Cabinet Mastic	8	YES	Chrysotile, Non Friable, Good, 5%
HA9 A-E	Window Glaze	30 ct	Yes	Chrysotile, Non Friable, Poor, 5%

Please see the attached test results and pictures of positive areas. This ACM would need to be removed prior to construction or demolition as they could potentially become friable during these activities. Other suspect ACMs found behind walls or in hidden cavities should be assumed to contain asbestos and handled and disposed of accordingly.
