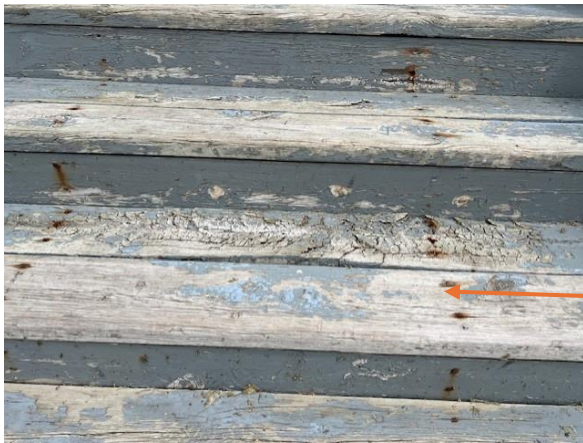
Elevated deck
boards create a
potential hazard
for guests

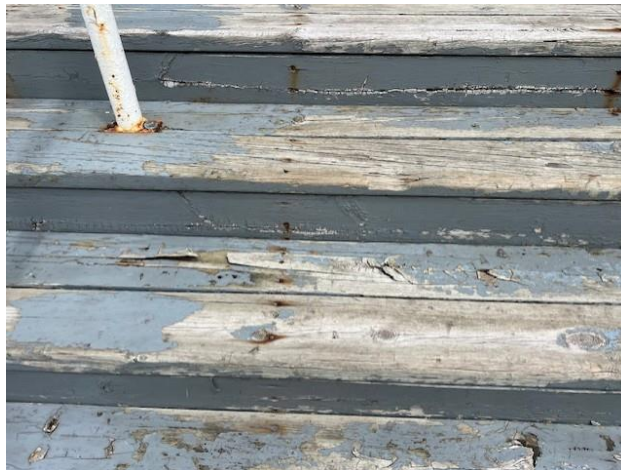
Wood treads
contain
exposed nails
and splintered
areas

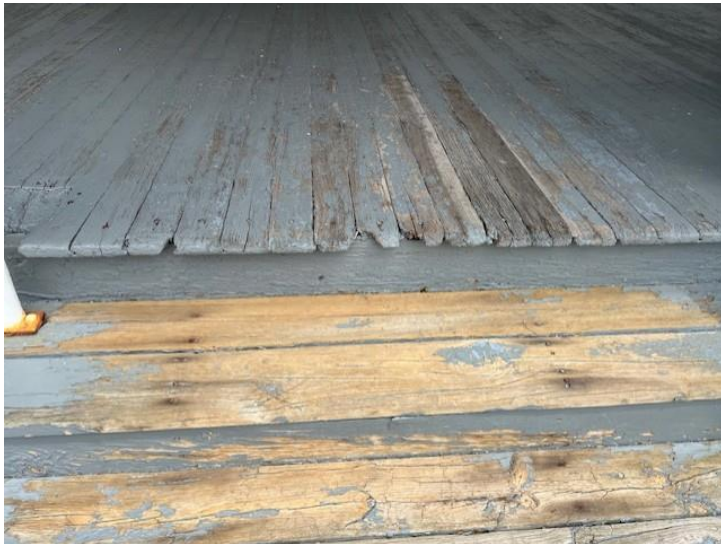
Tread wear
observed near
the top of both
staircases

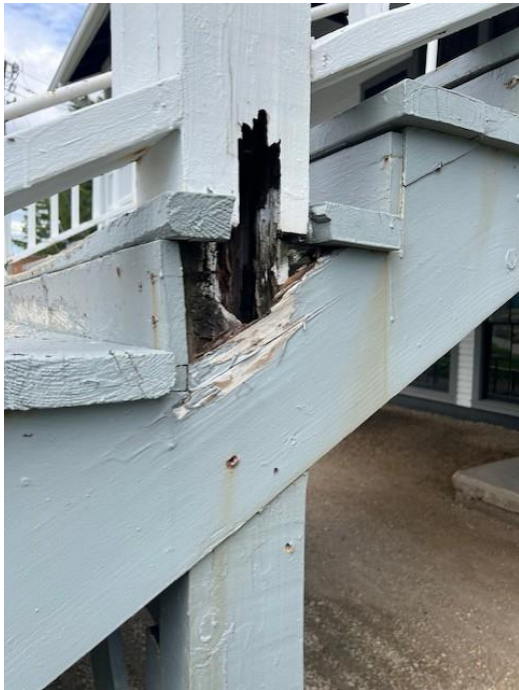
Areas of wood decay identified, though the structure is still sound
