# Stormwater Project Updates

August 10, 2021

# Riverwalk Slope Failure at Bay Ave.

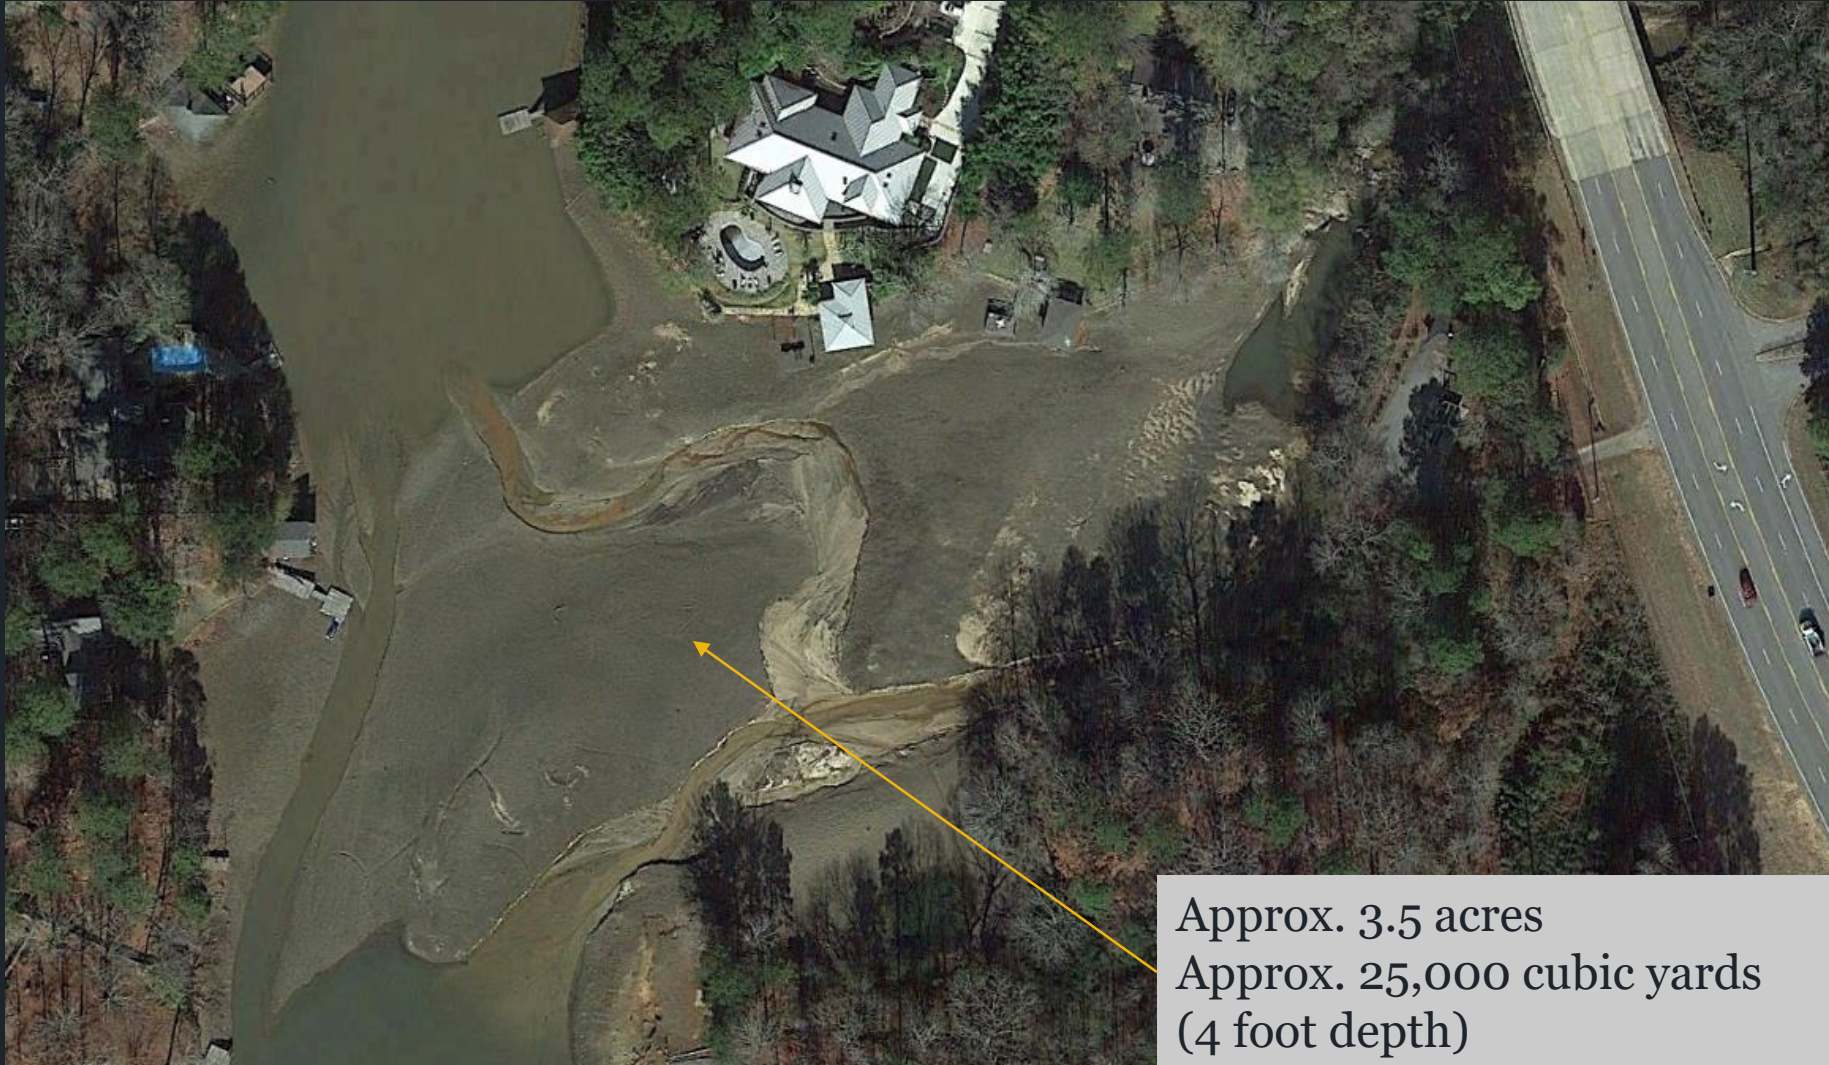
# Lake Oliver Sedimentation - 2012

Approx. 3.5 acres  
Approx. 25,000 cubic yards  
(4 foot depth)
