## INTRODUCTION

## LIFE SAFETY OVERVIEW

# ROOF REPLACEMENT/REPAIR \$510K

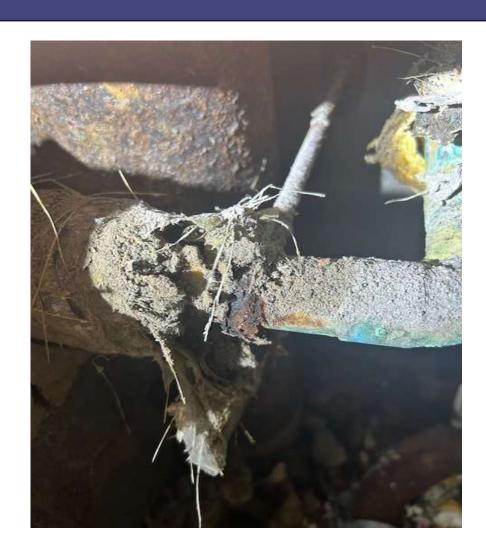
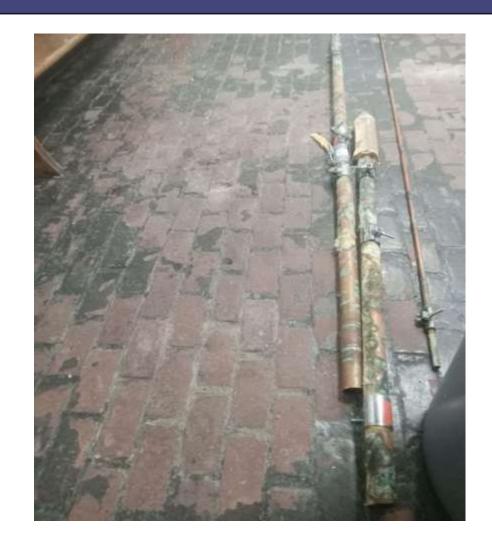
# **PLUMBING**

- Plumbing issues continue to deteriorate in this facility due to copper pipes with dissimilar hangers installed during construction causing a galvanic reaction.
  - Persistent water intrusion in housing units and common areas.
  - Continued Plumbing infrastructure failures throughout the facility.

Continue to monitor and replace damaged pipes as needed when leaks occur.

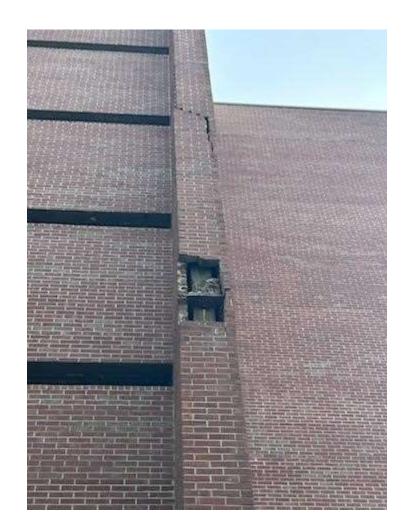
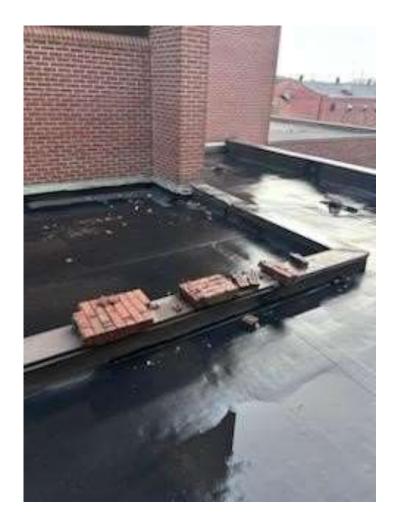
- Significant sections of the exterior facade are deteriorating and separating from the structural envelope.
- Pieces of brick/masonry have detached, creating falling debris hazards.
- Deterioration due to long-term water infiltration, thermal expansion, and lack of anchoring integrity.

- Immediate risk to staff, inmates, contractors, and visitors from falling materials.
- Non-compliance with structural safety and building codes.
- Potential for accelerated structural compromise if unaddressed.
- Potential damage to the new roof and rooftop HVAC equipment

Emergency barrier installation to prevent pedestrian access. Structural engineering assessment completed.

Anchoring loose materials.

Rebuilding compromised sections.

Sealing envelope to prevent water intrusion.
