## **Location Map | Garcia Creek**

#### **Scope Overview**

# **Existing Conditions | Garcia Creek**

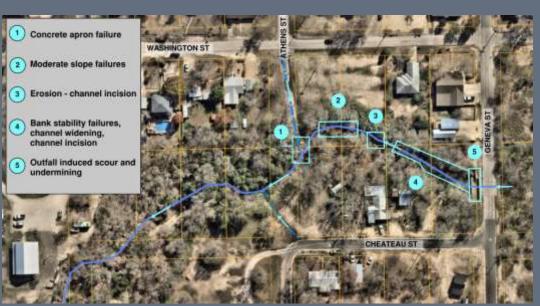
Structural failure of the side channel concrete apron due to scour-induced undermining. (Facing downstream)

2a - Moderate slope failures (Facing upstream)

2b – Moderate slope failures (Facing downstream)

3 – Channel degradation. Deep incision due to steep channel bottom and constriction of flow resulting in increased velocities. (Facing upstream)

Reconstruct portion of concrete side channel

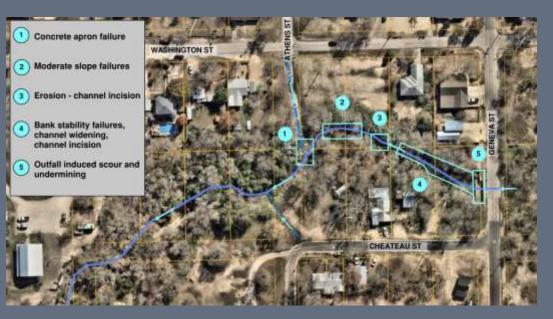
4a – Overhanging bank condition caused by toe erosion resulting in bank collapse, vertical banks (~15 ft. height) and mass wasting.

4b – Overhanging bank condition caused by toe erosion resulting in bank collapse, vertical banks (~15 ft. height) and mass wasting. (Facing downstream)

5a – Geneva Street culvert showing scour erosion, undermining of the concrete apron to a cantilevered condition, exposure of water line, accelerated failure of the northern bank. (Facing upstream)

5b - Geneva Street culvert showing scour erosion, undermining of the concrete apron to a cantilevered condition, exposure of water line. (Facing upstream)

**Construct concrete drop structure at Geneva Street Outfall**

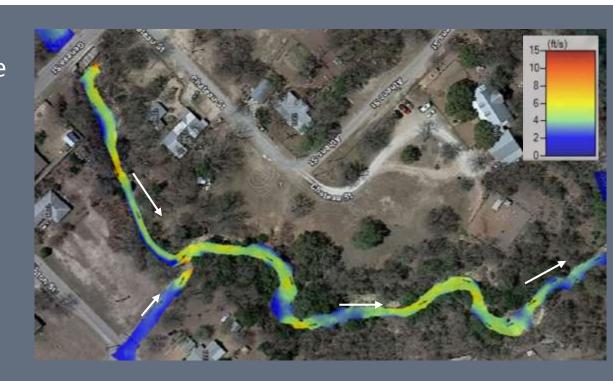
## **Defining the Problem Velocity (2-yr)**

Elevated velocities (above 5 ft/s)

Vulnerable to bed degradation, toe scour, and progressive bank erosion

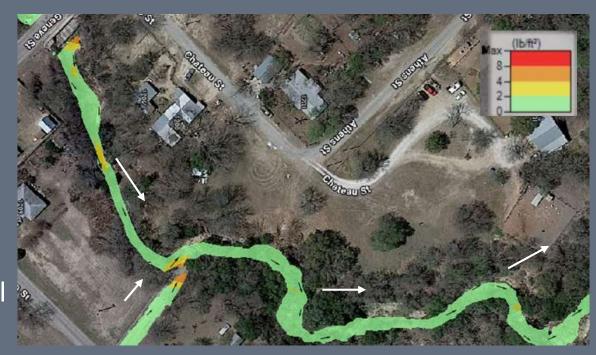
### **Defining the Problem | Shear Stress (2-yr)**

Elevated shear stresses\* observed primarily at:

Culvert outfall

Locations of flow constriction

Confluence of side channel
