TECHNICAL MEMORANDUM **DRAFT**

SUBJECT: Garcia Creek Channel Stabilization - Preliminary Engineering Evaluation

This memorandum summarizes KFA's findings from the preliminary engineering evaluation of Garcia Creek, conducted for the City of Castroville. The project limits extend approximately 500 linear feet, from Athens Street at the downstream end to Geneva Street upstream (**Figure 1**). The purpose of this study is to assess existing channel conditions, evaluate stabilization alternatives to address observed erosion and infrastructure risks, and provide preliminary design recommendations to protect public and private assets adjacent to Garcia Creek.

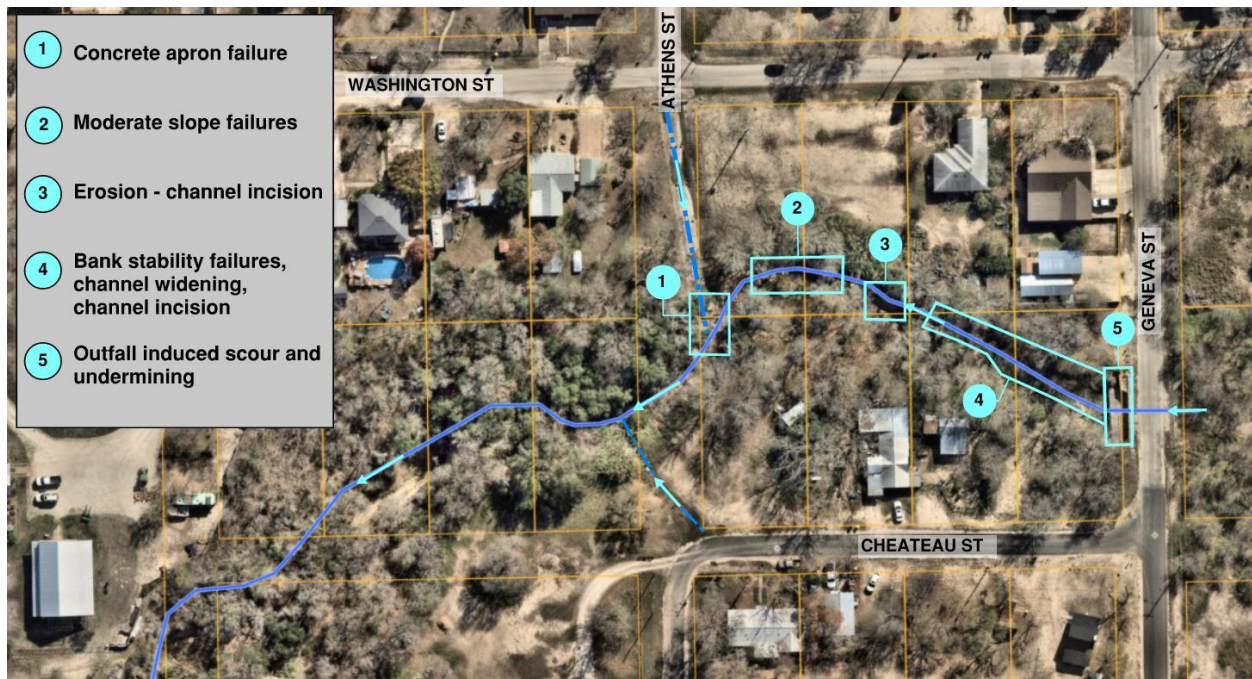
Figure 6 – Geomorphic Channel Conditions

From Old River Road to Geneva Street, both stream banks exhibit varying degrees of toe erosion. This toe scour has resulted in undercutting, cantilevered soil masses, vertical banks, and ongoing mass wasting in multiple locations. **Figure 6** illustrates the location of observed failure types along the study reach. **Figure 7** provides field observation photos of the failure condition.

The most severe erosion was observed between locations 3 and 5, shown in **Figure 6**. Based on qualitative field observations, an estimated 40% of the study reach appears to be severely eroded and exhibiting signs of complete instability. Approximately 15% shows moderate erosion and moderate instability, while roughly 25% shows slight erosion and appears slightly unstable. No segments were identified as fully stable. These estimates are approximate and based on visual assessment rather than quantitative measurement.

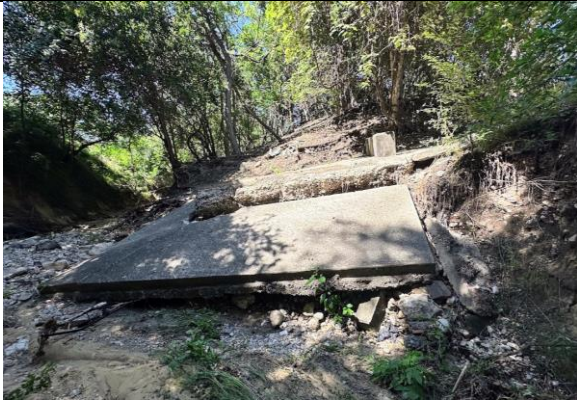
1 – Structural failure of the side channel concrete apron due to scour-induced undermining. (Facing downstream)

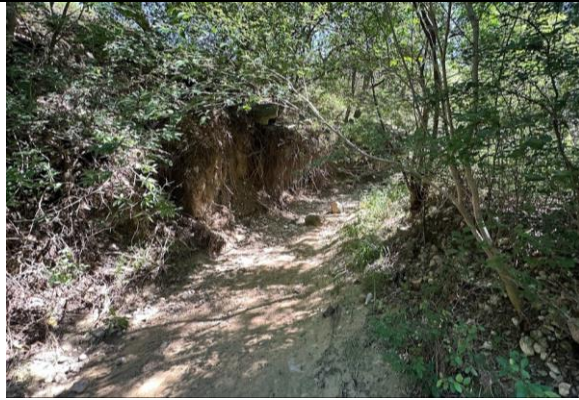
2a – Moderate slope failures (Facing upstream)

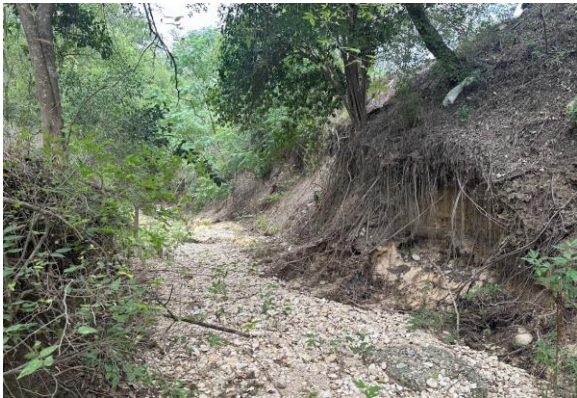
2b – Moderate slope failures (Facing downstream)

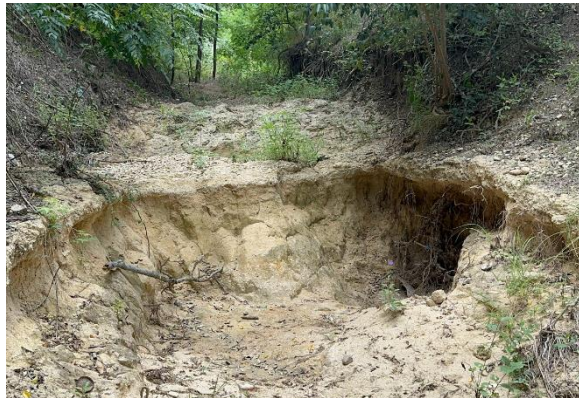
3 – Channel degradation. Deep incision due to steep channel bottom and constriction of flow resulting in increased velocities. (Facing upstream)

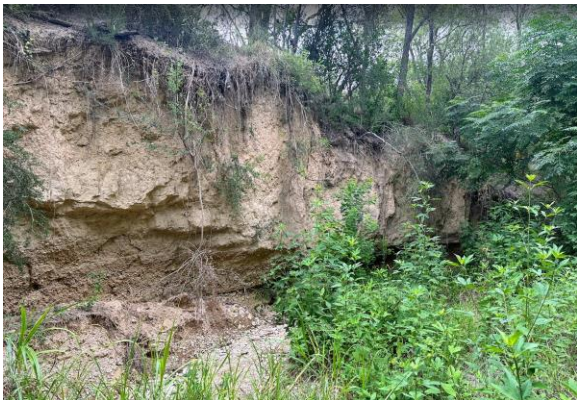
4a – Overhanging bank condition caused by toe erosion resulting in bank collapse, vertical banks (~15 ft. height) and mass wasting.

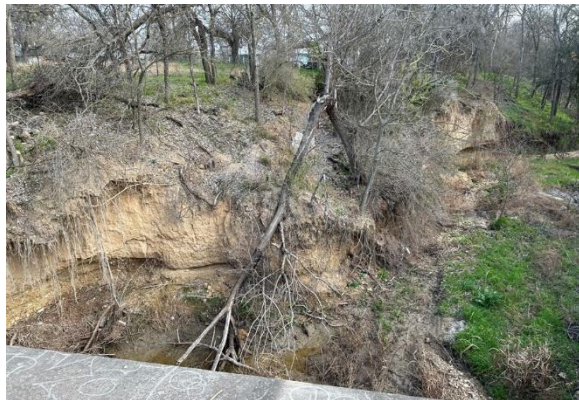
4b – Overhanging bank condition caused by toe erosion resulting in bank collapse, vertical banks (~15 ft. height) and mass wasting. (Facing downstream)

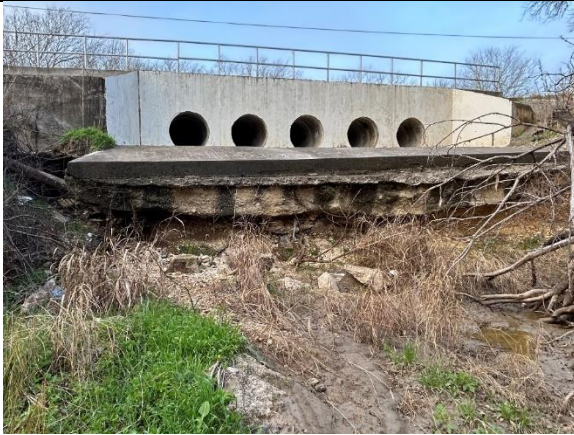
5a – Geneva Street culvert showing scour erosion, undermining of the concrete apron to a cantilevered condition, exposure of water line, accelerated failure of the northern bank. (Facing upstream)

Based on the findings of the preliminary engineering analysis, field reconnaissance, and hydraulic modeling, Alternative 1 – Geneva Street Culvert and Channel Wall Stabilization is recommended for advancement to final design. This alternative provides the greatest benefit in terms of protecting critical infrastructure, arresting the most severe erosion processes, and reducing the risk of culvert failure and further upstream degradation.

The use of driven sheet piles as structural grade controls embedded within the channel bed is a key design feature that enables stabilization of vertical channel degradation while reducing the need for full reconstruction along the entire reach. This hybrid approach balances constructability, performance, and cost.

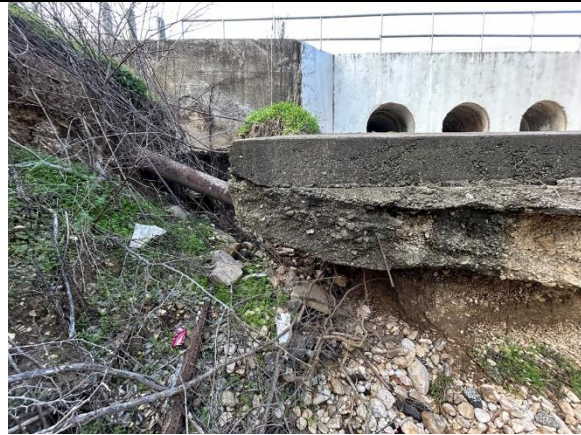
5b – Geneva Street culvert showing scour erosion, undermining of the concrete apron to a cantilevered condition, exposure of water line. (Facing upstream)

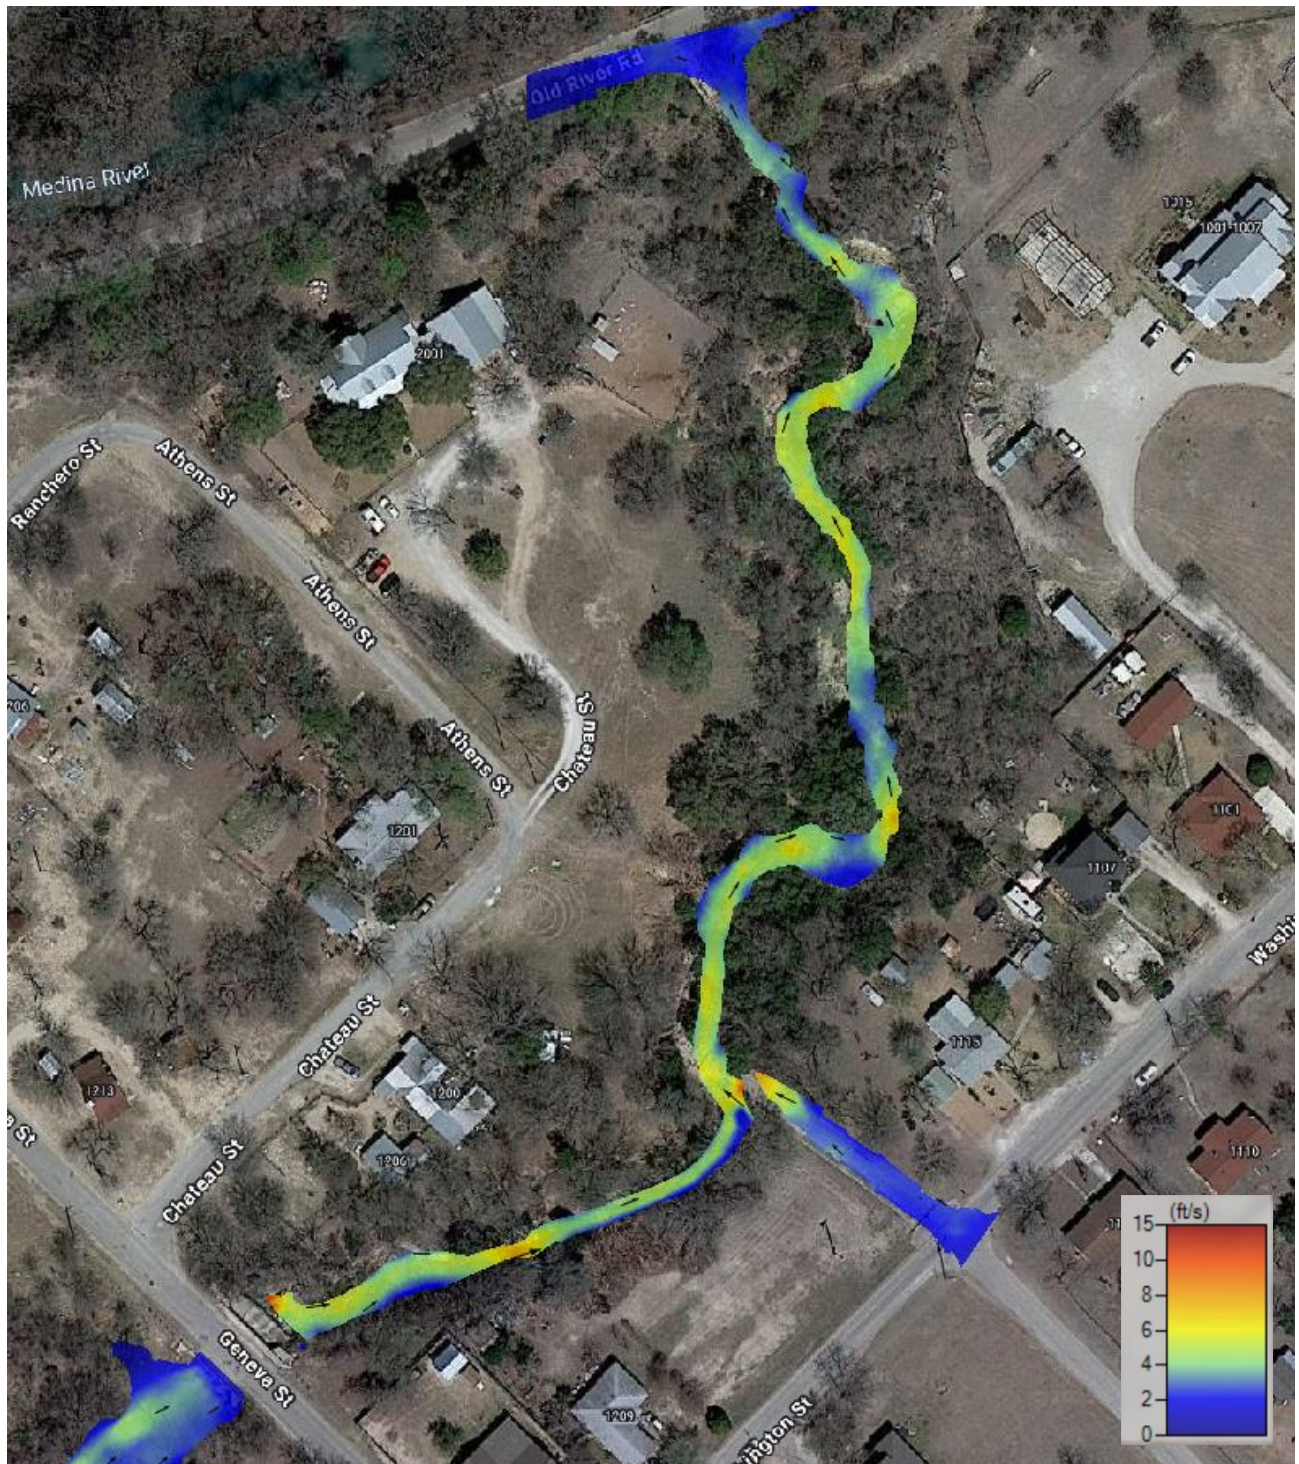
Figure 10 - Velocity Distribution (2-year)

Model results indicate that flow velocities in several channel segments exceed 5 ft/s, which is generally above the maximum permissible velocity for native soils and existing vegetation. These elevated velocities are most pronounced in the narrow segments of the channel reach with steep side slopes, where flow is confined and shear stresses are concentrated. These segments are especially vulnerable to bed degradation, toe scour, and progressive bank erosion.

Figure 10 illustrates the spatial distribution of flow velocities under the 2-year storm conditions, highlighting areas where velocities exceed erosion-resistant thresholds (yellow to red shading) and should be prioritized for stabilization.

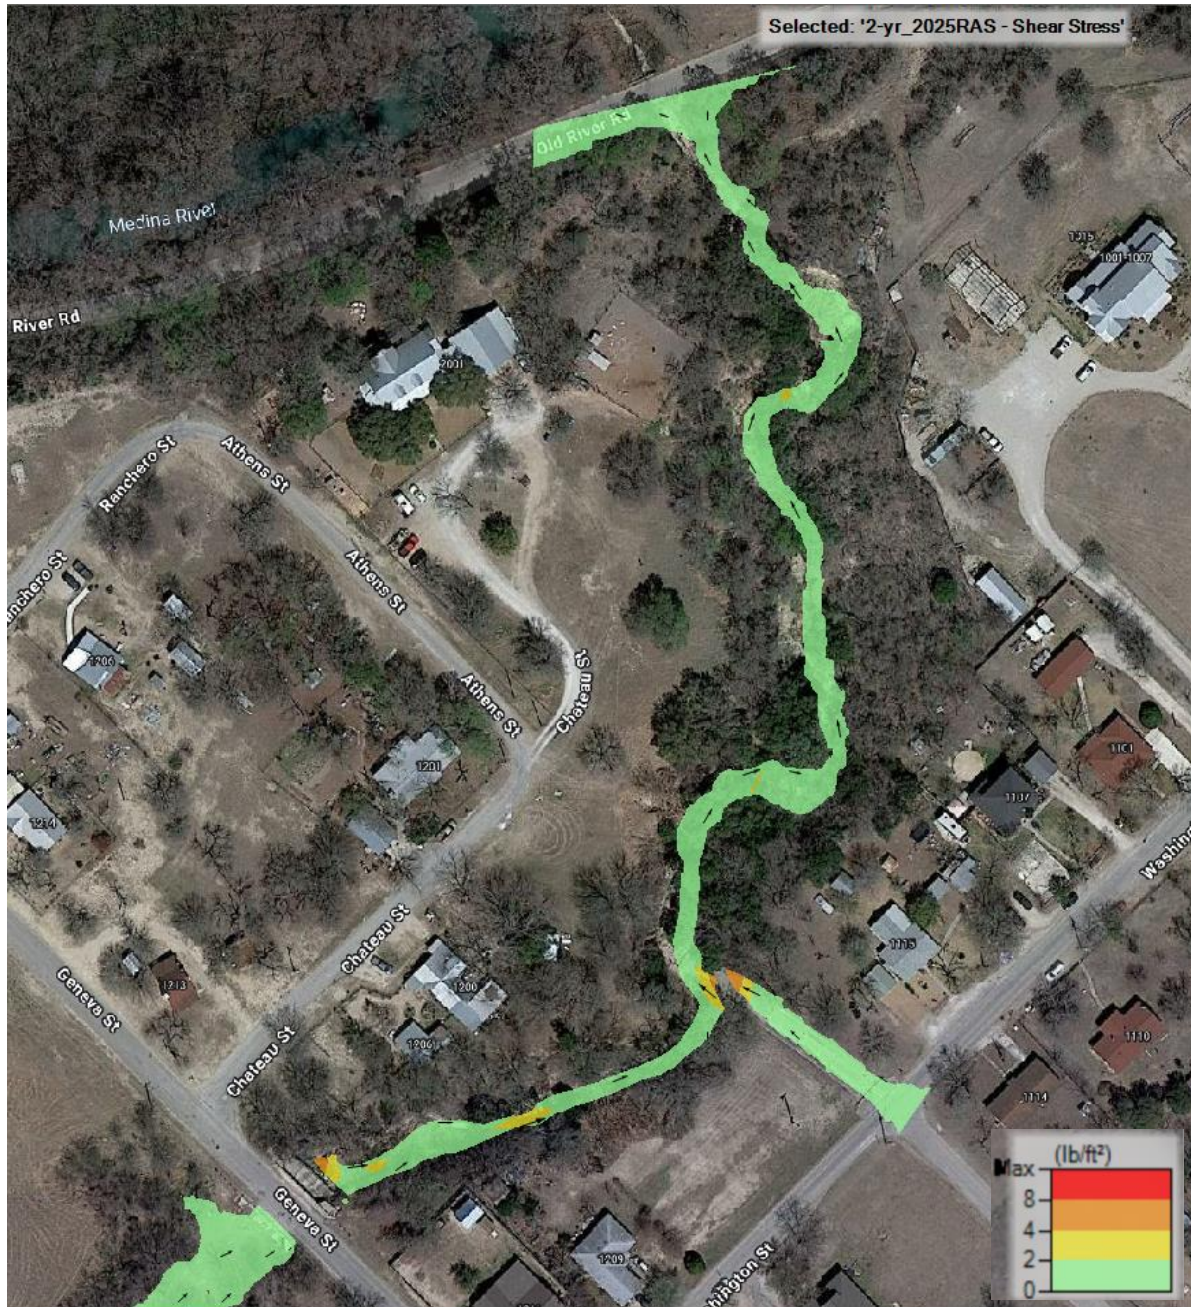
Figure 11 - Shear Stress Distribution (2-year)

These conditions pose risks not only for localized erosion but also for longer-term bank instability, which could lead to undercutting, slumping, and eventual channel migration or widening as the system seeks a new dynamic equilibrium.

Figure 11 displays the spatial distribution of modeled shear stress across the study reach. Highlighted in the figure are zones where shear stress values exceed permissible thresholds (yellow to red shading) —these should be prioritized for stabilization, particularly where they coincide with infrastructure, utilities, or steep, unprotected banks.
