Fire Facilities Inc. BCFD/Cartersville Joint Training Facility Cartersville, GA

Five Year Inspection - Structural Evaluation

RSE Project: 23906

Inspection Date: 28th April 2023

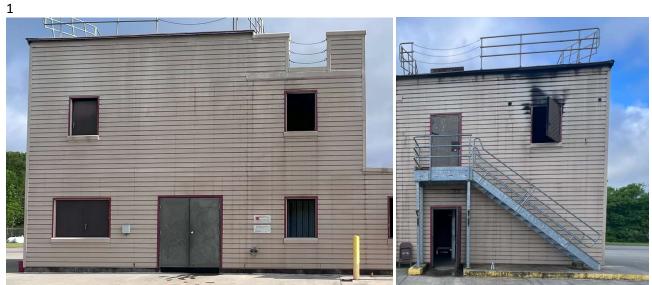
Item	Observations/Recommendations	Priority
Condition of Exterior	Observations:	
Wall Panels	 Overall condition of panels showed little to no wear. Some areas show signs of minor rust marks along screw lines at various locations of building. Soot buildup at panels adjacent to burn room door and at eave adjacent to burn room door. 	1. Low 2. Low
	Recommendations:	
	 Clean surfaces as recommended in Appendix III (Paint Care and Maintenance Manual). 1*

Rust Marks Along Screw Lines at Exterior Wall Panels/Soot Buildup Adjacent to 2nd Floor Burn Room Door

2. Clean surfaces as recommended in Appendix III (Paint Care and Maintenance Manual). 1*	
Condition of Exterior	Observations:	
Stairs and Landings	 Exterior stairs and landings showed minor wear. Minor corrosion at main exterior stair column base plates & stair bar grate treads. 	1. Low
	Recommendations:

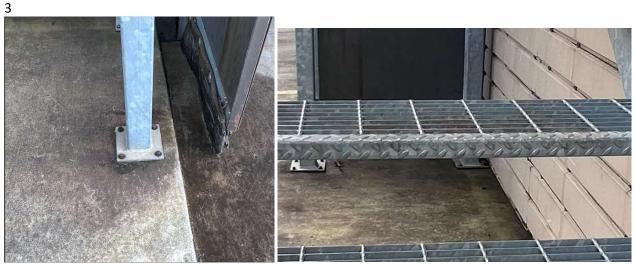
Rusting at Exterior Stair Column Baseplate/Rusting at Exterior Stair Grate Treads

***	 Remove corrosion via sand blasting and/or power tools. Paint this area with a ZRC 221 Cold Galvanizing Compound by ZRC Corporation or comparable galvanizing paint (1.5 mils minimum. 2*/3*

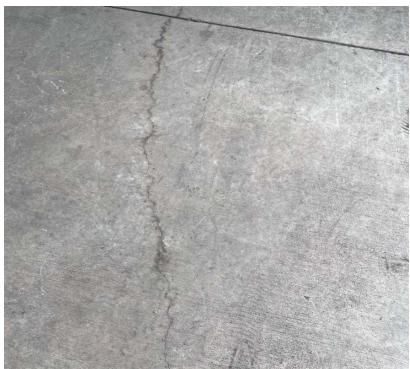
Item	Observations/Recommendations	Priority
Exposed Areas of	Observations:	
Foundation/Slab	 Foundation slab and surrounding pavement are in good condition with minor hairline shrinkage cracks. Recommendations: 	1. Low
,	 As cracks grow to greater than ¼" in width and 2" deep; route, clean, and seal large cracks. Sealant should meet the requirements of ASTM D5893/D5893M. 4*

Hairline Cracking at Exposed Foundation

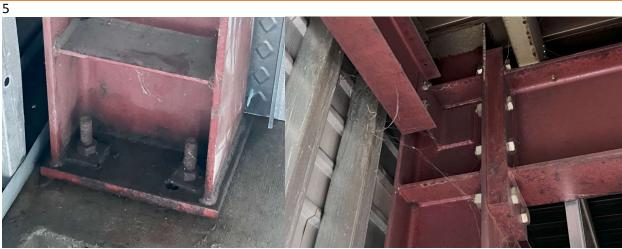
ltem	Observations/Recommendations	Priority
Exposed Red	Observations:	
Iron/Structural Steel	1. Rust onset occurring at various red iron column bases,	
at Base Plates/	columns, base plates & beams.	
Columns/Beams/	2. Heavy build-up of soot at exposed red iron/structural steel	
Plates	adjacent to 2 nd floor burn room.	1. Low
	Recommendations:	2. Low
-Rust	1. Prep area and re-paint with rust-resistant coating per	
-Corrosion	Rustoleum spec provided in Appendix III. 5*	
	2. Monitor condition of steel for corroision & rusting. *6

First Floor Columns & Baseplates Exhibiting Rusting/Paint De-lamination

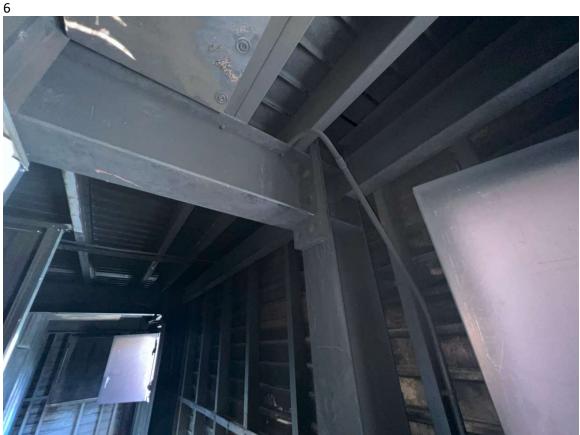
Structural Steel Adjacent to 2nd Floor Burn Room

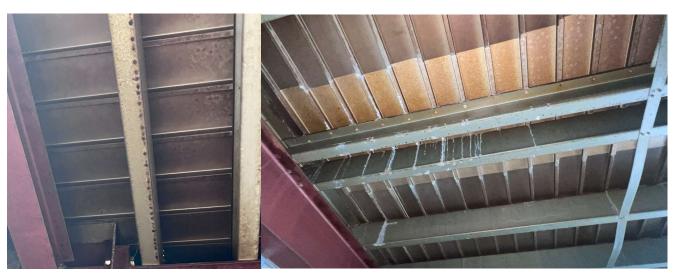
Item	Observations/Recommendations	Priority
Exposed Light Gage Interior Floor Panels/ Joists	 Observations: Minor rust occurring at light gage joists at various locations below 2nd floor concrete deck. Heavy soot build-up & areas of rust at 3rd floor light gage 	
-Rust -Corrosion	 floor panels/joists adjacent to 2nd floor burn room. Recommendations: Remove rust via sand blasting and/or power tools. Paint this area with a ZRC 221 Cold Galvanizing Compound by ZRC Corporation or comparable galvanizing paint (1.5 mils minimum. 7* 	1. Low 2. Low
	 Remove rust per 1. Continue to monitor members exhibiting soot buildup for rust or corrosion. 8*

Corrosion/Rusting of Light Gage Joists Below 2nd Floor Concrete Deck

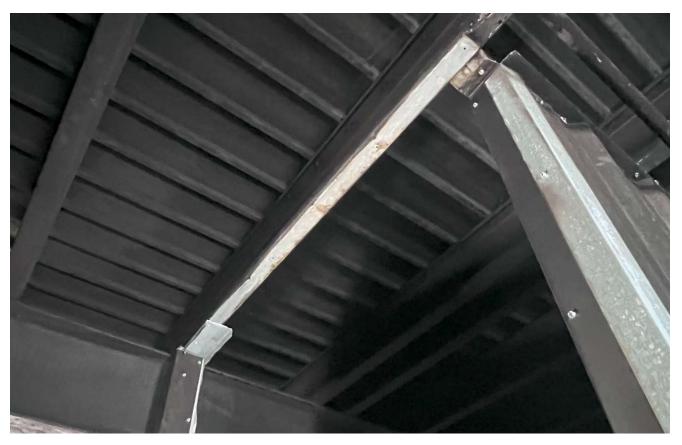
3rd Floor Floor Joists & Deck (Soot Buildup & Rust)

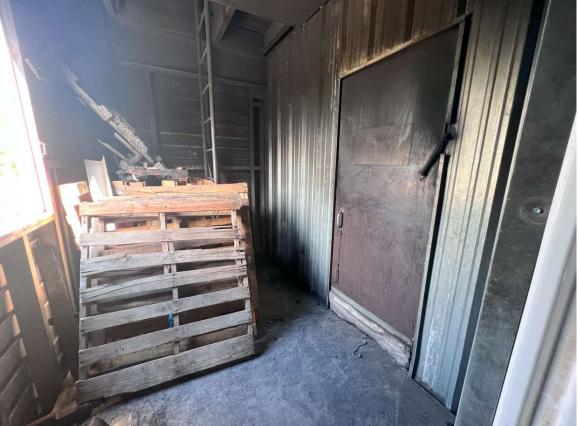
9B

ltem	Observations/Recommendations	Priority
Fuel Source Location	Observations: 1. Class A fuel source (Per section 3) being stored near burn Room.	1. High
	 Recommendations: 1. Remove fuel sources from area adjacent to burn room door to ensure that fire will not spread into unwanted areas. *9 	
Rapelling Anchors	Observations: 1. Rapelling anchors and bolts at roof exhibiting rusting/corrosion.	
	 Recommendations: 1. Ensure covers are installed on the recessed rappelling anchors when not in use. Remove corrision via hand tooks. Paint with ZRC 221 Cold Galvanizing Compound by ZRC Corporation or comparable galvanizing paint (1.5 mils minimum). *9B

Fuel Source Stored Adjacent to 2nd Floor Burn Room

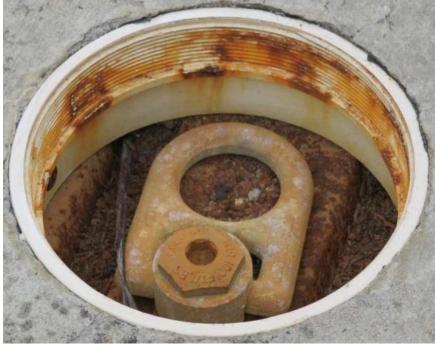
Rusted Rapelling Anchor

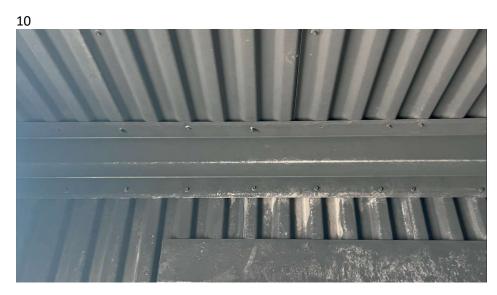
Item	Observations/Recommendations	Priority
Liner System in	Observations:	
Annex Burn Room	1. Numerous areas show screws backing out or missing on the	
	ceilings panels and trims.

Backed out & Missing Ceiling Trim Screws

2. Minor warping of ceiling panels.	
	Recommendations:	
	1. Periodically tighten all burn room screws to prevent screws	1. High
	from backing out. Use #12x2" stainless steel screws to	2. None.
	reattach ceiling Zee trims to panels. The #12 screws should	
	be screwed into place to attach the panels to the zees in the	
	proper location (See Appendix II & IV for installation	
	instructions). 10*

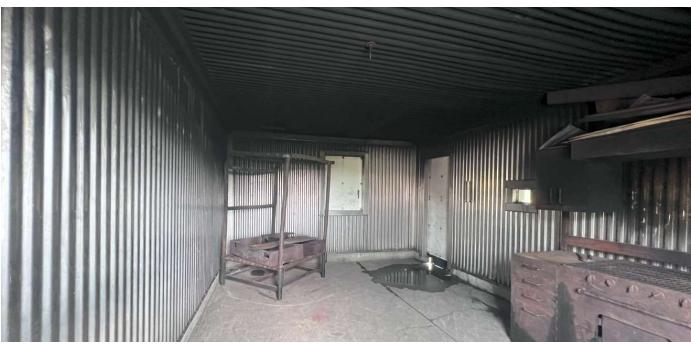
Annex Burn Room w/ Minor Warped Ceiling Panels

2. Monitor ceiling panels for future warping or corrosion. 11*	
Liner System in Burn	Observations:	
Room #2 – 2 nd Floor	1. Heavy warping of all ceiling panels and trims and horizontal	
	bulkhead panels. At some locations, ceiling trim is missing.

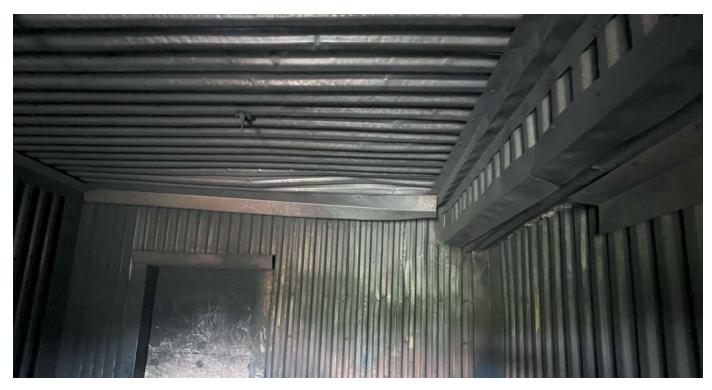
12

Burn Room #2 Warped Ceiling Panels & Trim

2. Minor warping and discoloration of wall panels. Heavily	
	warped wall panels & door trim at north west wall.	
	Recommendations:	1. High.
	1. Replace the Westec system on the entire ceiling and	2. High.
	bulkhead along with corresponding ceiling and bulkhead	_
	trim. See drawings, Appendix IV. 12*

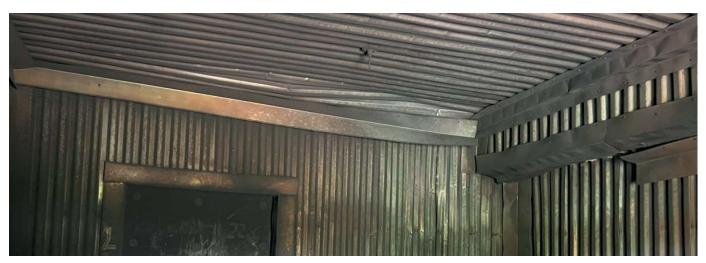
Burn Room #2 Warped Ceiling Panels & Trim / Northwest Wall Panel Heavily Warped & Discolored

2. Monitor wall panels for future for warping or corrosion.	
	Replace wall panels & door trim at north west wall. See	
	drawings, Appendix IV. 13*	
Liner System in Burn	Observations:	
Room #3 – 2 nd Floor	1. Minimal warping of wall panels, ceiling panels, and trims.

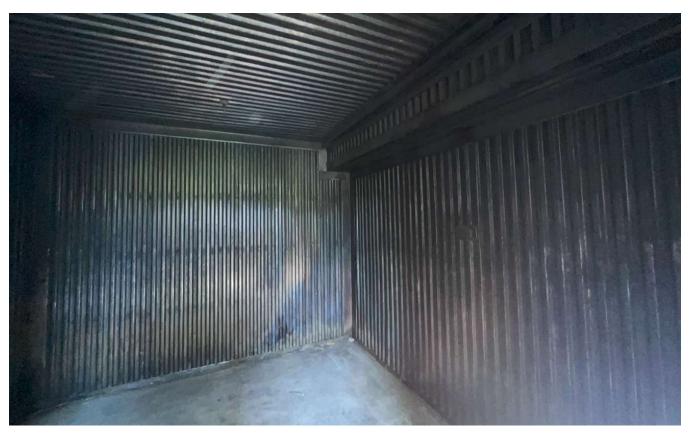
Burn Room #3 Ceiling Panels, Wall Panels & Trims

2. Ceiling trims at various areas missing screws.	
	Recommendations:	1. None.
	1. Continue to monitor condition of panels and trim for future	2. High.
	warping and discoloration. 14*

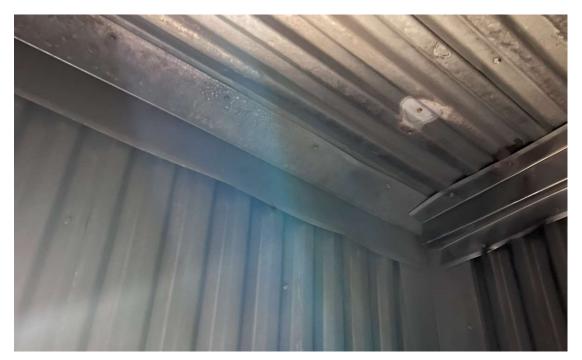
Burn Room #3 Corner Trim Missing Screws

2. Fasten ceiling trims to panels with #12 x ¾" stainless steel	
	hex head self drilling screws at 6½" on center. 15*	
Burn Room's Wall	Observations:	
Studs/Insulation	1. At each burn room, multiple new penetrations were drilled.	
	A scope camera was inserted into the wall cavities. Wall	
	studs and Westec insulation were viewed. At those	1. None.
	locations, studs appeared to show no signs of warping and	I. NOTE.
	insulation was intact.	
	Recommendations:

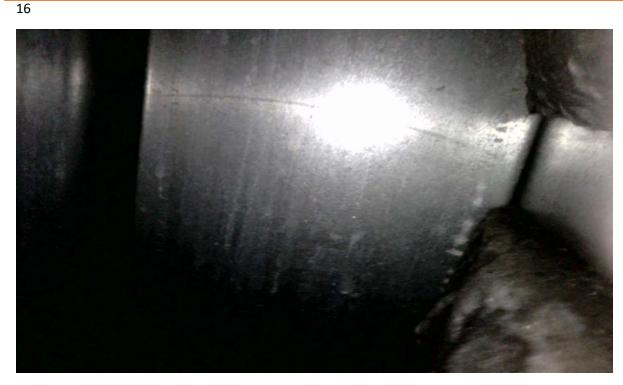
17

Annex Burn Room – Light Gauge Metal Stud

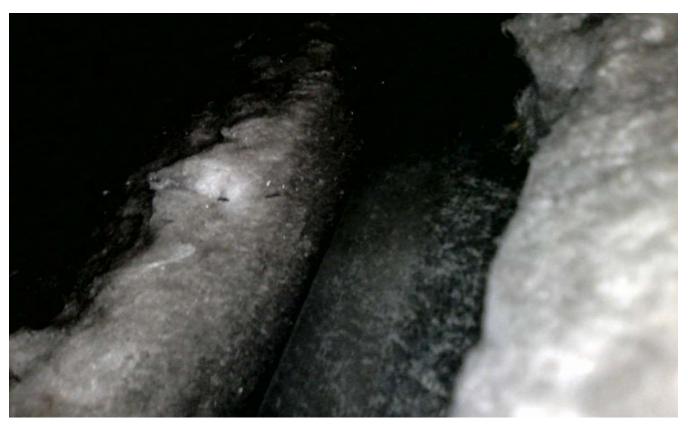
Annex Burn Room Wall Insulation
