**Asbestos Abatement and Other Hazardous Waste
Removal – Former Econo Lodge (2007 Tampico Way)**

Hazardous Materials Survey

Terracon Project No.: E2187132

HAZARDOUS MATERIALS SURVEY
Former Motel Commercial Structures
2007 Tampico Way
Dalton, Whitfield County, Georgia
Terracon Project No. E2187132
September 18, 2018

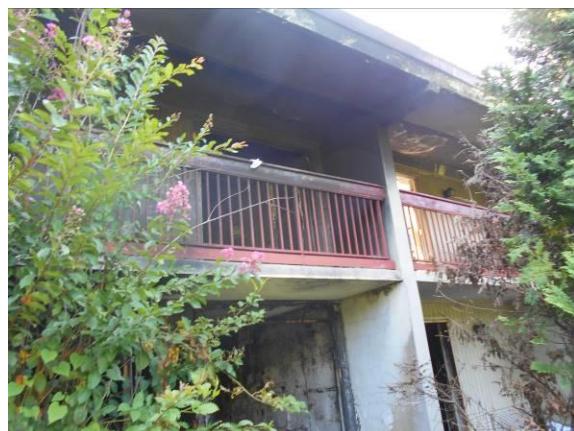
Photo #6 View of the exterior of the site looking towards a portion of the burned units.

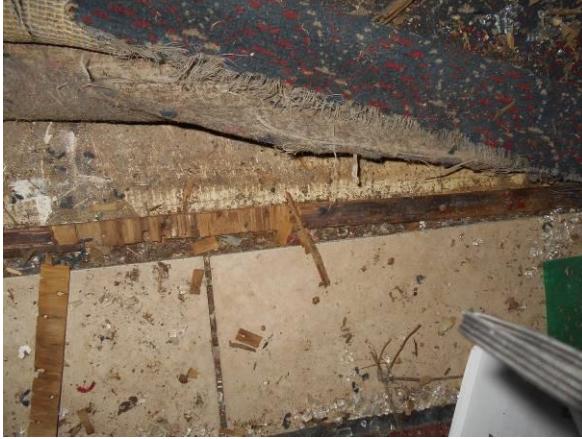
- § HA-5: Vinyl Composition Tile (3% Chrysotile) and black mastic (3% Chrysotile) under carpet with yellow mastic on concrete; Category I non-friable ACM in good condition
- § HA-20: Vinyl Composition Tile (3% Chrysotile) and yellow mastic; Category I non-friable ACM in good condition
- § HA-25: Joint compound (2% Chrysotile) and Old Texture (2% Chrysotile) on gypsum wallboard; Friable ACM in damaged condition
- § HA-26: Joint compound (2% Chrysotile) on gypsum wallboard; Friable ACM in damaged condition

Photo #11 View of the ACM vinyl composite tile (HA-5) under carpet in the lobby area.

Terracon recommends that the identified ACM be removed and disposed of by a licensed asbestos abatement contractor prior to the demolition activity that will disturb the asbestos-containing materials identified.

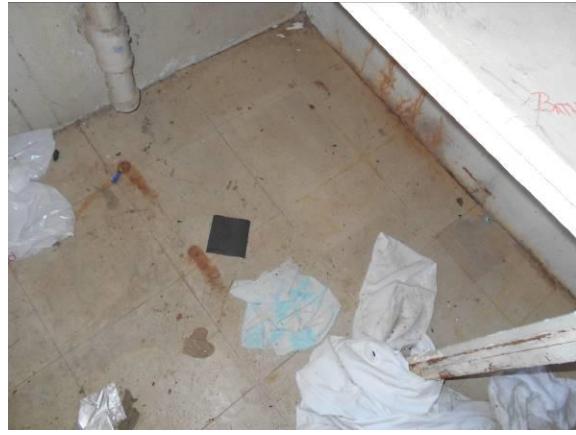
Photo #12 View of the ACM vinyl composite tile (HA-20) in the maintenance area.

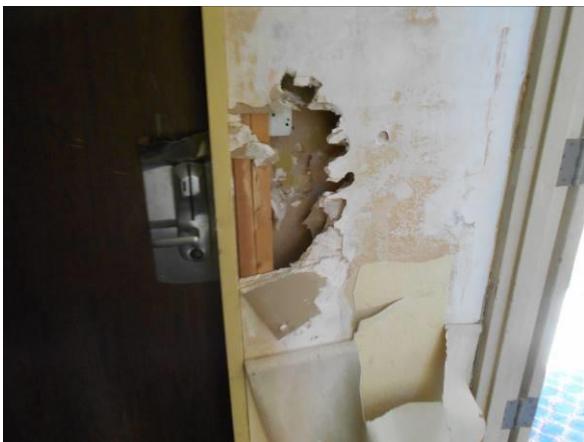
Photo #15 View of the ACM joint compound and textured (HA-25) wall surface in guest room.

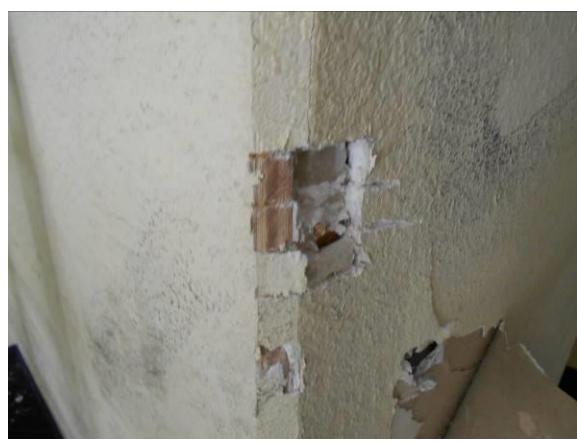
Photo #16 View of the ACM joint compound (HA-26) and textured wall surface in guest rooms.

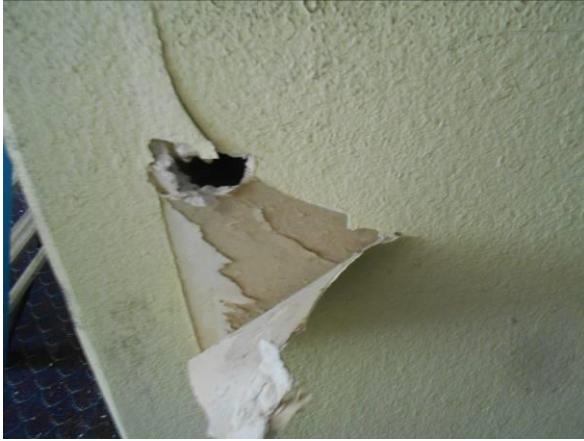
Photo #17 View of the ACM joint compound (HA-27) and textured wall surface in guest rooms.

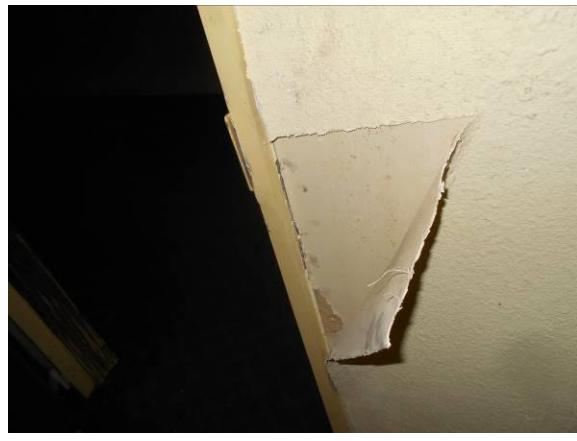
Photo #18 View of the ACM texture (HA-32) on wallboard in guest rooms.

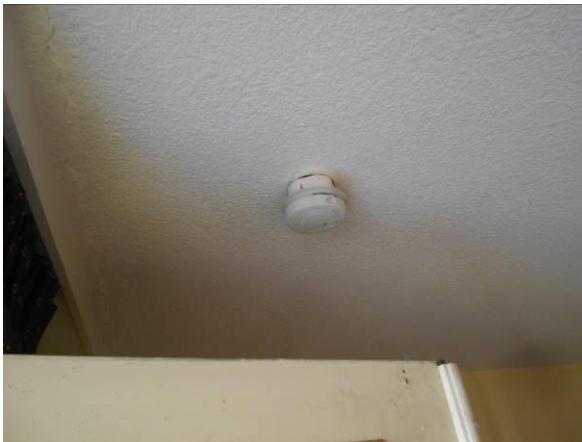
Photo #19 View of the ACM spray applied acoustical texture (HA-33) on ceiling in guest rooms
