RE: John Davis Recreation Center: Architectural, Structural, Electrical & HVAC Report

RE: Report of Structural Evaluation of Existing Building at 904 Civic Drive in Dalton, Georgia

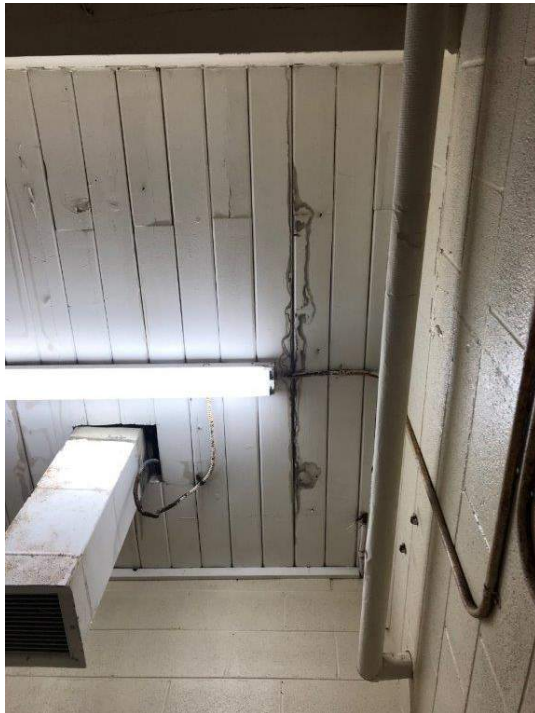
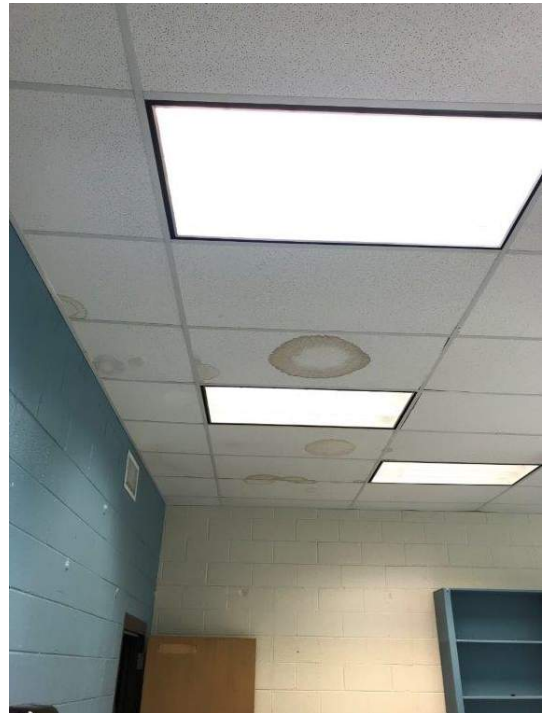
The absence of an air barrier can also allow hot humid air to enter the building and condensate on any cool surface within the building. This is usually most evident on air diffusers or other cool surfaces. We observed multiple stained ceiling tiles throughout the building. It is our understanding that the roof was replaced in the last two years so it is likely that these stains are a result of water condensing on ductwork and dripping onto the tile. (Please see Exhibit P1&P2).

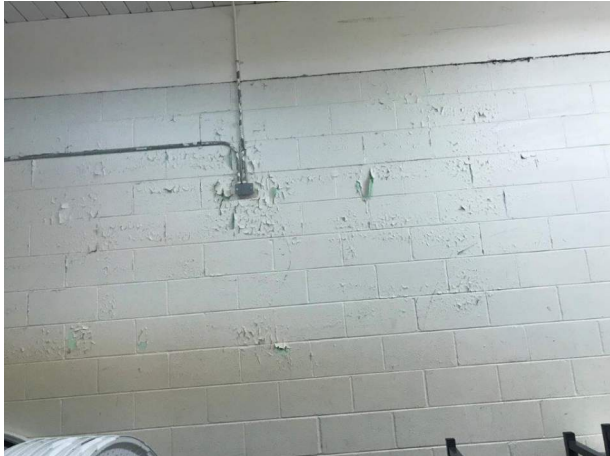
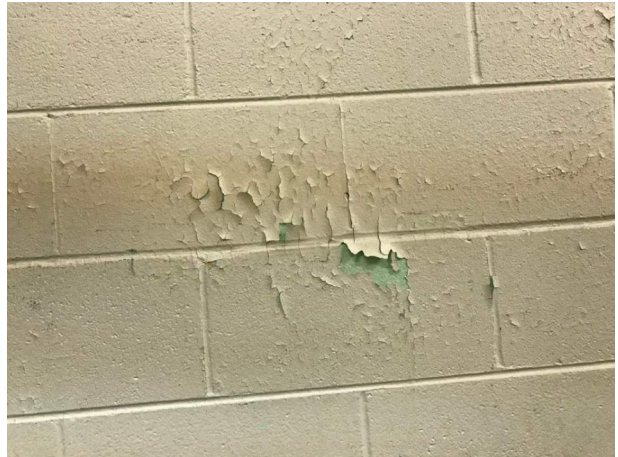
Based on our observations, the exterior walls of Building “A” do not include air, water or vapor barriers. Evidence of this can be seen in the on the interior surface of the concrete block walls. Paint is peeling from the surface of the walls due to condensation within the block. Also, per our discussions with maintenance personnel, we understand that the drywall has been replaced along many of these walls as a result of moisture issues. (Please see Exhibit P3&P4).

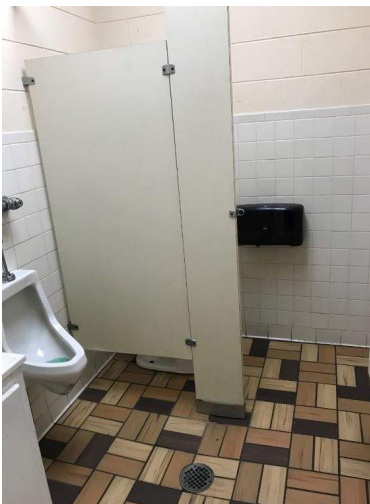
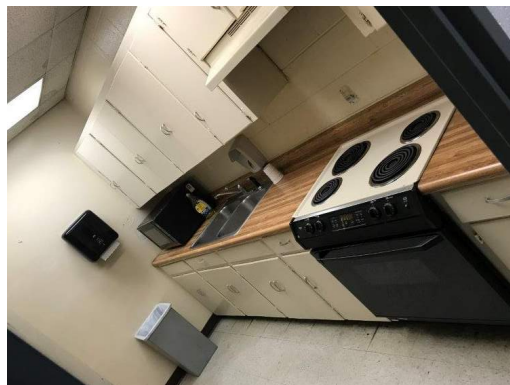
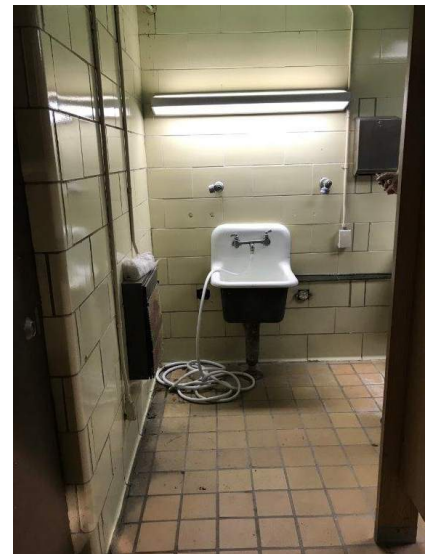
One of the most costly issues when renovating a building is complying with the current ADA standards. This building is accessed by the public and needs to be accessible to everyone. Currently, the restrooms do not meet the approach and/or clearance requirements of the code. Also, due to the age of the waste piping and fixtures, a complete replacement of the restrooms is recommended. (please reference the plumbing report). Other accessibility issues include door hardware, countertop heights and reach requirements for electrical devices. (Please see Exhibit P5,P6 & P7).

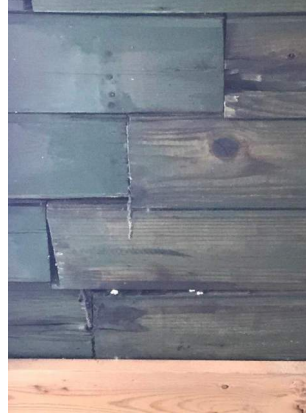
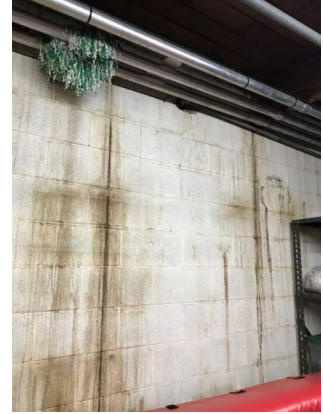
Building “A” also includes the pool locker rooms and equipment room. Significant moisture issues and termite damage was observed. It is our understanding that this area needs to be maintained until the pool is eventually replaced. Replacement of the roof structure and decking will be required in several areas. Please see the structural engineer’s report for further discussion. (Please see Exhibit P8, P9, P10 & P11).

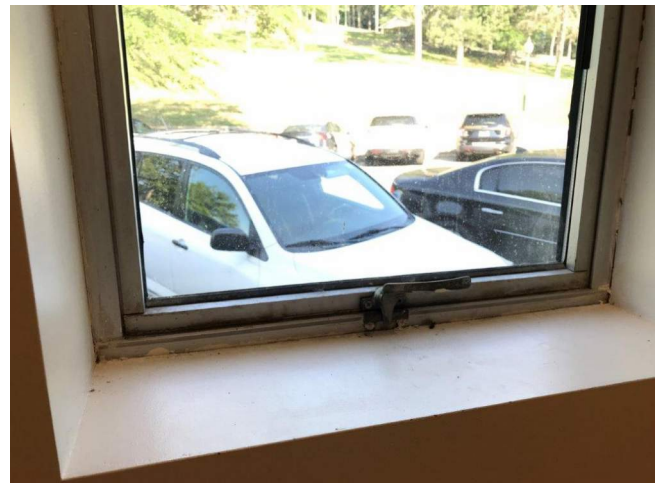
The original construction of Building “A” did not include insulation in the walls and roof. Some insulation has been added to the exterior walls of the meeting rooms. This should help slow the transfer of heat energy in these spaces, however, some of the walls are not insulated. Also, the insulation placed on the ceiling tile is not allowed by code. New insulation will be required to meet the current requirements of the Energy Code. The window frames and glazing do not meet current requirements for shading and heat gain or thermal transfer. These will need to be replaced. (Please see Exhibit P12 & P13).

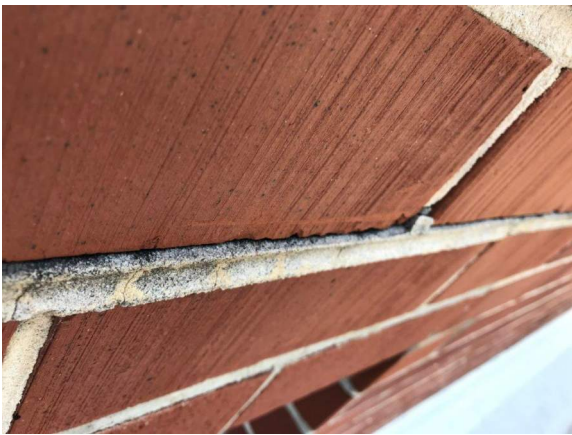
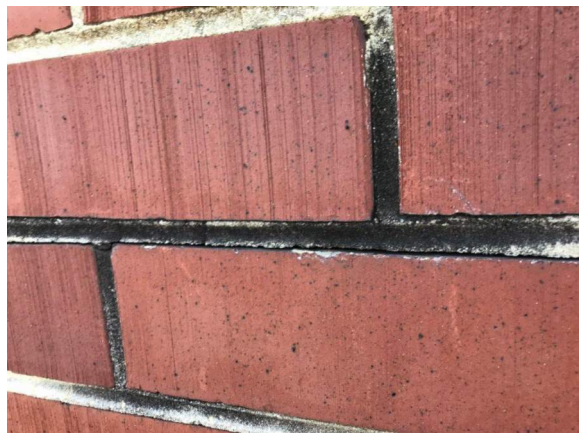
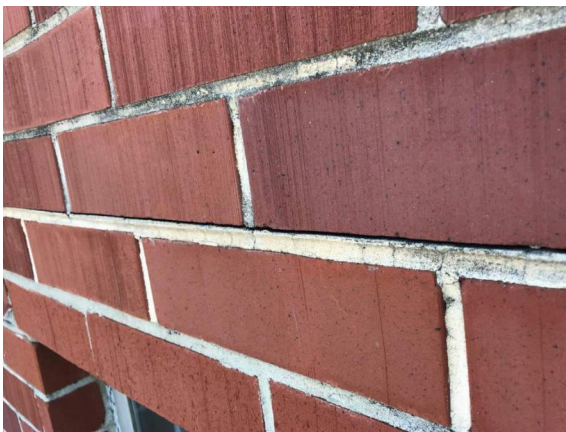
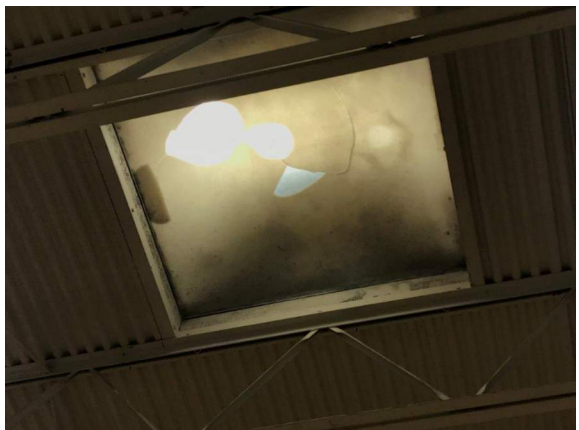
Much like Building “A”, the majority of Building “B” was not designed to receive air conditioning. The gymnasium is currently ventilated with fans and louvers. It is constructed with single width concrete masonry units, faced with brick. The mortar in the brick is failing in multiple areas. This is likely due to failure of the reinforcement in the walls. Further investigation will be required to determine the cause and repairs necessary. At a minimum, repointing of the masonry will be required. This building will also require new insulation, and an air, water, vapor barrier. (Please see Exhibit P14, P15, P16 & P17). Please refer to the Structural, Mechanical, plumbing and Electrical reports for additional information.

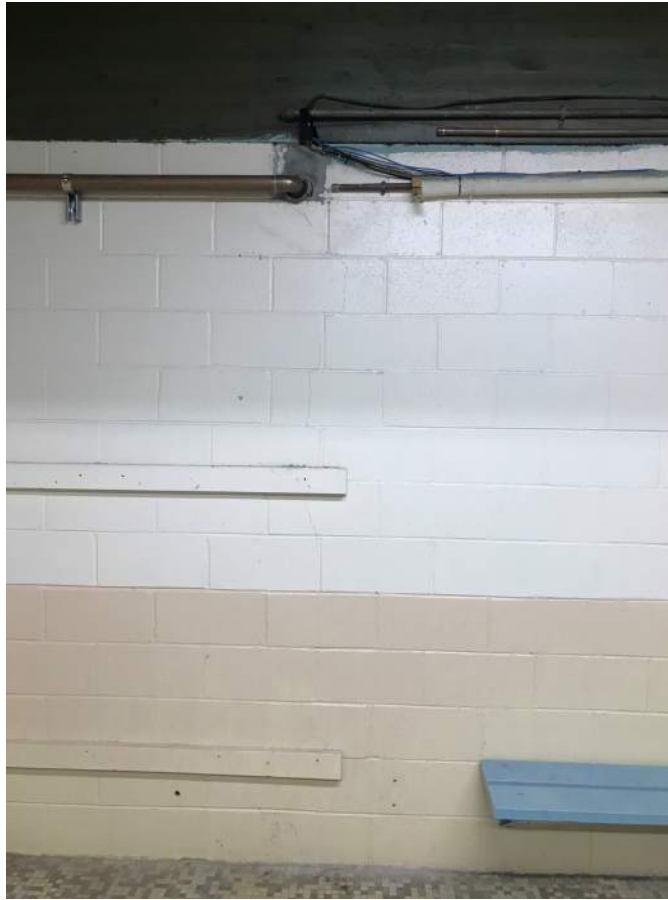
WJPA observed several cracks on the CMU wall at the North end of Building A. Please see Photographs C-E for more information. WJPA also observed significant deflection and cracking on the timber decking. Considering the extent of the damage, it is likely that sections of the roof decking will need to be replaced. Please see Photographs F and G. WJPA noticed the door frame at the pool mechanical room was rusted. WJPA suspected the rust was caused by the exposure to water and caused the CMU wall to protrude out, as shown in Photograph E. WJPA also observed termite tubes hanging from the ceiling at several areas. Please see Photograph J for more information. WJPA did not observe any additional structural issues on Building A.

***Photograph C:***  
Cracks on Building A Men's Restroom CMU Wall #1

It is our understanding that certain portion of the Building A (pool area) may remain depending on the owner's decision to expand or rebuild the facilities. Should the owner choose to expand the facilities, WJPA recommend sealing all CMU cracks, replace the cracked timber decking as required, and repair cracked brick mortar joints. Due to the age of the building, any repair budget should allow for unforeseen contingencies that may be discovered during the repair.

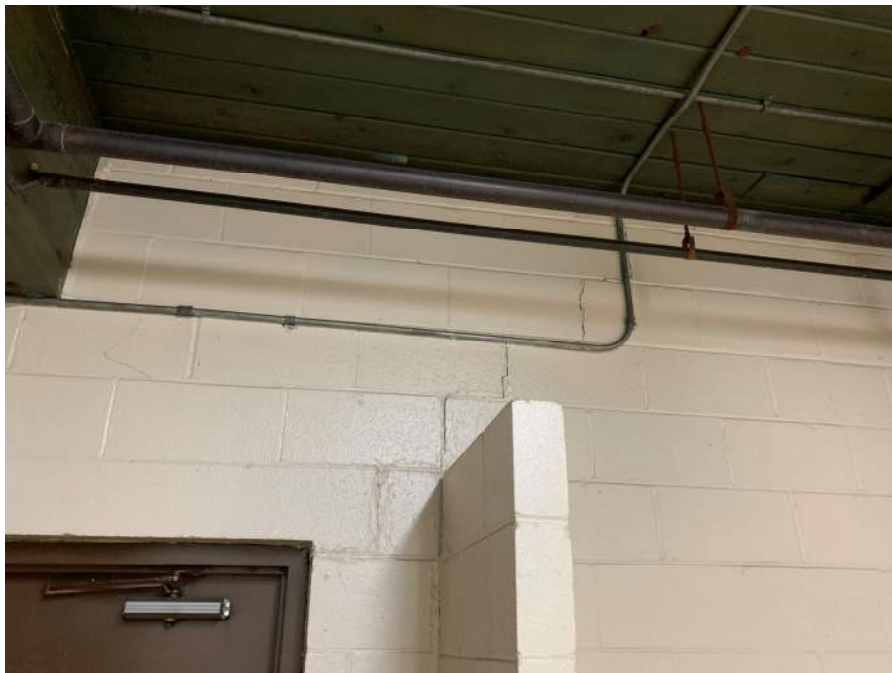
***Photograph D:***  
Cracks on Building A Men's Restroom CMU Wall #2

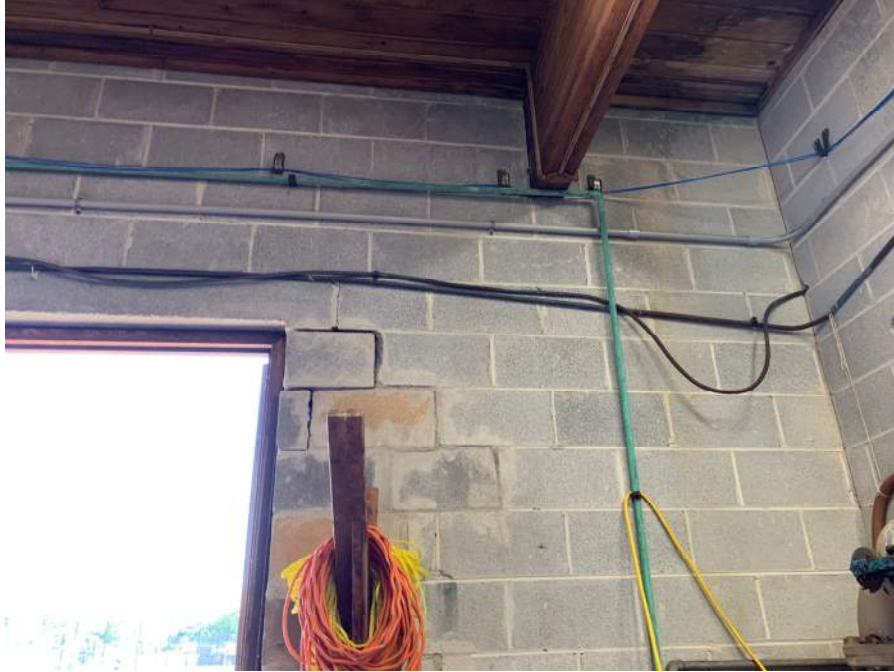
***Photograph E:***  
Cracks on Building A Pool Mechanical Area (Looking North)

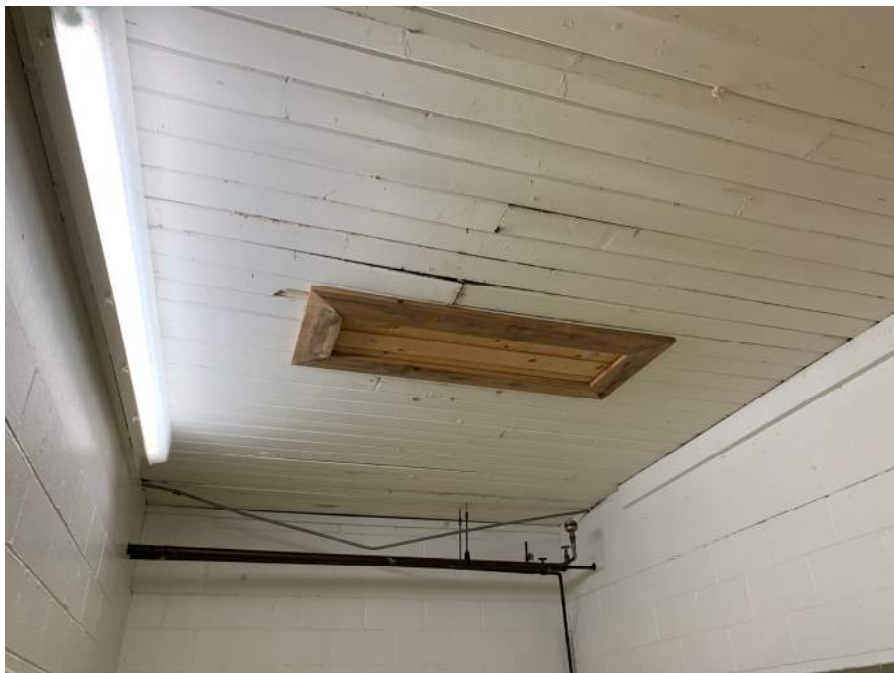
***Photograph F:***  
Cracks on Building A Men's Restroom Timber Decking

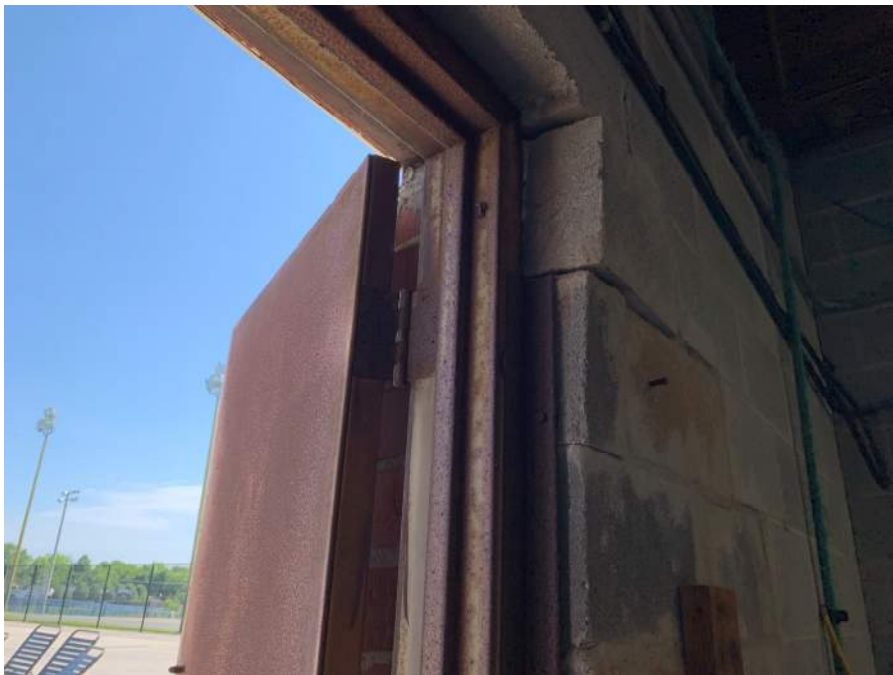
***Photograph H:***

Building A Rusted Door Frame

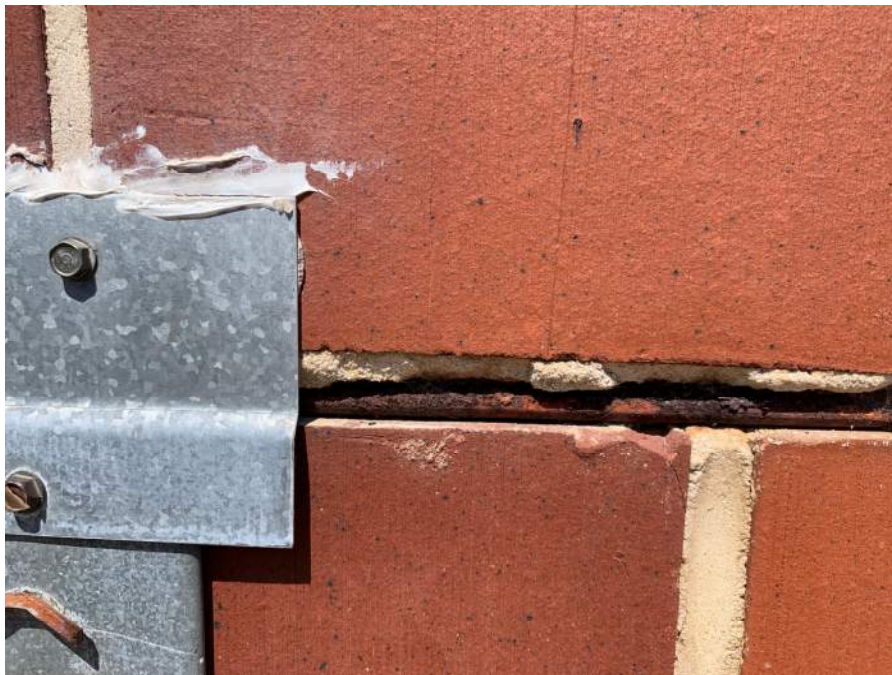
WJPA observed vertical wall cracks on the CMU wall at storage room #1. WJPA also observed several horizontal cracks on brick veneer located at the East end and South end of Building B. WJPA suspected the horizontal cracks were caused by the expansion of the rusted steel shelf angle and steel wire reinforcing. Please see Photograph N to R for more information. WJPA did not observe any additional structural issues on Building B.

***Photograph P:***  
Rusted Steel Shelf Angle (Looking West)

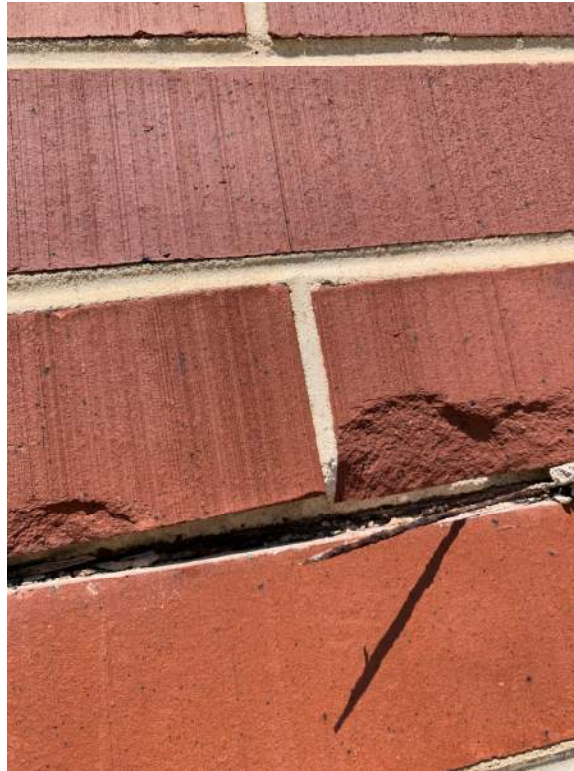
***Photograph Q:***  
Rusted Steel Wire Reinforcing (Looking North)

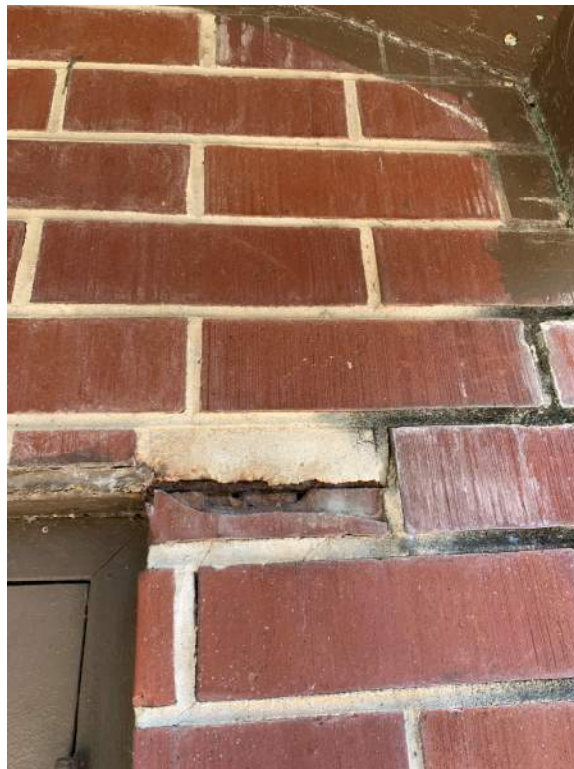
***Photograph R:***  
Cracks on Building B Brick Veneer (Looking North)

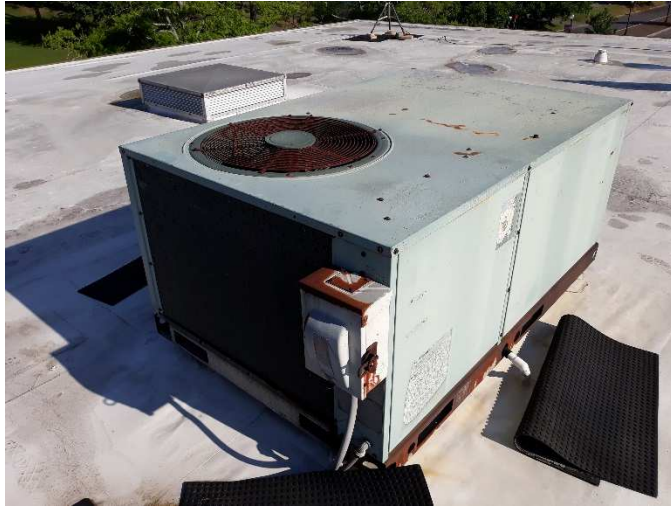
Two abandoned single package all electric rooftop units still exist on the roof above the multi-purpose room. They originally conditioned the multi-purpose room, but they are no longer operative. They appear to be over 15 years in age.

Original Multipurpose Rooftop Unit - Abandoned

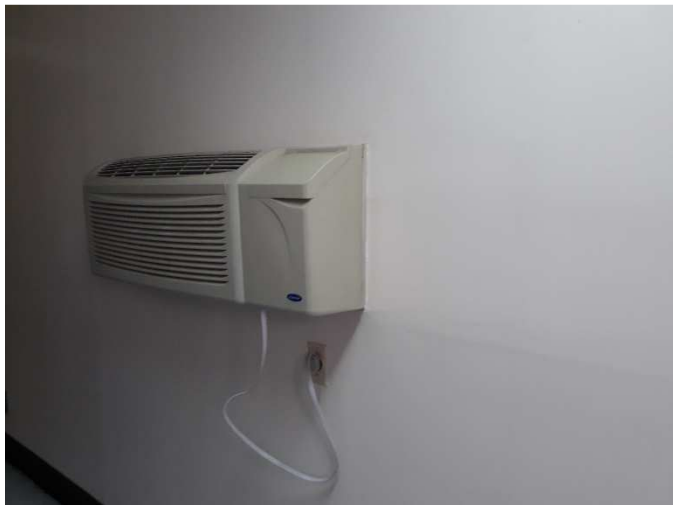
The upper level connecting corridor between the multi-purpose room and the second level of the gym is conditioned by a motel style unit located high in an exterior wall and discharging into to corridor. This unit was manufactured in 2001,

The other two small single package A/C units installed for the upper level corridor and equipment storage room are in need of immediate replacement.

Upper Corridor Motel Style Unit

The upper level gym corridor and elevator lobby shall be conditioned with new ductless split system to replace the current thru-wall motel type unit.

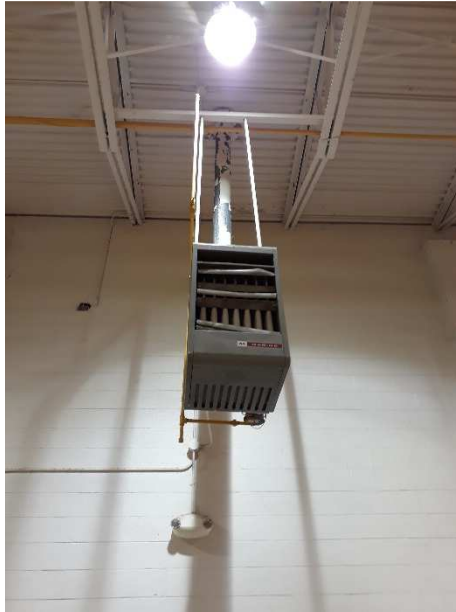
Heating for the gym is provided by 3 gas-fired unit heaters. Two of the units are much older than the third, and they are in poor condition with damaged cabinets and louvers. The third unit has been installed recently.

Typical Unit Heater for Gym

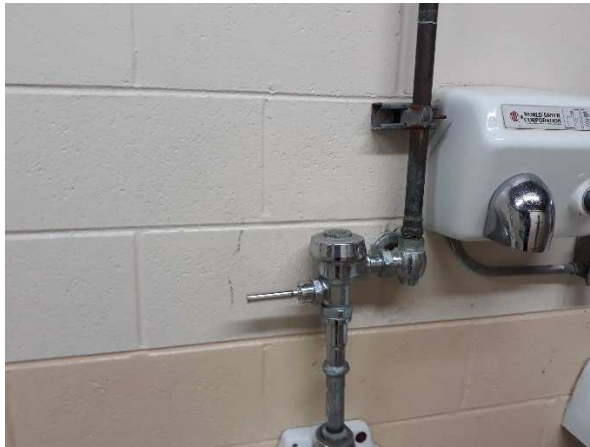
Conversations with the maintenance staff indicate that repair of underground sanitary piping is difficult due to the level of corrosion present for the buried piping.

Locker Room Piping indicating corrosion

A full and complete replacement of the plumbing systems within the facility is warranted due to the current conditions observed. Modification of fixture types and locations are needed to comply with current standards and occupant needs.
