**Total Length of Project Repairs- 2,140 LF**

- 1,070 LF of Pipe Outside Building Footprint
- 1,070 LF of Pipe Inside Building Footprint

**Repair Approach Breakout**

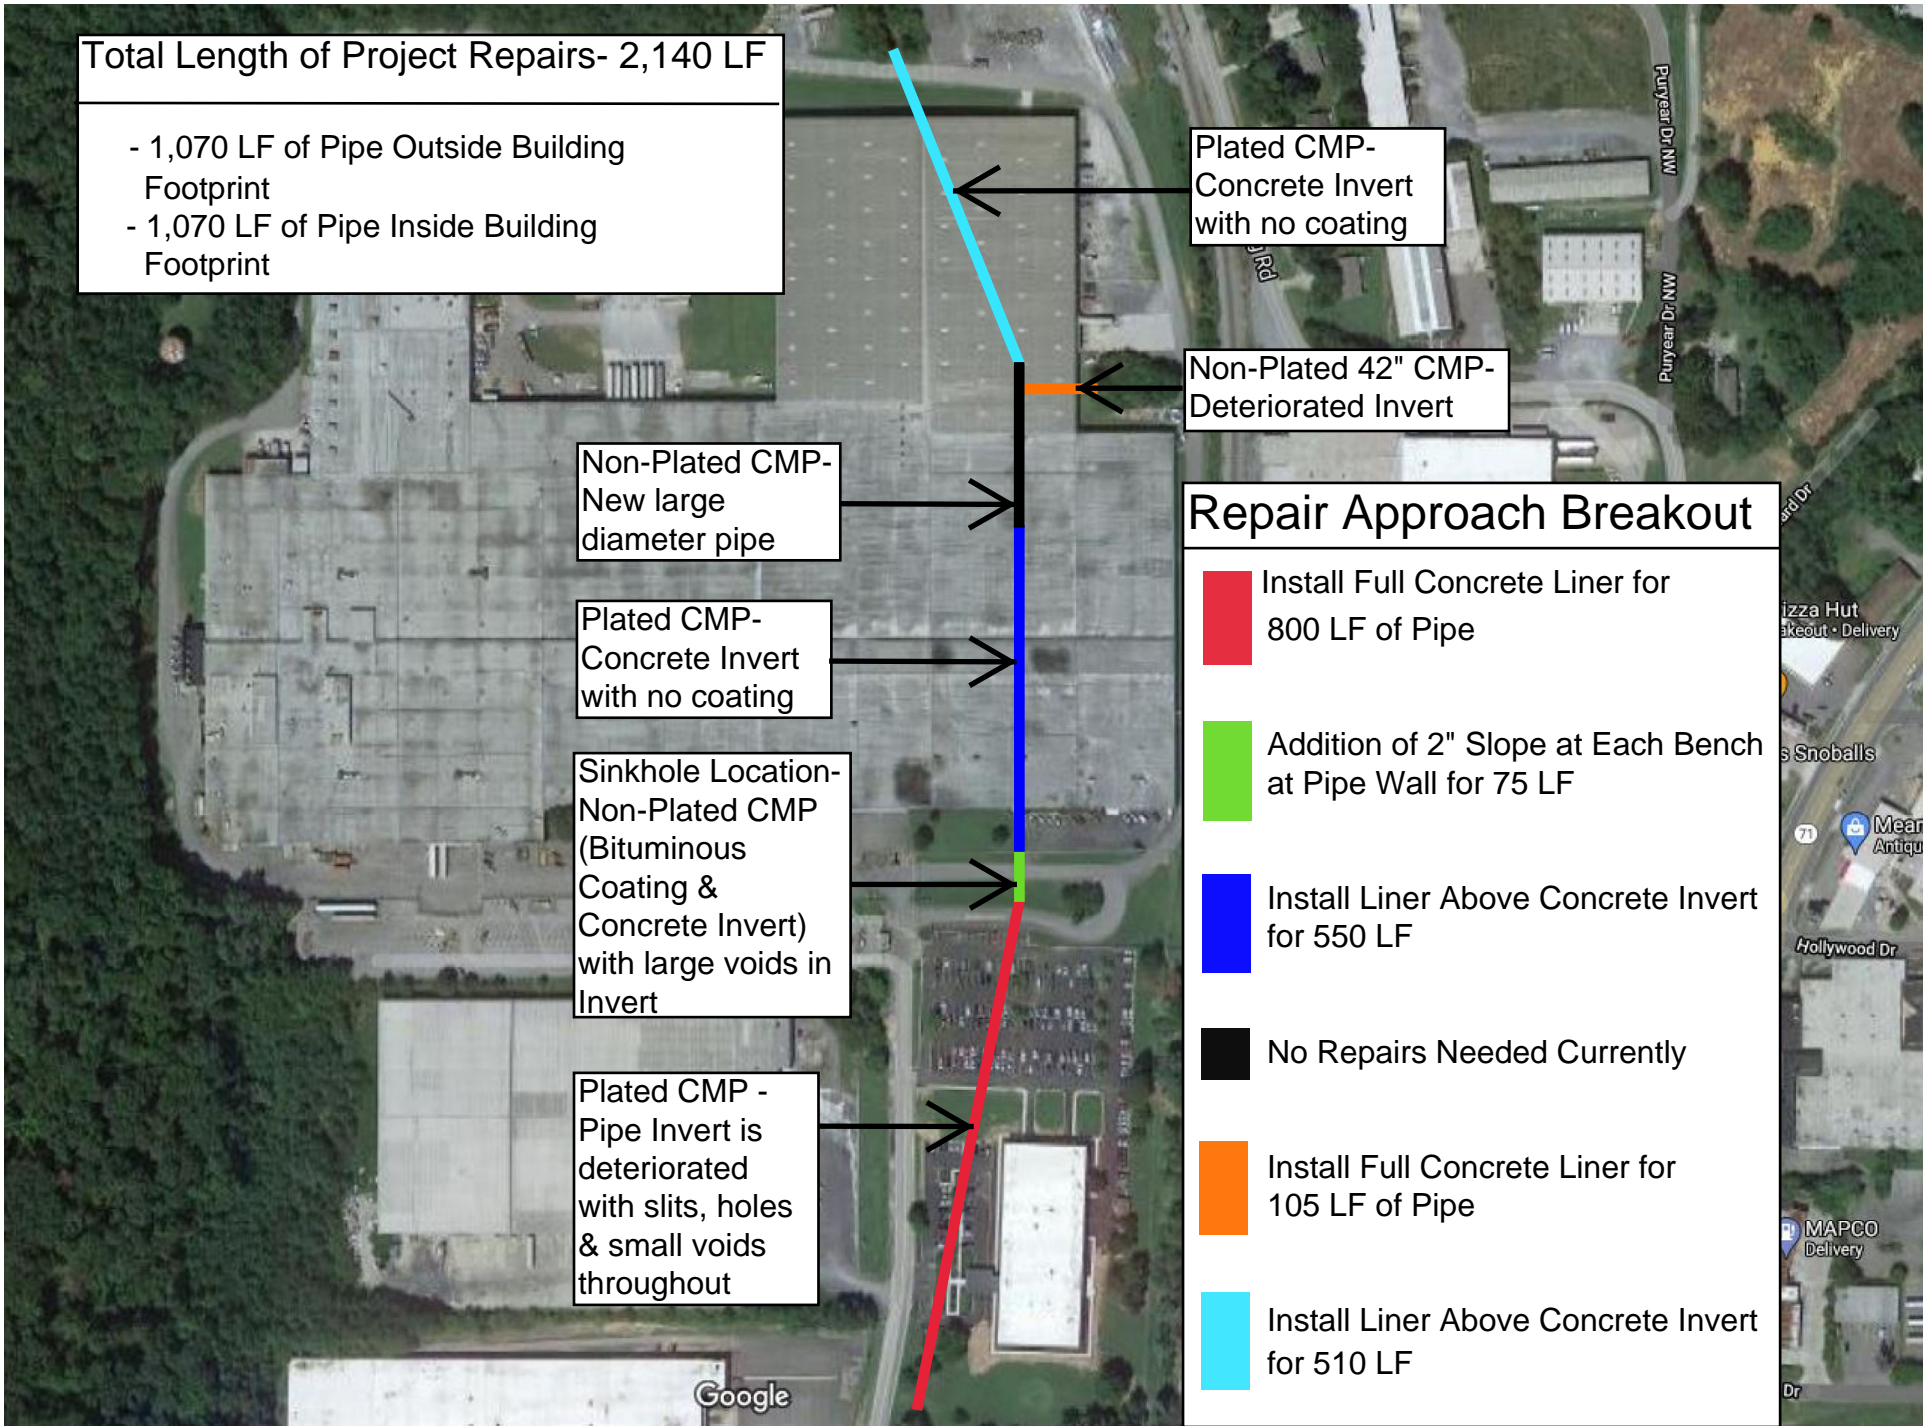
Non-Plated CMP-  
New large  
diameter pipe

Plated CMP-  
Concrete Invert  
with no coating

Sinkhole Location-  
Non-Plated CMP  
(Bituminous  
Coating &  
Concrete Invert)  
with large voids in  
Invert

Plated CMP -  
Pipe Invert is  
deteriorated  
with slits, holes  
& small voids  
throughout

Non-Plated 42" CMP-  
Deteriorated Invert

Install Full Concrete Liner for 800 LF of Pipe
-

Addition of 2" Slope at Each Bench at Pipe Wall for 75 LF
-

Install Liner Above Concrete Invert for 550 LF
-

No Repairs Needed Currently
-

Install Full Concrete Liner for 105 LF of Pipe
-

Install Liner Above Concrete Invert for 510 LF
