RE: John Davis Recreation Center: Architectural, Structural, Electrical & HVAC Report

RE: Report of Structural Evaluation of Existing Building at 904 Civic Drive in Dalton, Georgia

BUILDING HVAC & PLUMBING SURVEY

BUILDING ELECTRICAL SURVEY

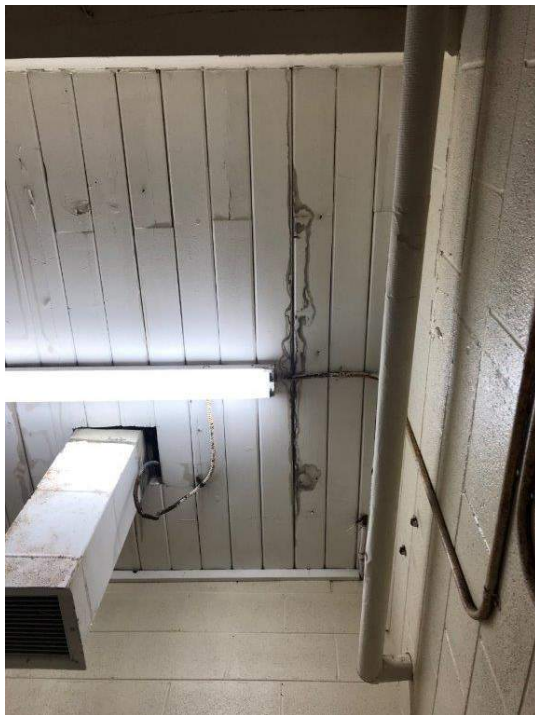
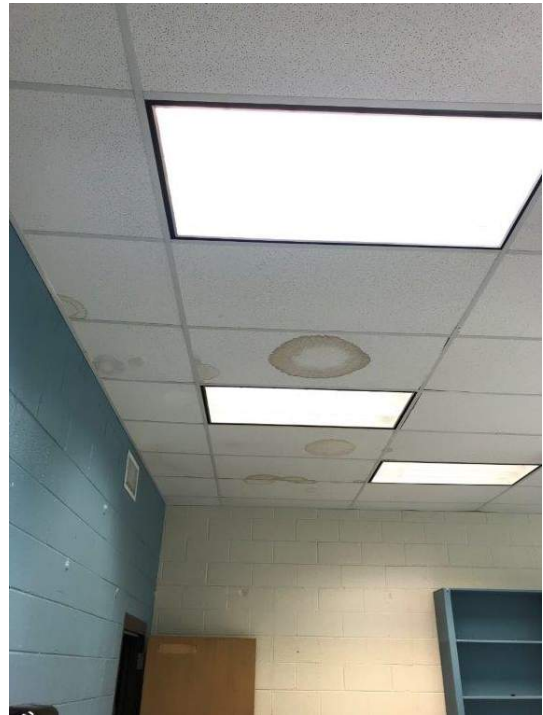
The absence of an air barrier can also allow hot humid air to enter the building and condensate on any cool surface within the building. This is usually most evident on air diffusers or other cool surfaces. We observed multiple stained ceiling tiles throughout the building. It is our understanding that the roof was replaced in the last two years so it is likely that these stains are a result of water condensing on ductwork and dripping onto the tile. (Please see Exhibit P1&P2).

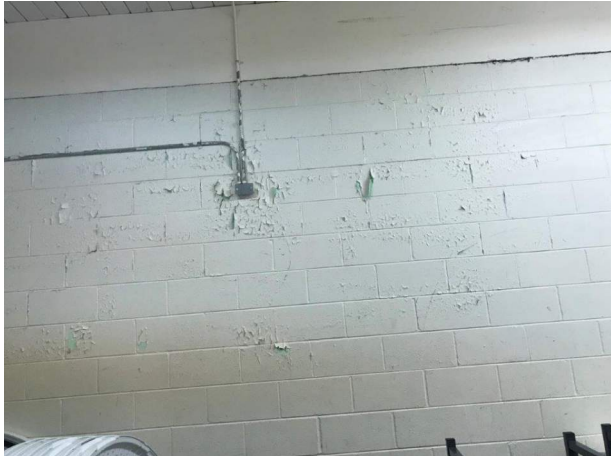
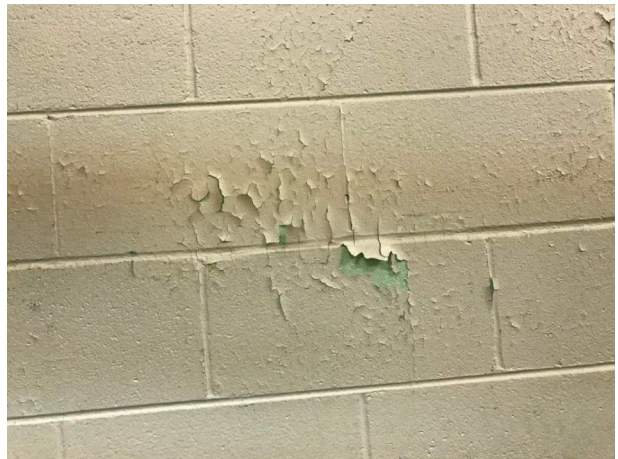
Based on our observations, the exterior walls of Building “A” do not include air, water or vapor barriers. Evidence of this can be seen in the on the interior surface of the concrete block walls. Paint is peeling from the surface of the walls due to condensation within the block. Also, per our discussions with maintenance personnel, we understand that the drywall has been replaced along many of these walls as a result of moisture issues. (Please see Exhibit P3&P4).

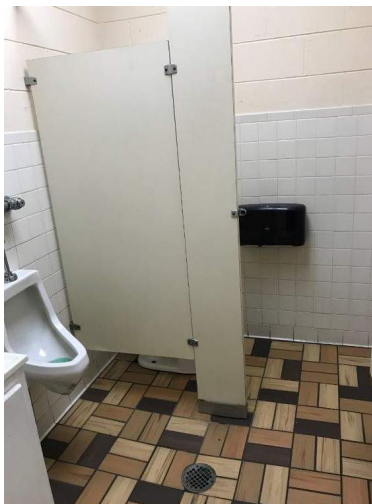
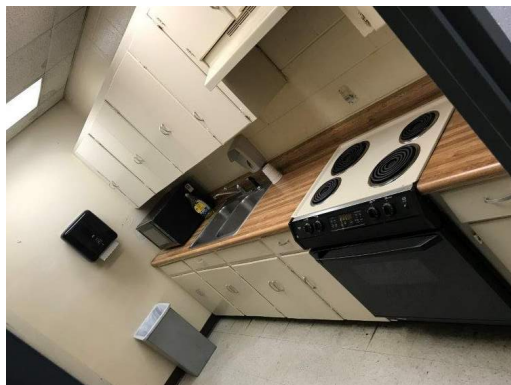
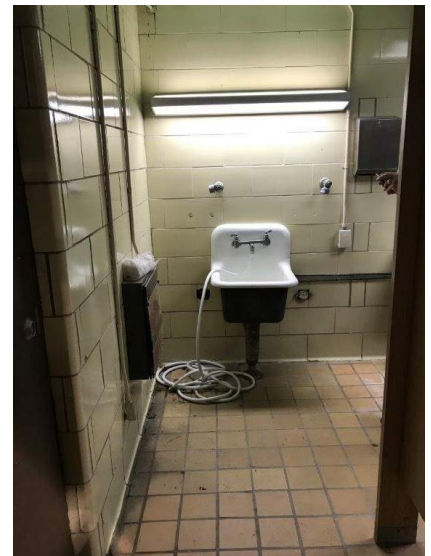
One of the most costly issues when renovating a building is complying with the current ADA standards. This building is accessed by the public and needs to be accessible to everyone. Currently, the restrooms do not meet the approach and/or clearance requirements of the code. Also, due to the age of the waste piping and fixtures, a complete replacement of the restrooms is recommended. (please reference the plumbing report). Other accessibility issues include door hardware, countertop heights and reach requirements for electrical devices. (Please see Exhibit P5,P6 & P7).

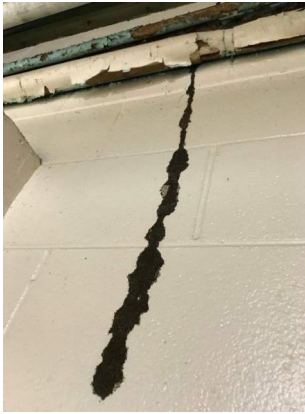
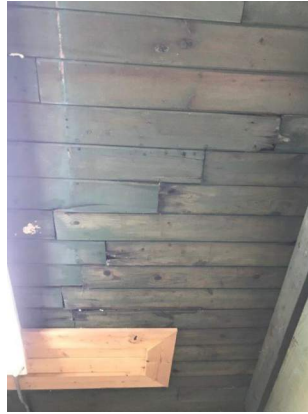
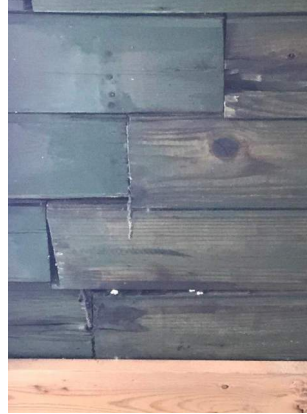
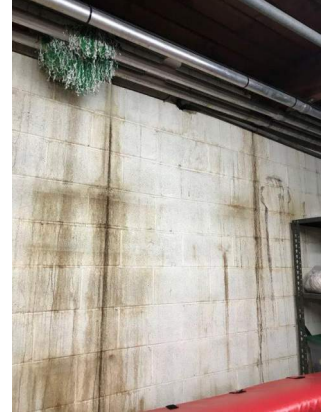
Building “A” also includes the pool locker rooms and equipment room. Significant moisture issues and termite damage was observed. It is our understanding that this area needs to be maintained until the pool is eventually replaced. Replacement of the roof structure and decking will be required in several areas. Please see the structural engineer’s report for further discussion. (Please see Exhibit P8, P9, P10 &P11).

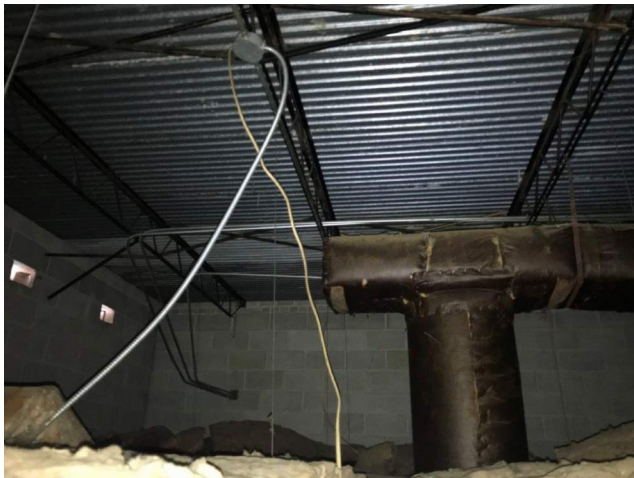
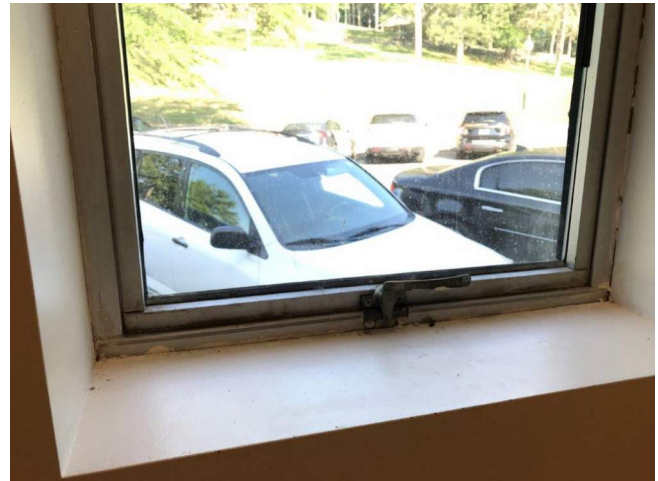
The original construction of Building “A” did not include insulation in the walls and roof. Some insulation has been added to the exterior walls of the meeting rooms. This should help slow the transfer of heat energy in these spaces, however, some of the walls are not insulated. Also, the insulation placed on the ceiling tile is not allowed by code. New insulation will be required to meet the current requirements of the Energy Code. The window frames and glazing do not meet current requirements for shading and heat gain or thermal transfer. These will need to be replaced. (Please see Exhibit P12 & P13).

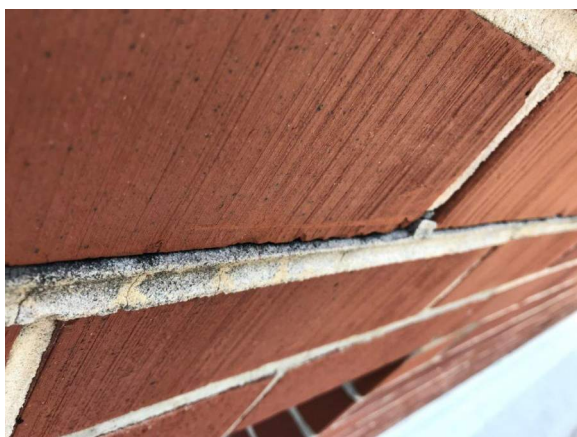
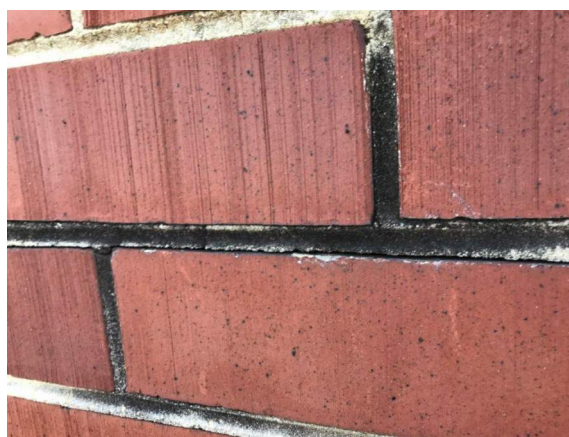
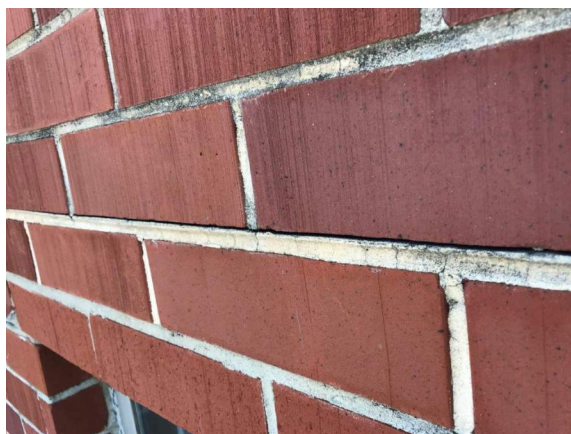
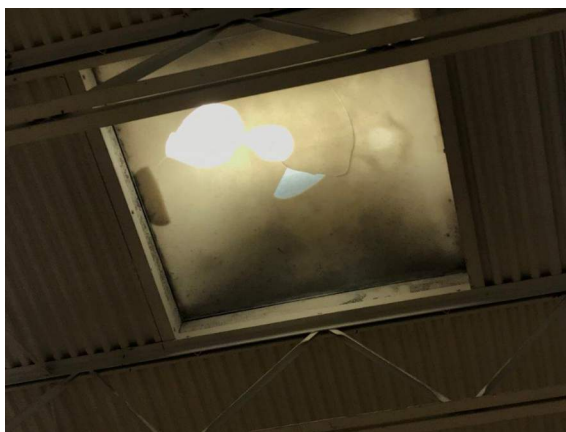
Much like Building “A”, the majority of Building “B” was not designed to receive air conditioning. The gymnasium is currently ventilated with fans and louvers. It is constructed with single width concrete masonry units, faced with brick. The mortar in the brick is failing in multiple areas. This is likely due to failure of the reinforcement in the walls. Further investigation will be required to determine the cause and repairs necessary. At a minimum, repointing of the masonry will be required. This building will also require new insulation, and an air, water, vapor barrier. (Please see Exhibit P14, P15, P16 & P17). Please refer to the Structural, Mechanical, plumbing and Electrical reports for additional information.

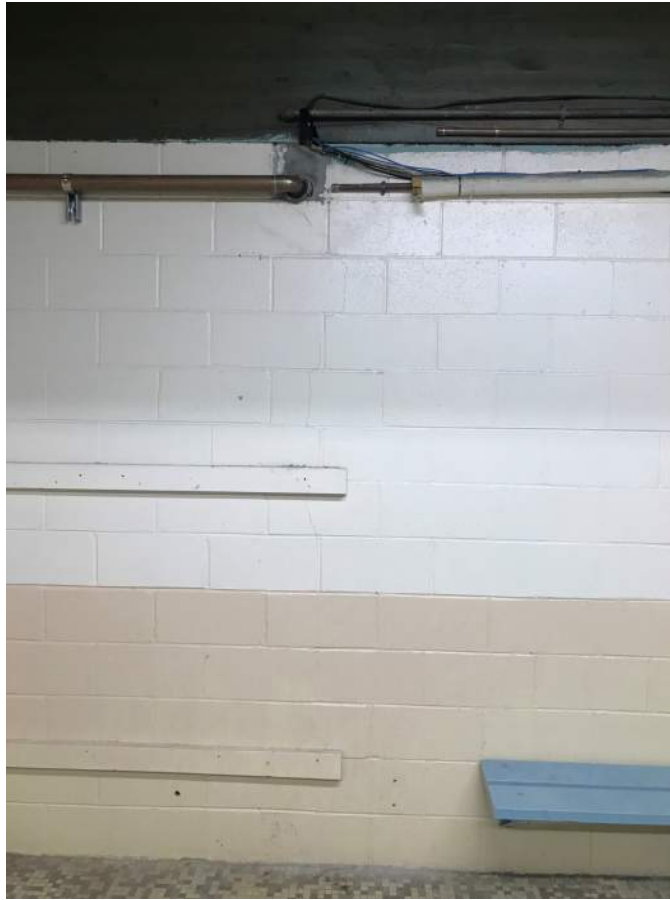
WJPA observed several cracks on the CMU wall at the North end of Building A. Please see Photographs C-E for more information. WJPA also observed significant deflection and cracking on the timber decking. Considering the extent of the damage, it is likely that sections of the roof decking will need to be replaced. Please see Photographs F and G. WJPA noticed the door frame at the pool mechanical room was rusted. WJPA suspected the rust was caused by the exposure to water and caused the CMU wall to protrude out, as shown in Photograph E. WJPA also observed termite tubes hanging from the ceiling at several areas. Please see Photograph J for more information. WJPA did not observe any additional structural issues on Building A.

Photograph C:
Cracks on Building A Men's Restroom CMU Wall #1

It is our understanding that certain portion of the Building A (pool area) may remain depending on the owner's decision to expand or rebuild the facilities. Should the owner choose to expand the facilities, WJPA recommend sealing all CMU cracks, replace the cracked timber decking as required, and repair cracked brick mortar joints. Due to the age of the building, any repair budget should allow for unforeseen contingencies that may be discovered during the repair.

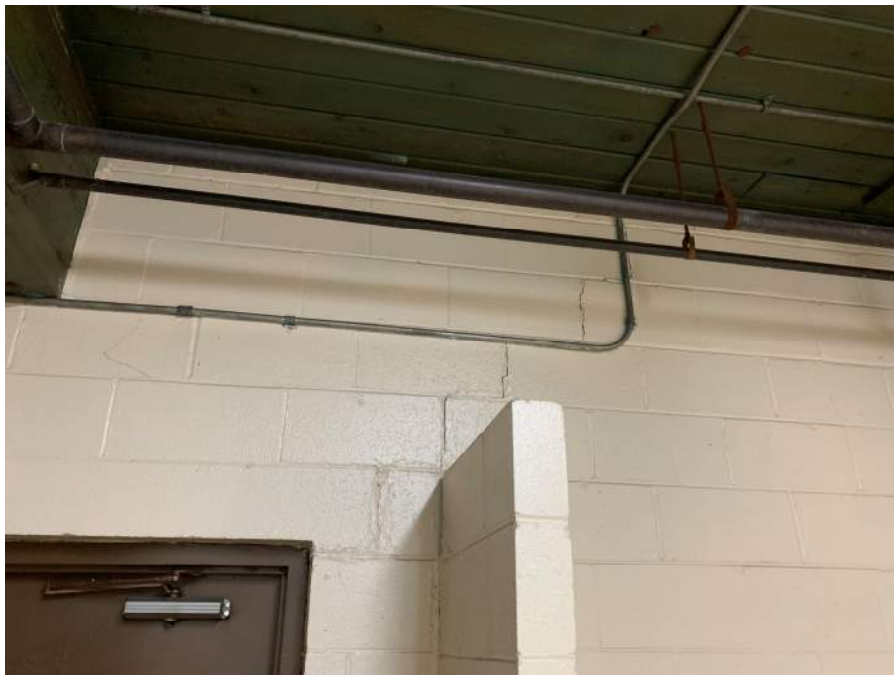
Photograph D:
Cracks on Building A Men's Restroom CMU Wall #2

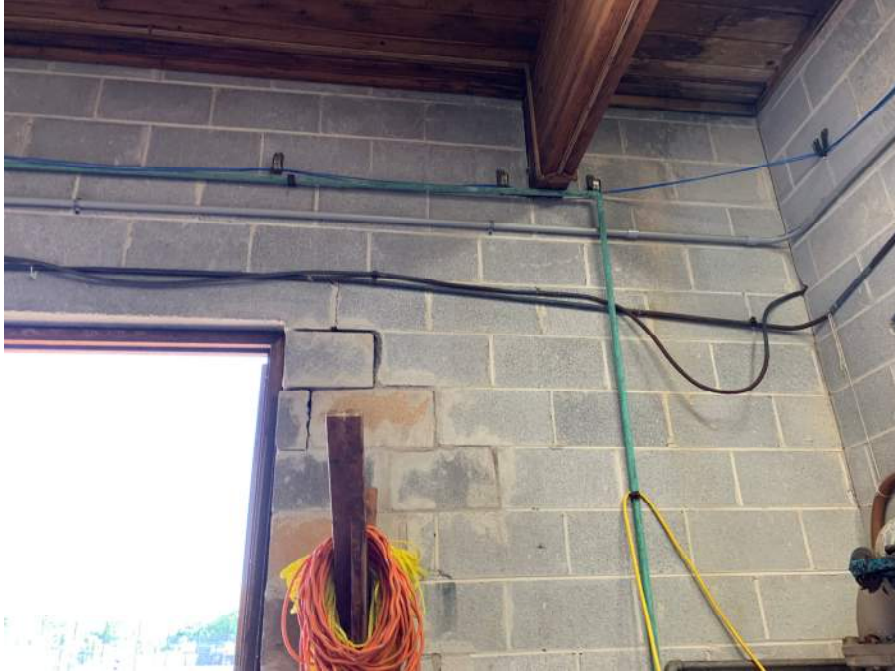
Photograph E:
Cracks on Building A Pool Mechanical Area (Looking North)

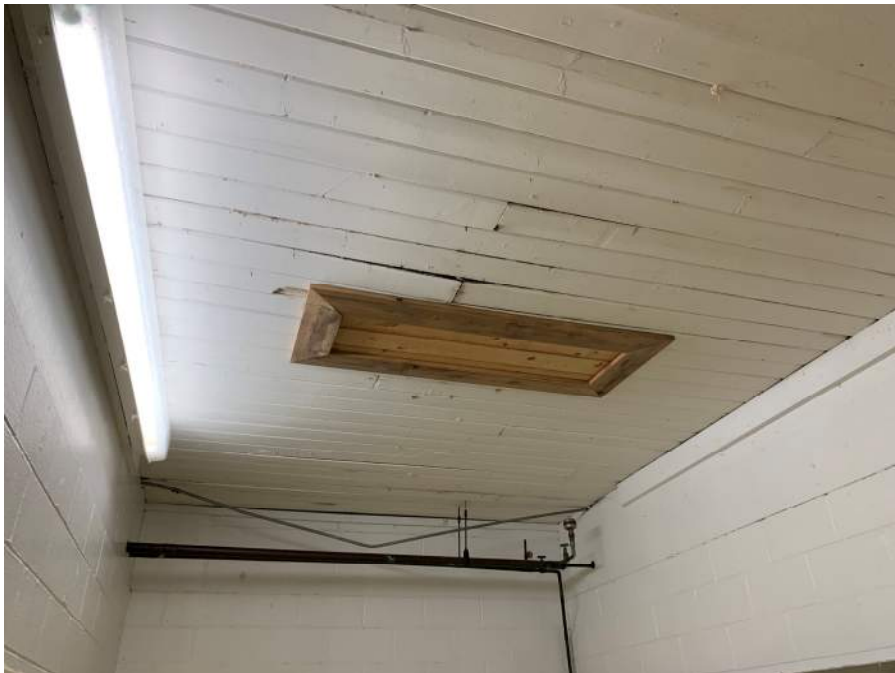
Photograph F:
Cracks on Building A Men's Restroom Timber Decking

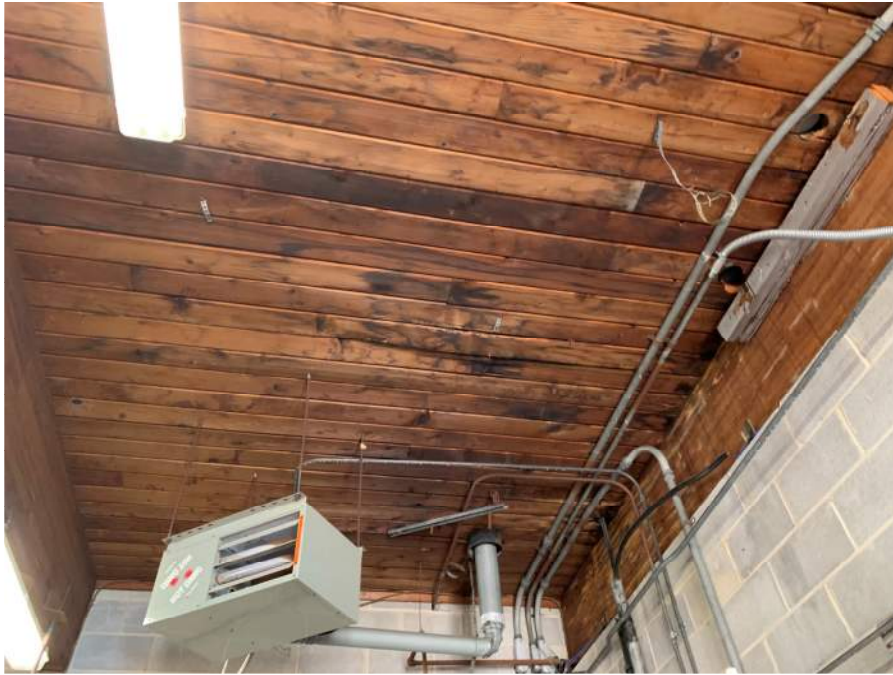
Photograph G:
Significant Deflection on Building A Timber Decking Over Pool Mechanical Room (Looking South)

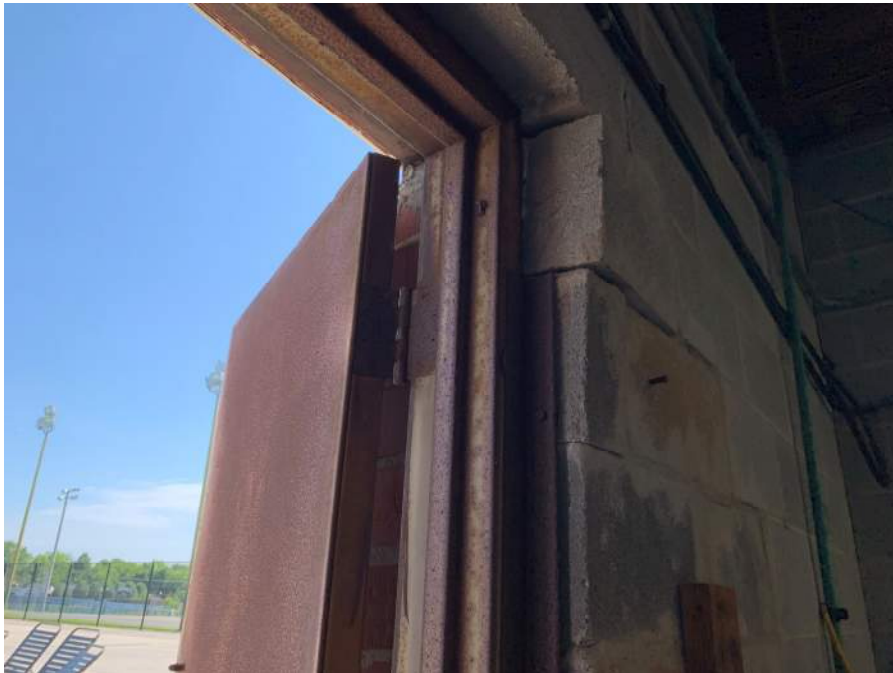
Photograph H:
Building A Rusted Door Frame

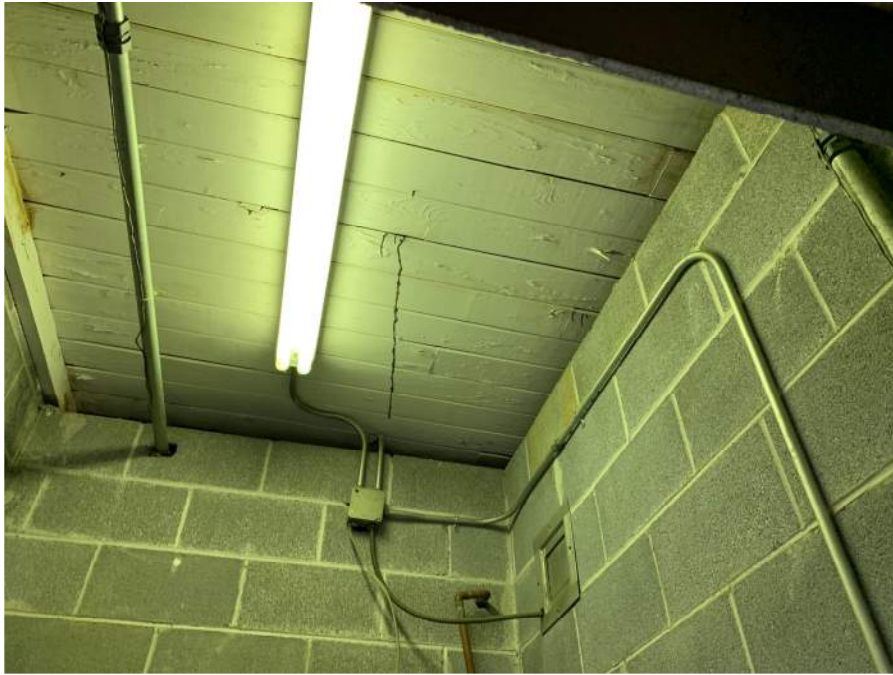
Photograph J:
Building A Termite Infestation

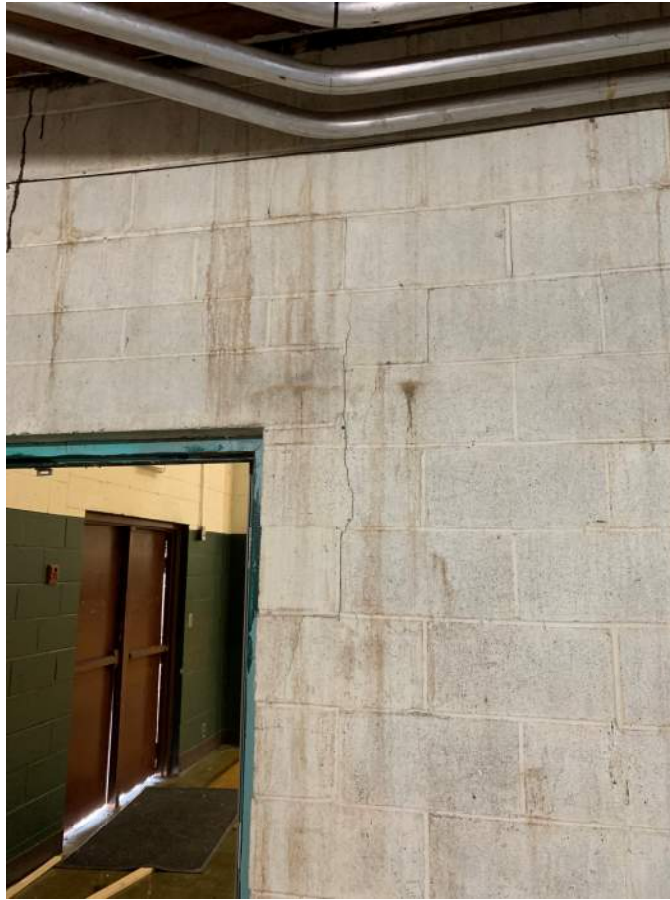
WJPA observed vertical wall cracks on the CMU wall at storage room #1. WJPA also observed several horizontal cracks on brick veneer located at the East end and South end of Building B. WJPA suspected the horizontal cracks were caused by the expansion of the rusted steel shelf angle and steel wire reinforcing. Please see Photograph N to R for more information. WJPA did not observe any additional structural issues on Building B.

Photograph N:
Cracks on Storage Room #1 CMU Wall (Looking South)

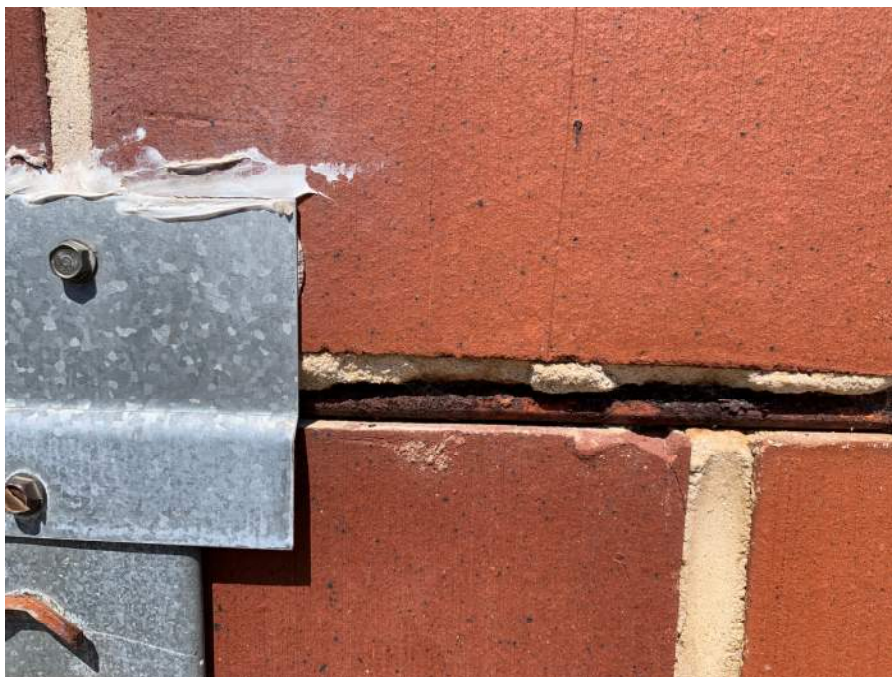
Photograph P:
Rusted Steel Shelf Angle (Looking West)

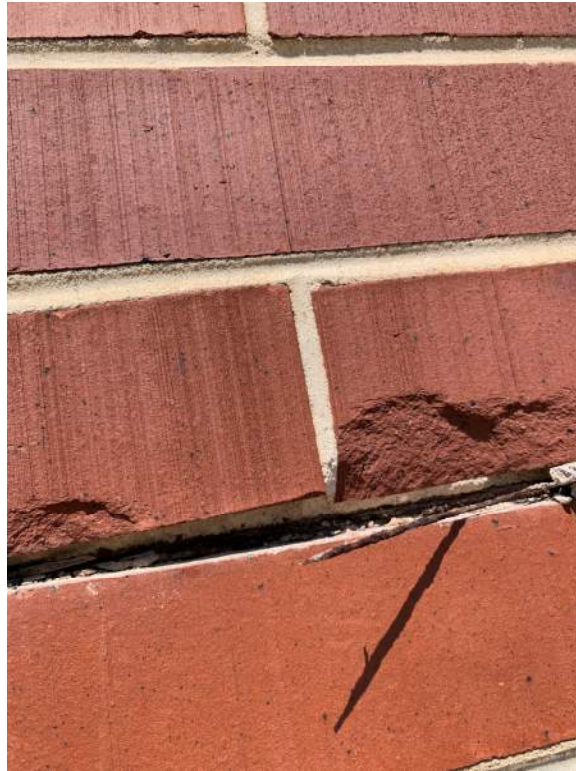
Photograph Q:
Rusted Steel Wire Reinforcing (Looking North)

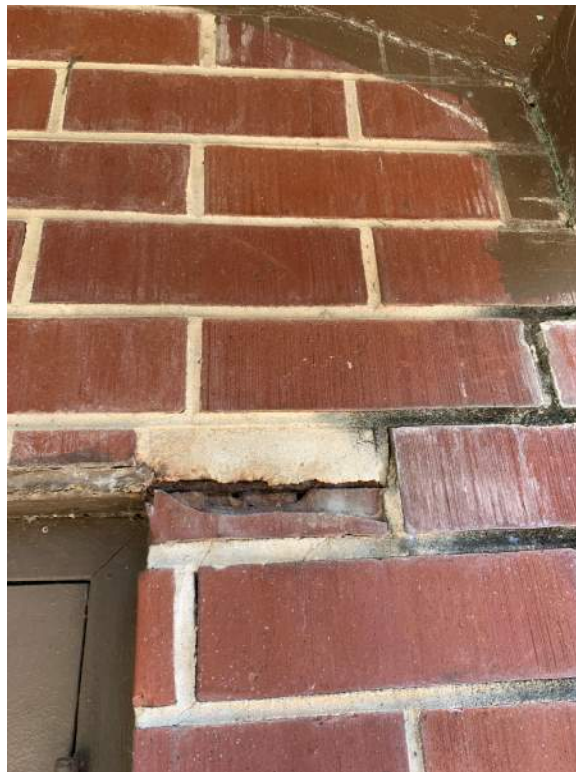
Photograph R:
Cracks on Building B Brick Veneer (Looking North)

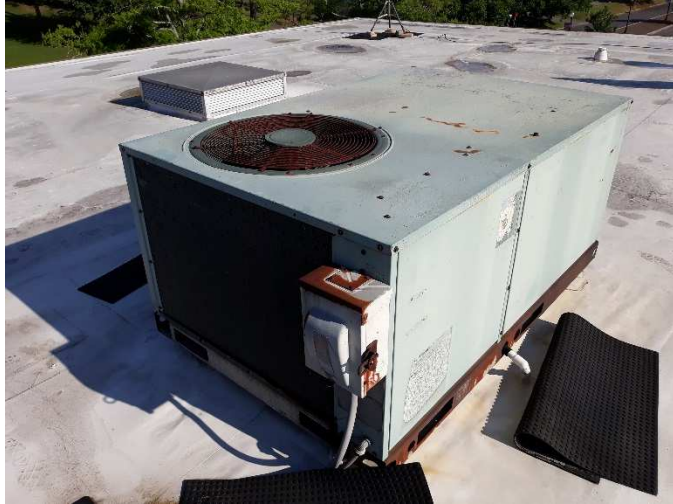
Two abandoned single package all electric rooftop units still exist on the roof above the multi-purpose room. They originally conditioned the multi-purpose room, but they are no longer operative. They appear to be over 15 years in age.

Original Multipurpose Rooftop Unit - Abandoned

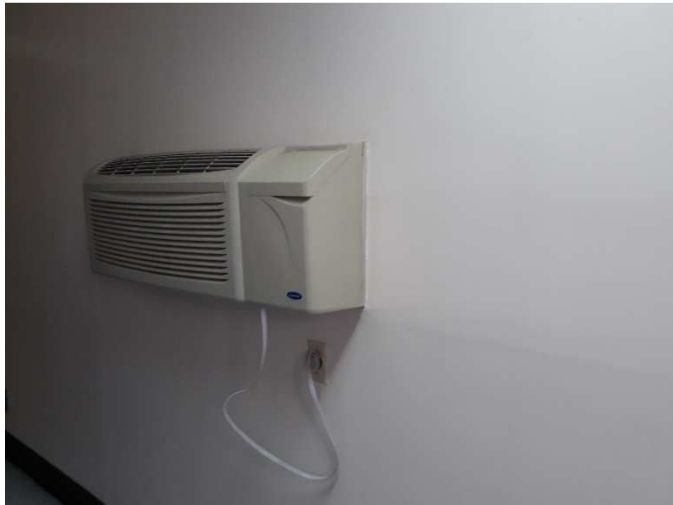
The upper level connecting corridor between the multi-purpose room and the second level of the gym is conditioned by a motel style unit located high in an exterior wall and discharging into to corridor. This unit was manufactured in 2001,

The other two small single package A/C units installed for the upper level corridor and equipment storage room are in need of immediate replacement.

Upper Corridor Motel Style Unit

The upper level gym corridor and elevator lobby shall be conditioned with new ductless split system to replace the current thru-wall motel type unit.

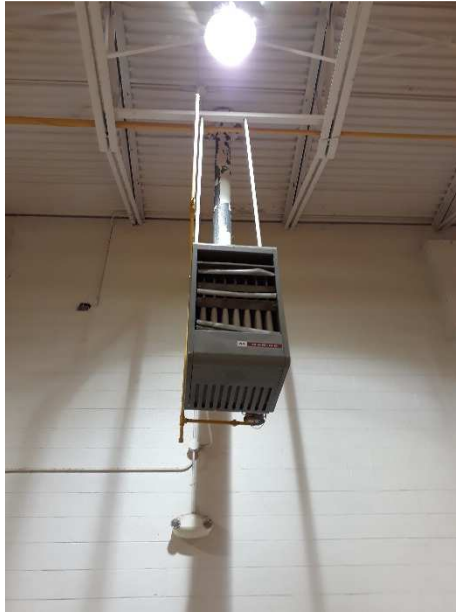
Heating for the gym is provided by 3 gas-fired unit heaters. Two of the units are much older than the third, and they are in poor condition with damaged cabinets and louvers. The third unit has been installed recently.

Typical Unit Heater for Gym

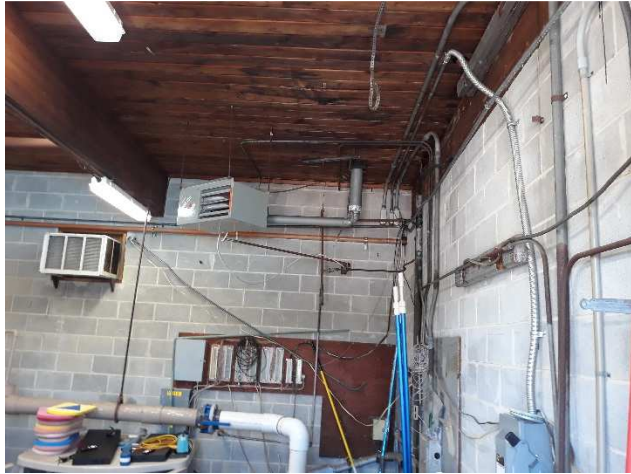
A small window type air-conditioning unit is also installed for the equipment storage area of the gymnasium. The back side of this unit is located in the pool equipment room.

Pool Equipment Area – Window Unit from Storage

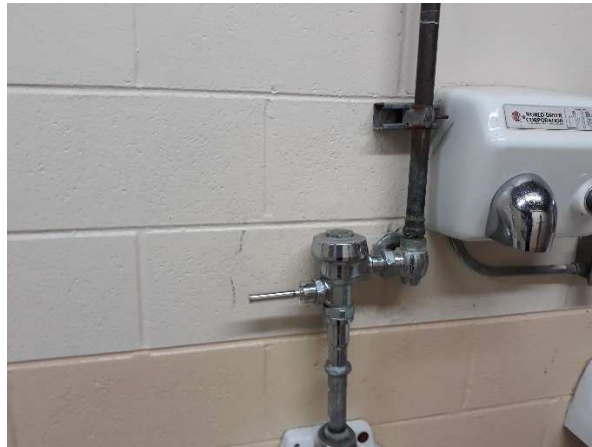
Conversations with the maintenance staff indicate that repair of underground sanitary piping is difficult due to the level of corrosion present for the buried piping.

Locker Room Piping indicating corrosion

A full and complete replacement of the plumbing systems within the facility is warranted due to the current conditions observed. Modification of fixture types and locations are needed to comply with current standards and occupant needs.
