10th Ave E Mill & Overlay - E Villard St to Museum Dr E

Sanitary Sewer Manhole Condition Evaluation

City of Dickinson, ND

Prepared By: Moore Engineering, Inc.

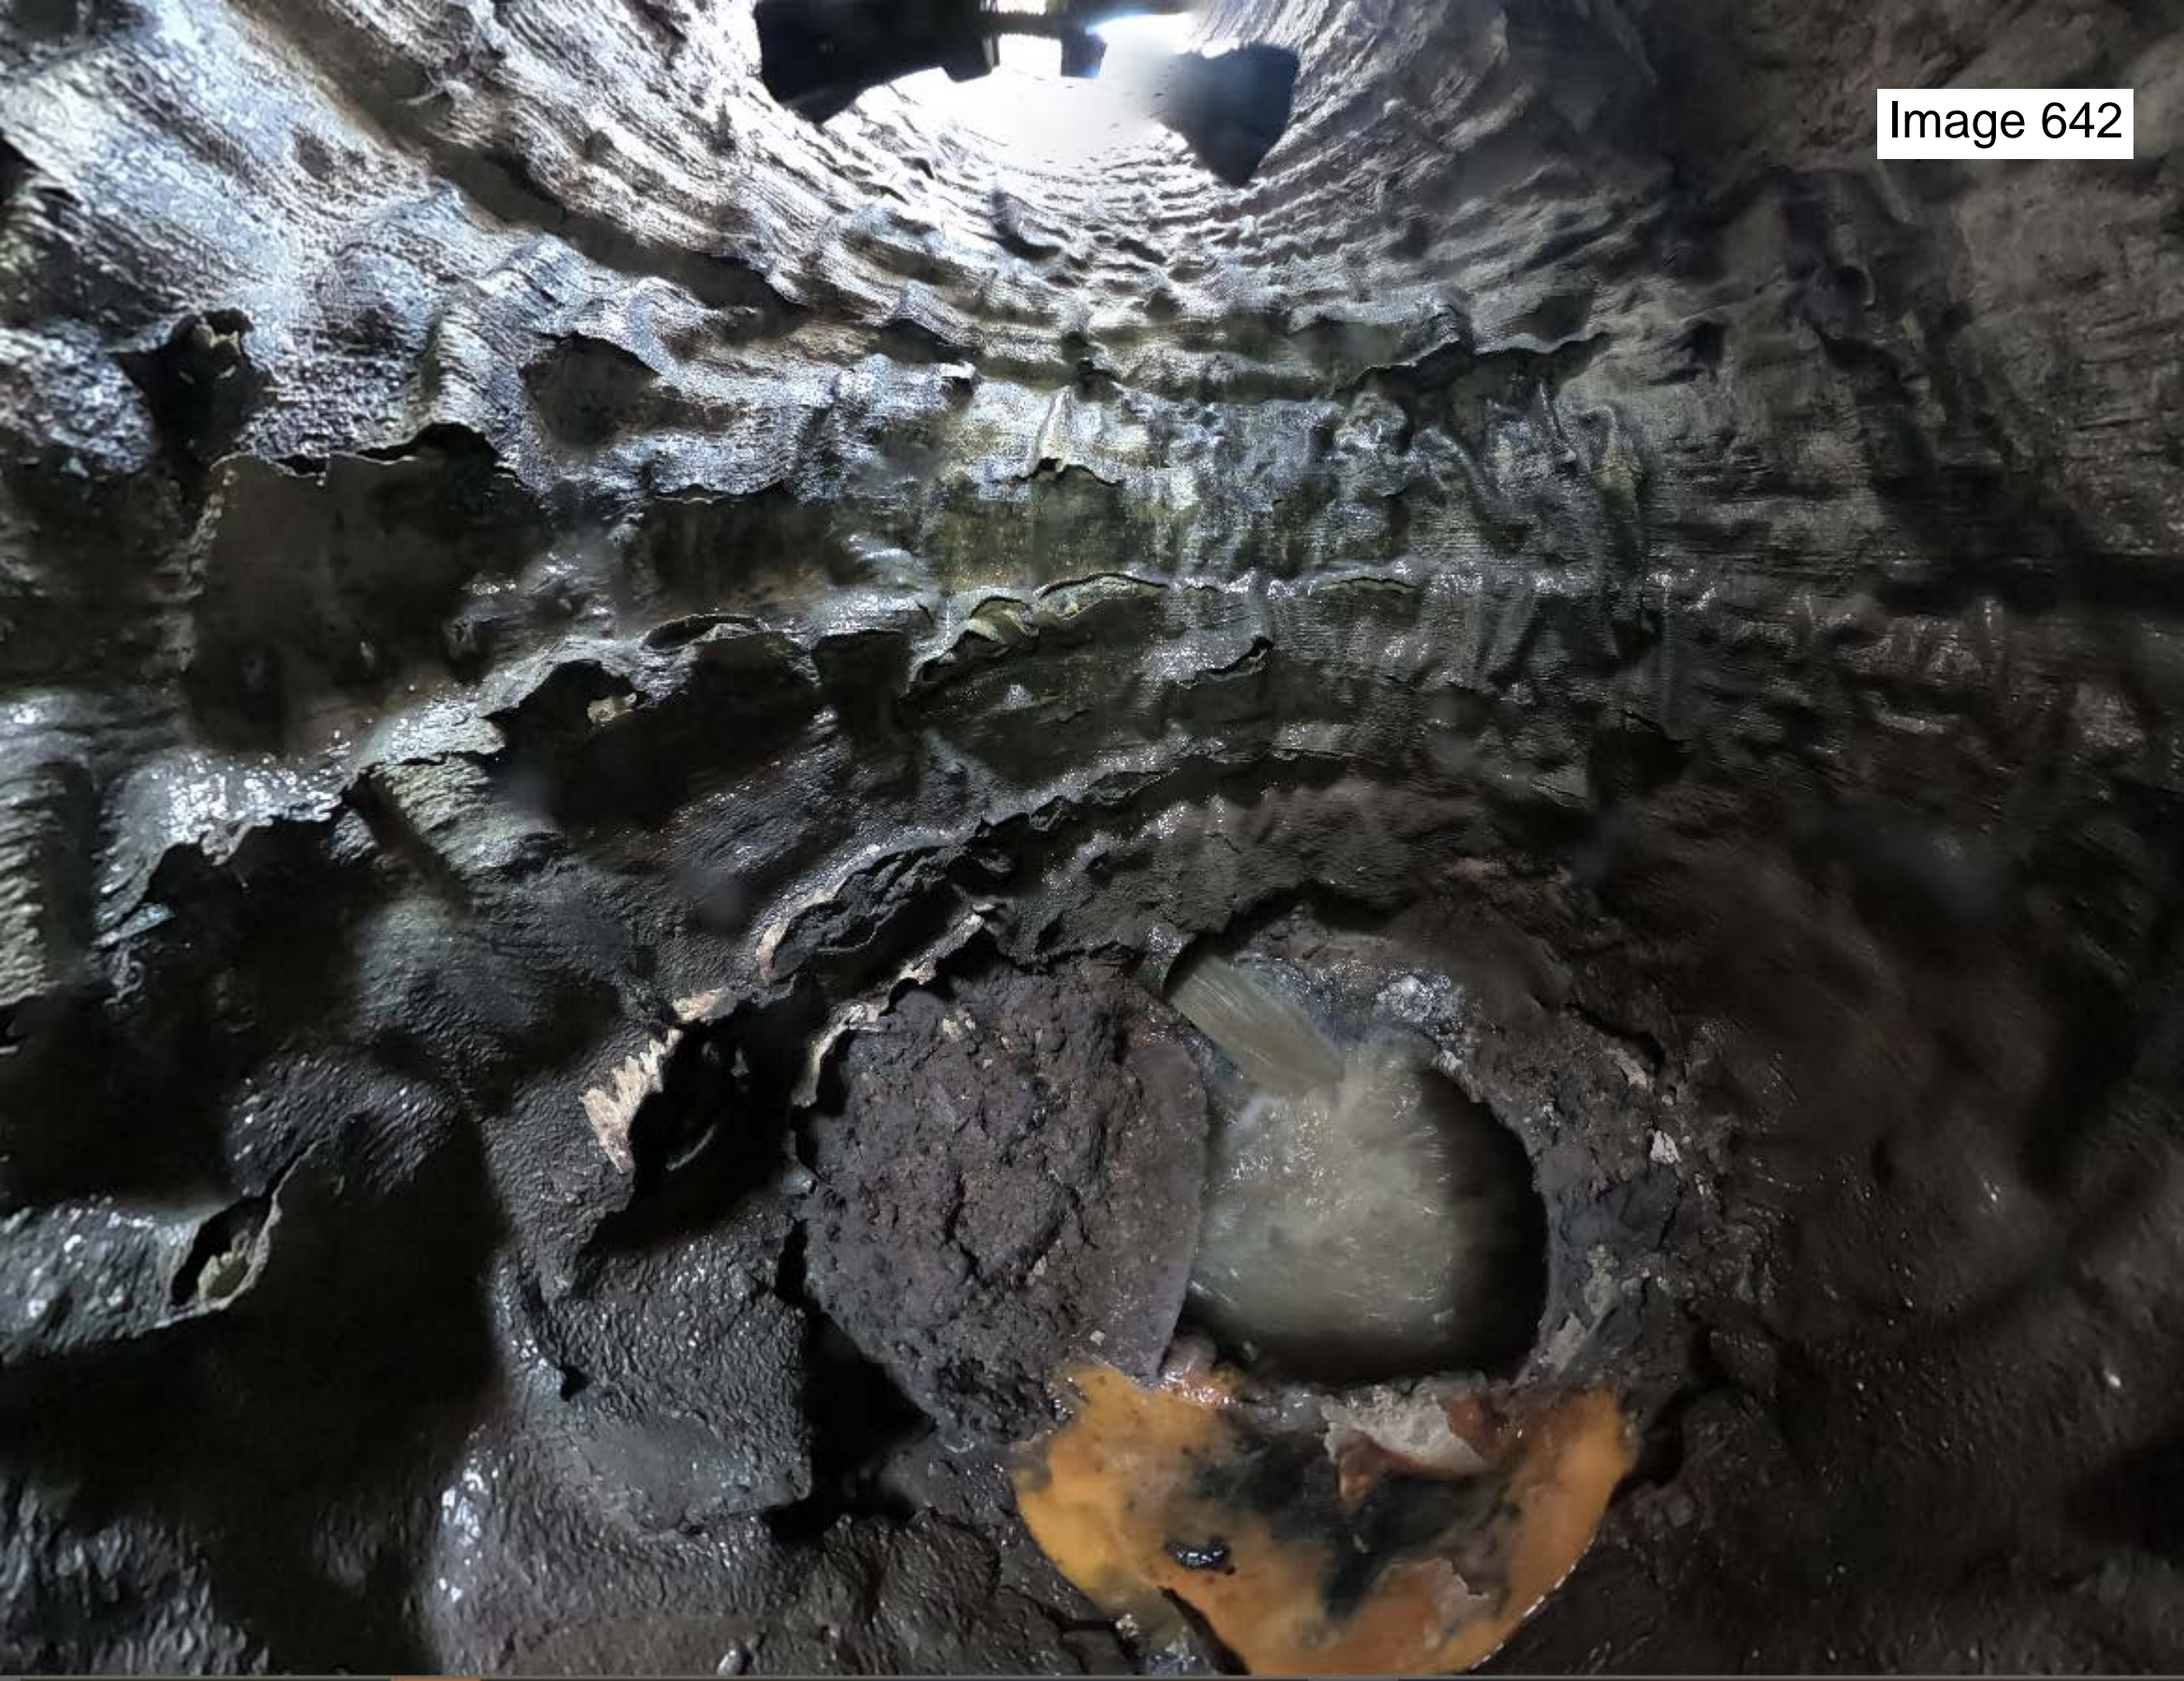
Image 645

Buffalo Bend	86870	637-639	4	8	2	Coal Tar	MH walls in fair condition, beginning to bubble.
7th St E & 10th Ave E	86863	640-642	5	10	3	Epoxy	Coating bubbling and cracking.
Between 7th St & 8th St	86869	643-645	2	4	4	Epoxy	Coating bubbling and cracking, especially in bottom 8', portions of coating completely missing.
8th St E & 10th Ave E	86833	646-648	6	12	2	Epoxy	Coating bubbling and cracking, especially in bottom 4'.
9th St E & 10th Ave E	86800	649-651	4	8	3	Epoxy	Coating completely missing from bottom 6', wire mesh from MH structure exposed.
Franklin St & 10th Ave E	86793	653-655	6	12	2	Epoxy	Coating bubbling and cracking.
Between Franklin St & 10th St	88738	656-658	4	8	2	Epoxy	Coating bubbling and cracking, especially in bottom 4', portions of coating completely missing
10th St E & 10th Ave E	86781	659-661	2	4	3	Epoxy	Coating bubbling and cracking.
Between 10th St & Museum Dr	86785	662-664	2	4	2	Epoxy	Coating bubbling and cracking especially in bottom 4', portions of coating completely missing.

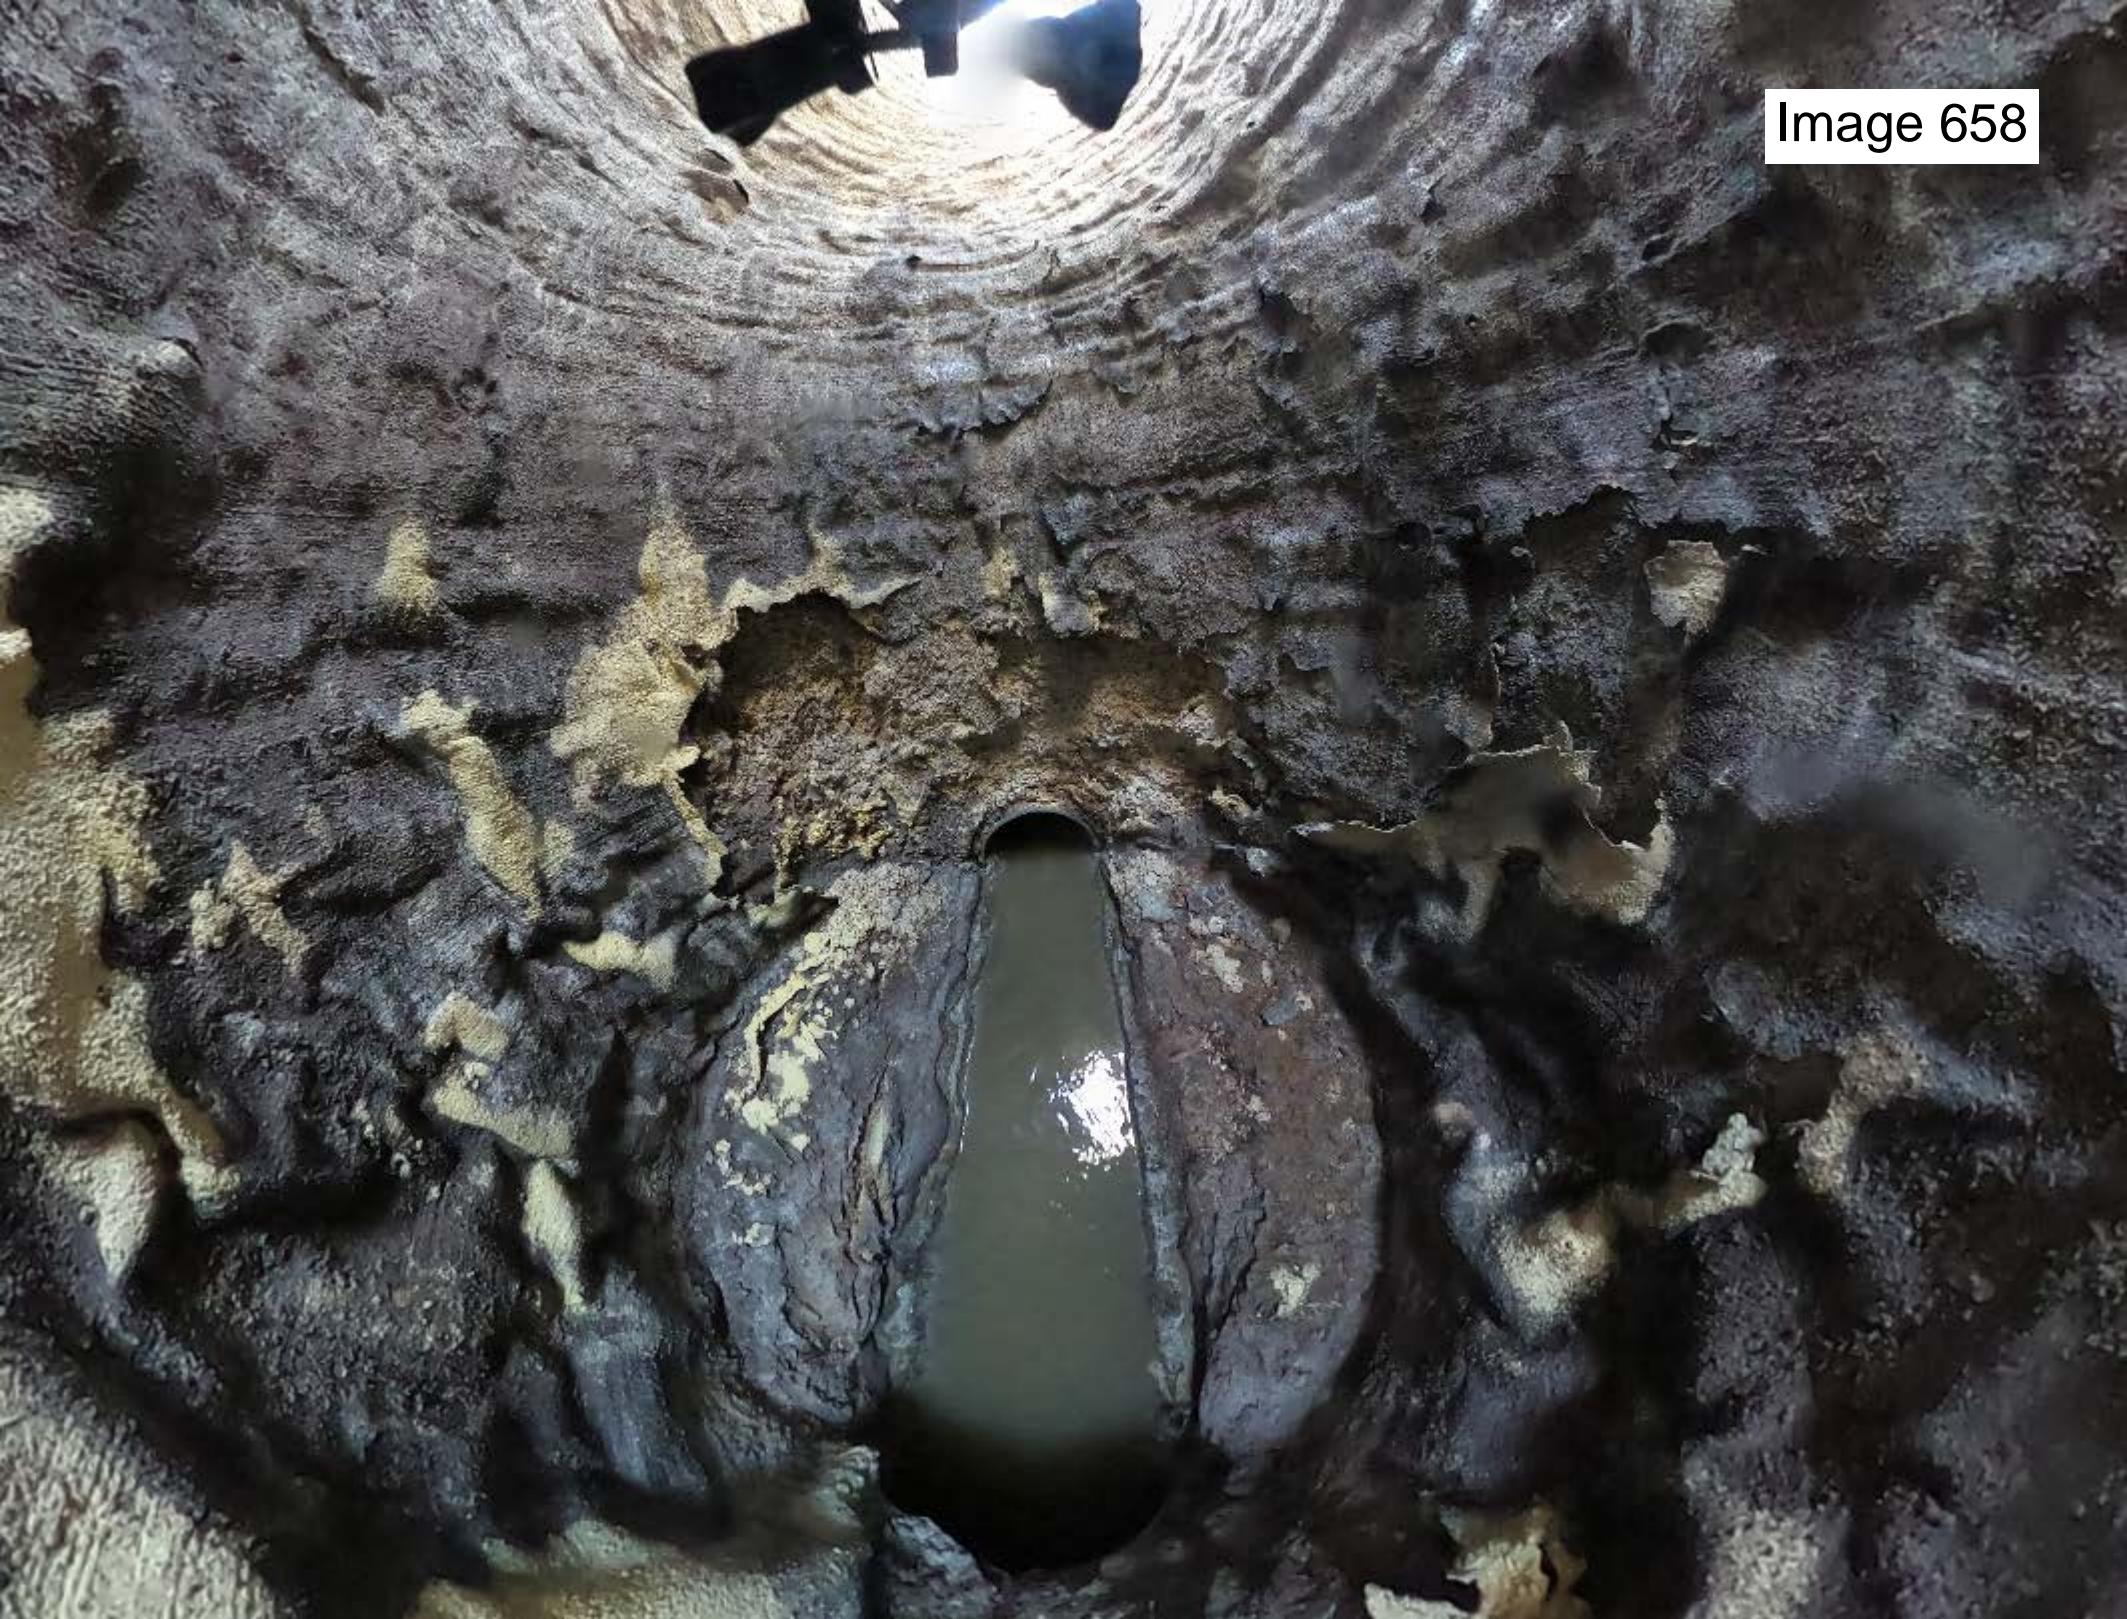
Image 667

Museum Dr & 10th Ave E	86775	665-667	6	12	4	Liner	Liner functioning well except for at pipe penetrations where structure severely deteriorating around liner hole.
8th St E	86832	668-670	13	26	3	Coal Tar	Good condition. No deterioration.
7th St E	86862	671-673	3	6	2	Coal Tar	Good condition. No deterioration.
9th St E	86795	674-676	2	4	3	Coal Tar	Good condition. No deterioration.
Franklin St	86788	677-679	14	28	2	Coal Tar	Good condition. No deterioration. Sewage backup at time of photo.
