Technical Memorandum

Date: September 26, 2024
Prepared By: Taylor Braaten, PE
Project: Dickinson Project No. 202423
Dickinson 2024 Sanitary Sewer Manhole Repairs
Moore Project No. 24219
Owner: City of Dickinson, ND
Subject: Assessment of Sanitary Sewer Manholes

2024 Sanitary Sewer Manhole Repairs

Sanitary Sewer Manhole Condition Evaluation

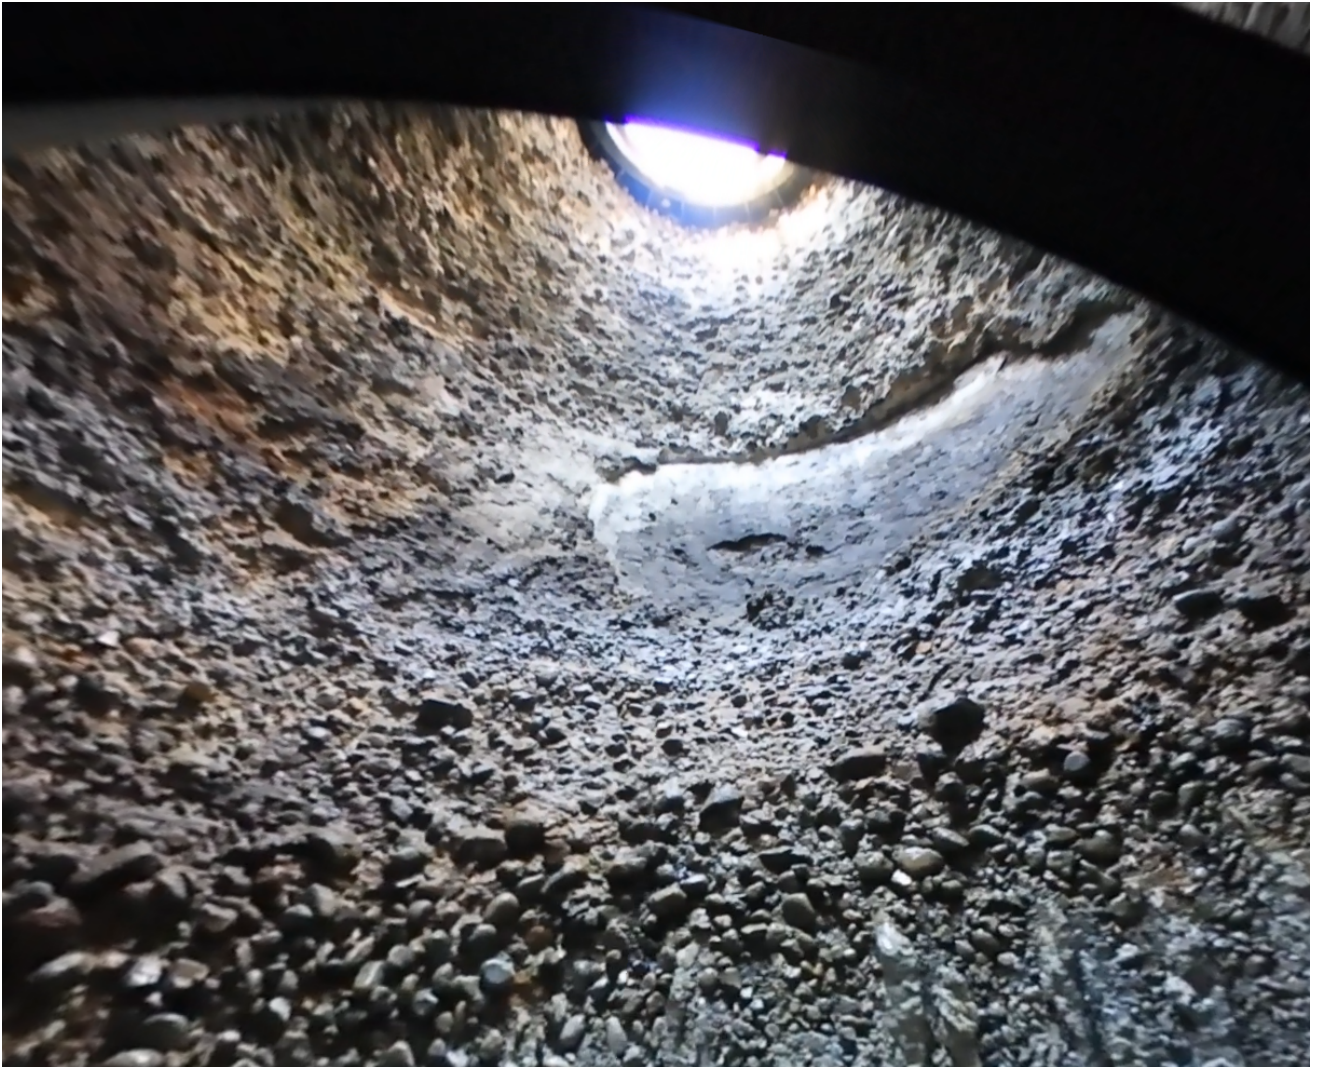
B10-51 - River Drive

Severe Deterioration

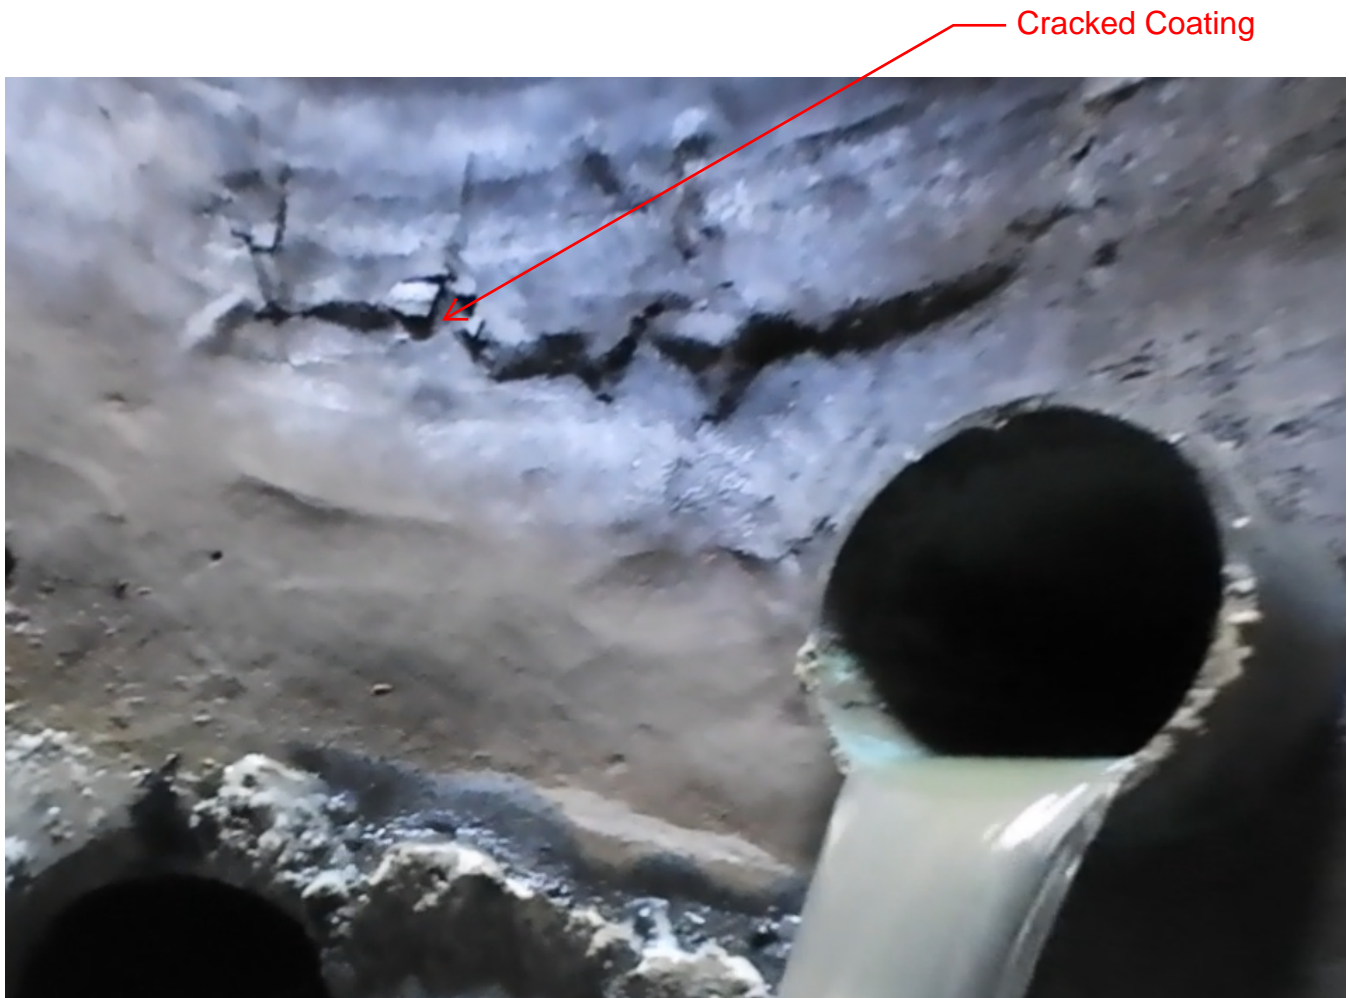
B9-11 - 1st St SW

Coating Failure
