MAIN STREET MASTER PLAN APPENDIX A: ENGINEERING REPORT

December 2021

Appendix A: Deadwood Main Street Master Plan

Engineering Report

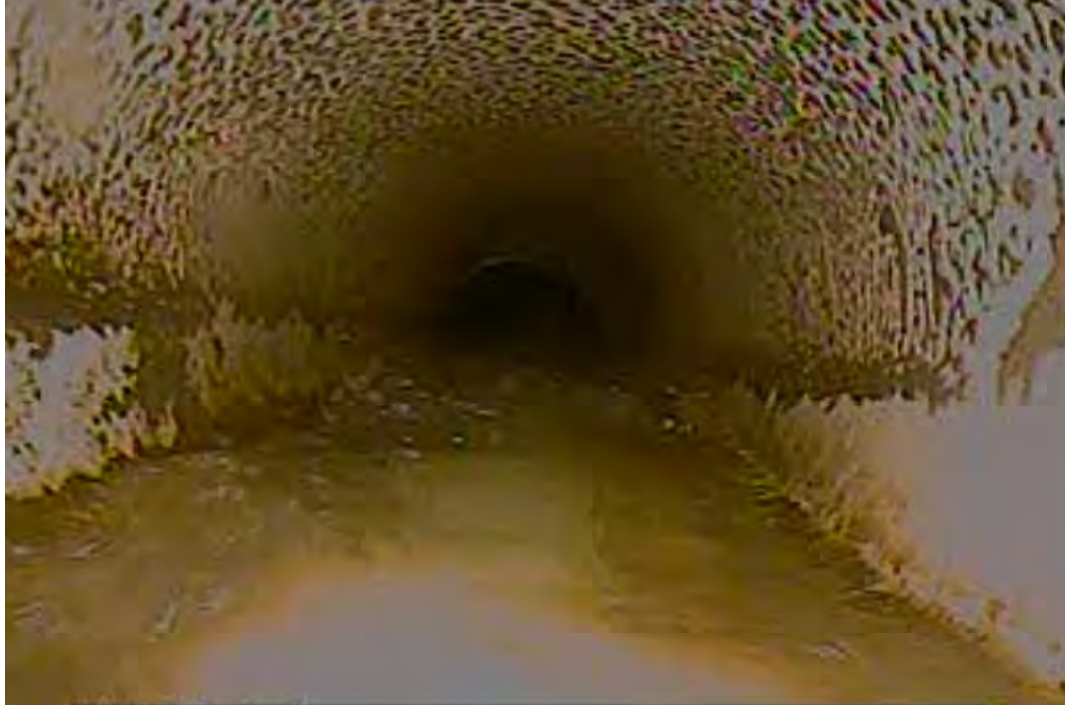
Defects observed during the sewer investigation included minor sags, grease buildup, and sediment deposits in the mains. Where there were buildups and deposits, Rapid Rooter had to jet and clean prior to videoing. Mains that required jetting and cleaning were between manholes 422 and 467 (under the parking garage), 73 and 494 (in front of the Mineral Palace), 58 and 59 (in Main Street) and 57 and 55 in Wall Street. The City was called to jet the main between manholes 62 and 454 in US Highway 14A due to a blockage. The camera was generally able to pass through the minor sags. However, sags can end up creating a long-term maintenance issue when sediment and other debris settles in the main, eventually creating a blockage. [Picture 3](#) shows an example of a sag in a sanitary sewer main.

Picture 3 Example of sag in sewer main

The sanitary sewer system would be best served by spot fixing the issues highlighted above, especially with regards to servicing. Overall, the mains and manholes appeared to be in good shape. To keep the mains in optimal condition, periodic jetting is recommended to clear obstructions. Any manhole cover and rim with perforations should be replaced with ones that have none to reduce inflow potential. FEC also recommends the installation of chimney seals in the upper areas of cone sections to prevent infiltration during wet periods.

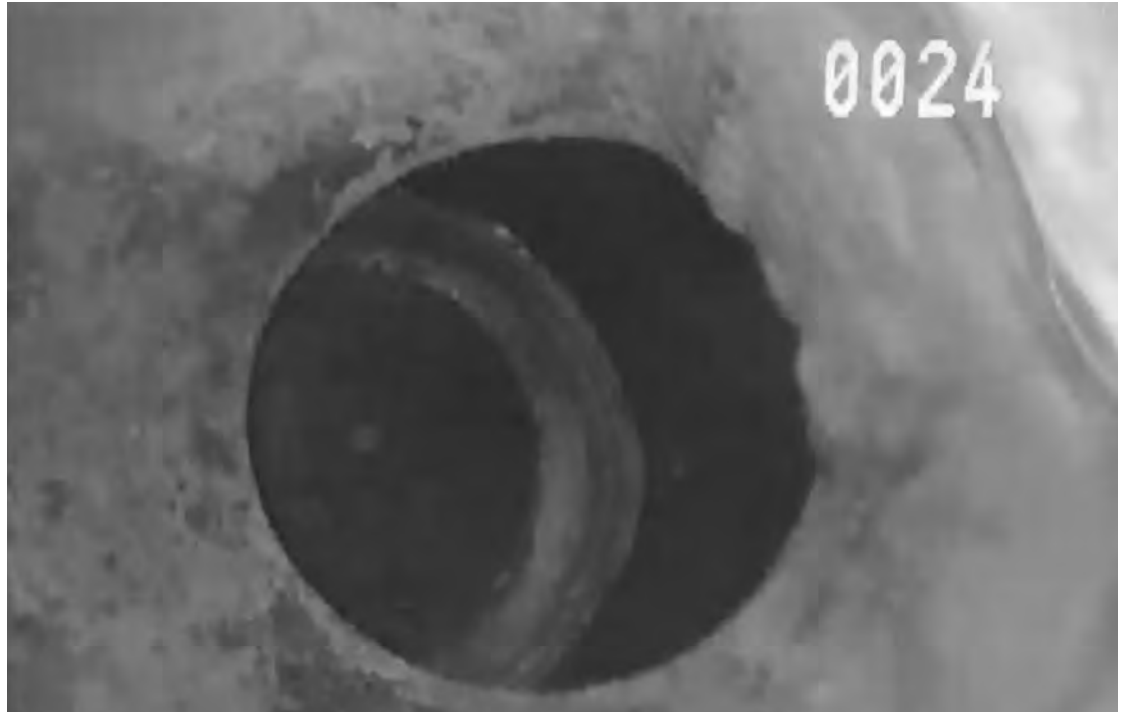
- **8 Shine Street** – Unable to find cleanout, attempted to pull the interior toilet but were still unsuccessful in videoing due to multiple interior bends.
- **415 Williams Street** – Were not able to contact the owner and gain access to the residence.
- **405 Williams Street** – Were not able to access the service through an internal or external location.
- **37 Lee Street** – Service was drawn in based on discussion with the owner. Tried to access the service through a roof vent without success.
- **667 Main Street** – Could not gain access to the building.
- **668 Main Street** – Gold Dust C-Store – There was a separation in the lateral 25' from the bathroom under the building. The separation was severe enough it appeared to be discharging below the building. (Picture 4)

Picture 4 Example of Sewer Service Joint Separation

Five buildings also detected smoke inside during testing, all of which are located along Main Street, between Shine Street and Gold Street. The most significant of these was located at 668 Main Street, which was shown to have lateral separation during the video portion of the sanitary sewer investigation. Other addresses that detected smoke in the building were:

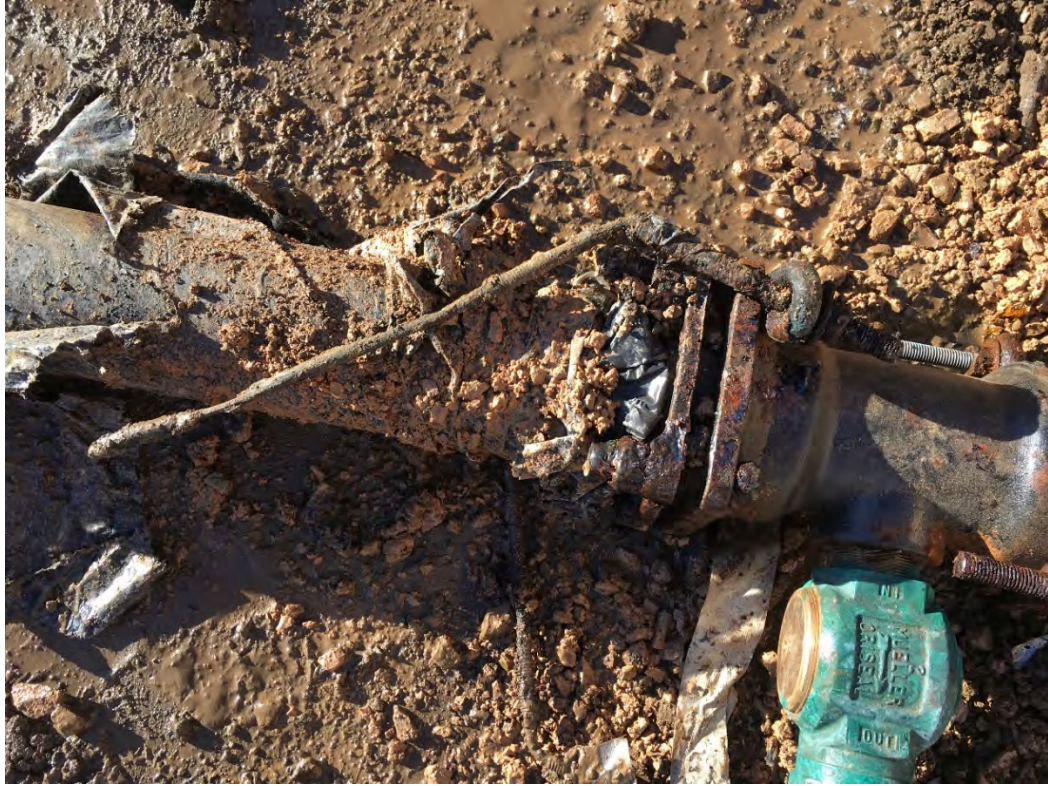
As mentioned previously, no detailed investigation into the water system (**Figure 3**) was performed, however, based off recently completed FEC work in downtown Deadwood and discussions with Public Works Staff, several potential water service-related issues have been identified. Primary among these concerns is premature corrosion of various water system components. The water system was constructed in the early 1990's and is comprised of a combination of PVC (plastic) pipe and ductile iron (metallic) fittings. Public Works Staff have specifically identified that the bolts on a number of valves have experienced significant corrosion. Corrosion was also evident on metallic components of the water system in Deadwood Street, which was recently reconstructed as part of the Outlaw Square Project as shown below in **Pictures 5 and 6**.

Picture 5 Metallic Component Corrosion

Prior to or most likely in conjunction with an overall street reconstruction, there is a need to inspect every fitting. At that time, FEC recommends that every valve and metallic fitting be exposed, inspected, and a decision then be made to either wholesale replace the valves and other fittings, replace bolts, and/or connect an anode for further protection. Also, the installation of tracer wire access boxes and the relocation of existing faulty tracer wire from inside the valve to a separate access box will greatly increase the probability of proper system maintenance.

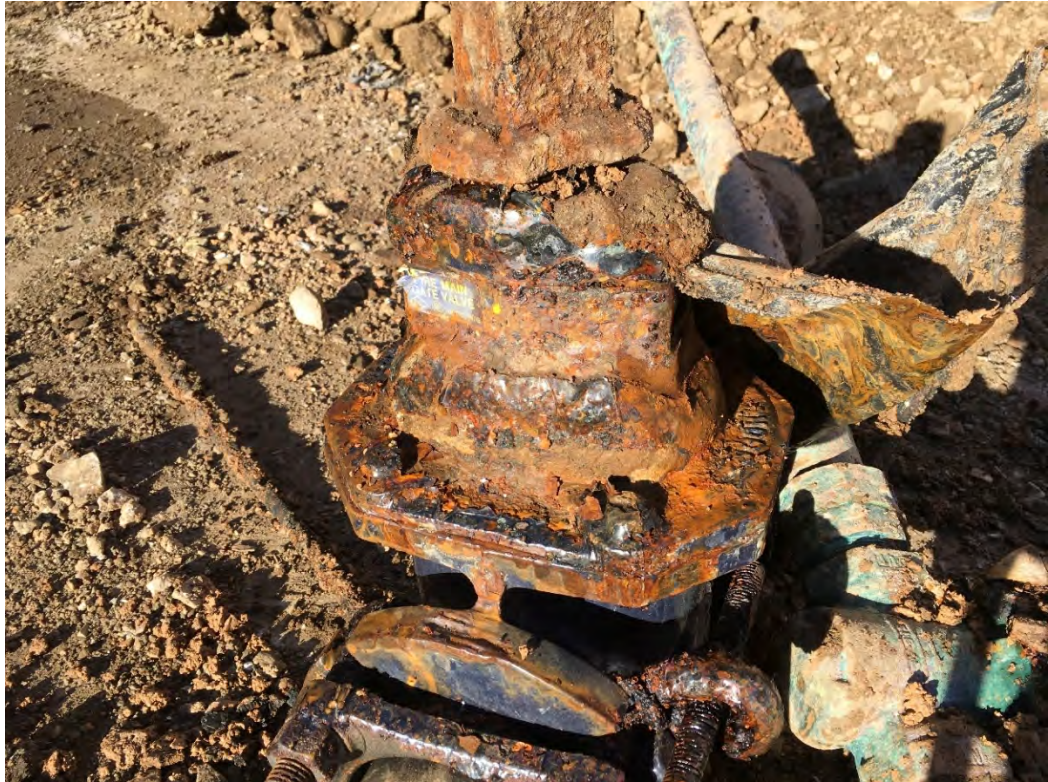
Picture 6 Valve Corrosion

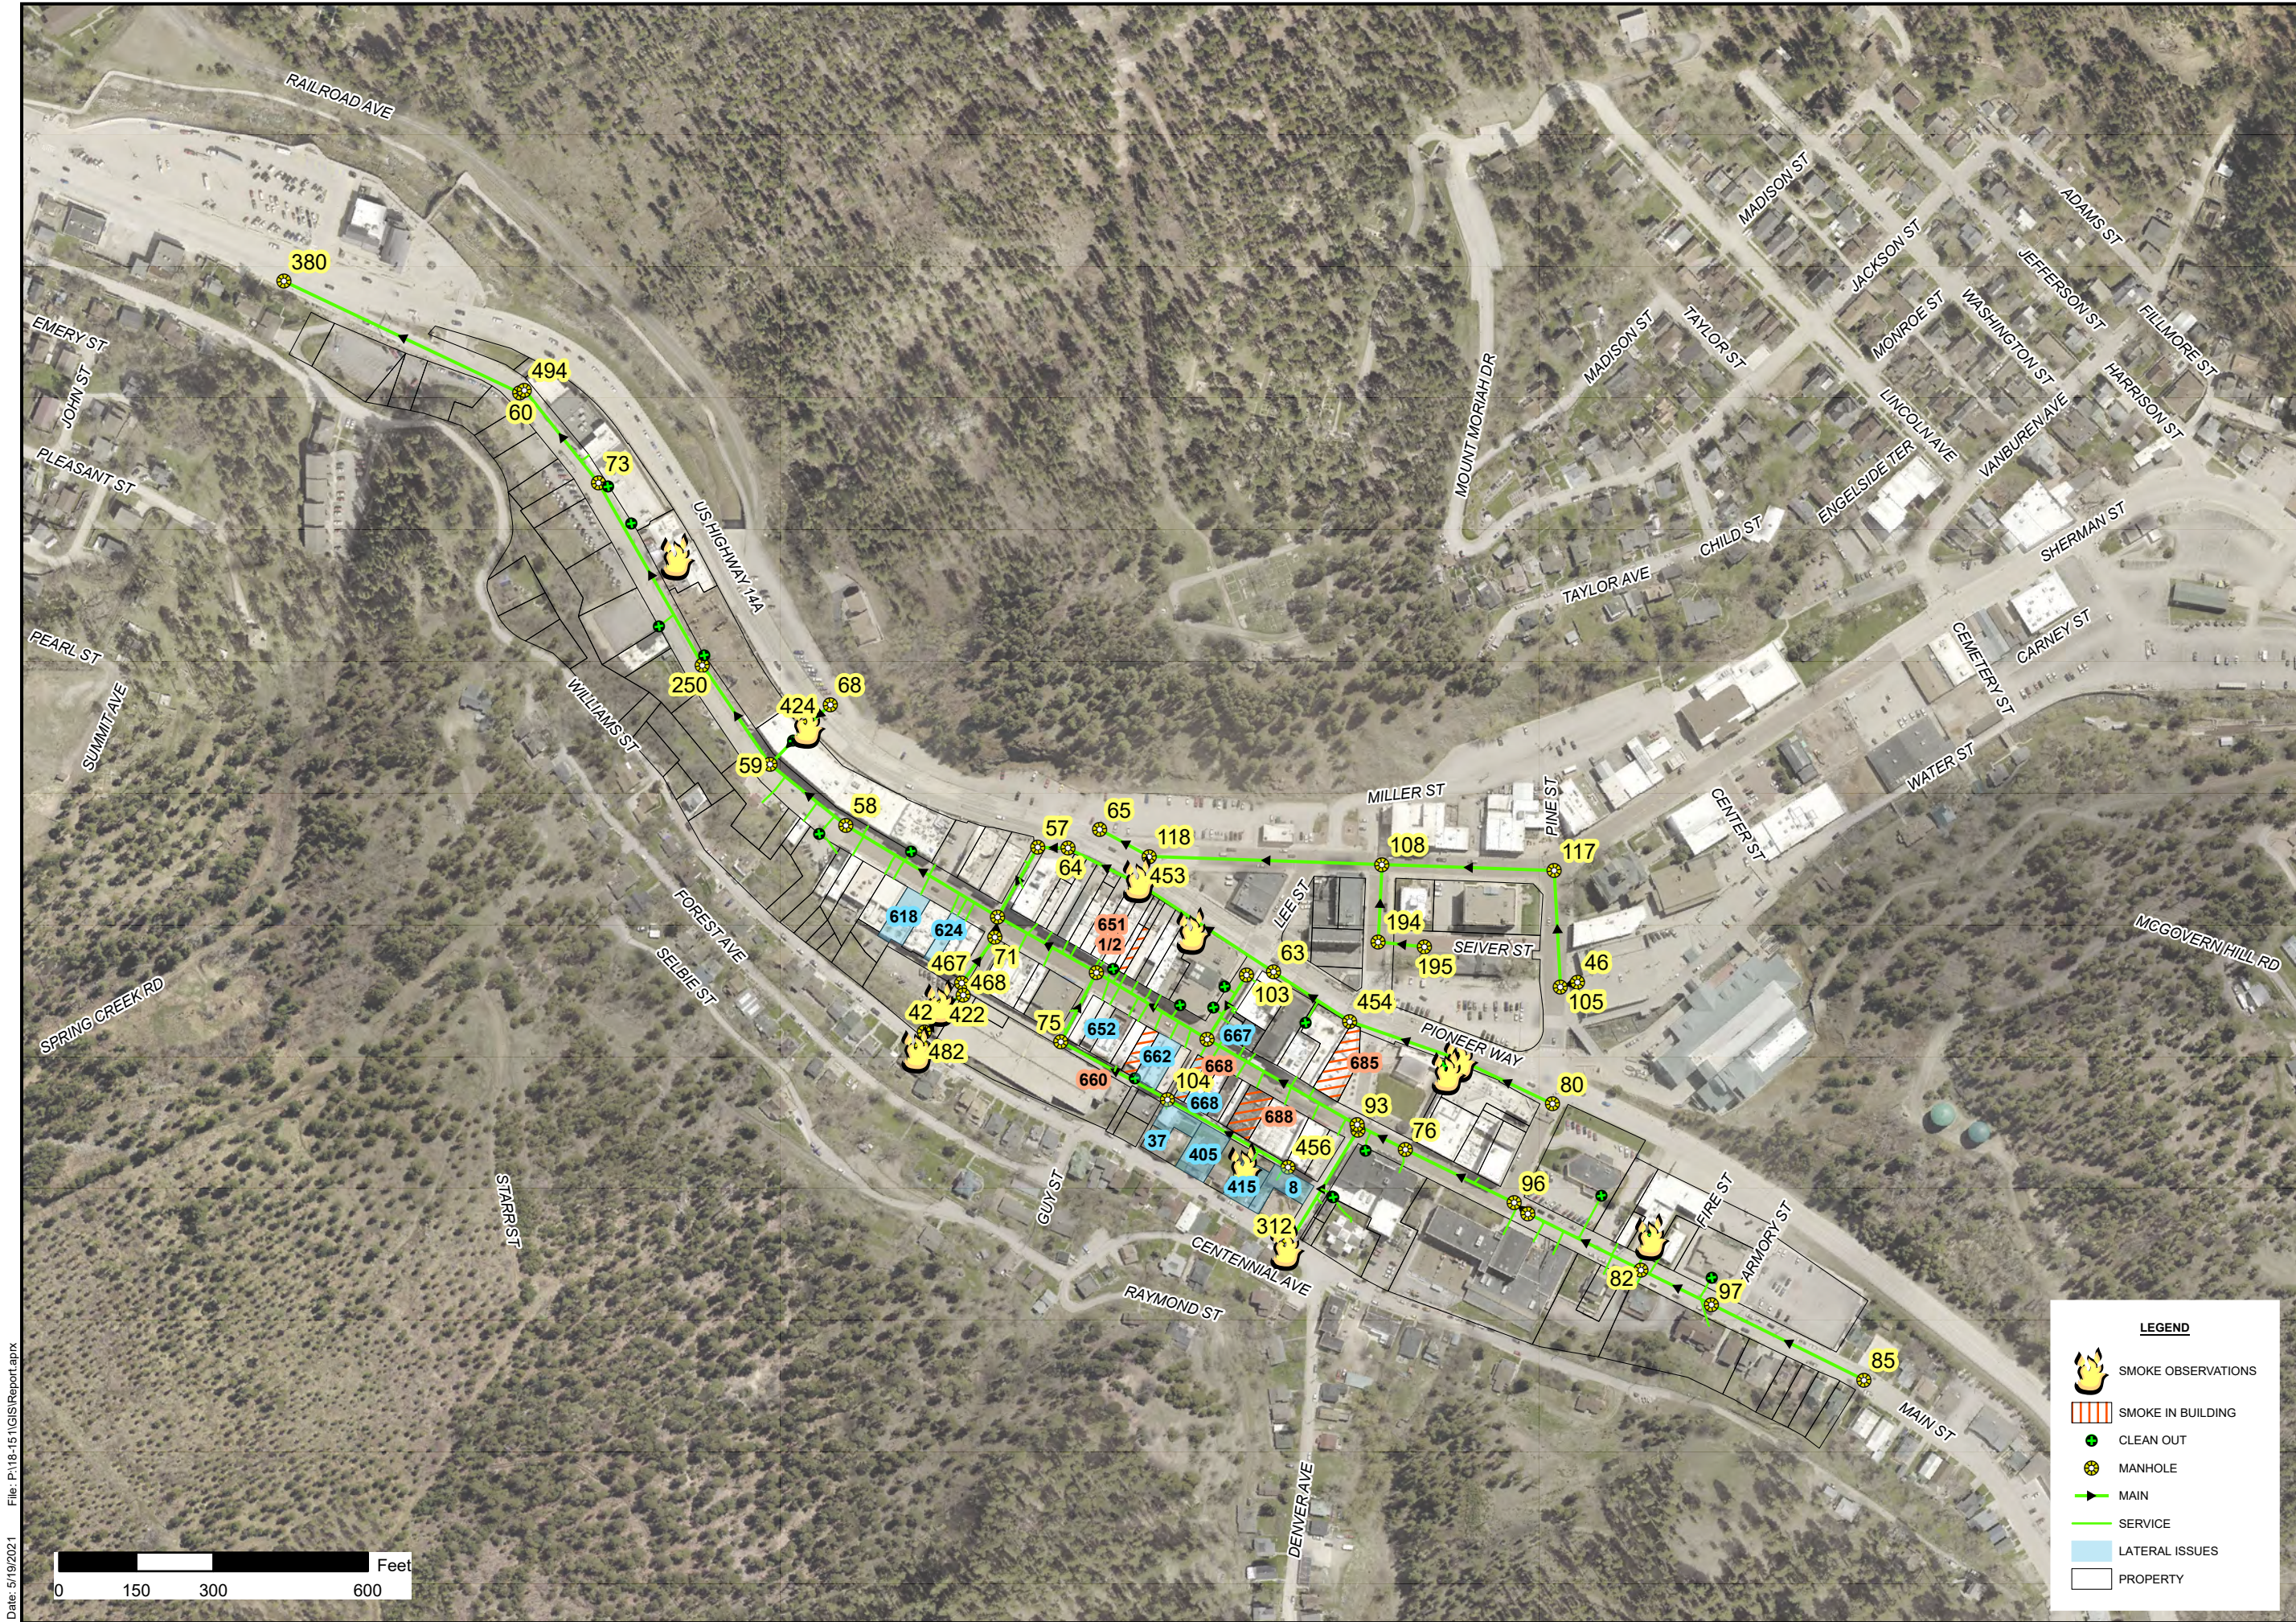
FIGURE 2.
SANITARY SEWER
INVESTIGATION

Overall, the sanitary sewer mains within the project area are in good working condition. Most of the issues encountered were due to grease buildups. [Figure 2](#) illustrates the sanitary sewer system and the webmap referenced above contains links to all the videos and assessments performed.

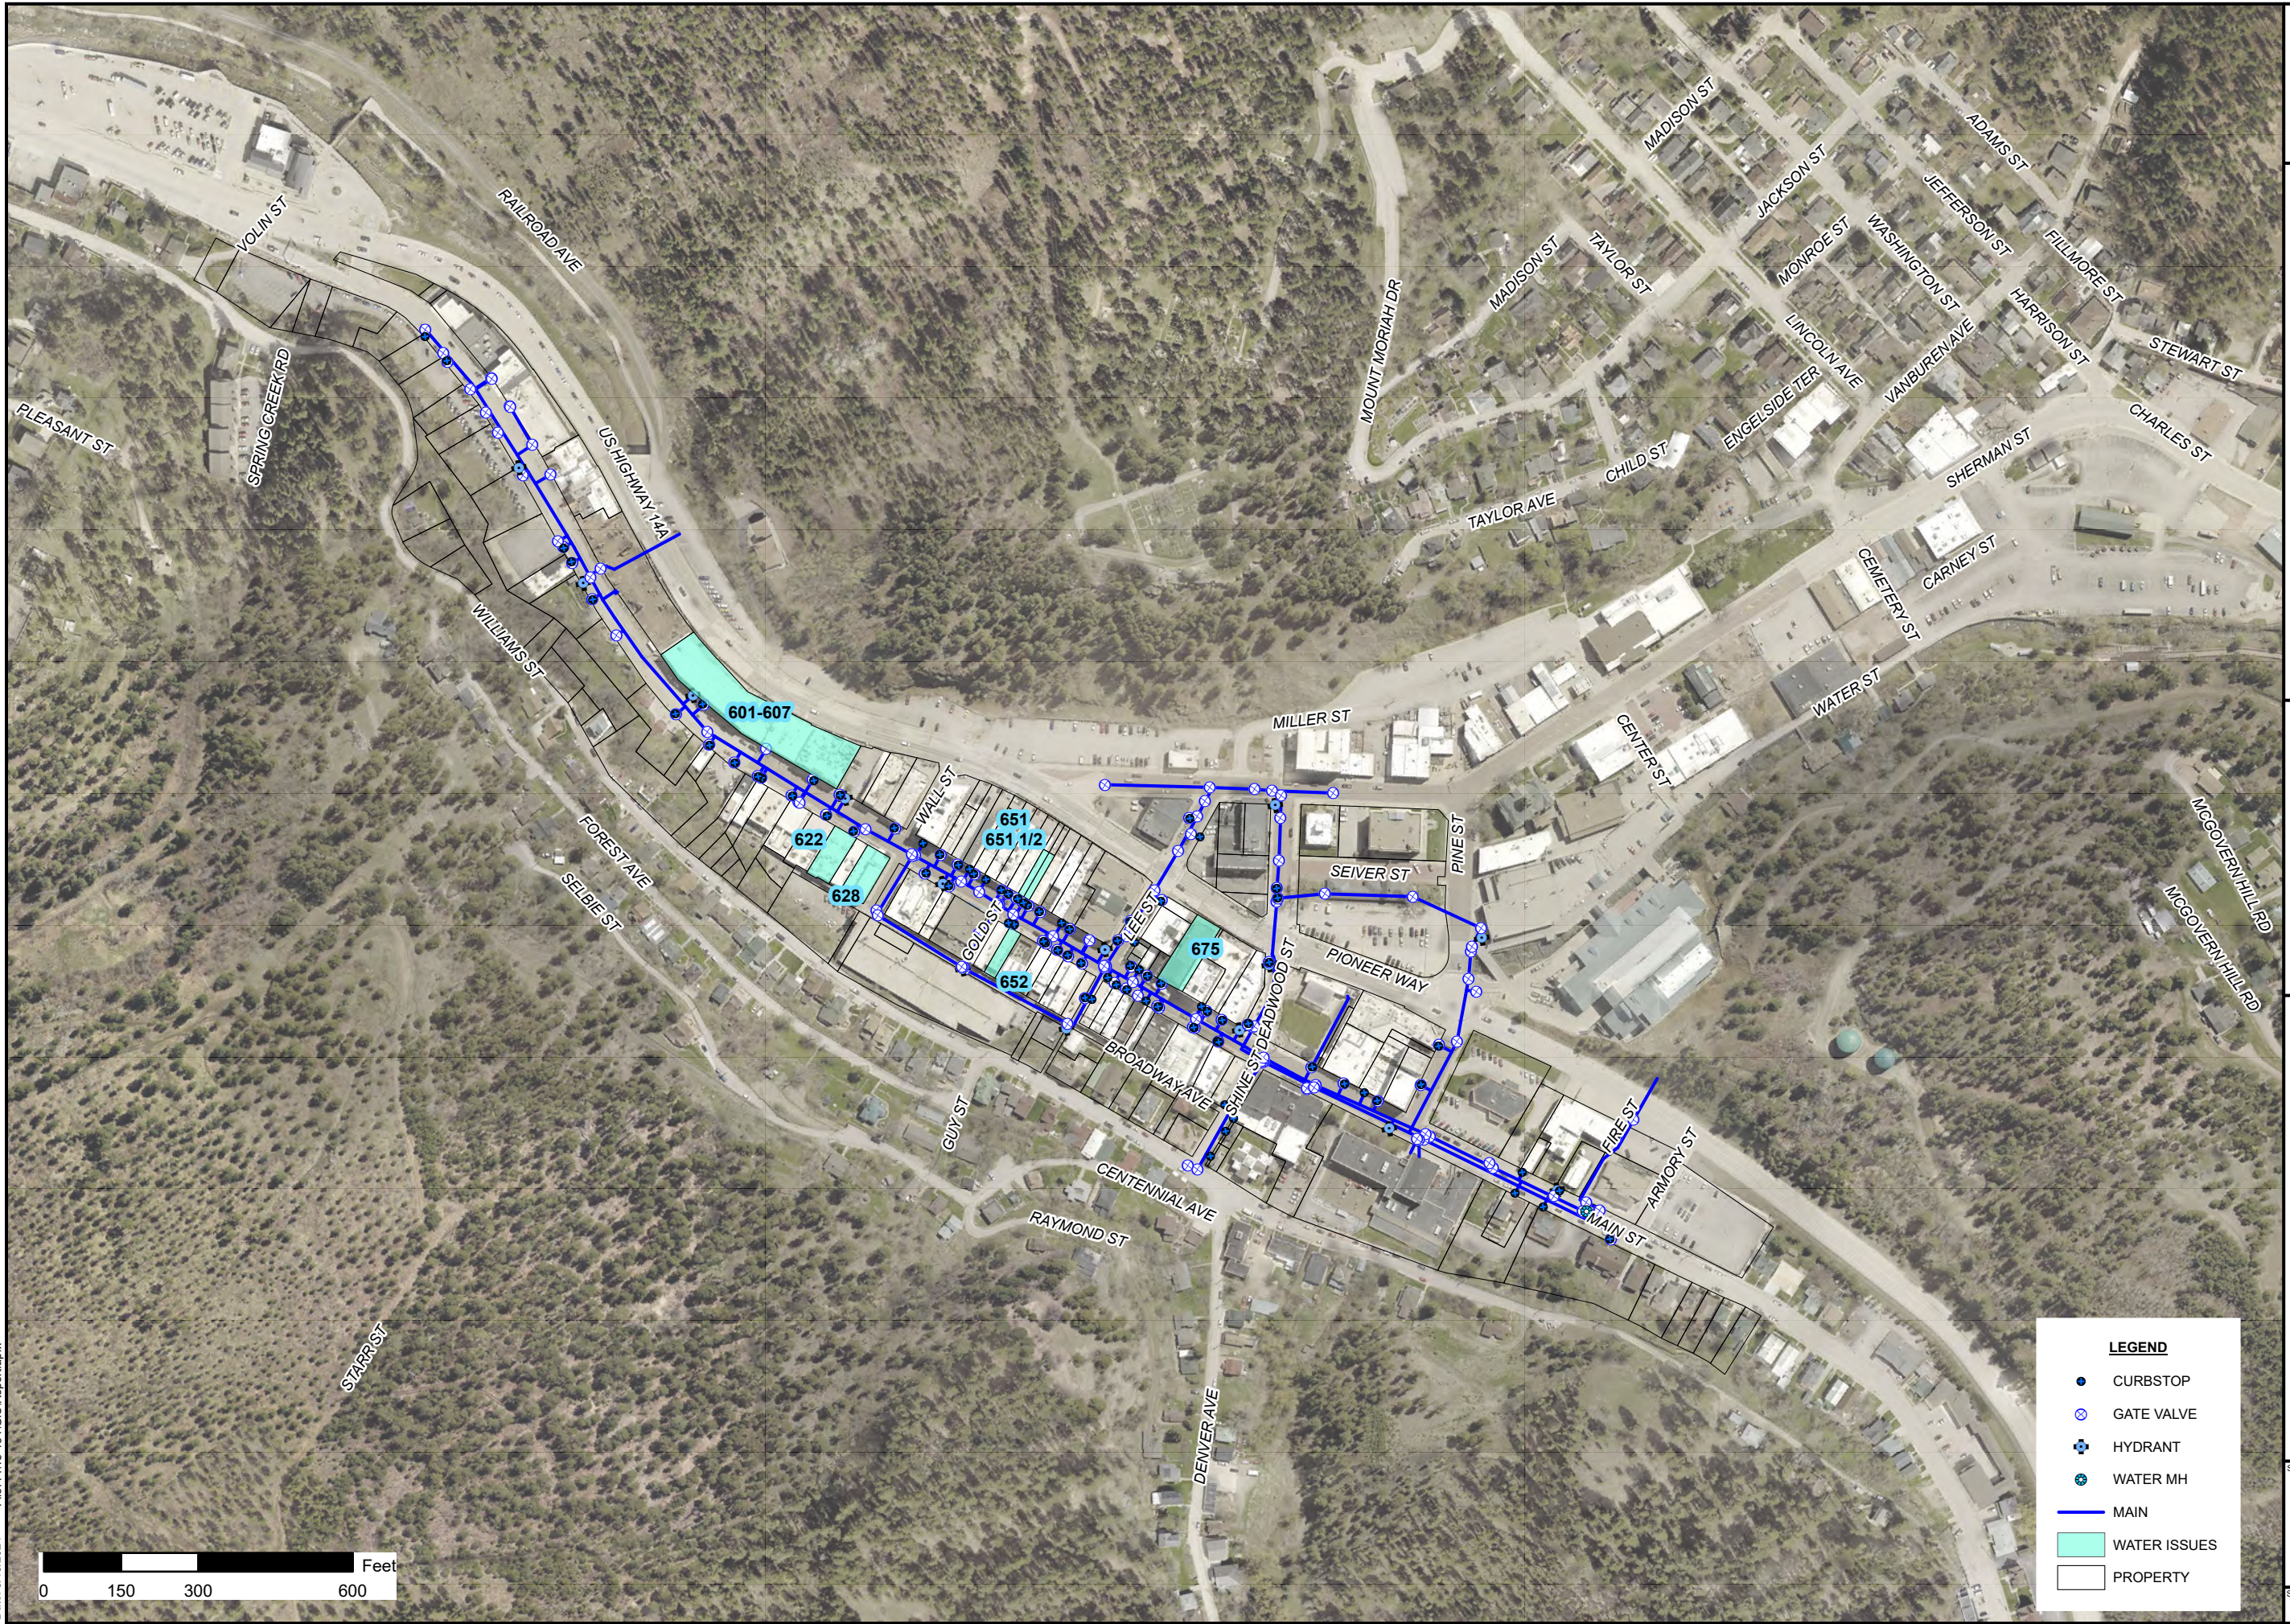
FIGURE 3.
WATER SYSTEM
INVESTIGATION

Other issues brought to light in discussions with City staff include a handful of situations in which there are shared water services and/or multiple meters in one building. This is currently known to occur at 628 Main Street, 652 Main Street and 675 Main Street. This is also occurring at the Mineral Palace (601-607 Main Street) where there are four meters coming off a single service inside the building. At 651 and 651 ½ Main Street there is currently a single service and meter supplying two separate business. Similarly at 622 Main Street, there is currently one owner with two tenants being served by a single service and meter.

The City Public Works Division would like to see uniformity across the water service system, with one meter per service. In the situations where two businesses are currently sharing a single service and meter, Public Works would prefer to remedy the situation by providing a second service connection and meter during an overall reconstruct to alleviate any potential financial burden on the owners. For 651 and 651 ½ Main Street, there are currently unused existing stub-outs in the street that could be tied directly into the building via directional drilling or some other appropriate method. For 622 Main Street, a new tap, service and meter would need to be installed.

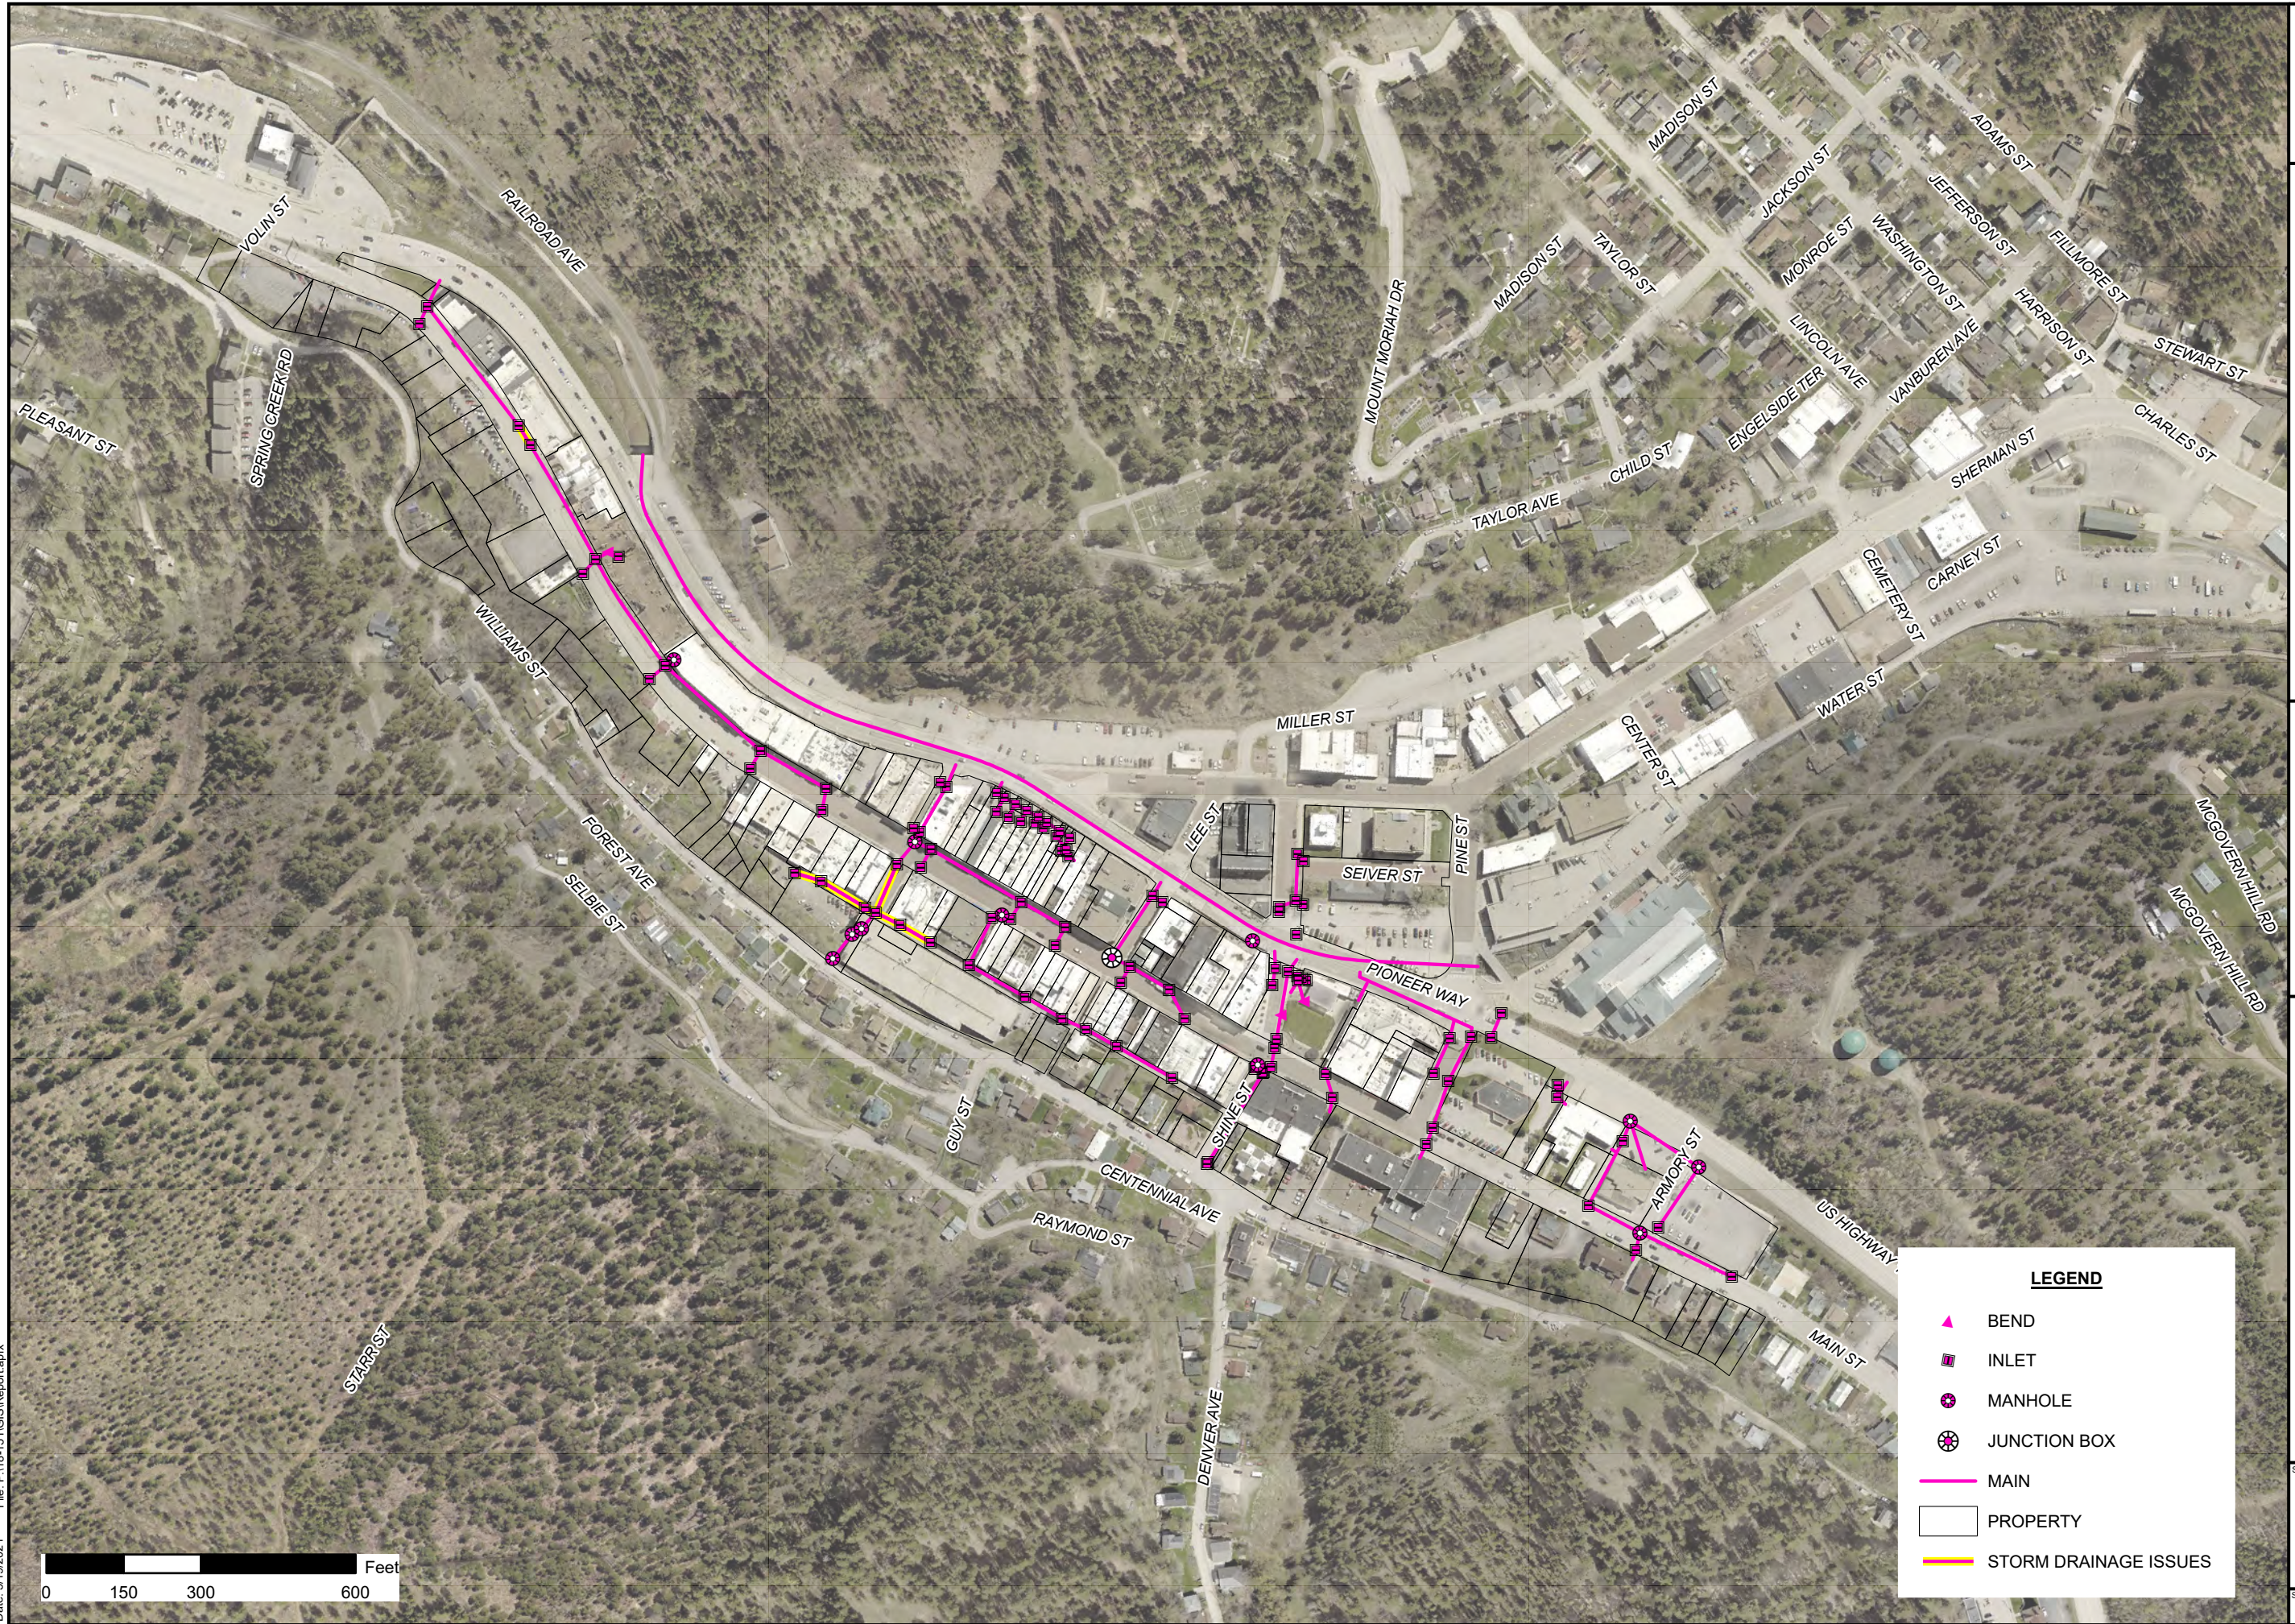
From the surface, visual inspection of the storm drain system indicates it is in relatively good shape. Gold Street and a small section of Broadway Avenue, near the parking garage, have known issues of disjointed and/or plugged pipes which will warrant some pipe replacement (Figure 4). The Hampton Inn at Tin Lizzie's is another area of potential drainage concern. The finished floor elevation of the hotel is low in relation to the adjacent street. Public Works Staff stated that during significant precipitation events water leaves the street and ponds in the hotel entryway.

Pipe replacement near the parking garage in Gold Street and Broadway Avenue should be considered. On Main Street, the final design of the typical section will ultimately dictate whether the location of the existing storm sewer inlets in this area can stay or go. Curb changes and inlet location will be the determining factor in whether the existing mains are in an adequate location to convey storm water in the future typical section. If the final design dictates relocation of the inlets, an evaluation of what portions of the existing storm drainage system can remain needs to take place.

As stated previously, it has been indicated that there is a drainage concern (ponding during significant rain events) at the Hampton Inn - Tin Lizzie's. Adjustments to the street and curb profiles along with the potential addition of storm inlets should be considered to resolve this issue.
