# SITE INSPECTION REPORT

## CATEGORY D – DRAINAGE CHANNELS & NAVIGATIONAL WATERWAYS

## **Whitewood Creek Site Inspection Addendum**

DR4467-SD Project #123108 Whitewood Creek

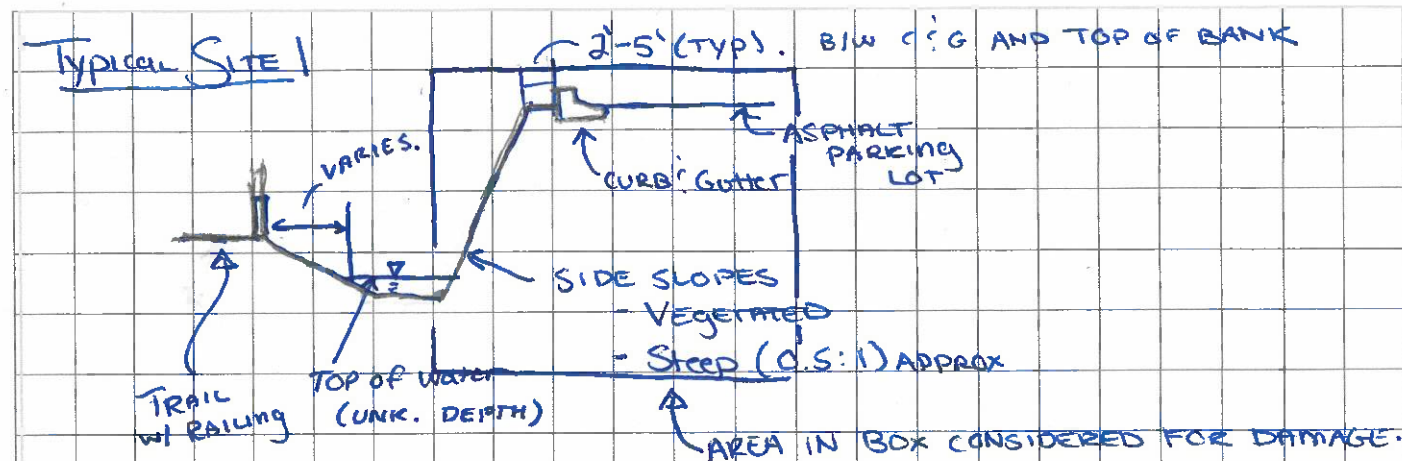
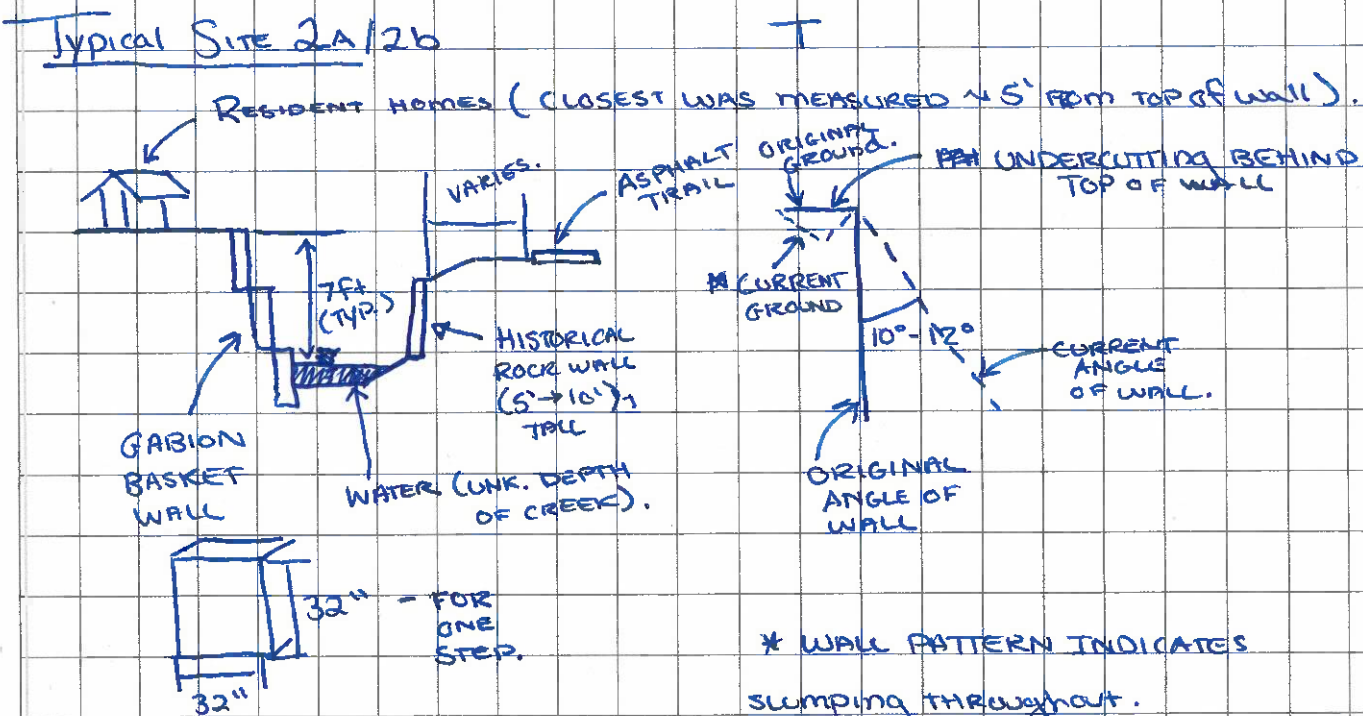
\* WALL PATTERN INDICATES  
SLUMPING THROUGHOUT.

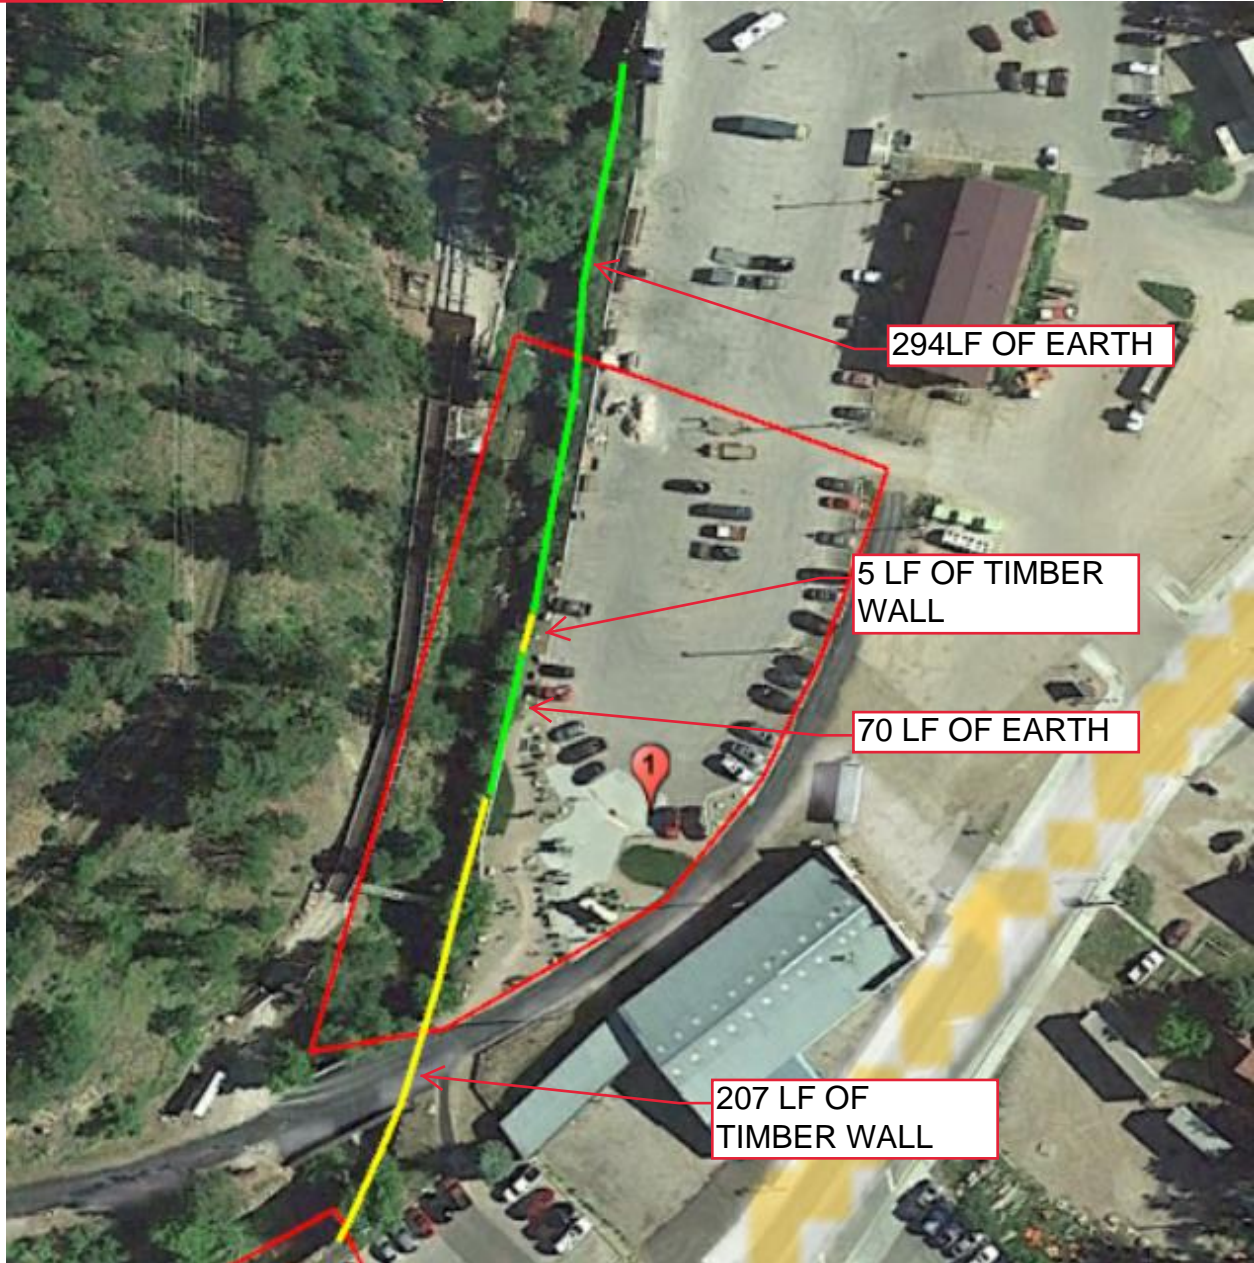
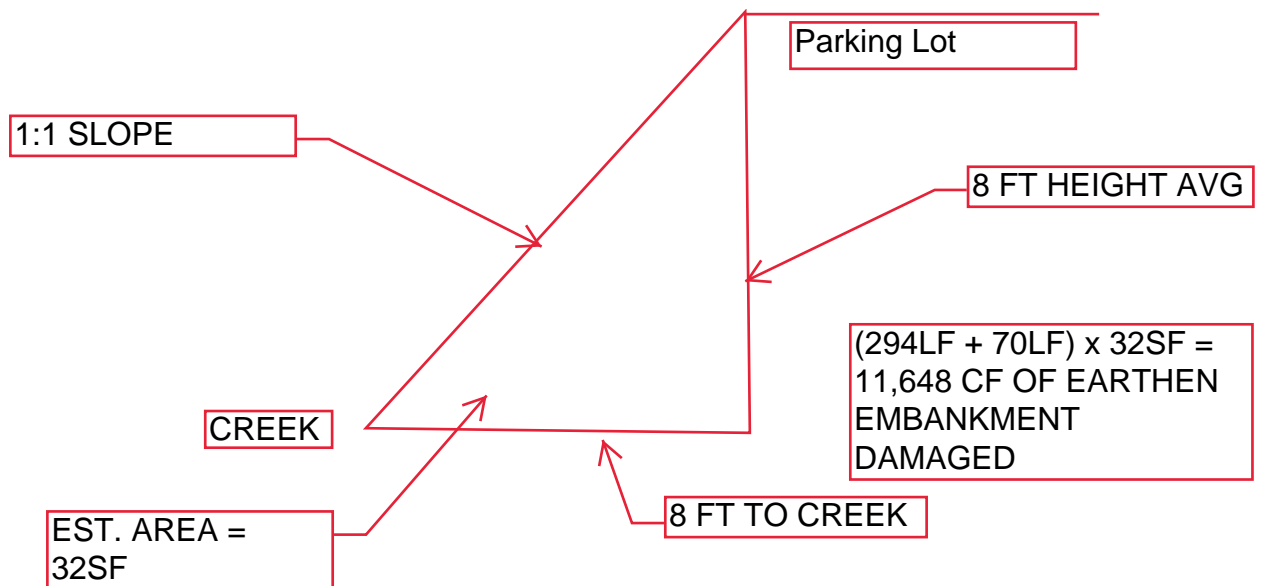
APPENDIX E: Site 1 Breakdown

The applicant provided FEMA with photos of the creekbanks shortly after the event. Photos #48-#59 show the unvegetated creek banks and the amount of erosion that took place. For the purposes of the damage description the entire earthen hillside from the rock wall on the north end to the timber wall on the south end is damaged. Looking at pre-disaster photos and site inspection notes the best way to estimate the volume of earthen embankment is to assume a 8FT height at 1:1 slope throughout. Please see Appendix E for a more detailed breakdown.
