## DEADWOOD HISTORIC PRESERVATION COMMISSION

DEADWOOD NOT-FOR-PROFIT GRANT PROGRAM FOR  
SITES NOT ELIGIBLE FOR STATE PROPERTY TAX MORATORIUM

RE: Summary Report  
Extent of Damage to Wood Girder Truss  
Insured: Masonic Center Association, 715 – 717 Main St., Deadwood, SD  
Claim Number: PHNP20121407260  
KMS Engineering File Number: 20-023

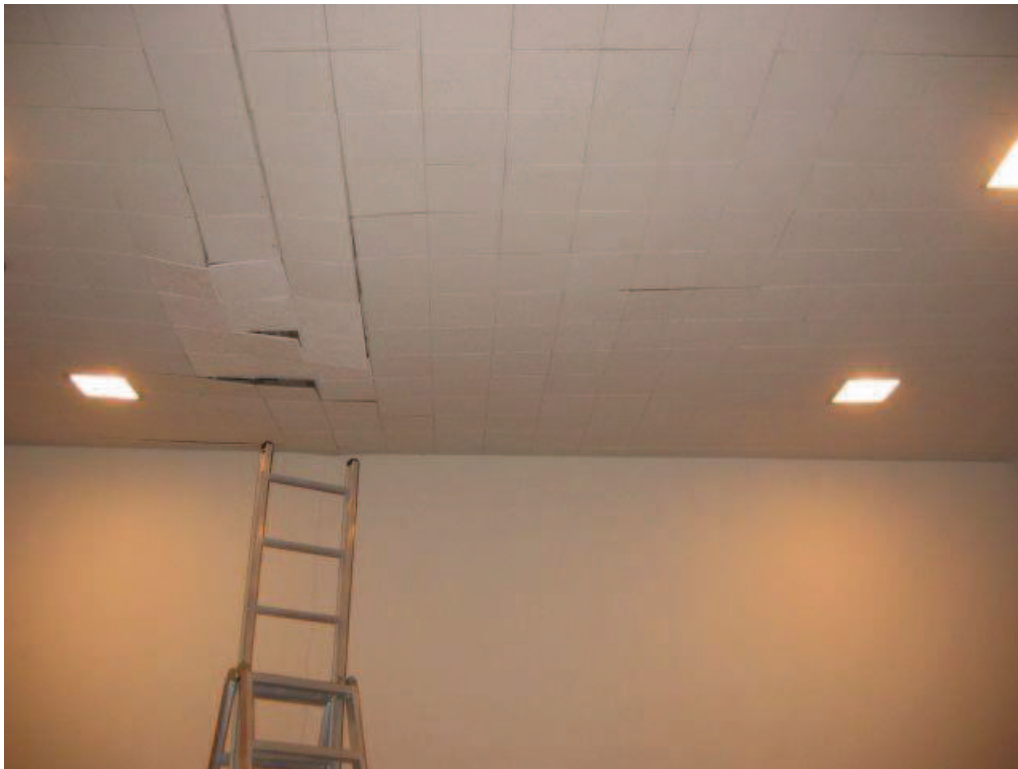
Photo No. 2: Displaced ceiling tile in auditorium at north end of girder truss.

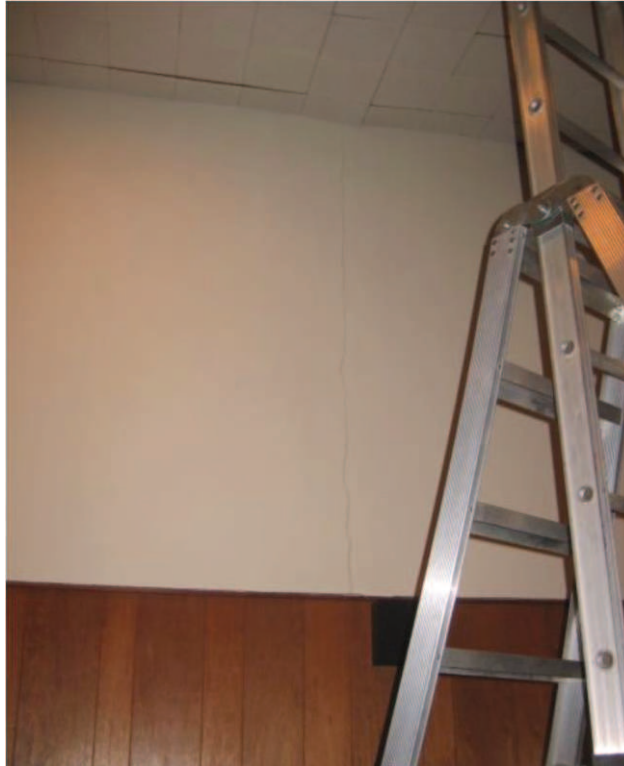
Photo No. 3: Plaster crackage at north wall of auditorium under girder truss bearing.

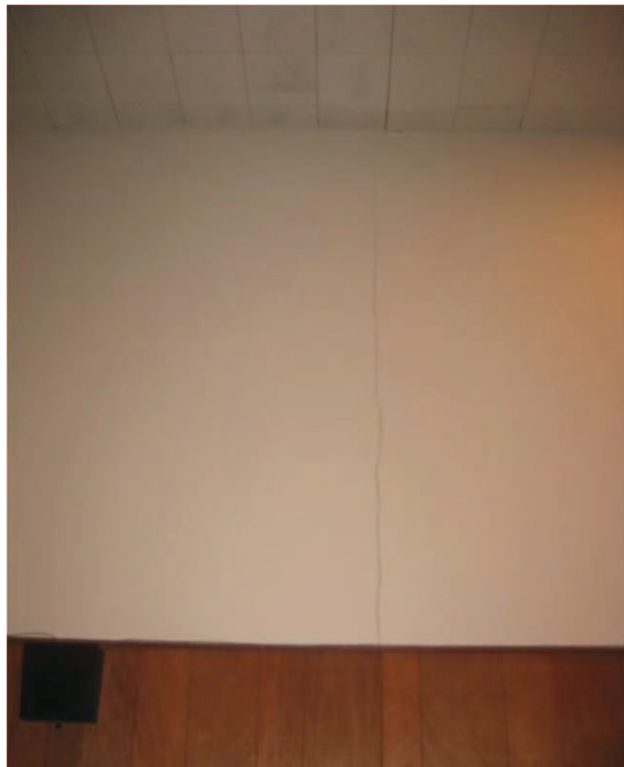
Photo No. 4: Plaster crackage at south wall of auditorium.

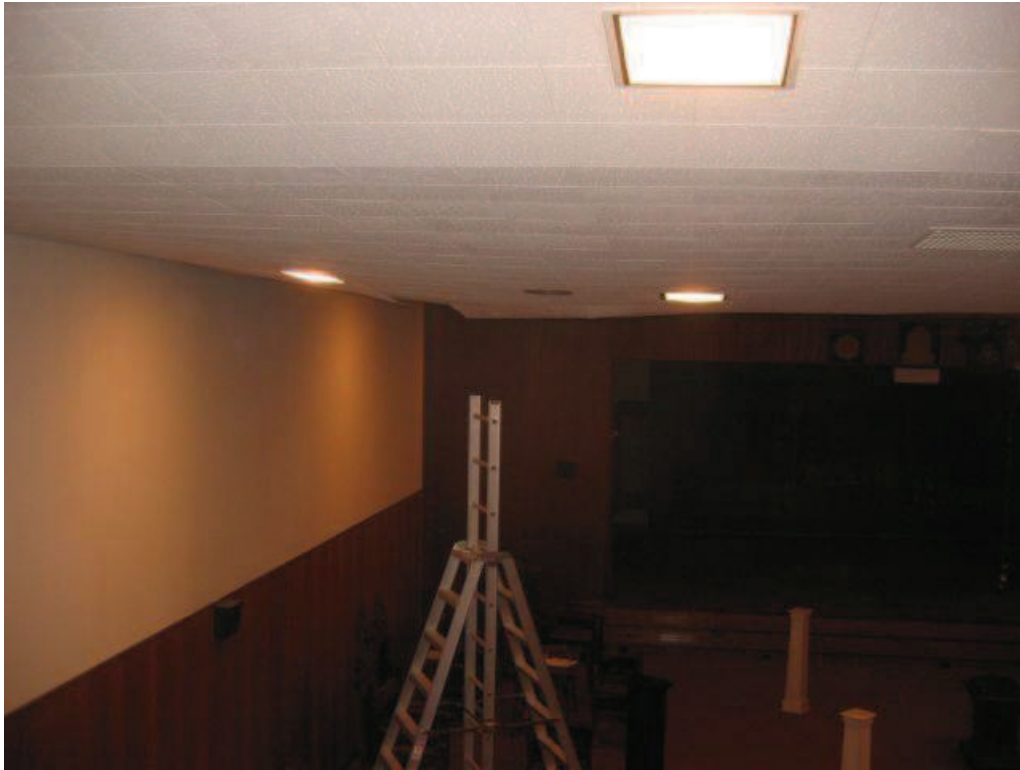
Photo No. 5: Deflection of ceiling tile at auditorium at north end of girder truss bearing.

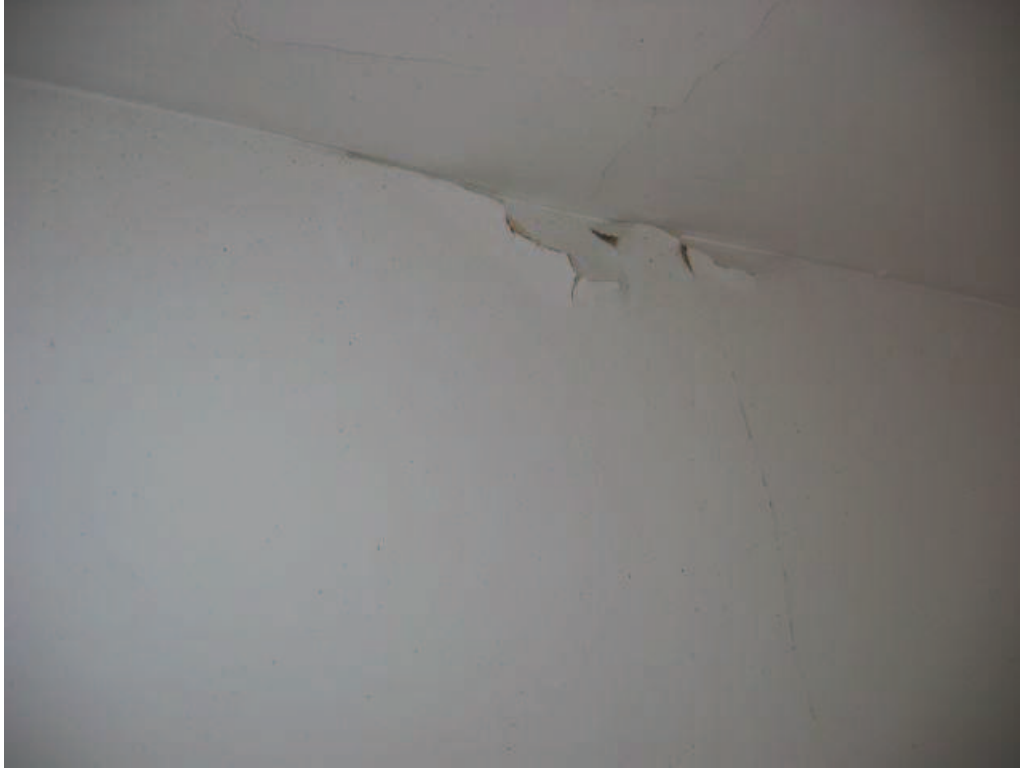
Photo No. 7: Crackage at ceiling in hallway at south end of girder truss.

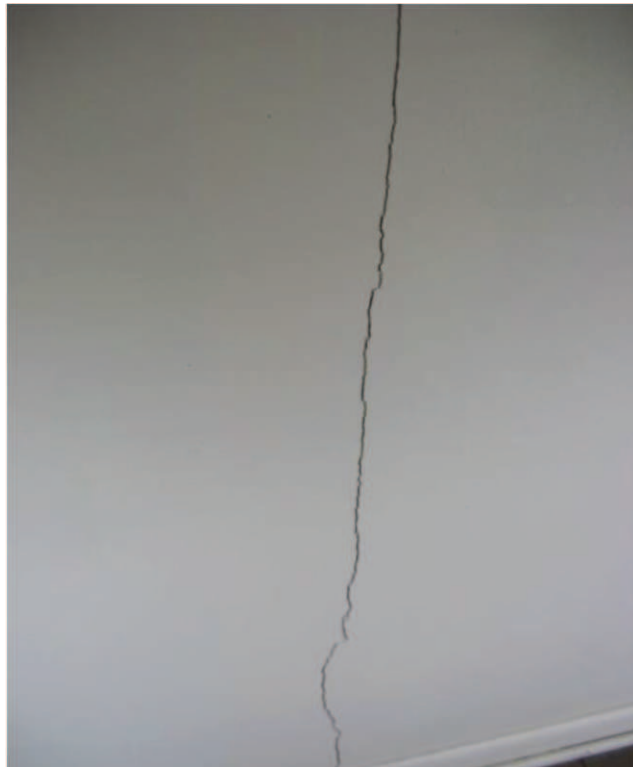
Photo No. 8: Crackage in plaster at hallway on south side of building under the girder truss bearing.

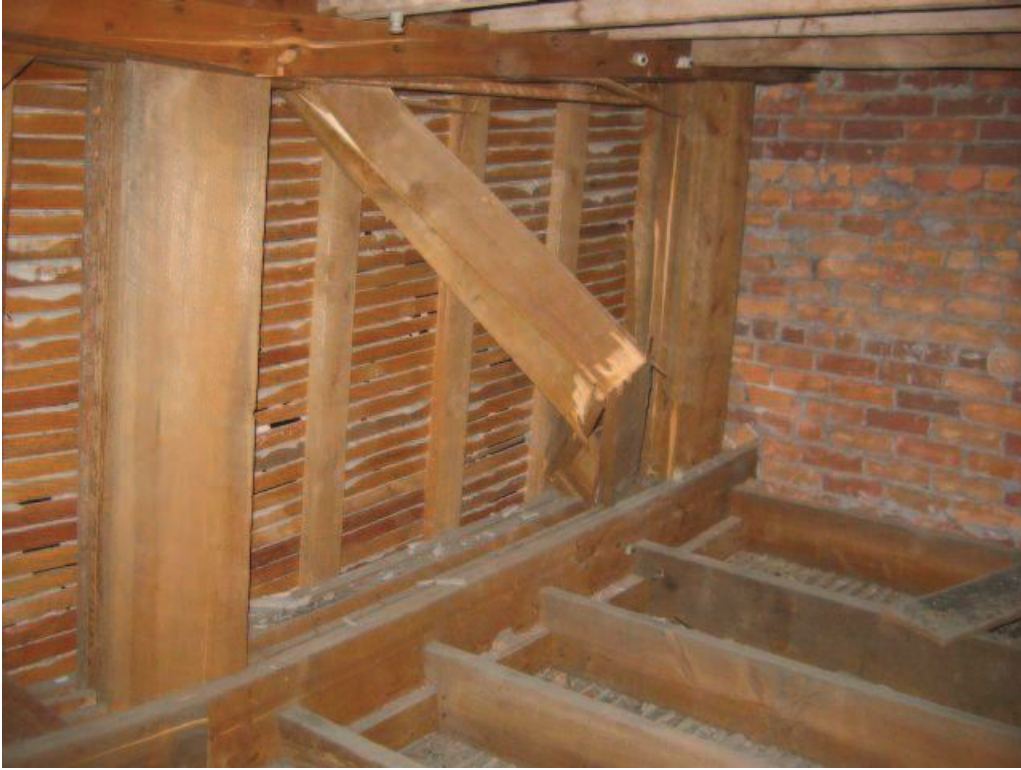
At the north end of the girder truss the first panel diagonal boards had buckled to the east and were broken. The end vertical boards were also broken. Both the top and bottom chords were broken at the second panel point. Deflection of the girder truss had occurred and was approximately 12-inches downward. Both the top and bottom chords had pulled out of the brick wall. At the south end, the diagonal boards of the first panel had buckled toward the east and had cracked. This same condition was observed on the outside board of the diagonal of the first panel at the north end of the girder truss to the east of the girder truss under investigation.

Photo No. 9: Overall view of broken girder truss members at north end of girder truss.

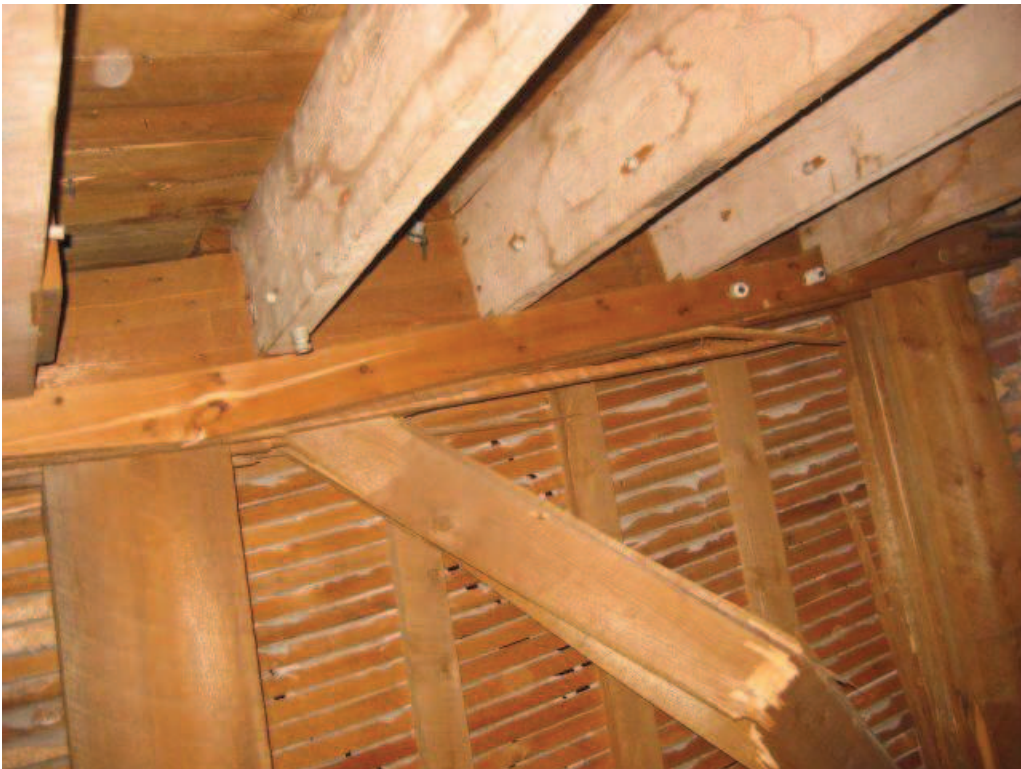
Photo No. 10: Breakage of the top chord boards at the north end of the girder truss.

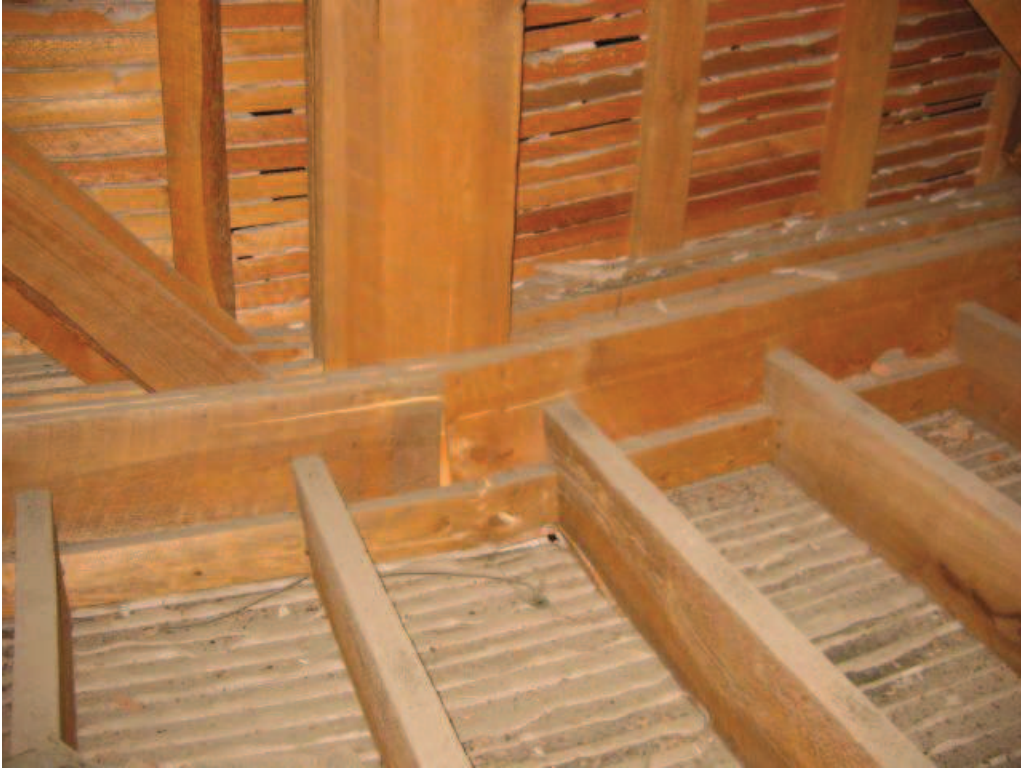
Photo No. 11: Breakage of the bottom chord boards at north end of girder truss.

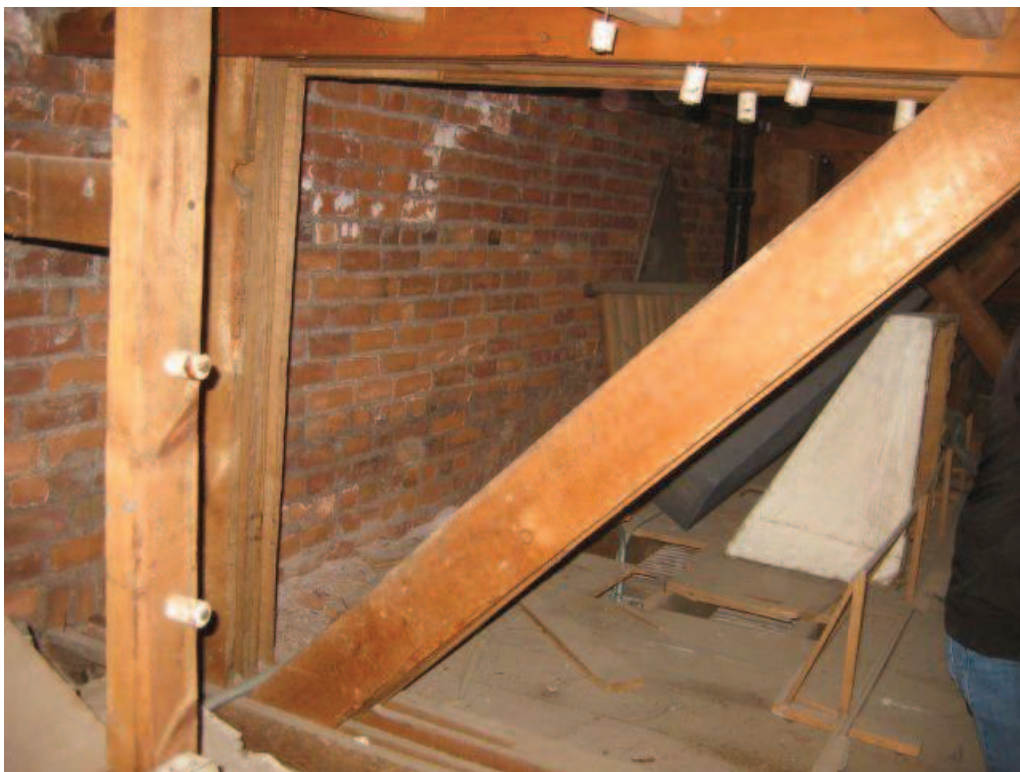
Photo No. 14: Diagonal chord member at south end of girder truss.

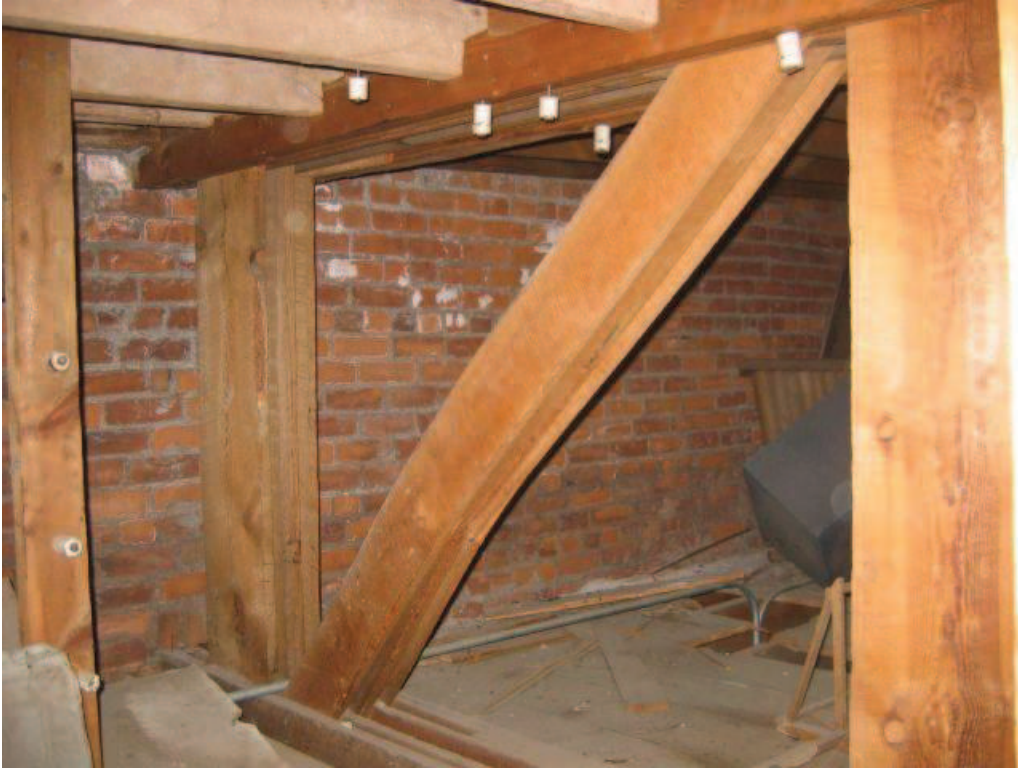
Photo No. 15: Breakage of the diagonal at south end of girder truss.

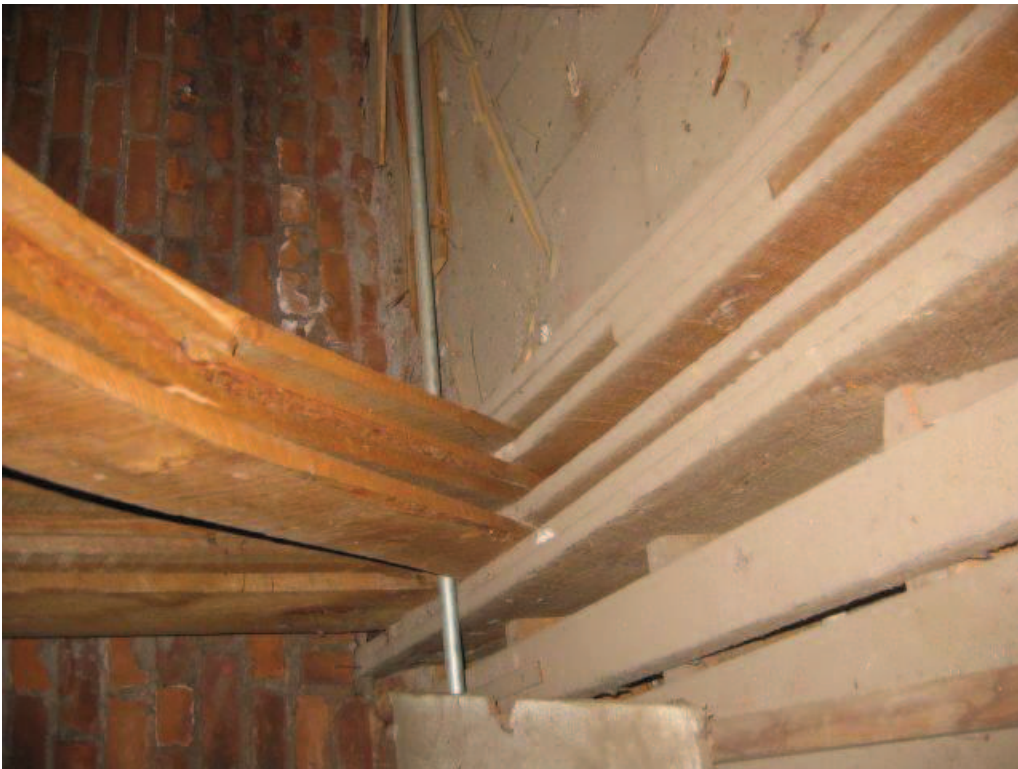
Photo No. 16: Breakage of the diagonal at south end of girder truss.

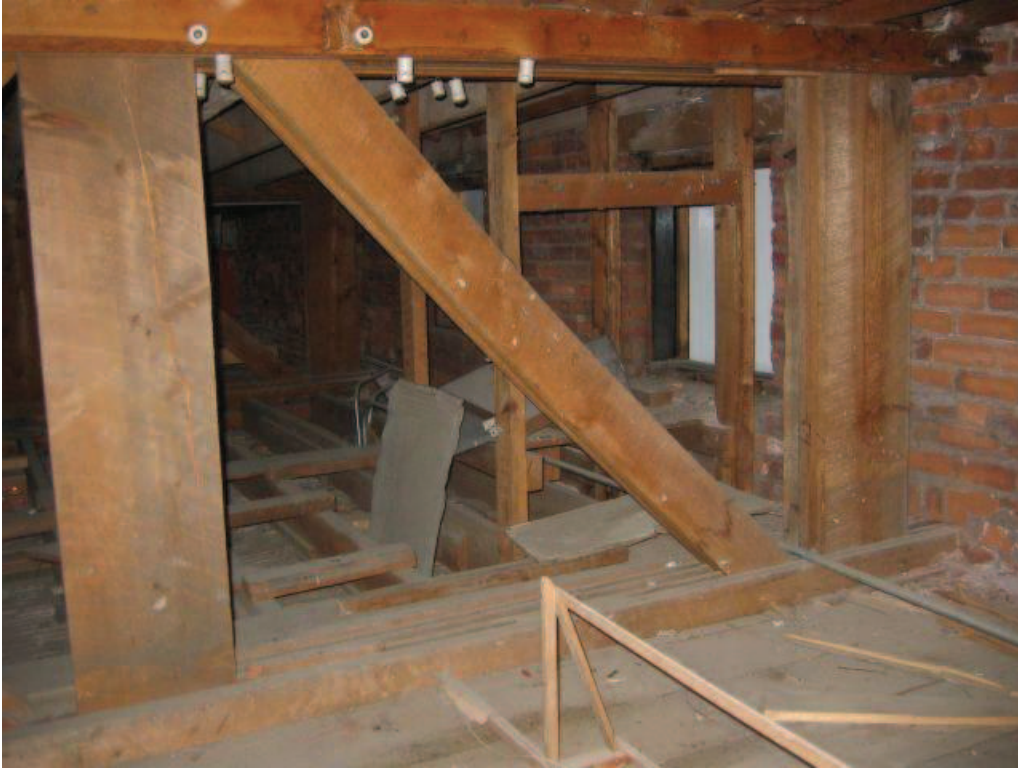
Photo No. 17: Breakage of the vertical chord member at south end of girder truss.

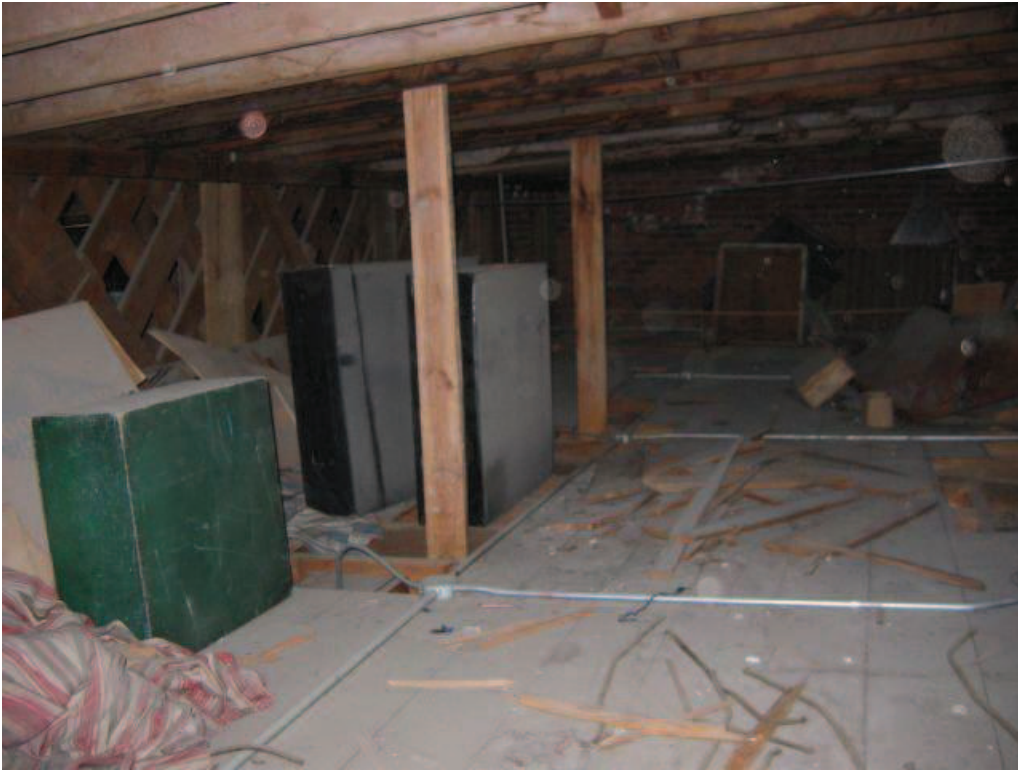
Photo No. 20: View of diagonal breakage at south end of girder truss.

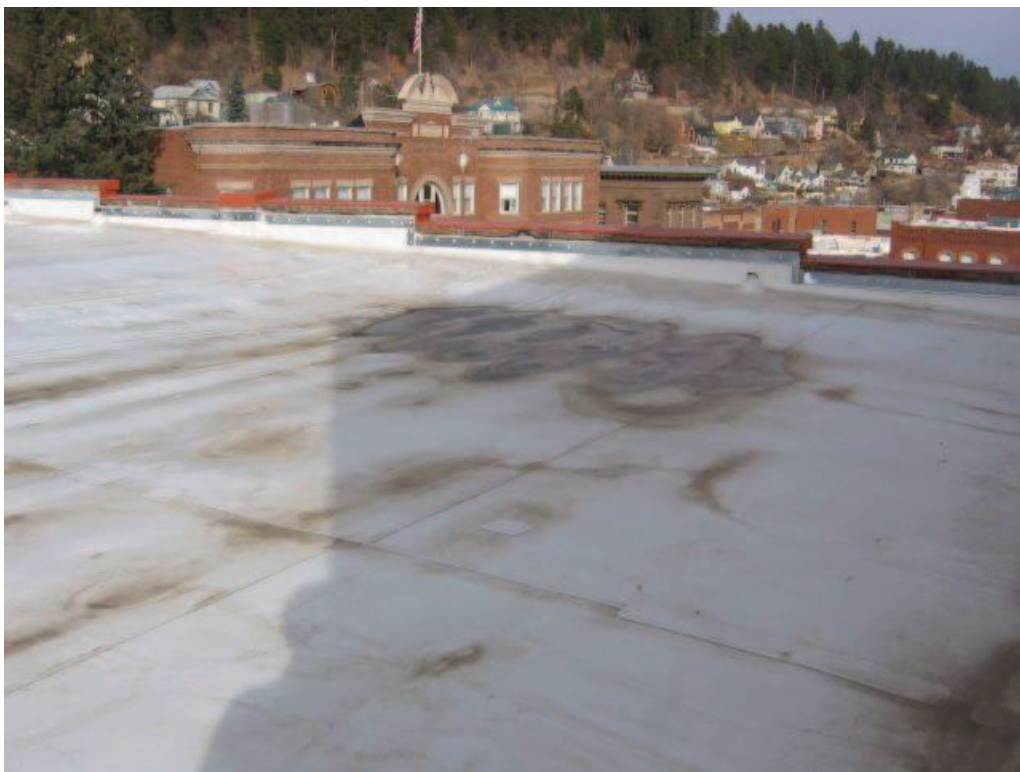
At the north end of the subject girder truss the roof was observed to have deflected downward approximately 12-inches. There was noticeable sediment markings on the roof membrane at this location indicating long term water ponding.

Photo No. 33: North parapet at drain inlet. Note sediment from long term water ponding.

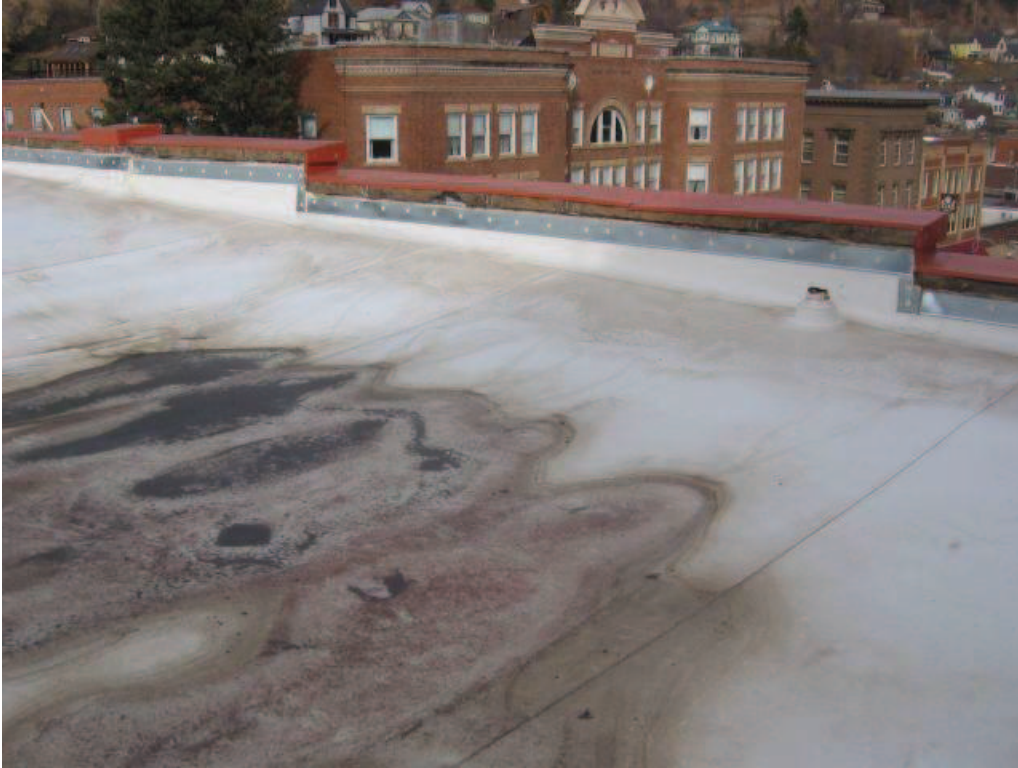
Photo No. 40: North end of truss deflected downward.

KMS Engineering recommends that additional block and shoring be placed to support the entire length of the girder truss. Shoring should be located on each side of the girder truss and support the roof joists as well as the ceiling joists. The shoring should extend to the lowest level of the structure as subsequent floor framing may not be adequate to support the roof ceiling framing and live loads. This shoring should be placed such that removal and reconstruction of the girder truss can be performed. Deflection of the roof structure has occurred and lifting of the roof structure will be required. Lifting of the roof structure will require the use of hydraulic jacks and adjustable shoring. During this period there should be very limited use of the facility. Additionally, snow and rain loads should be removed as quickly as possible.
