STAGE TRUSS ASSESSMENT & REPAIR REPORT

PROJECT: Outlaw Square  
DATE: February 25, 2022  
AE Project # 2018-405

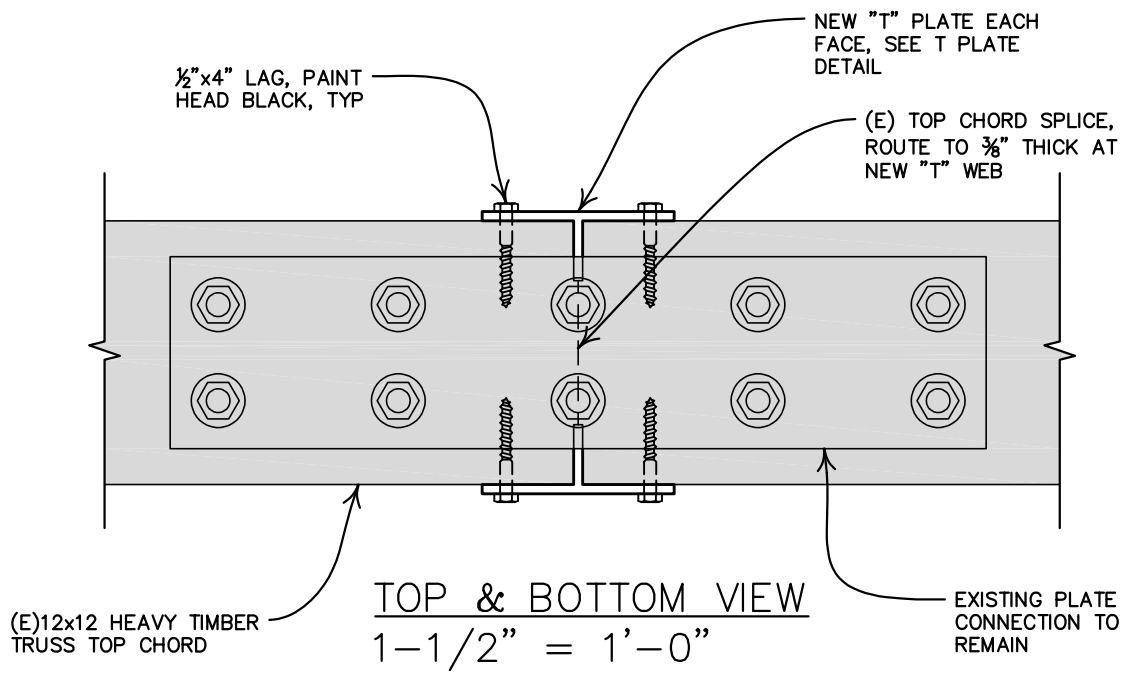
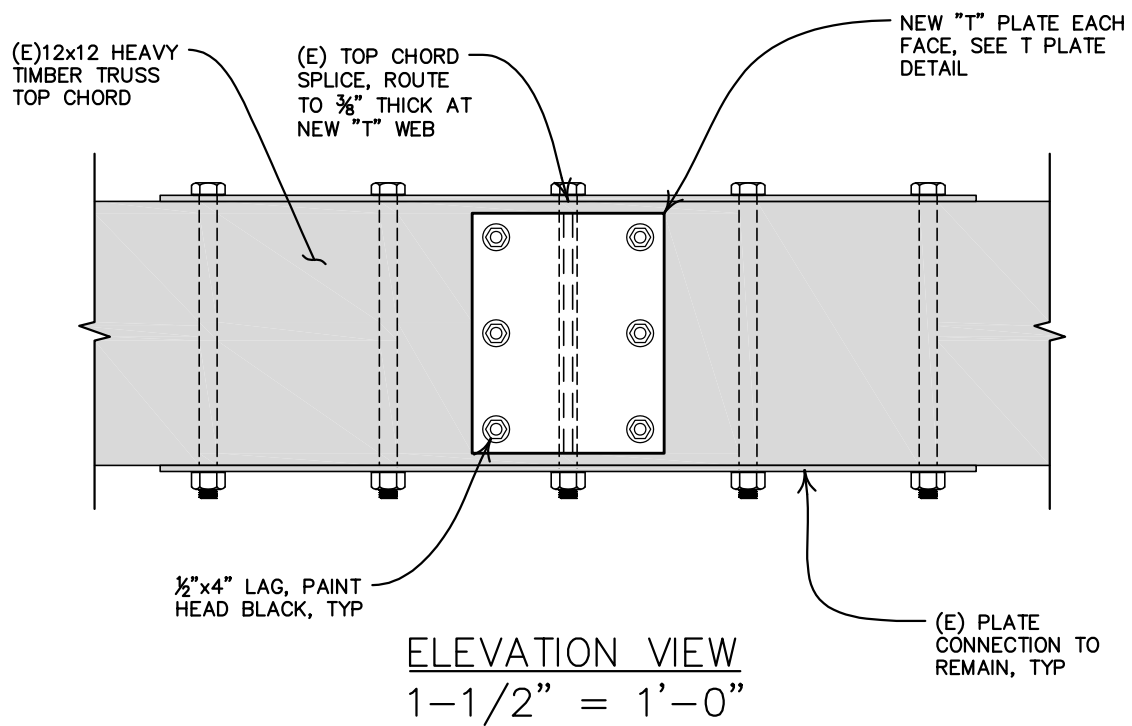
**OVERALL TRUSS VIEW**

Albertson Engineering was recently contacted by City of Deadwood personnel that the stage truss appeared to have a sag. After additional investigation, the sag was found to be approximately 2".

We believe the sag is related to the shrinkage in the top chord of the truss. The mechanics of the top chord rely on direct contact at splice locations. As the top chord has shrunk, the truss has slightly deflected until direct contact is again made at the splice locations.

- REPAIR STEPS.**
1. JACK UP TRUSS TO LEVEL POSITION. SHORE IN PLACE.
  2. ROUTE 3/8" THICK X 2-1/2" DEEP GAP ENTIRE TOP CHORD HEIGHT.
  3. INSTALL "T" PLATES EA SIDE OF TOP CHORD (8 TOTAL "T" PLATES).  
SEE ATTACHED DETAILS.
  4. REMOVE SHORING.
