March 9, 2021

RE: Masonic Lodge Roof Repairs – Phase 1  
Structural Recommendations  
Albertson Engineering File #2021-060

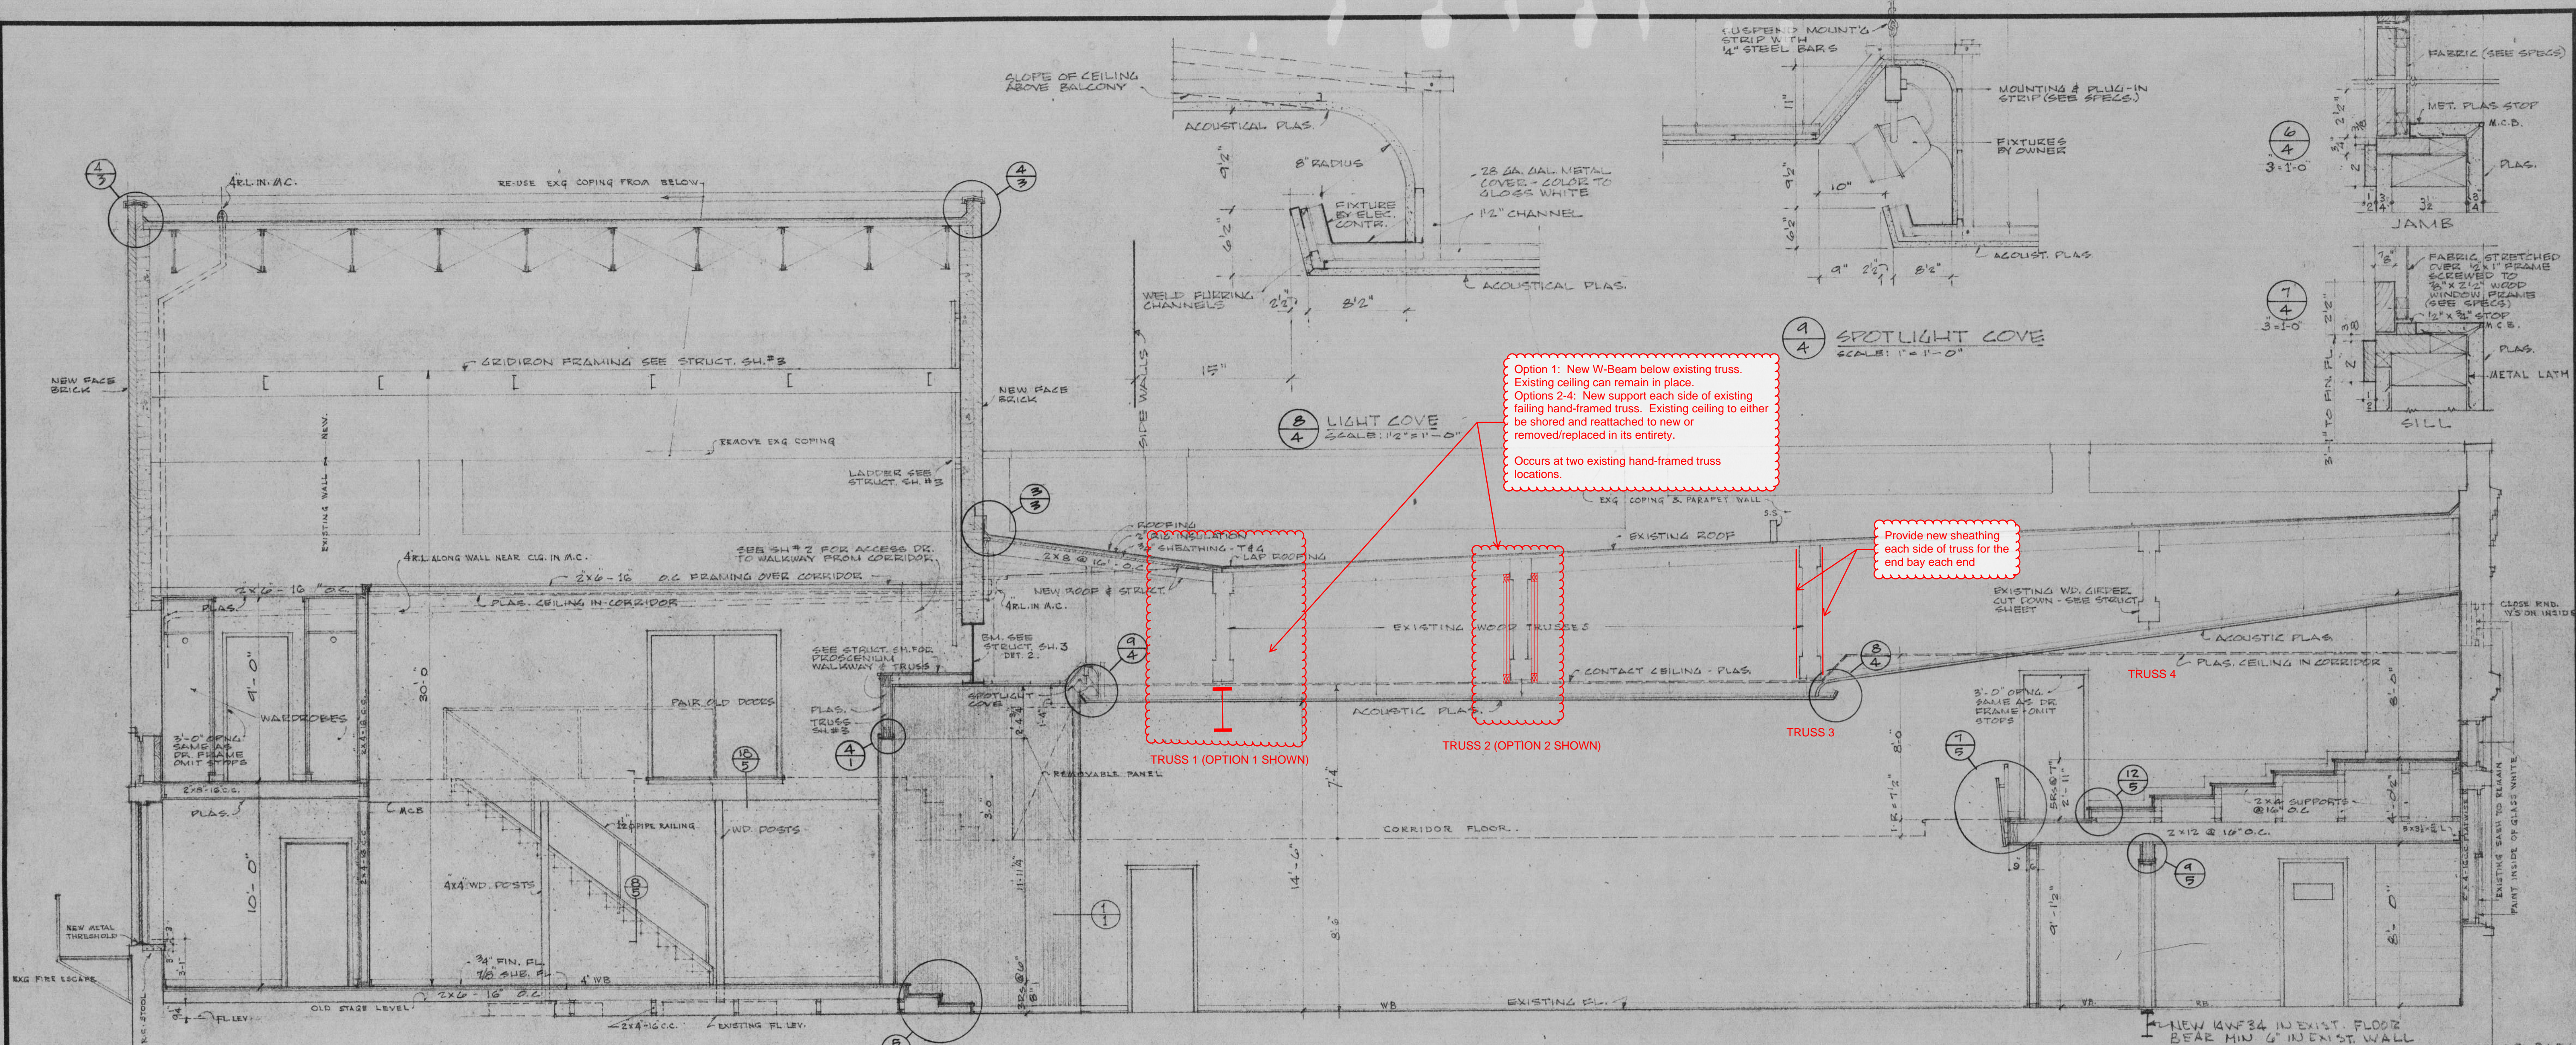
1  
4 LONGITUDINAL SECTION  
SCALE 1/4" = 1'-0"

Truss 3: The existing third truss was field inspected to determine if any distress could be observed. No splitting or other signs of broken members were observed. However, it was noted that the diagonal members of the truss on the far east end did appear to be bowing. Because this occurs in the same vicinity within the truss as the trusses that failed, it would be our recommendation that Truss 3 be strengthened as follows:

- Provide new ½ plywood sheathing on each side of the truss for the first bay of the truss on each end. Solid blocking should be provided between the diagonal members and between the outer ply and the wood sheathing such that the sheathing can be nailed off to the diagonals. Any splices in the sheathing (vertical or horizontal) will need to be blocked. Perimeters of the sheathing should be nailed to existing framing at 3” on center full perimeter, and 12” on center in field.
- Please note that this will effectively cut-off any ‘passing thru’ the attic space from south to north. Each end can still be accessed from their respective ends, but passing from one end to the other will no longer be available.
- Also note that the existing ‘hidden room’ in the attic space on the south side of this truss at the east end will need to be removed in its entirety to get this sheathing installed.

To supplement these recommendations, we have provided redline mark-ups on an existing building section from the plans dated 1959. This, in addition to the repair drawings for the various options that were previously referenced, should help to firm up both repair costs as well as a timeline for completing the repairs. We are prepared to move into Phase 2 services and provide final construction drawings once you have determined which repair option you and the Owner would like to proceed with.

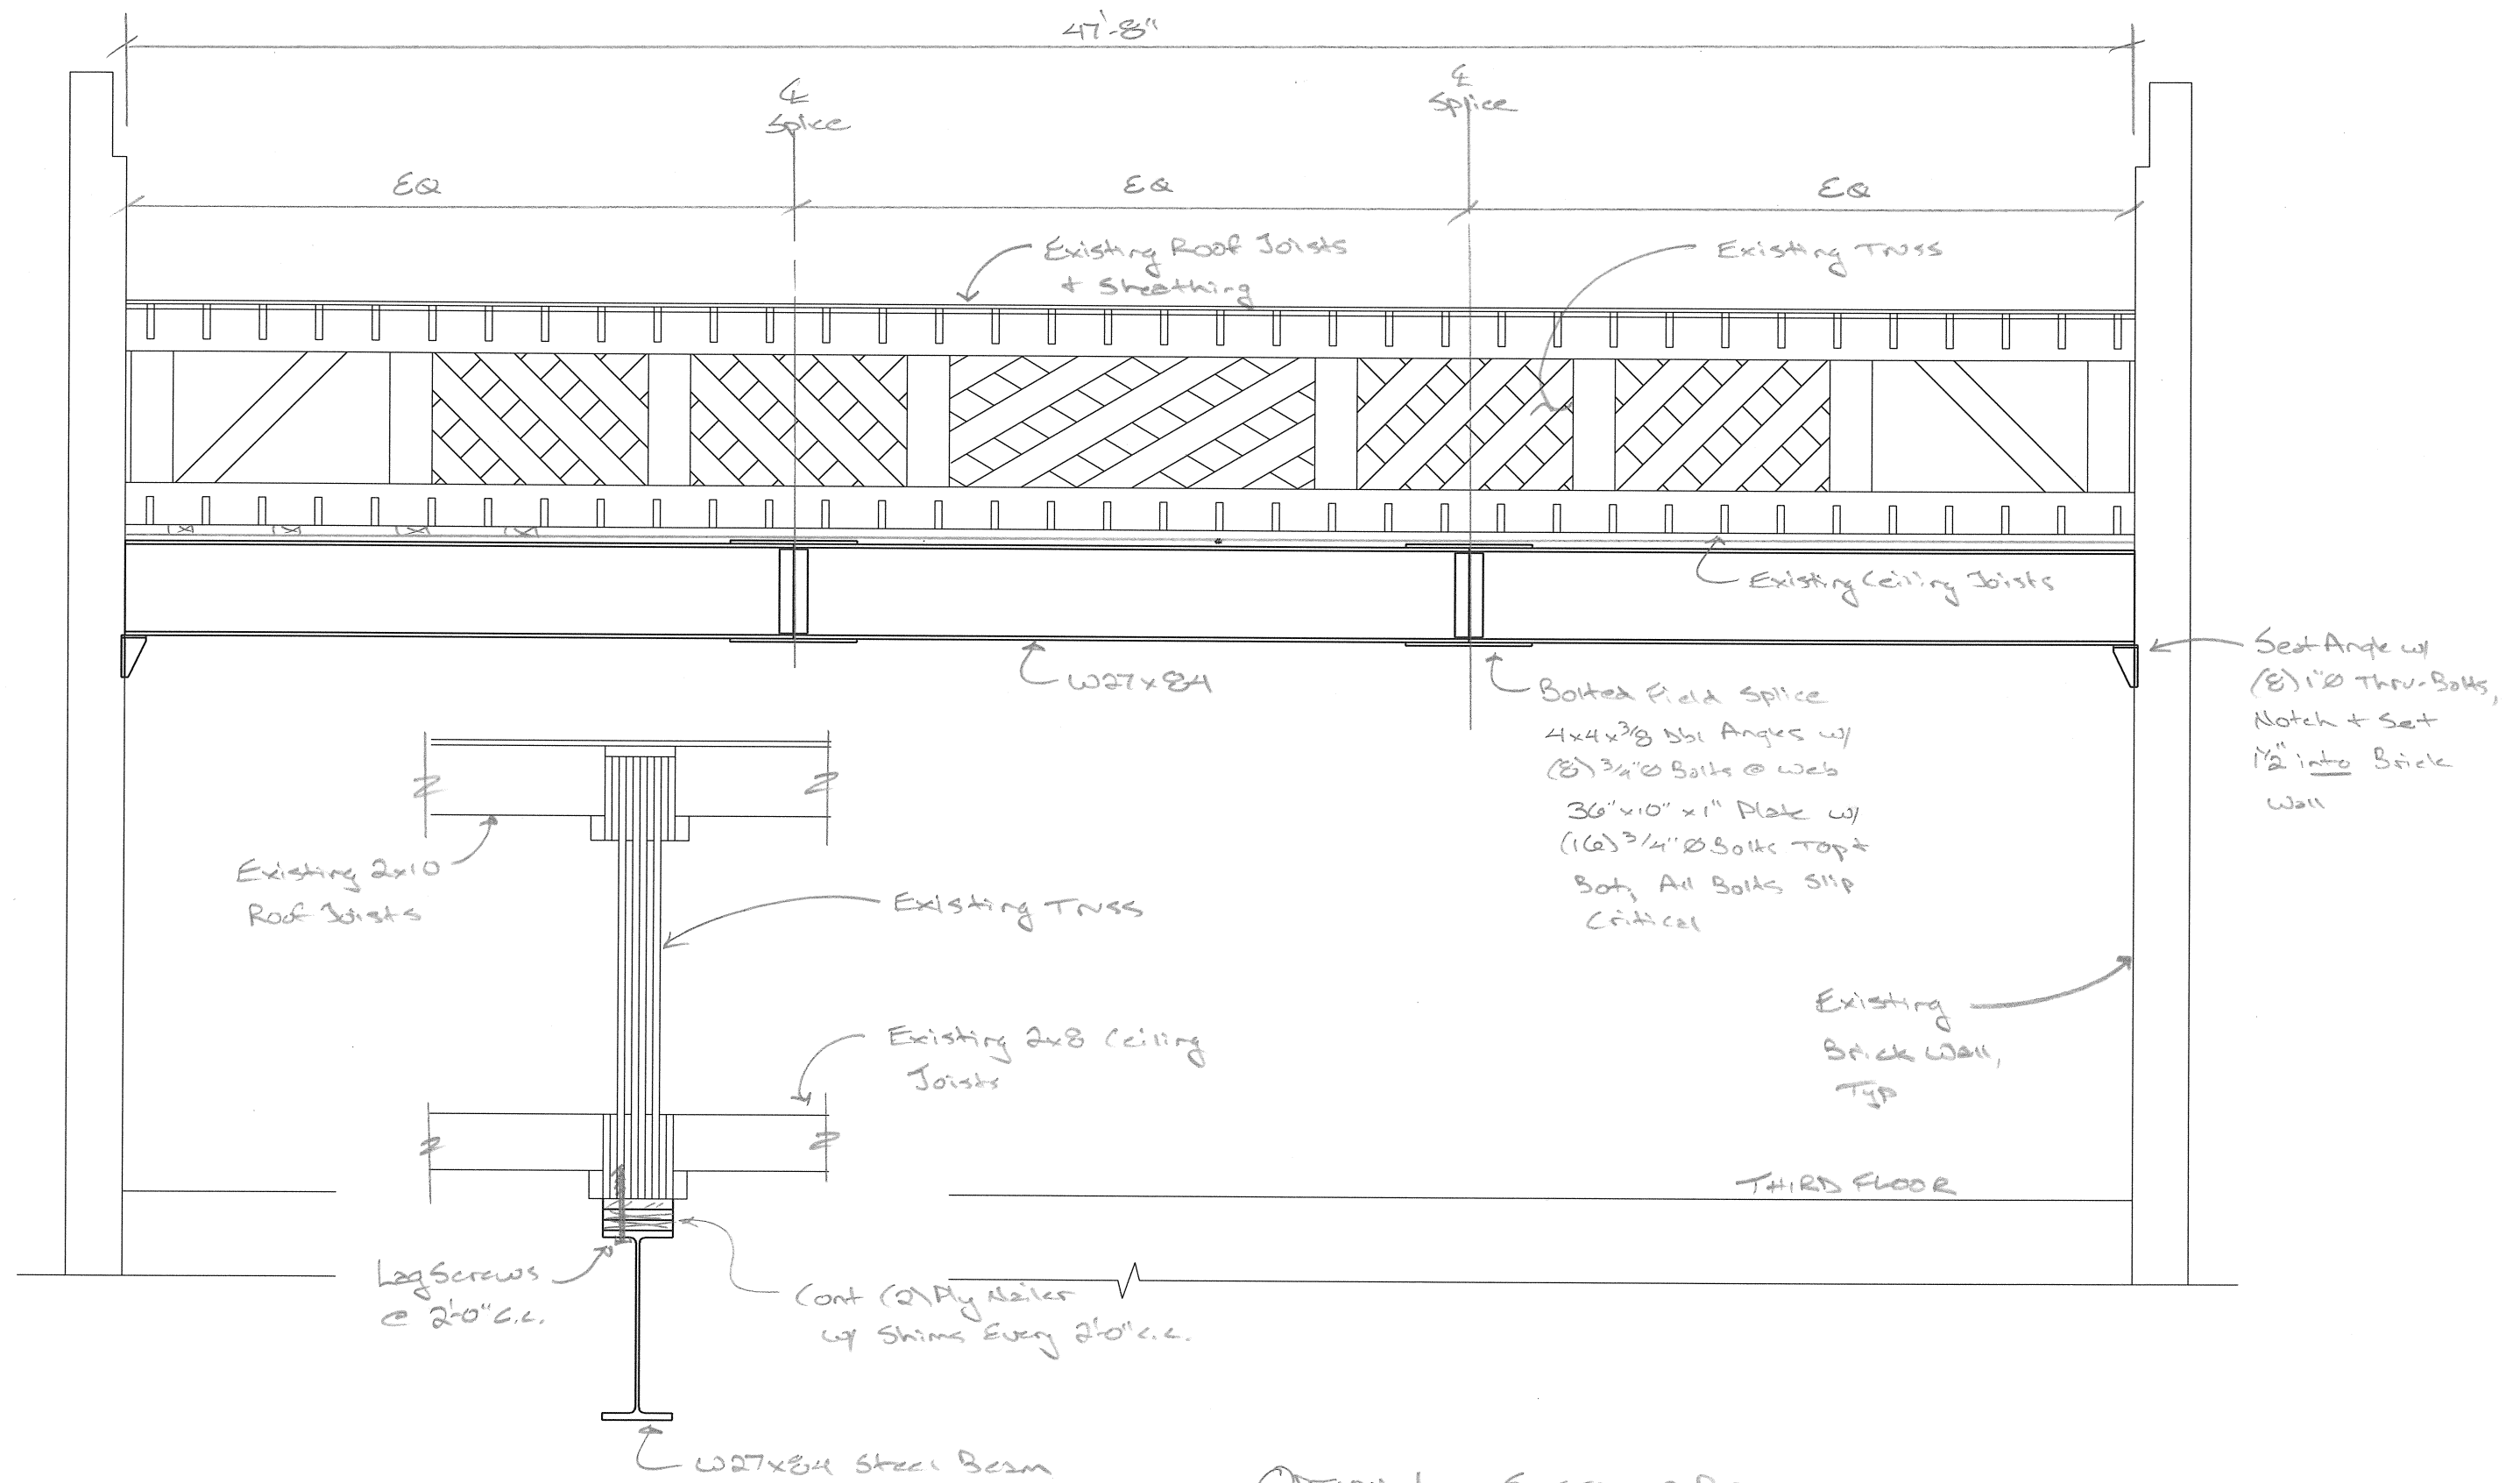
OPTION 1 - STEEL W-BEAM

Truss 1 & Truss 2: Truss 1 and Truss 2 are the trusses that have experienced structural failure and are currently shored. These trusses need to be vertically jacked back into place as much as able, and then replaced with new support framing consisting of one of the following repair options:

- Option 1 – W-Beam: Provide a new W27x84 steel beam below the existing wood trusses.

- Beam to be spliced at roughly third-points using bolted field splice connections. Field splices will require slip critical connections with direct tension washers or equal to verify the bolts have been pretensioned.

- Beams to be supported at each end on the existing brick wall with a seat angle assembly that will be notched slightly into the existing wall for bearing, with pull-out resisted by providing thru-bolts that will pass through the entire brick wall. Exterior plate washers and nuts will remain exposed on the exterior face of wall.

- Beams are to be set slightly below the existing truss with 2x nailers pre-attached to the steel beam. Wood blocking spacers/shims will then be provided at roughly 2'-0" on center to engage the existing truss.

- Both roof and ceiling framing can remain largely in-place during repairs, with a new soffit framed around the new beam as required to aesthetically cover the framing.
