## **Re: Hilo Street Culvert**

Pursuant to Work Assignment number 00-09-2021, “Hilo Street Culvert Replacement – Investigation”, as executed on December 16, 2020, please accept this letter-form report outlining existing conditions, proposed recommendations, and effects of these proposed recommendations on the existing culvert under Hilo Street, its out-falling channel, and the downstream retention pond on the golf course.

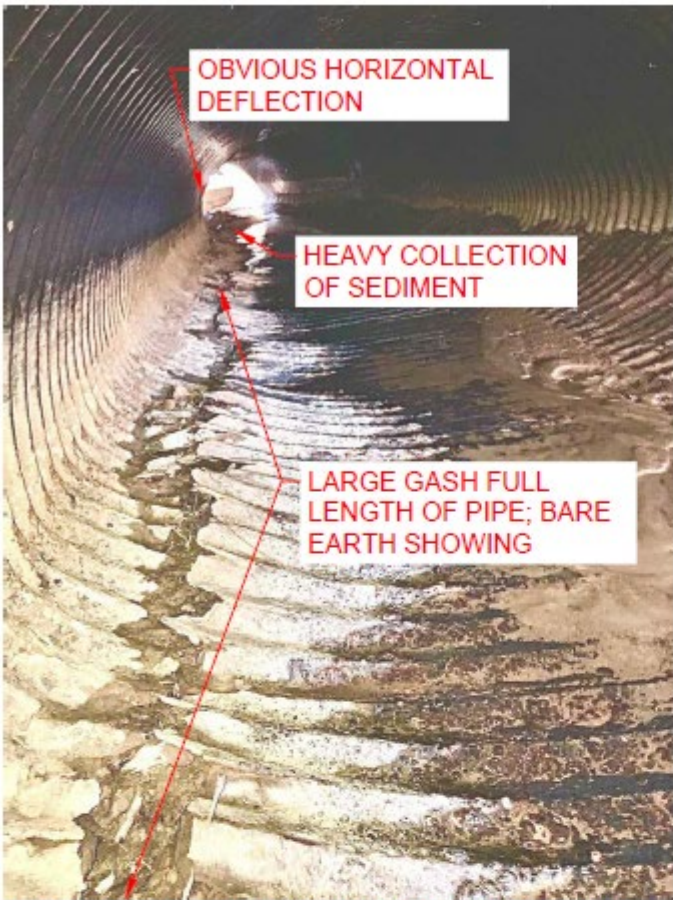
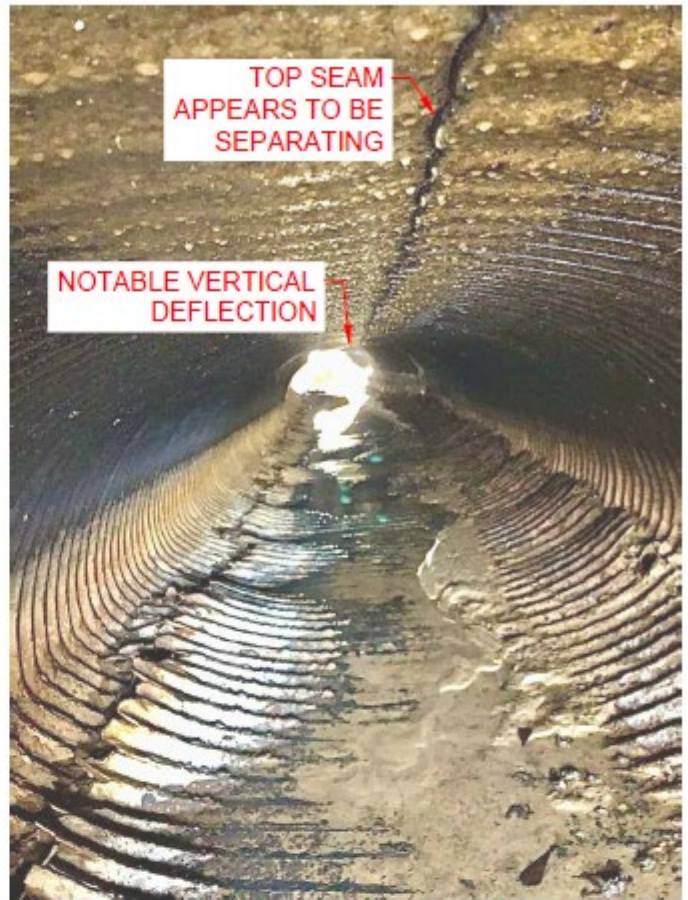
On the downstream culvert, a large (approximately 3"- 4") gash was found to run longitudinally along the majority of the pipe and a seam along the top of the culvert was apparent. This top seam appears to be further separating and does not appear to be part of the pipe's construction (i.e. this seam is not present on the end of this section as viewed from the concrete junction box nor does it appear in the upstream pipe section). This downstream pipe also had a large horizontal deflection and a notable vertical deflection. A large gap was noted between the outside diameter of this culvert and the concrete junction box. Finally collected sediment, including a "pile", was noted in various portions of this culvert.

In the downstream section, the horizontal deflection is likely an installation issue, however, the vertical deflection could be indicative of settlement of a section(s) of the culvert. In this case, the vertical deflection is near the sediment pile suggesting it possible that vertical deflection has compromised the pipe integrity and is allowing sediment to enter the culvert; were this the case, it appears the vertical deflection is under Hilo Street which may lead to road failure. The obvious longitudinal failure along the flow line and the probable longitudinal failure along the culvert's top compromise the overall structural integrity of the culvert; a complete circular or arch culvert will evenly distribute load around the pipe's circumference (similar to trying to squeeze an egg in your hand). The "breaks" in these sections will limit the distribution of the loading and cause the upper sections to bear more of the loading likely to failure. The annular space between the culvert and concrete junction box further allows for water flow on the outside of the culvert which can similarly cause sediment loss around the pipe. Collectively the failures noted create high potential for sediment loss which will eventually cause failure of Hilo Street.

LOOKING UPSTREAM ON DOWNSTREAM CULVERT

Due to the severe existing pipe deterioration, its lower cost, the higher likelihood of providing a structurally-sound culvert, the ability to select the culvert size, the ability to remove horizontal and vertical deflections, and concrete’s less corrosive nature, it is recommended to perform a complete removal and replacement of this culvert with a 40”x65” reinforced concrete arch pipe.

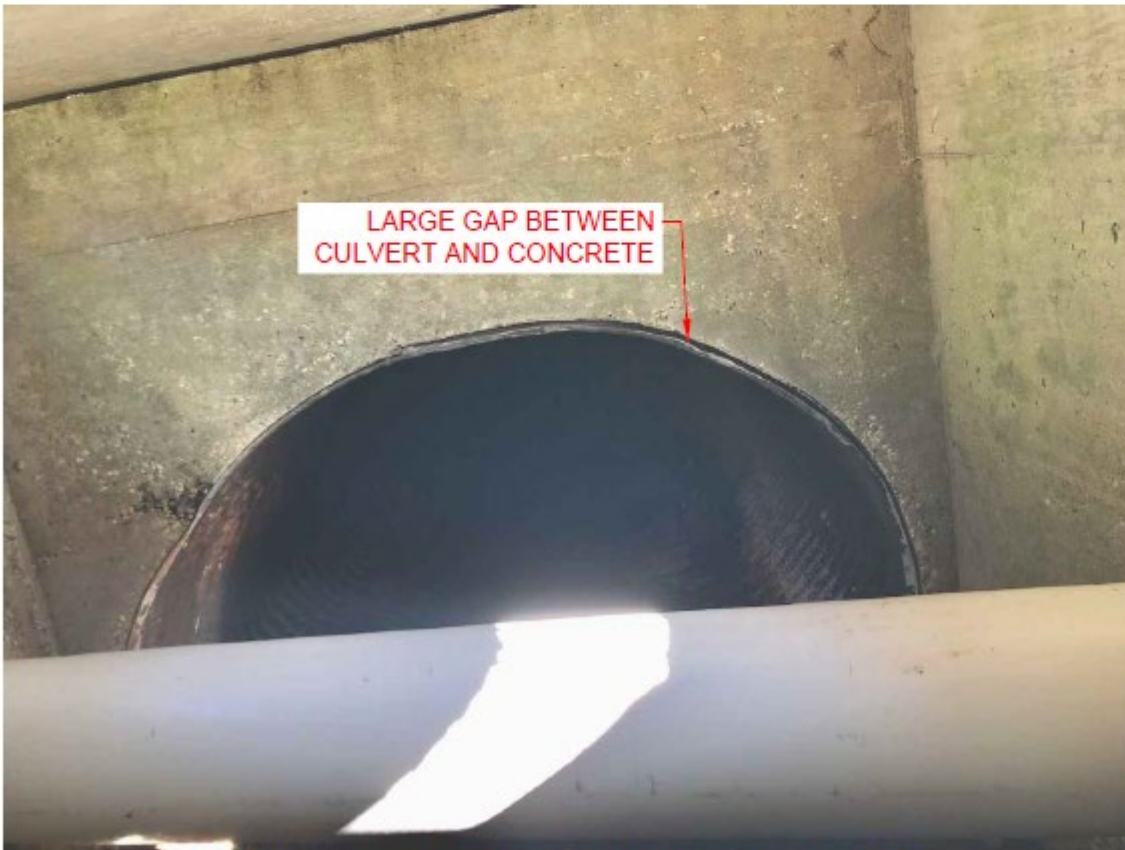
INTERIOR OF JUNCTION BOX LOOKING DOWNSTREAM

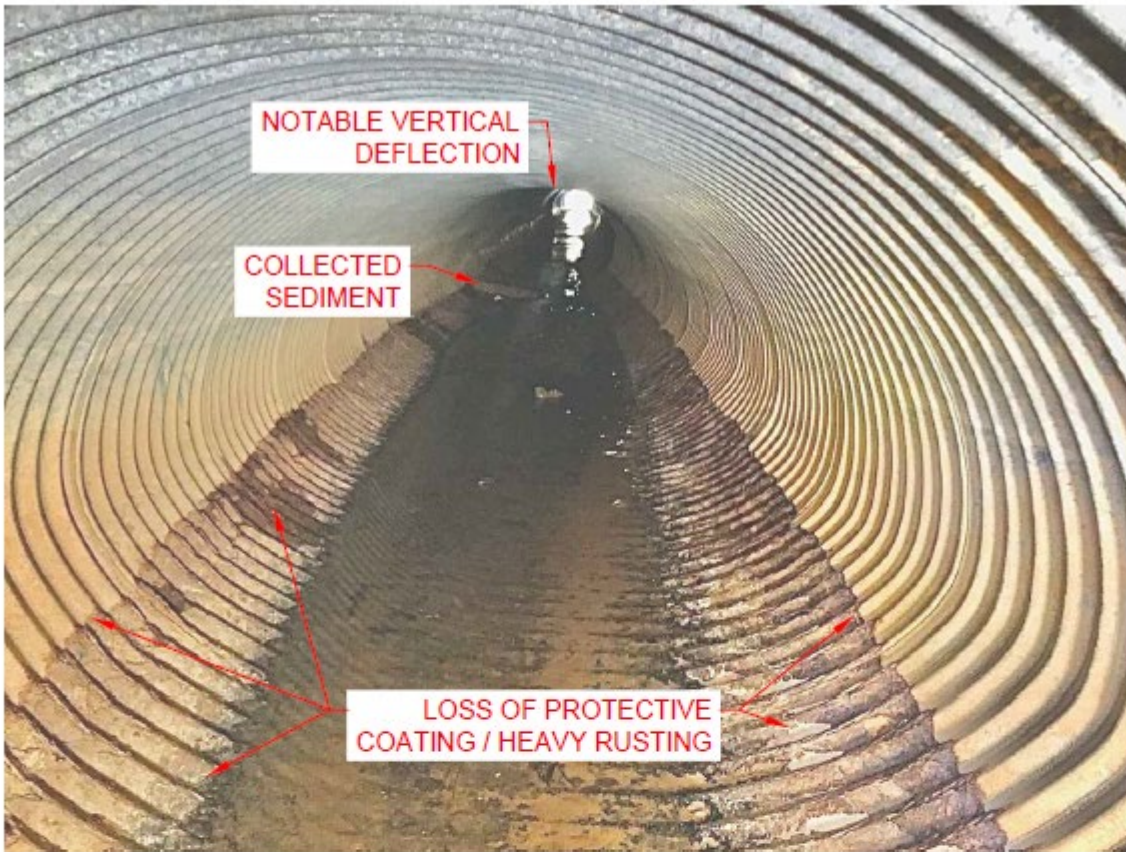
The upstream culvert similarly had a vertical deflection and collected sediment. Most notable, the upstream end of this upstream culvert has experienced significant section loss along the flow line of the pipe; this section loss is estimated to be 25% of the entire pipe's inner diameter. This upstream culvert had a surficial sinkhole above the culvert further suggesting sediment loss through the pipe walls.

The upstream culvert analysis is similar to the downstream culvert. Notably, it appears the vertical deflection in the culvert has sediment collected underneath it; this appears to be approximately in line with the above grade sinkhole. The flowline section loss at the upstream end is compromising structural integrity.

LOOKING UPSTREAM ON UPSTREAM CULVERT

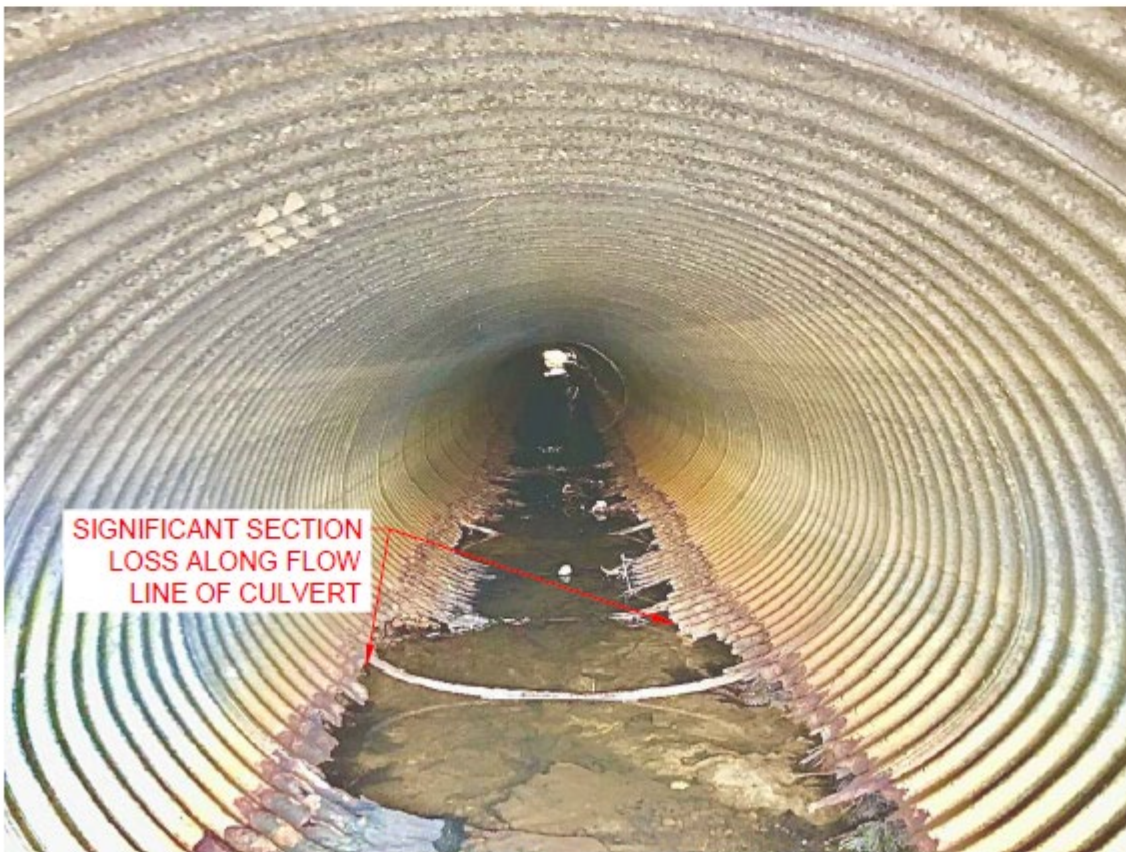
LOOKING DOWNSTREAM ON UPSTREAM CULVERT

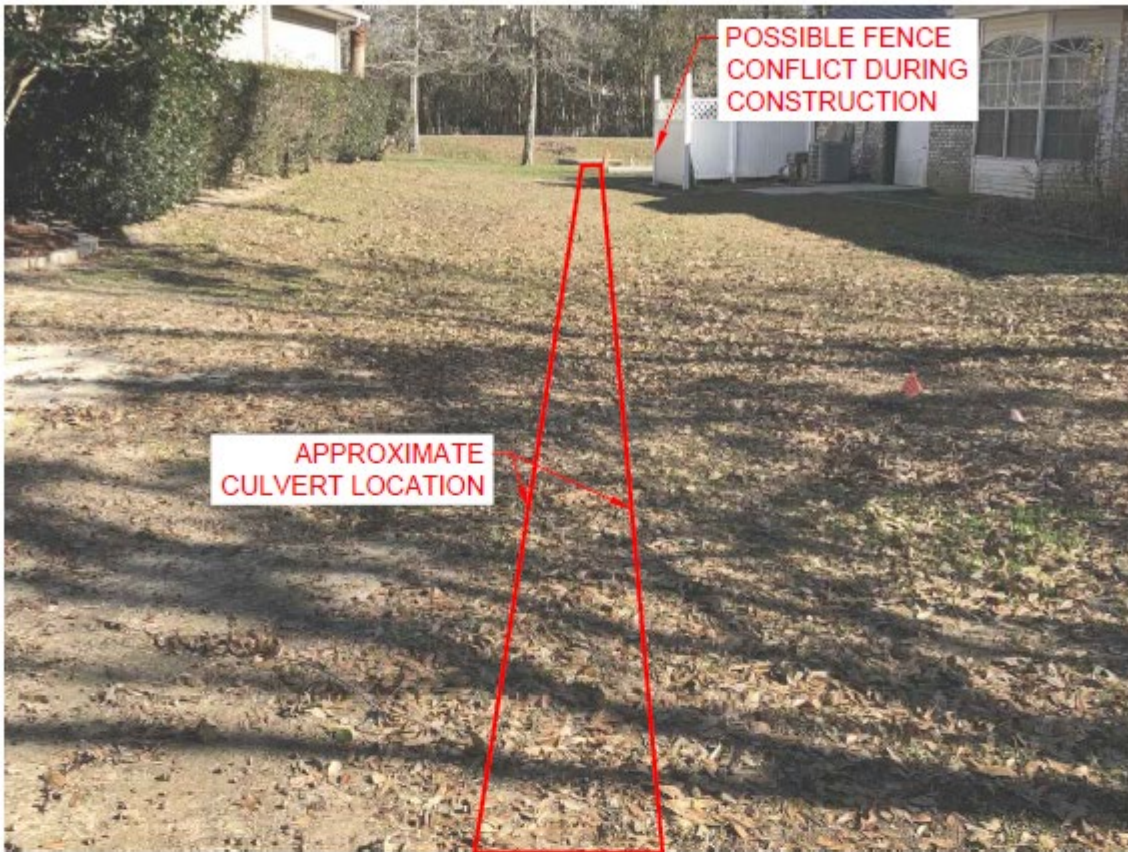
LOOKING DOWNSTREAM ON UPSTREAM CULVERT (GRADE LEVEL)

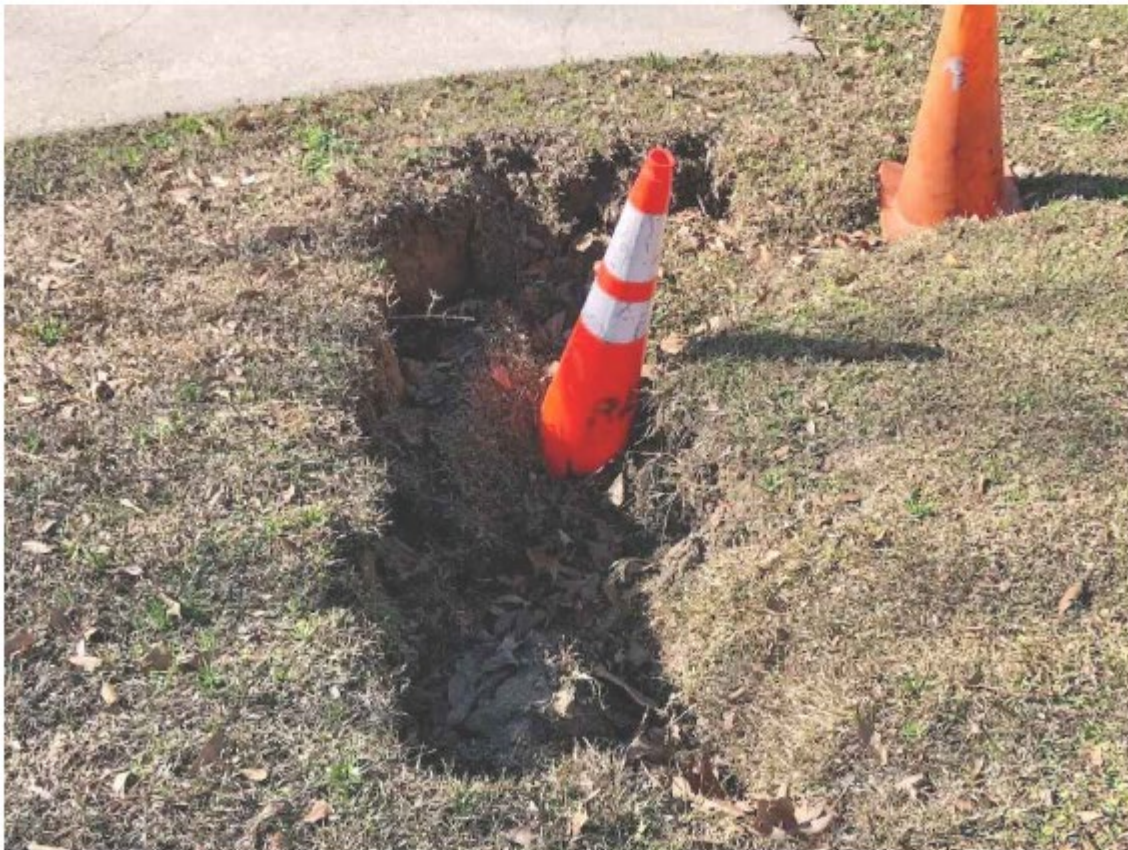
AT-GRADE SINKHOLE
